Appendix B

Tongass Best Management Practice Implementation and Effectiveness Monitoring Report: Fiscal Year 2012

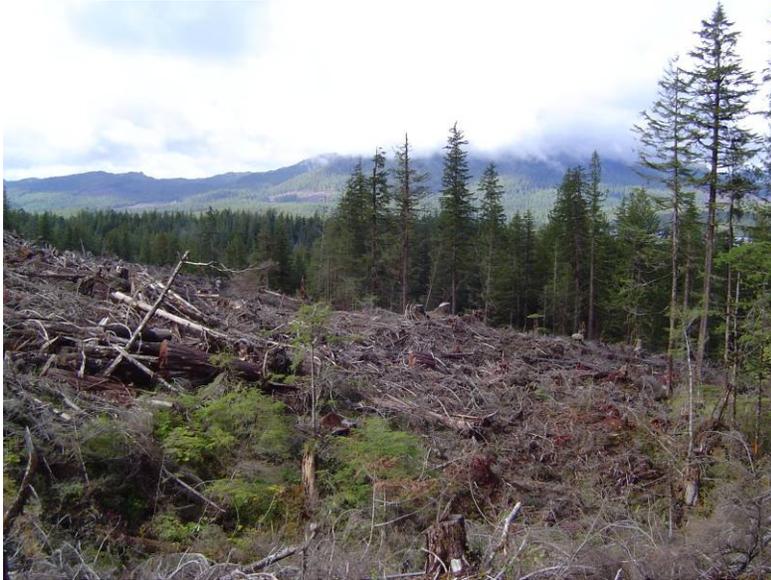
Picture 1. Slake Timber Sale unit 67B

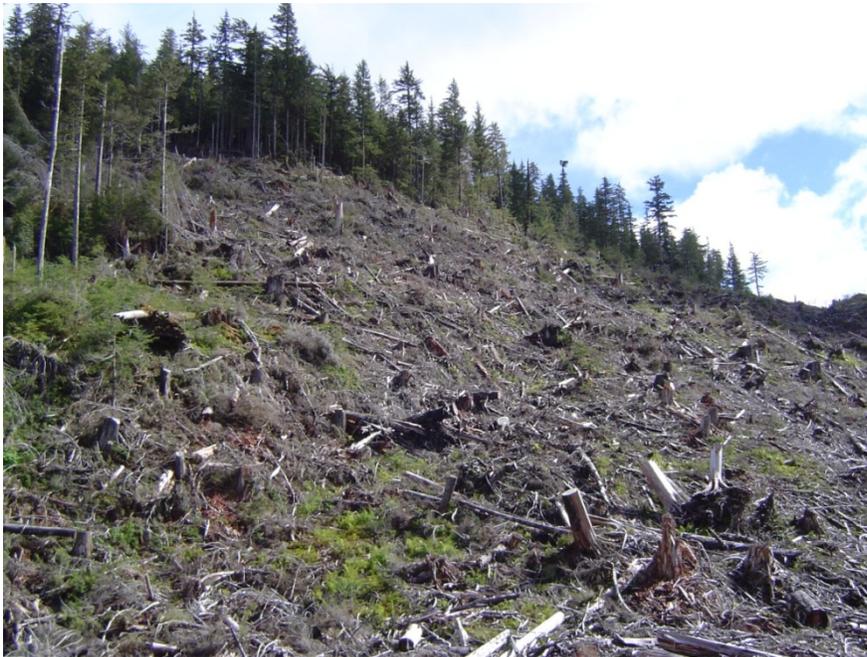
Picture 2. Slake Timber Sale unit 73D

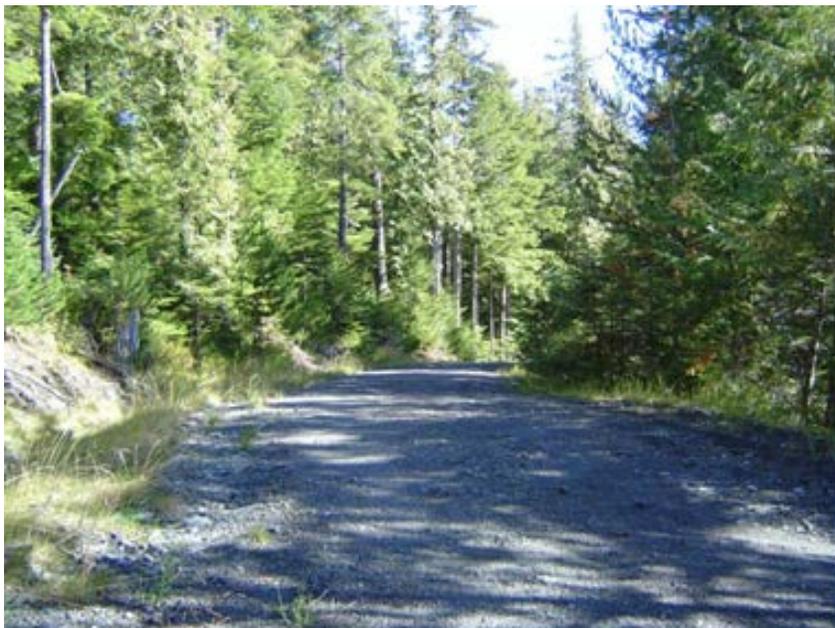
Picture 3. Prince of Wales Road 3000360 road corridor

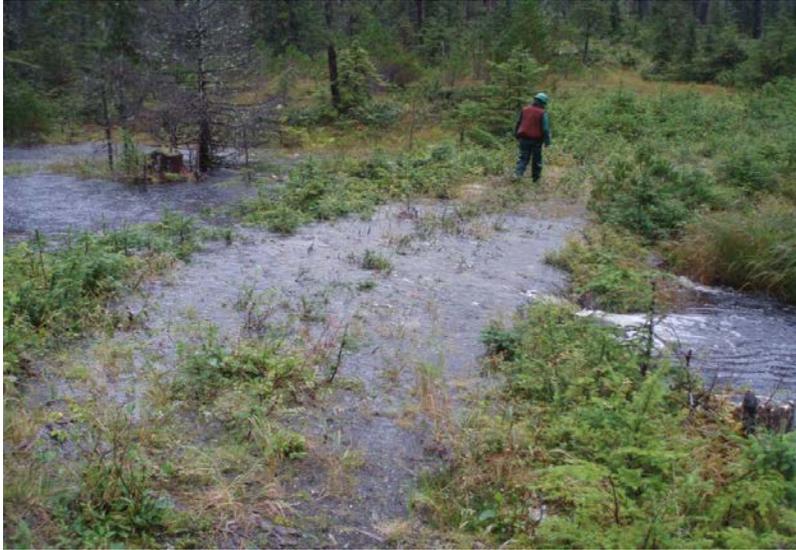
Picture 4. Mitkof road 6200 MP 0.273

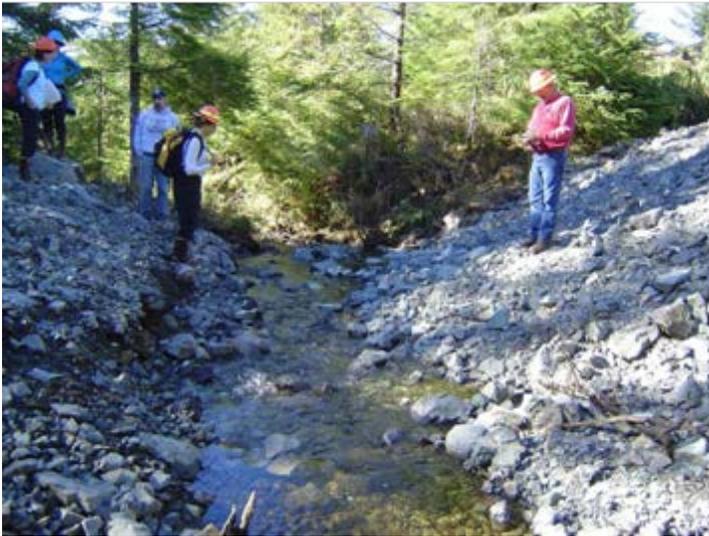
Picture 5. Road 3000382 culvert removal site

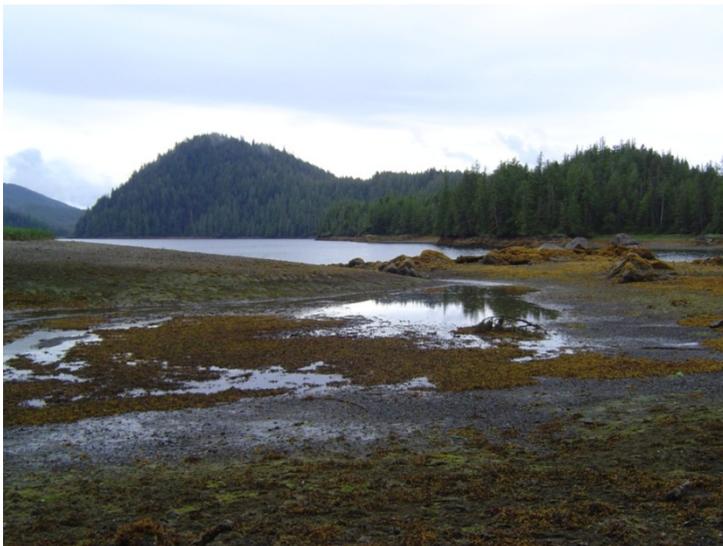
Picture 6. Winstanley Island Dispersed Recreation Site
