**United States Department of Agriculture
Forest Service**

Aviation Safety Alert

No. 2004-07

M-18 Dromader Throttle Clevis Assembly

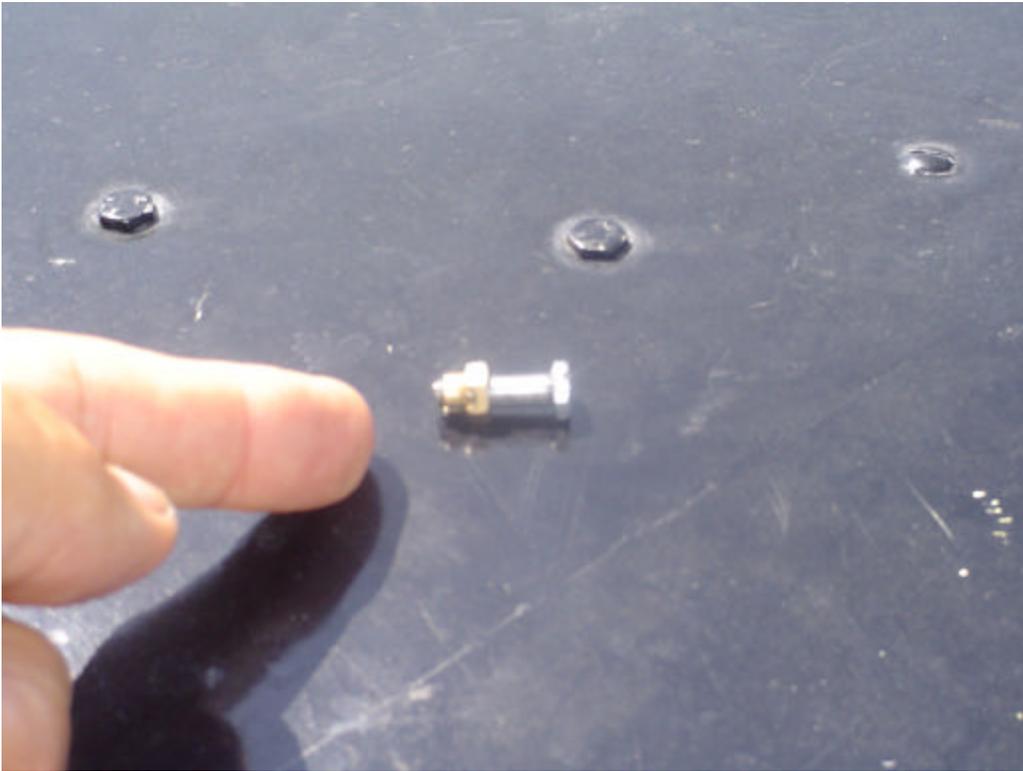
On the afternoon of 7/27/04 investigators inspected the throttle linkage assembly on a second Dromader that was sent to replace the mishap aircraft. A nylon lock nut had been installed on the clevis bolt and was loose enough to move on and off the bolt by finger. The attached photos show the repair made by the mechanic which included a drilled bolt and castellated nut with a cotter pin to prevent backing off.

Nylon locking nut

Recommendation: The FAA has been contacted to suggest that the manufacturer issue a Service Bulletin on this issue and establish a set procedure for attachment of the clevis bolt assembly. In the interim, it is recommended that Maintenance Inspectors inspect all M-18 Dromader engines for this discrepancy. Assemblies that are found to be installed with nylon locking nuts should be immediately replaced and a SAFECOM filed to document the finding.

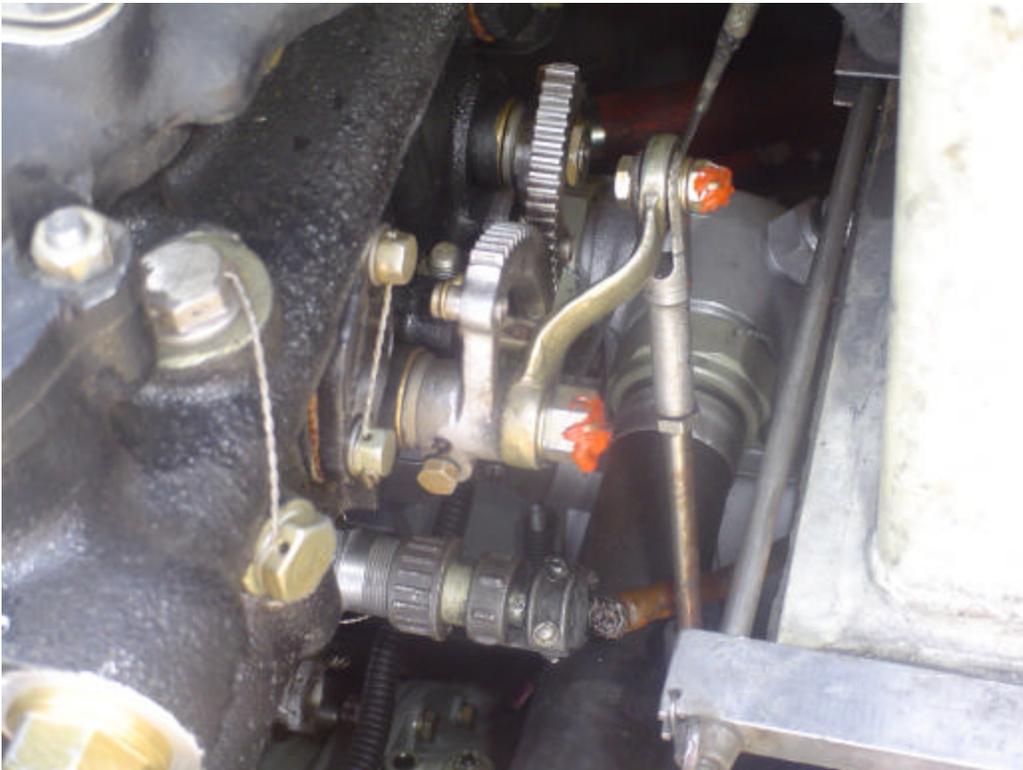
Castellated nut with cotter pin
