Date of Report: 10/12/2022

BURNED-AREA REPORT

Gifford-Pinchot National Forest

A. Fire Name: Goat Rocks
Kalama

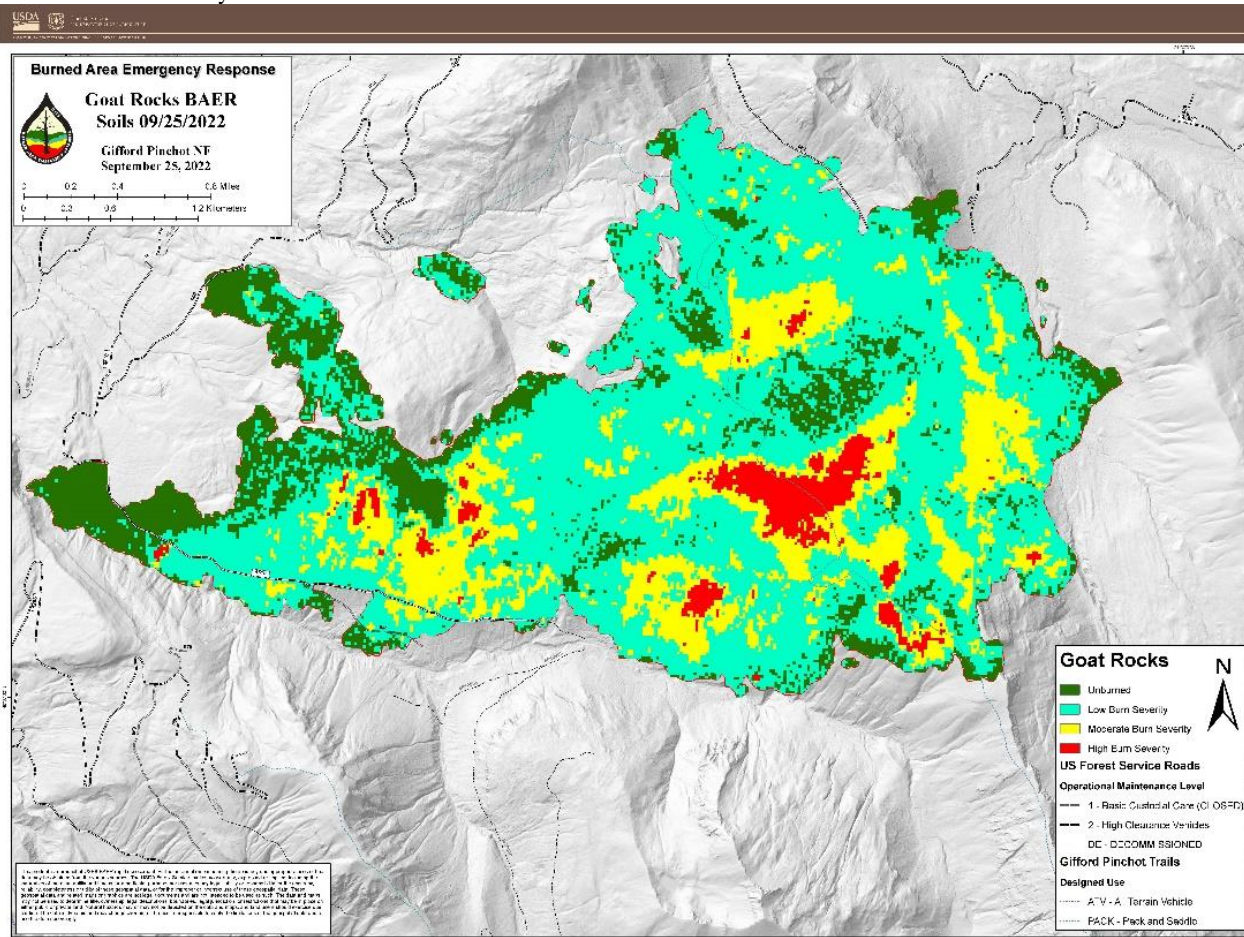
Figure 1. Soil Burn Severity of Goat Rocks Fire

Soil Burn Severity	GPNF Goat Rocks	GPNF Kalama	State	Private
Unburned/ Very Low	617	105	0	0
Low	2,127	169	0	0
Moderate	719	25	0	0
High	144	2	0	0
Total	3,608	352	0	0

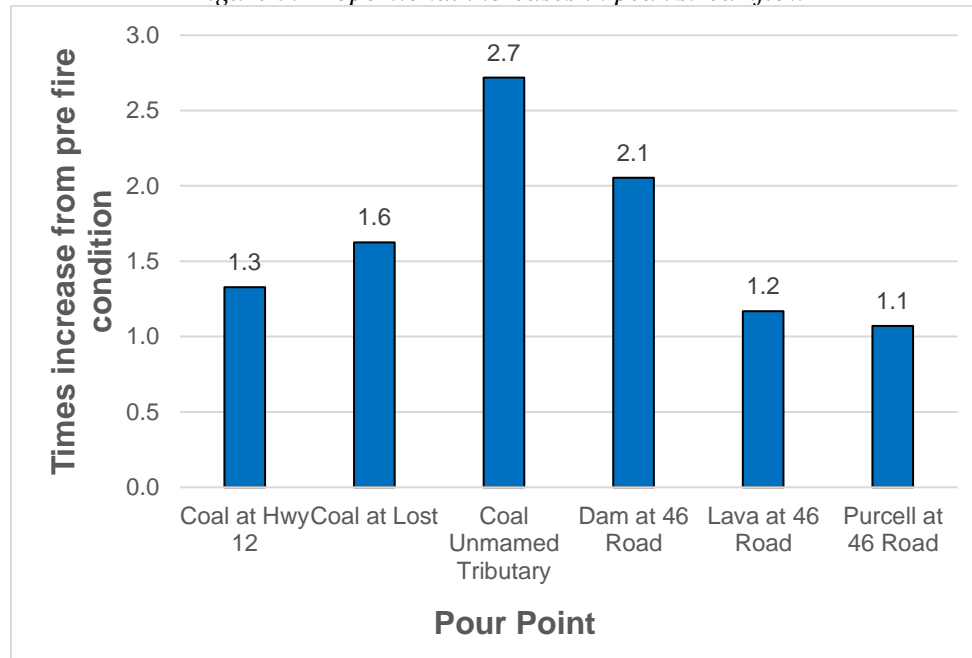
Figure 3. Proportional increases in peak streamflow

Six pour points were modeled to assess fire impacts on peak streamflows. All of the pour points except Coal at Lost and Coal unnamed tributary were modeled to assess potential impacts to infrastructure. Coal at Lost and Coal unnamed tributary were modeled to assess the high range of fire impacts on peak streamflows.

Pour Point	Acres	Pre-Fire Discharge (cfs)	Post-Fire Discharge (cfs)	Times Increase
Coal at Hwy 12	6,593	755	1002	1.3
Coal at Lost	3,008	368	599	1.6
Coal Unnamed Tributary	784	103	279	2.7
Dam at 46	1,454	181	372	2.1
Lava at 46	2,291	278	325	1.2
Purcell at 46	1,354	170	182	1.1

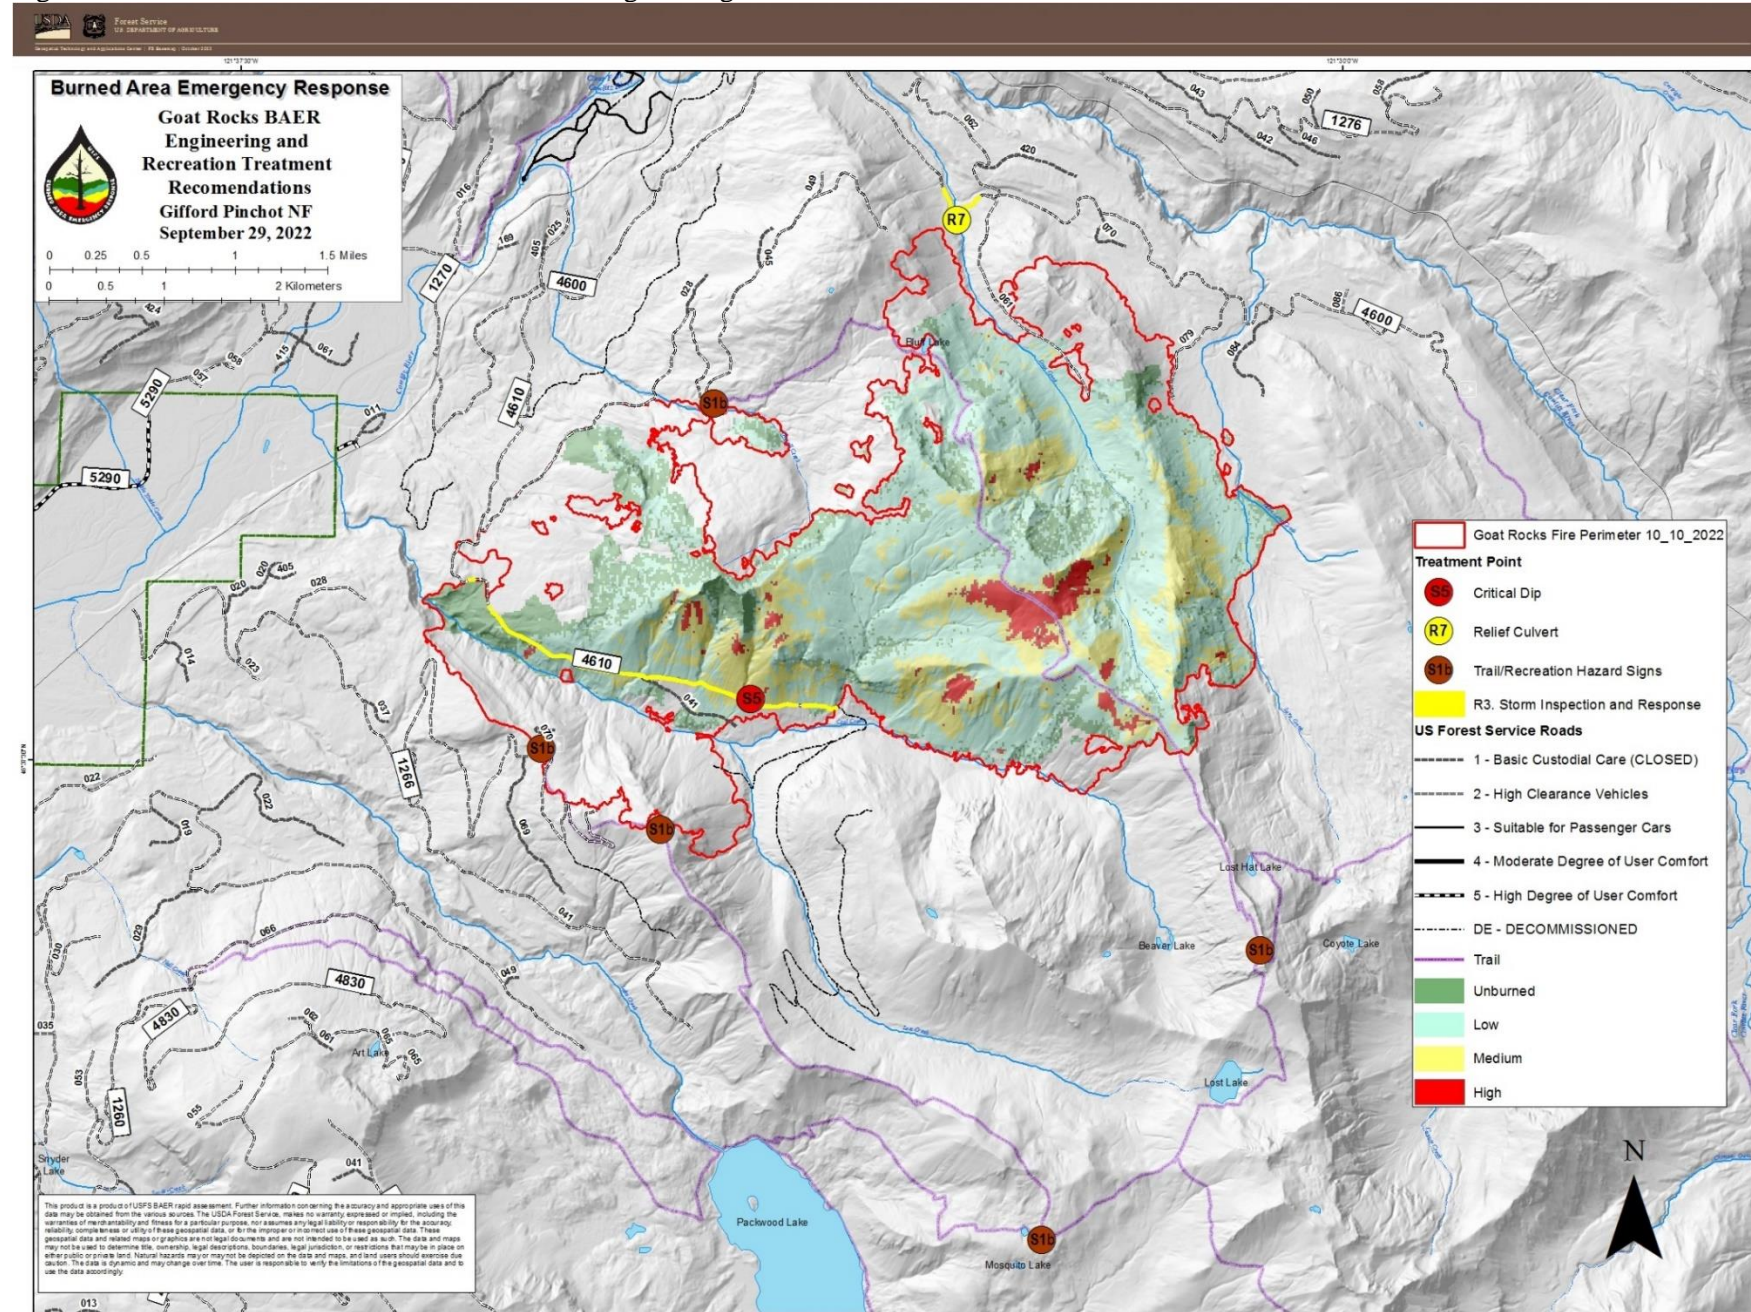
Figure 4. Goat Rocks Fire BAER Treatments for Engineering and Recreation.

Life/ Property/ Resources	Critical Value	Threat to Value	Probability of Damage or Loss	Magnitude of Consequence	Rationale	Risk	Treatment Options Considered	Recommended Treatment
Property - Roads	4600000	Increased flow causing road prism and drainage structure failures	Likely	Major	MP 4.9 Dam Cr Culvert. Large portion of Dam Creek drainage Low to High burn severity, evidence of previous overtopping, deposition, existing culvert damage, culvert inlet skewed to stream, deep 30ft-fill on Dam Creek, and lots of debris readily moving through the system.	High	R3. Storm Inspection and Response, R4.Culvert Removal R5. Critical Dip, R6.Culvert Modification- (NewRiser + Crushed inlet repair), R7.Relief Culvert, R9.Debris Rack, R10. Channel Clearing(wood). R13.Fill-Slope Stabilization	R3. Storm Inspection and Response, R6.Culvert Modification- (NewRiser + Crushed inlet repair), R7.Relief Culvert R13.Fill-Slope Stabilization

Property - Roads	4610000	Increased flow causing road prism and drainage structure failures	Likely	Moderate	Previous Washouts, flashy steep cross slopes, moderate to high burn severity, If road failure or diversion occurred at high risk stream crossings, the loss of property would be considered moderate	High	R1. Stormproofing R3. Storm Inspection and Response R5. Critical Dip	R1. Stormproofing R3. Storm Inspection and Response R5. Critical Dip
Property - Roads	4612000	Increased flow causing road prism and drainage structure failures	Unlikely	Minor	Road is hydrostabilized	Very Low	None	No Treatment

1. No trail treatments recommended.
2. Protect road investments from becoming damaged due to increased post-fire runoff . R3. Storm Inspection and Response, R6. Clean and Repair Culvert Inlet, R7. Relief Culvert 48" CMP, R13. Fill Slope Stabilization (Riprap)

1. Protect human life and safety by raising awareness through posting hazard warning signs at recreation sites, trailheads, trails (S1a – Road Hazard Signs, S1b – Trail/Recreation Hazard signs).
2. Protect human life and safety by temporarily closing Road 4610 (S2. Physical Closure Devices (gate, berm, boulders, etc.)

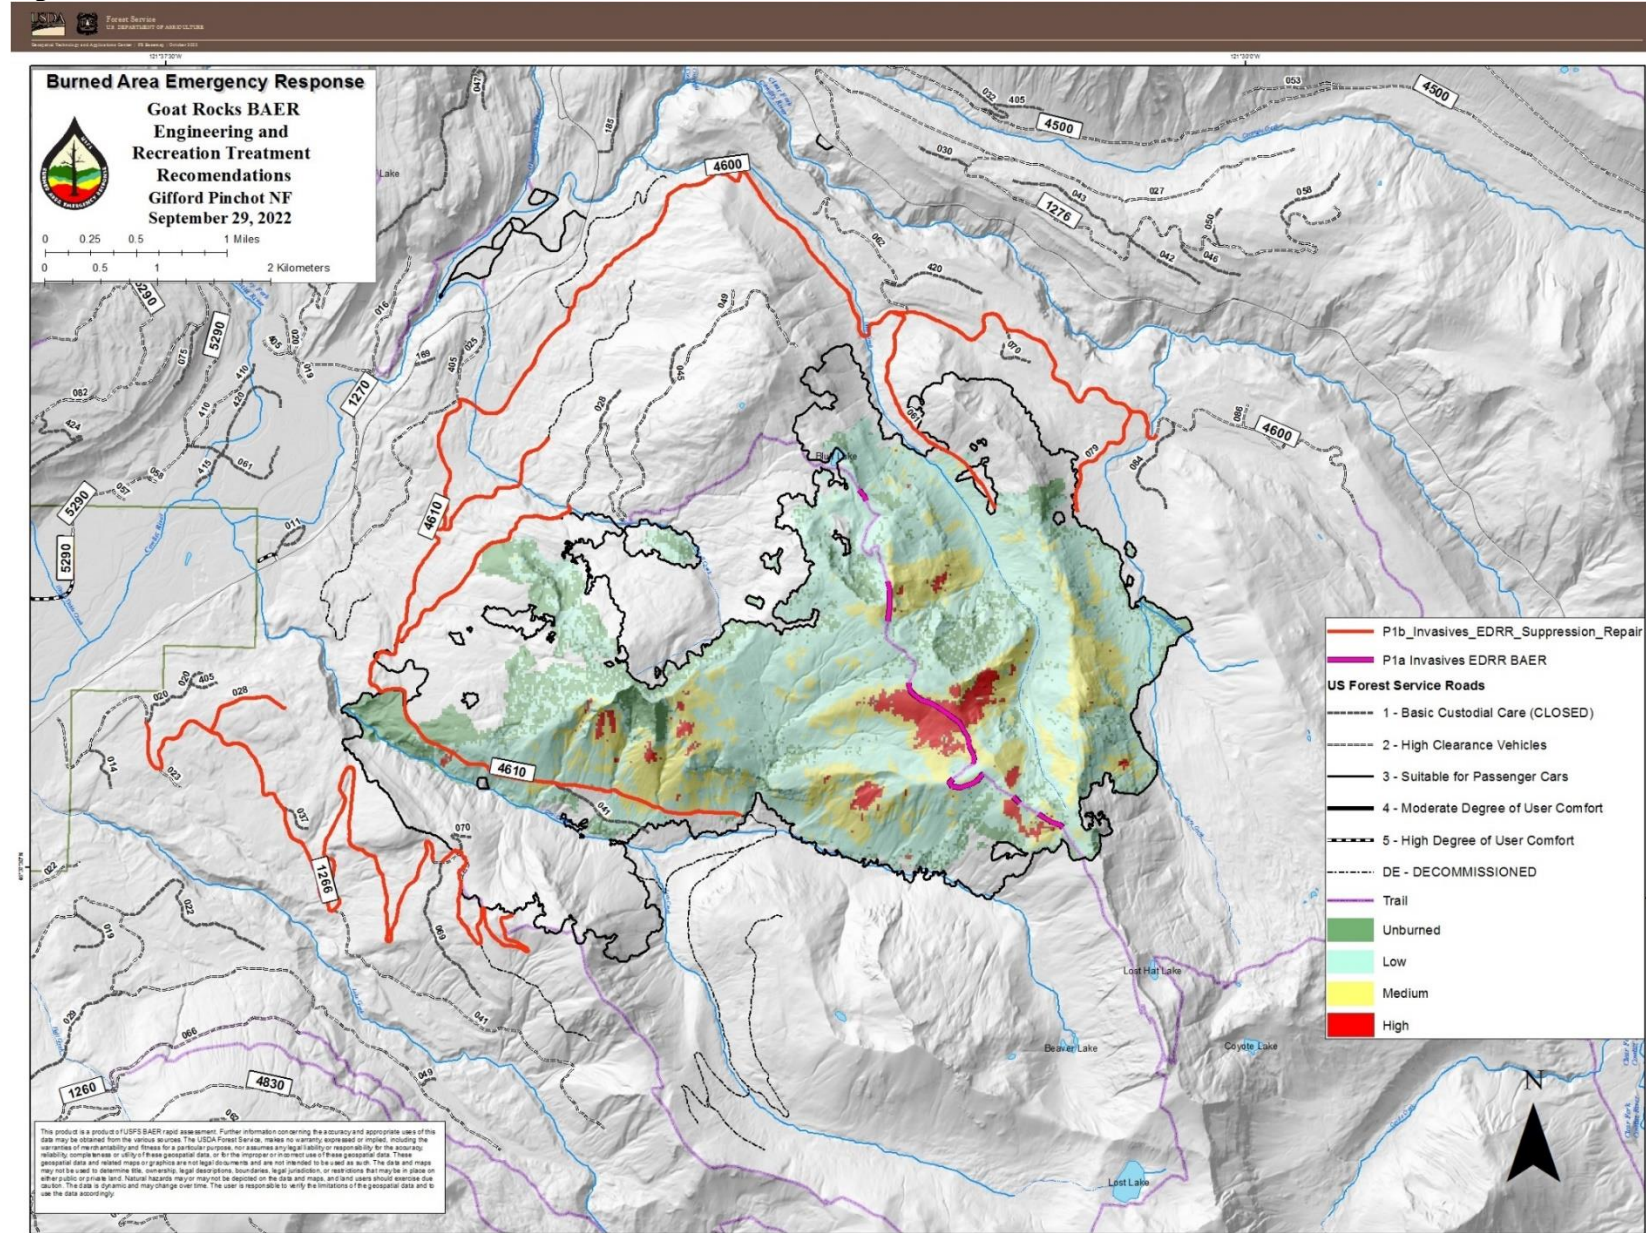
Figure 5. Goat Rocks Fire BAER Treatments for Invasive Weeds.

Natural Resources - Native Plants	Native and Naturalized Plant Communities - Invasives within Burned Area	Native Plants- Invasive plant colonization of undisturbed (weed-free) areas within the burned,area	Likely	Moderate	Areas of high and moderate vegetation mortality (estimated here by soil burn severity) are highly susceptible to invasion by high priority noxious weed species. Road and Trail system in fire perimeter has	High	P1a. Invasives EDRR - BAER	P1a. Invasives EDRR - BAER – areas of high and moderate burn severity and adjacent to FS system roads and trails in 2023.

periodic, infestations of high priority weed species which provide seed sources into newly fire disturbed areas. Judged moderate because prior information about invasive species within the burned area is lacking, but noxious weed presence is believed to be minimal away from system roads. Precautions should be taken in case there were undetected infestations of invasive species that could expand following fire-generated disturbance.			
Resources - Hydraulic Function	Loss of hydrologic function in high to moderate soil burn severity.	Loss of hydraulic function in high to moderate SBS	Likely	Minor	Low magnitude	Low	No Treatment	No Treatment
Resources - Soil Productivity	Loss of soil productivity in high to moderate soil burn severity.	Loss of soil productivity in high to moderate soil burn severity.	Likely	Moderate	Moderate change of loss of soil in Moderate and High SBS	High	Small area of moderate and high SBS, No Treatment	No Treatment

1. Promote and protect native and naturalized vegetative plant communities by reducing the spread of noxious weeds (P1b. Invasives EDRR- Suppression Repair)

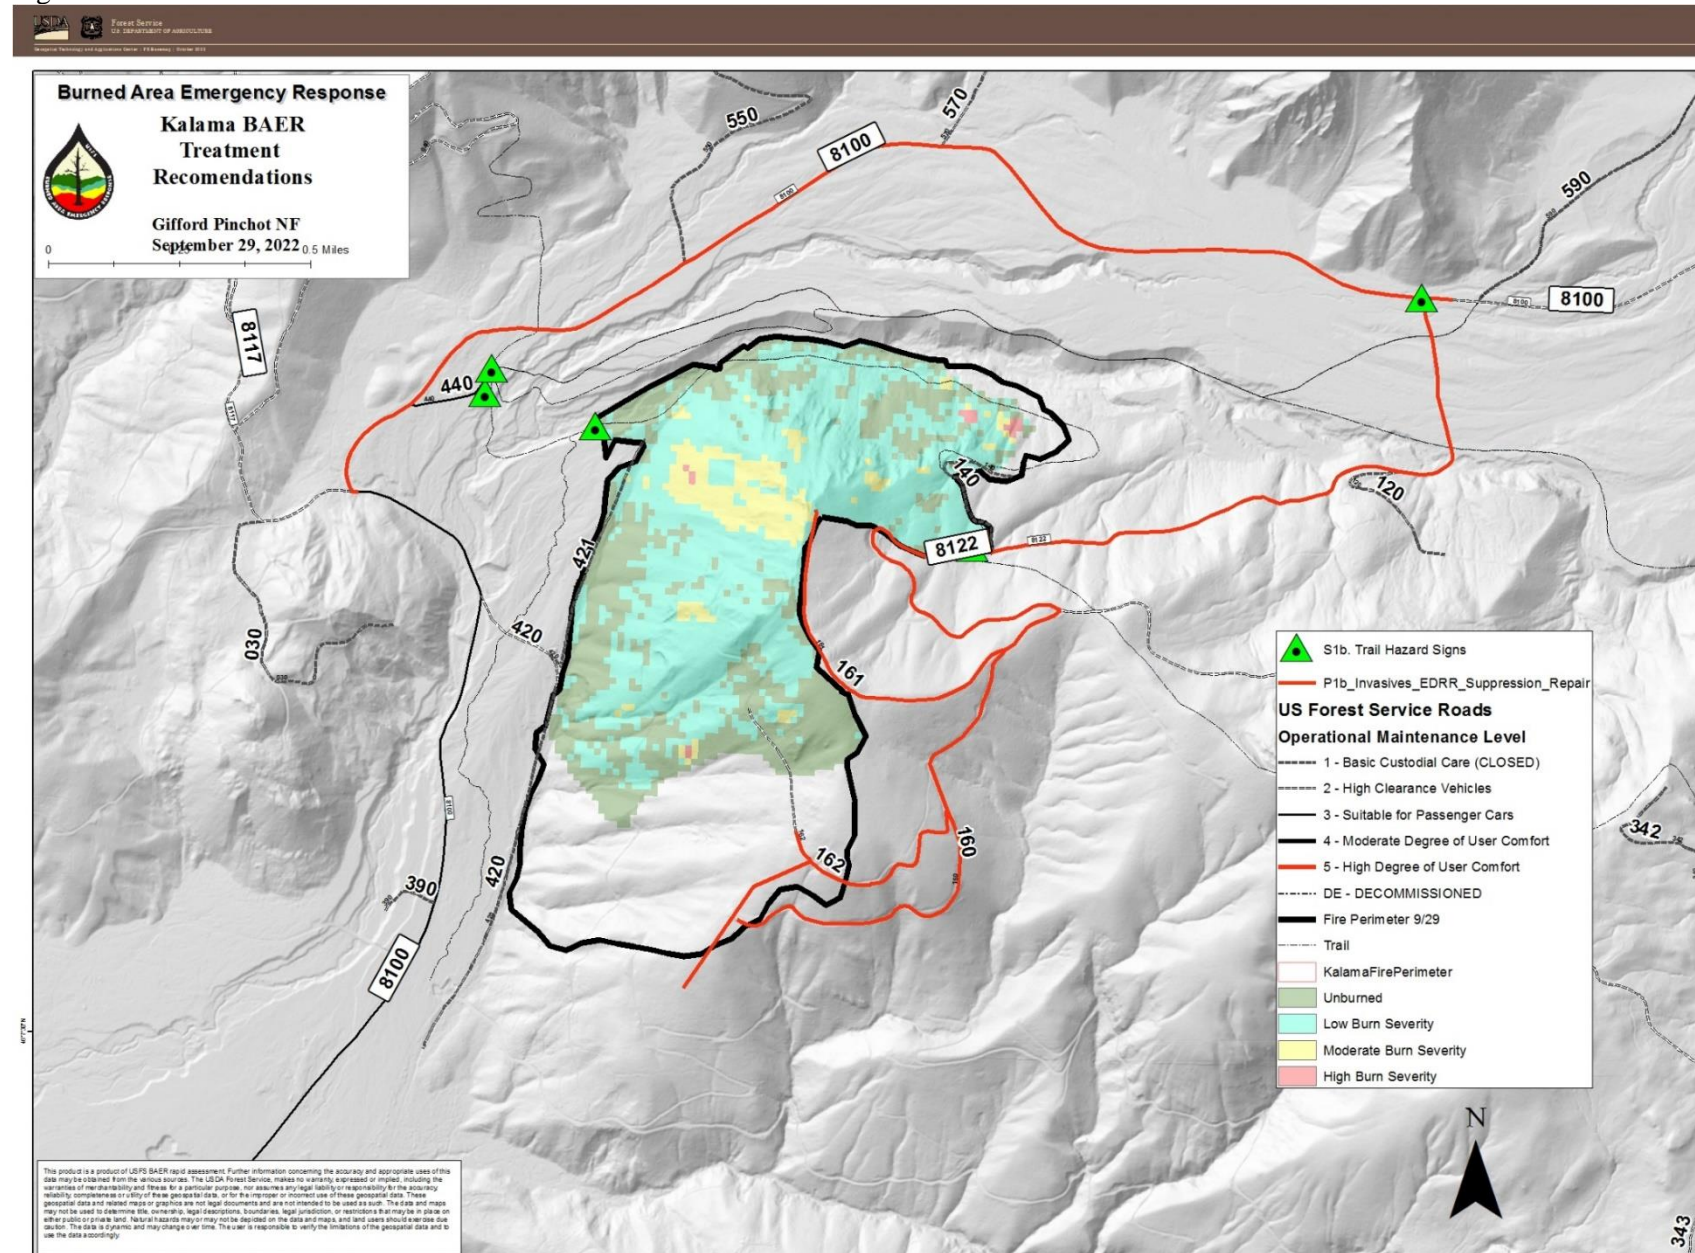
Figure 6. Kalama Fire Recreation and Invasive Weed BAER Treatments.

Life/ Property/ Resources	Critical Value	Threat to Value	Probability of Damage or Loss	Magnitude of Consequence	Rationale for Magnitude	Risk	Treatment Options Considered	Recommended Treatment
Life and Safety	Cinnamon Trail #204 - Loss of life or injury to humans	Hazard trees falling across trail	Possible	Major	Failure involves trees > 6" dbh, with direct impacts to designated recreation area with high concentrations of transitional use (humans/stock animals along trail)	High	S2. Close trail to ensure public safety. S1b Sign area to Hazards	S1b Sign area to Hazards
Life and Safety	FR 8122	Hazard trees falling across road and hitting people	Possible	Major	Failure involves trees > 6" dbh, with direct impacts to road with transitional use (humans/car/stock animals)	High	S2. Close trail to ensure public safety. S1b Sign area to Hazards	S1b Sign area to Hazards
Life and Safety	Cinnamon Trail #204 - Damage to trail prism on SBS H and M and steep locations	Water and erosion	Unlikely	Moderate	moderate property damage (loss of trail tread)	Low	None	None.

Natural Resources - Native Plants	Native plant communities along the 81, 8122, The 8100421, 8122161, 8100162, and the 8122140 roads roads and along the Horse Trail	Canada thistle, Diffuse knapweed, Spotted knapweed, Scotch broom, and Tansy ragwort -high risk of expansion and impact to native communities	Possible	Minor	Major: Invasive weeds already present are likely to cause major disruption of native plant communities. degradation of Wilderness character/values	Low	None	None
Natural Resources - Native Plants	Native plant communities: adjacent habitat to roadside or fire-line openings created by soil disturbing equipment	Spread of invasive plants into native habitats – adjacent to fire- lines openings and burning.	Likely	Moderate	Major: Presence of invasive species in or near fire line openings, and spread of seed by suppression efforts, cause increased vectors for invasive spread into burned area.	High	P1b. Invasives EDRR - Suppression Repair P2. Preventative Seeding for Invasive Species	P1b. Invasives EDRR- Suppression Repair
