# Klamath National Forest

## Best Management Practices

MONITORING REPORT

2014 Fiscal Year

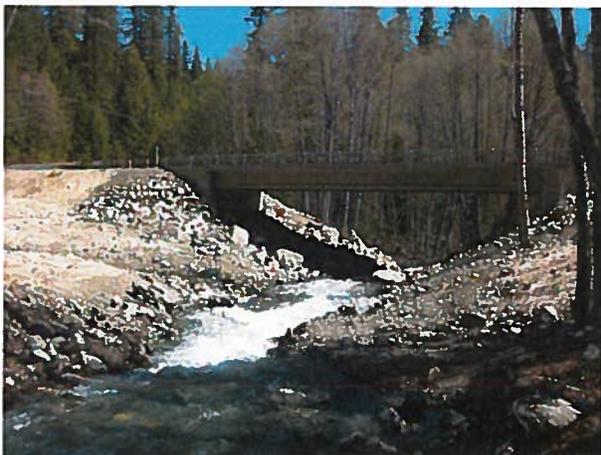
Bridge construction required a temporary bypass road upstream resulting in approximately 100’ of disturbed channel from top of the bypass road down through the bridge to the lower end of the project. Some fill material was left on flood plain from the bypass road. Alder is beginning to grow adjacent to the channel with dense grass and shrubs on floodplain and sideslopes. The site is recovering but it will not fully recover for a decade or more.

Picture was taken after the first winter post-construction in 2010, looking downstream at the bridge crossing of the West Branch of Indian Creek. Site had excessive disturbance due to temporary bypass road that was created due to the road being a scenic byway.

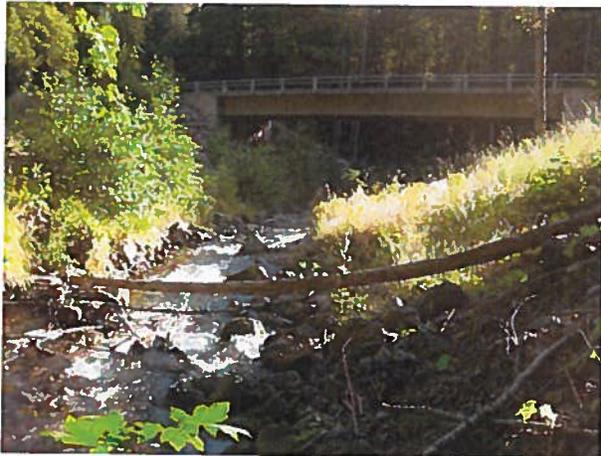
Picture was taken after the fifth winter post-construction in 2014, looking downstream at the bridge crossing of the West Branch of Indian Creek. Temporary bypass road alignment has vigorous grass and shrub growth, including alder growing on restored stream channel.

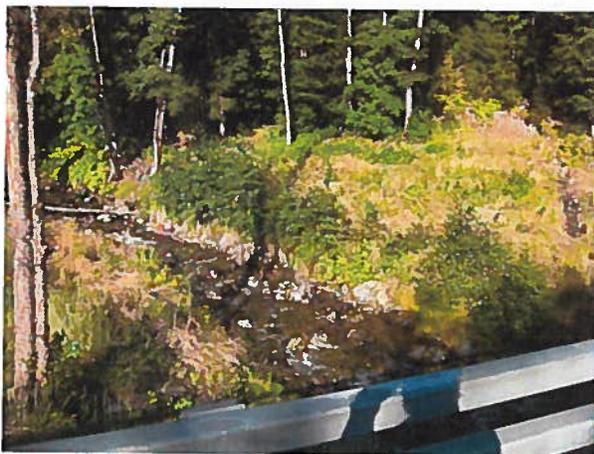
Picture taken from bridge looking upstream further illustrates five years of vegetative recovery on the temporary bypass road. Vegetation is greater than waist height with alder trees up to 10 feet tall growing along the stream bank. Planting of alder and other trees post-project would have accelerated site recovery.

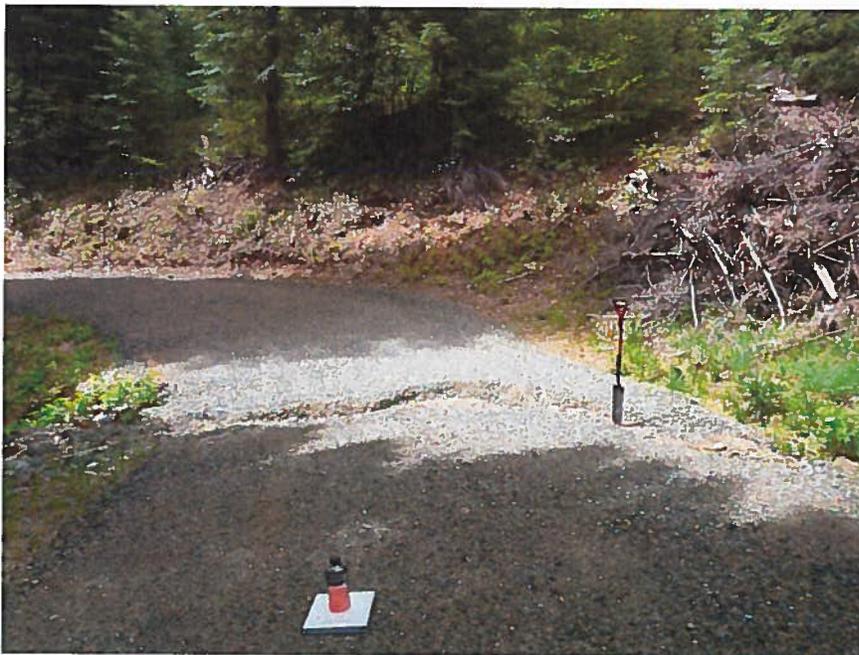
Picture 8. Gully across a rolling dip on 44N45A

This was the second time gully erosion occurred at this rolling dip location. This problem has caused minor impacts at the stream reach by contributing less than 3 cu yds of gravel and fine sediment to the fill slope and stream channel. Klamath Engineers were made aware of the gully in 2012 and aggregate was re-applied at this site. After the gully reformed in 2013 it was determined that a coarser aggregate was needed to prevent gully formation. Instead of using ¾ inch minus, 1 ½ inch minus aggregate was brought in to resurface the rolling dip. This coarser material fixed the erosion problem at this site.

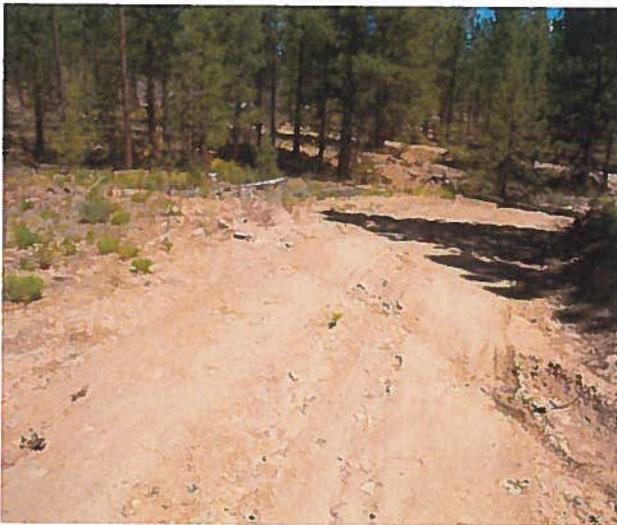
A waterbar that was constructed on one of the approaches to the stream crossing had been driven over causing it to fail. Rills have formed on the road surface resulting in <3 cu yds of sediment being delivered into the intermittent stream channel. This has a minor impact on water quality as this intermittent

**Picture 4. A waterbar that had been driven over on a temporary road**

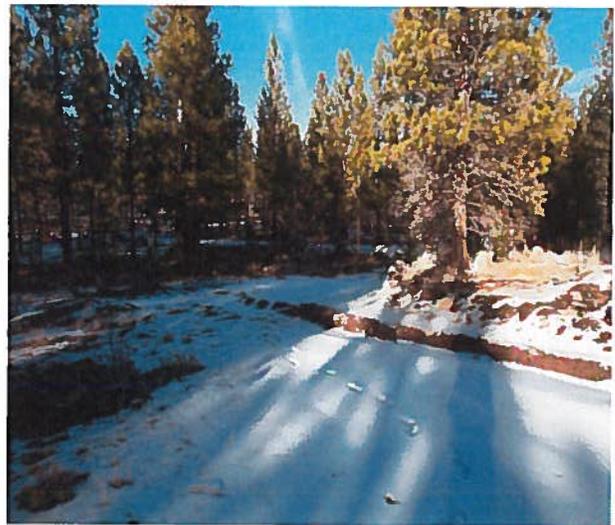
**Picture 5. The waterbar was reconstructed and the temporary road was blocked**

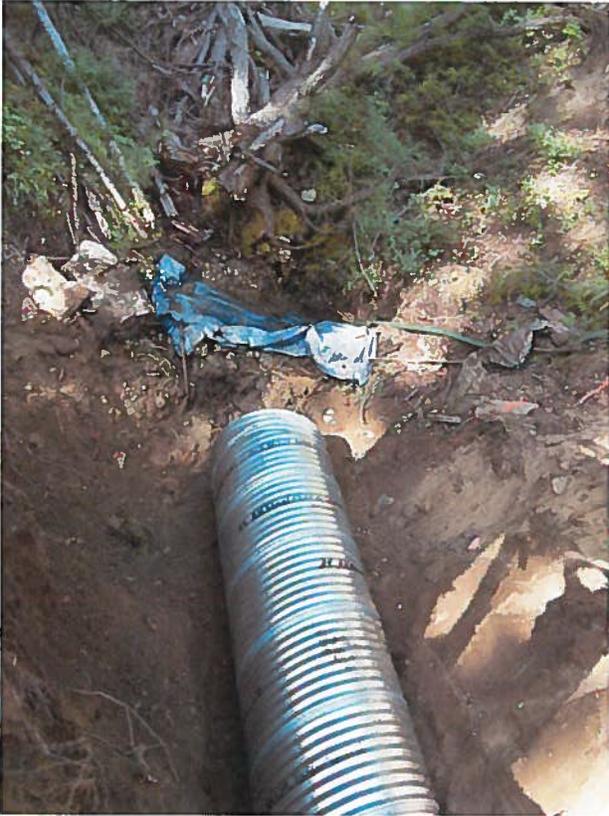
P1 – Pipe aligned in subgrade; point of water diversion

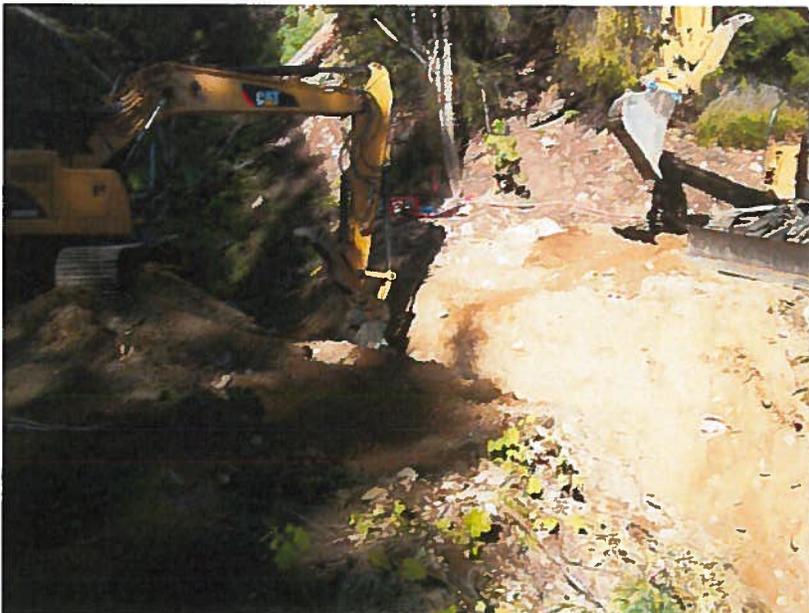
P2 – Backfilling

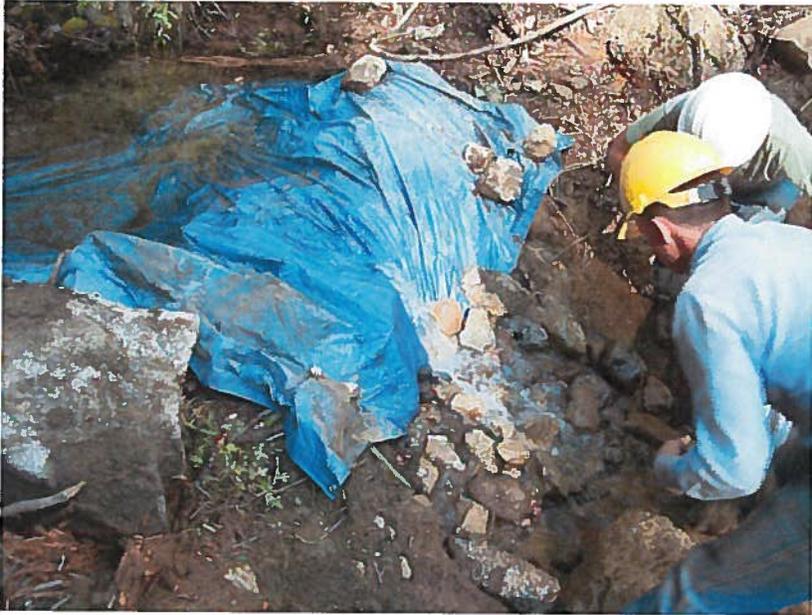
P3 – Rewatering

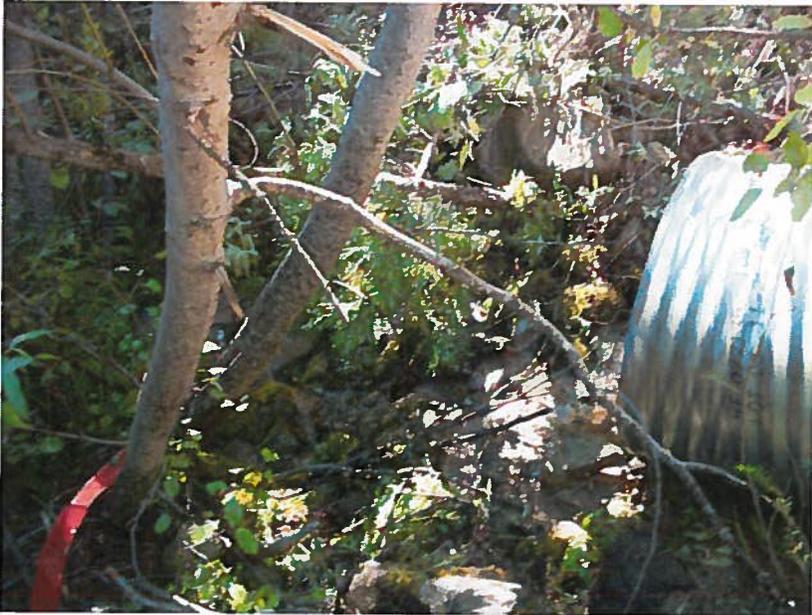
P4 – Outlet turbidity immediately upon rewatering

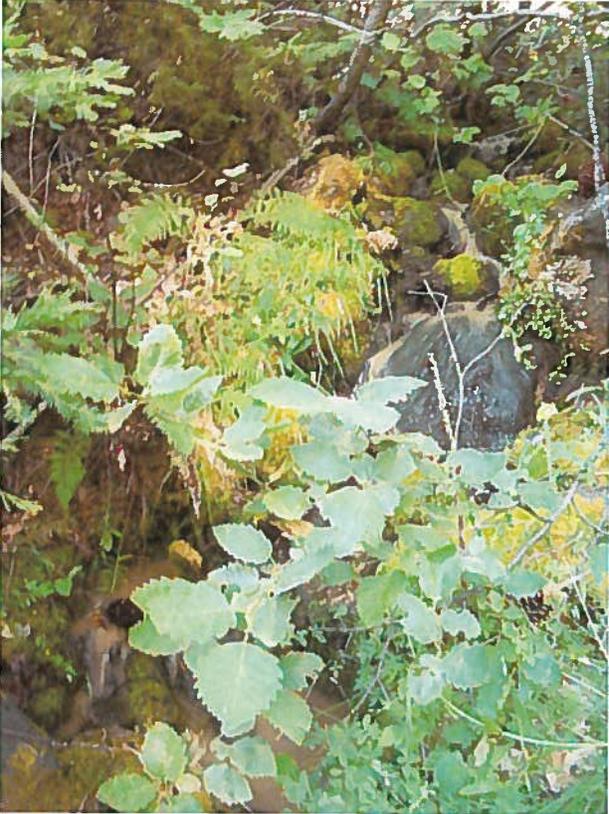
P5 – Downstream turbidity upon rewatering

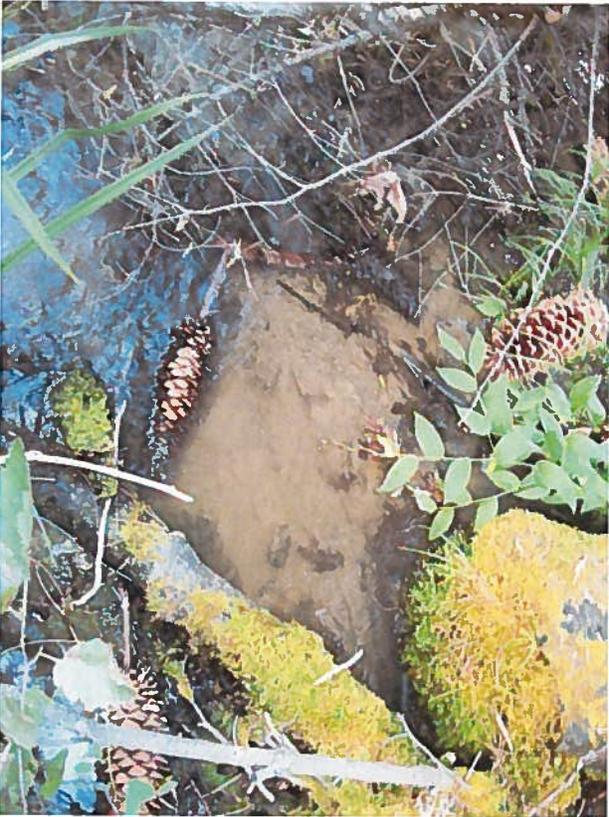
P6 – Water largely cleared, 15 minutes post-rewatering

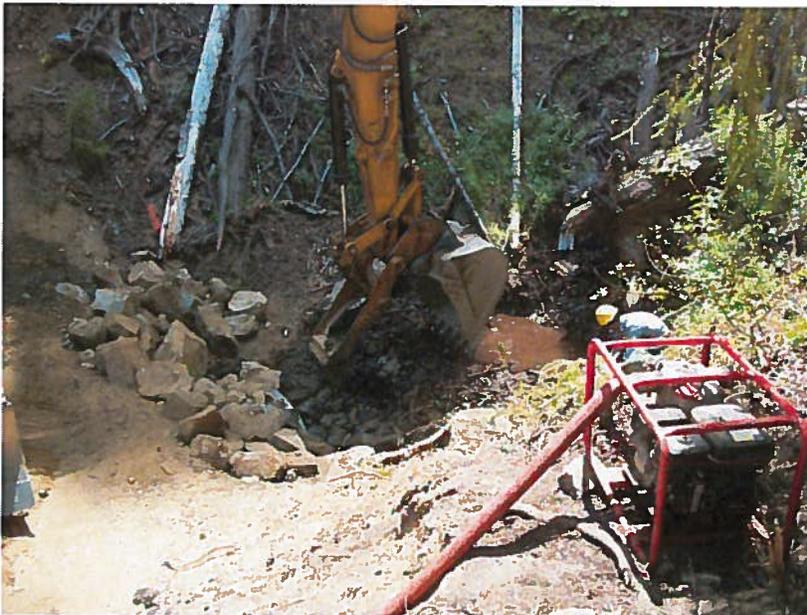
P7 – Dam removed

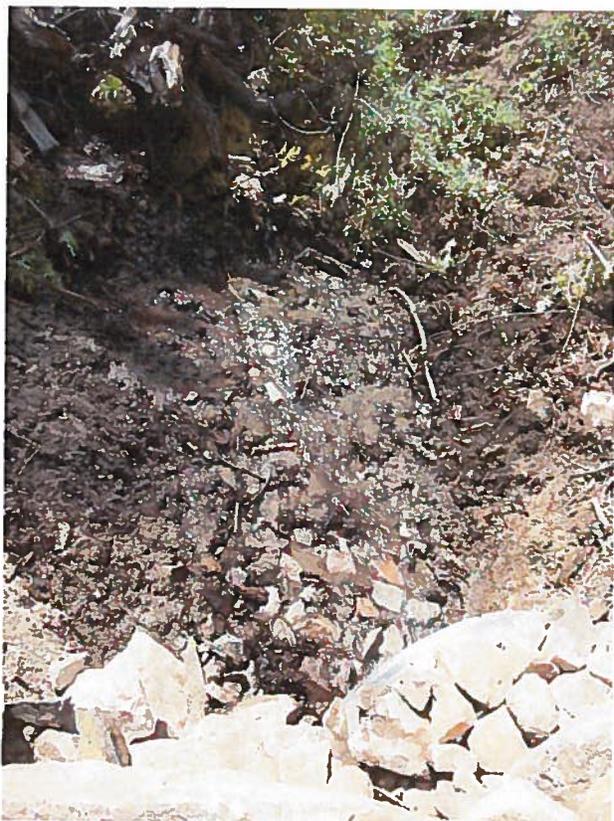
P8 – Turbidity at 15 minutes after dam removal

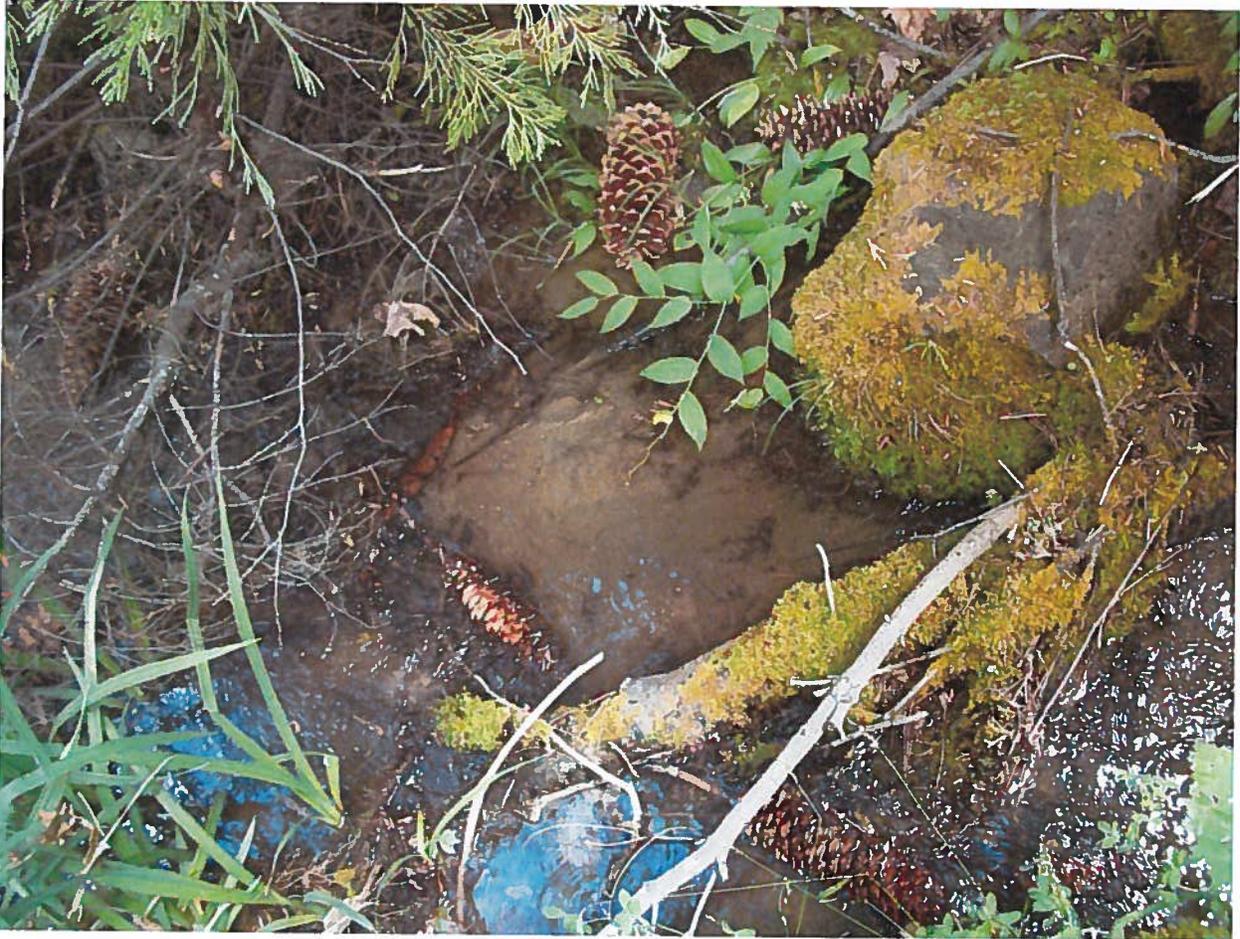
P9 – Turbidity at 40 minutes post-removal, downstream of culvert
