## Questions and Answers concerning the Corner Bay Prospectus

October 9, 2015

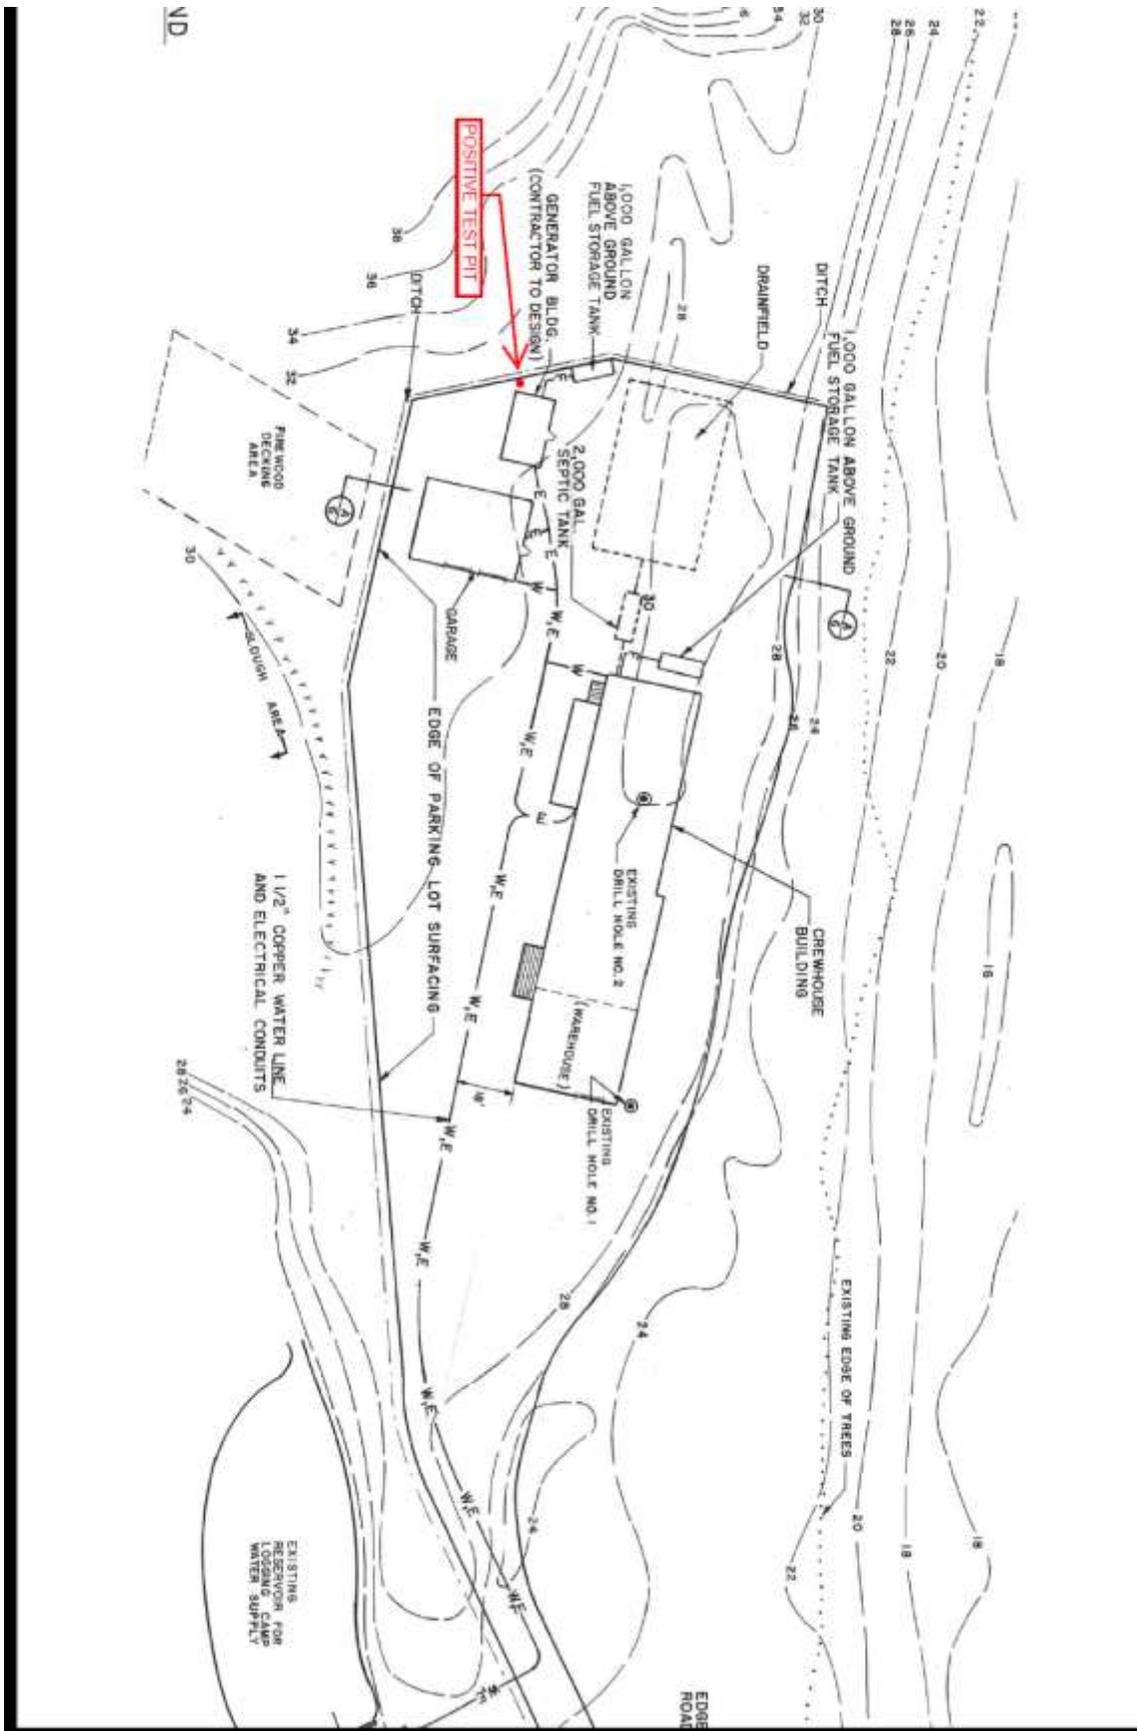
A preliminary site investigation of the Corner Bay Admin site and the separate bulk fuel storage area was performed on 10/1/15 and 10/2/15. Test pits were hand excavated at 12 locations. Test pit locations were determined by proximity to, and relative elevation from, historic and existing fuel storage tanks, fuel lines, and fuel dispensing areas. Six test pits were excavated at the Administrative site, and six test pits were excavated at the bulk fuel storage area. Test pit depths varied from 14 to 30 inches below adjacent grade. Field screening samples were collected at each test pit and analyzed via heated head space field screening procedures, performed with a photoionization detector. The presence of organic vapors, suspected to be petroleum, was detected at one test pit, at a depth of 18 inches below adjacent grade. This positive test pit was located adjacent to the west corner of the Generator Building. Organic vapors were not detected at the test pit approximately 15 feet downgradient of the positive test pit, nor were they detected at any other test pit. A sheen was not detected in the ditch adjacent to the positive test pit. Therefore, it is assumed that the positive field screening result is due to historic spill(s) of less than 10 gallons and static in nature, assumed to be related to the exterior fuel/water separator on the diesel fuel line between the Generator Building and the incinerator. Investigation of the beaches down gradient of the Administrative site and the bulk fuel storage area did not detect oil sheens, odors, or other signs of contamination. A map of the site is attached below.
