# **Klamath National Forest**

## **July 2015 Storm Report**

*August 2015*

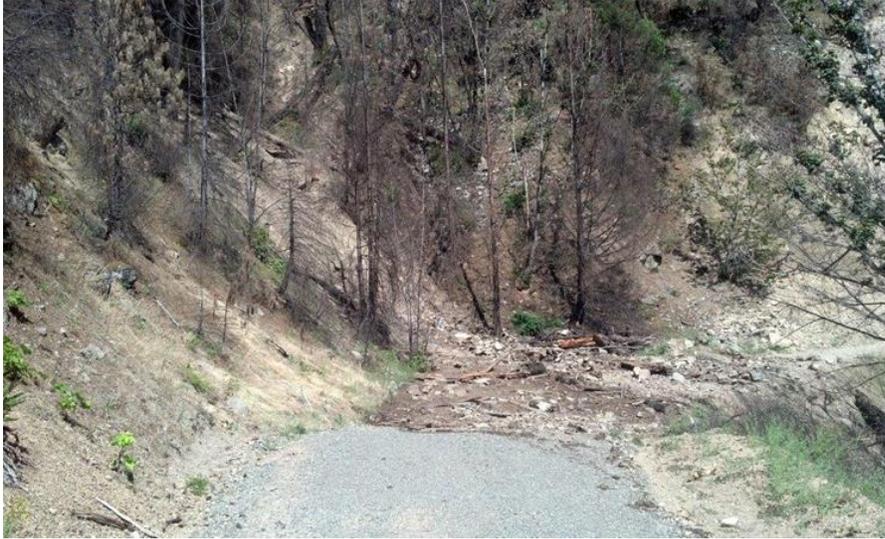
Figure 1. Walker Creek, KNF Road 46N64, Marker Point 22. Road dip contained debris flow and prevented stream diversion down the road.

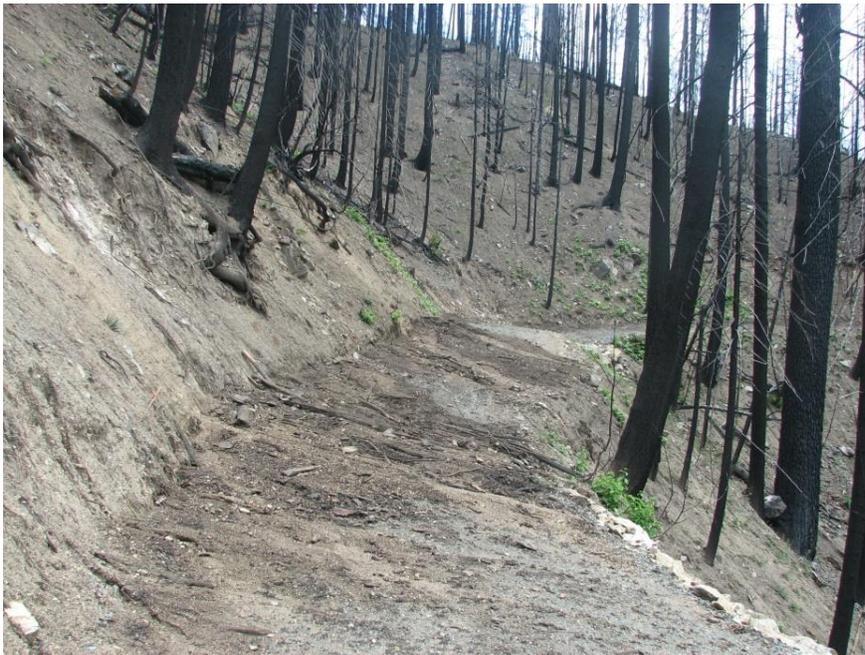
Figure 2. Runoff from high-severity burn washed over outsloped road surface without causing road failures.

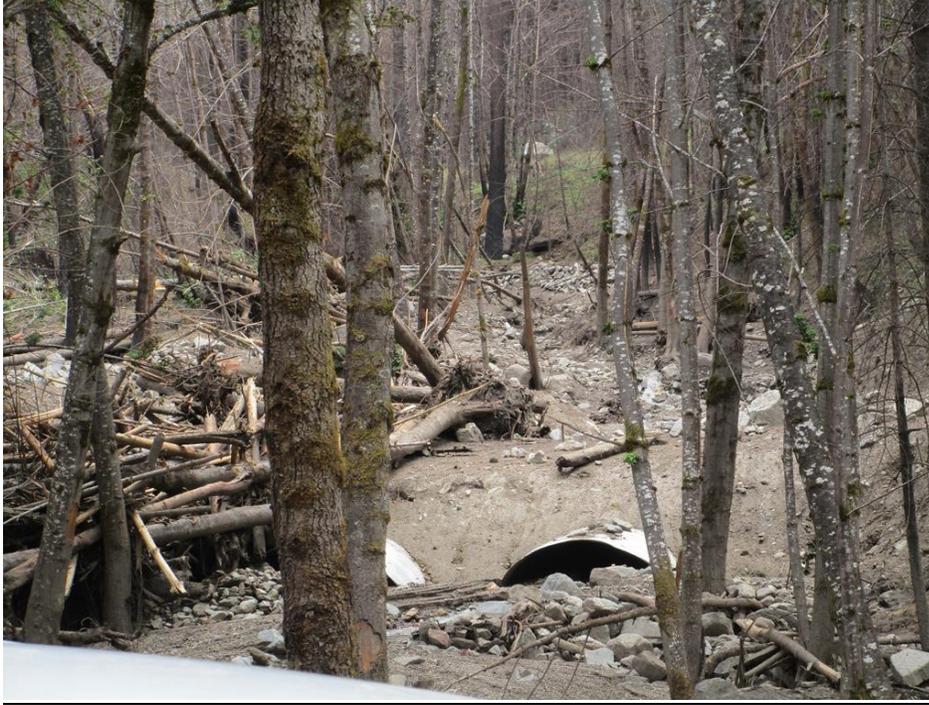
Figure 3. Walker Creek, KNF Road 46N64, Marker Point 9. Storm flow materials deposited at the crossing.

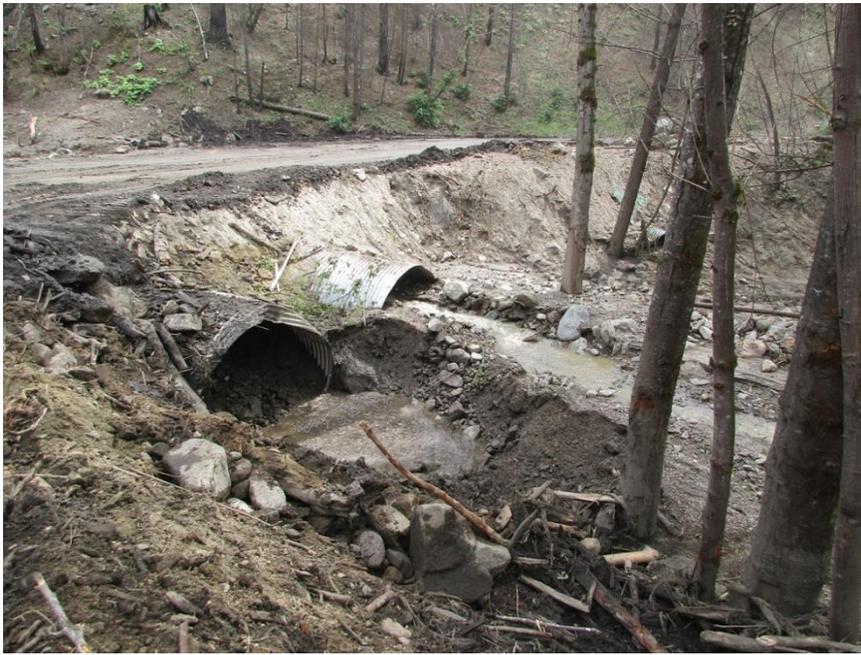
Figure 4. Walker Creek, KNF Road 46N64, Marker Point 9. Storm flow materials cleared from the crossing, and eroded road fill and armoring at crossing outlet.

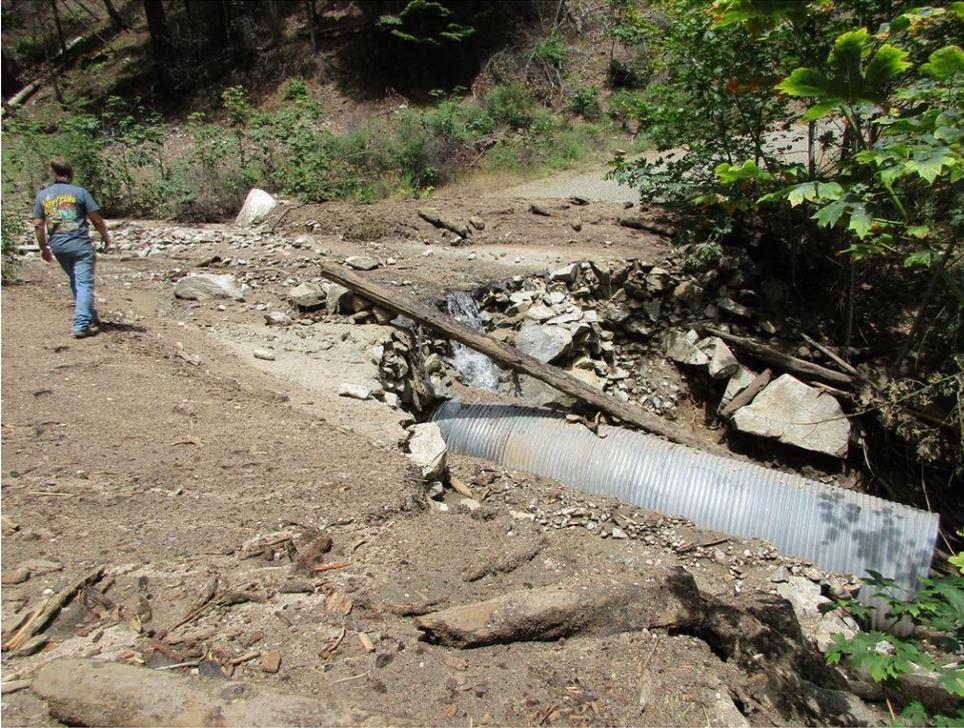
Figure 5. Walker Creek, KNF Road 46N64, Marker Point 8. A 500 pound boulder clogged culvert inlet and storm materials deposited on the road bed, and eroded road fill and armoring at crossing outlet.

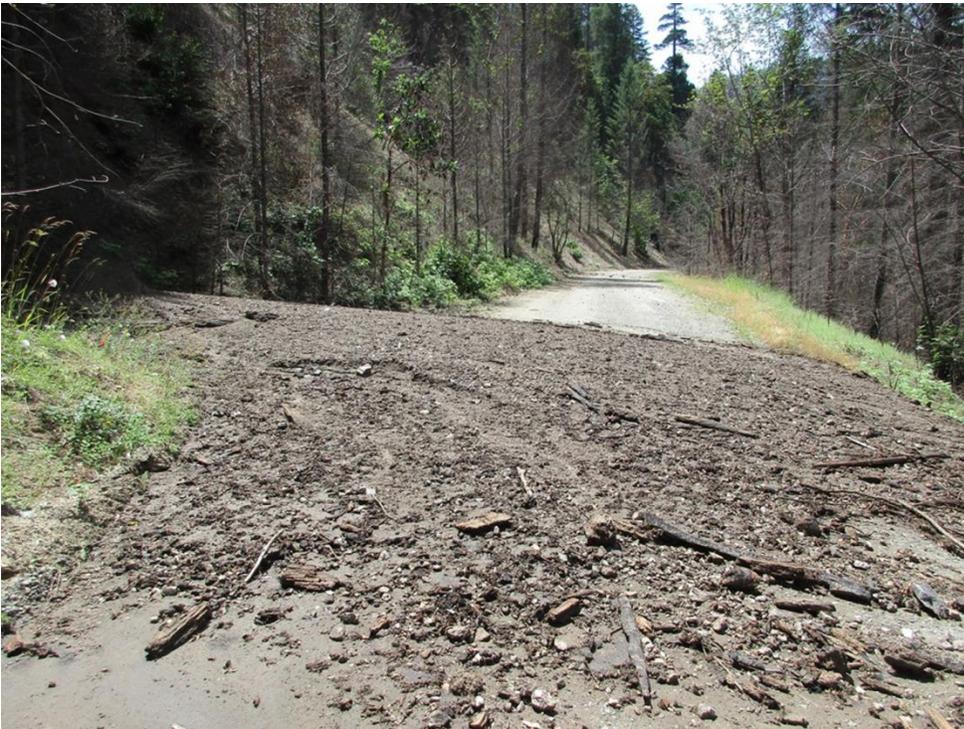
Storm Patrols also observed storm flow material deposited onto road surfaces. Debris fan deposits (Figure 6) were identified on many road sections. Cross drains and rolling dips features functioned well to channel storm flows across road surfaces rather than along road lengths (Figure 1). Out sloped surfaces passed storm flow materials across road surface and down the cut bank side of the road prism (Figure 2). Approximately 2400 cubic yards of deposited storm flow material was cleared and hauled to spoil sites.

Figure 6. Walker Creek, KNF Road 46N64, Marker Point 6. Storm Debris Fan deposited on road surface and flowing across the shoulder.

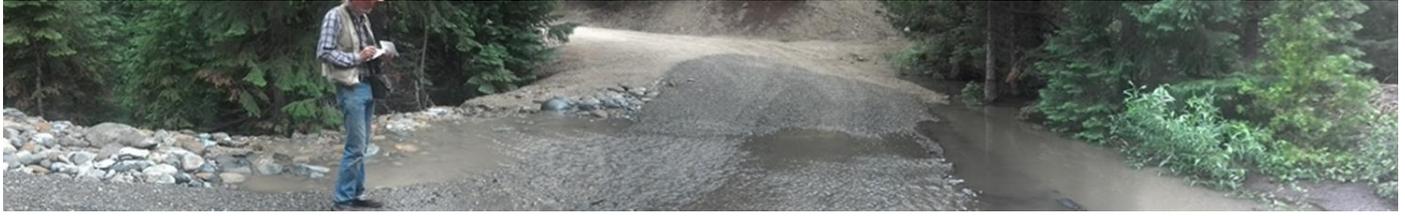
South Music Creek, KNF Road 40N54. Storm flow materials deposited at the crossing.

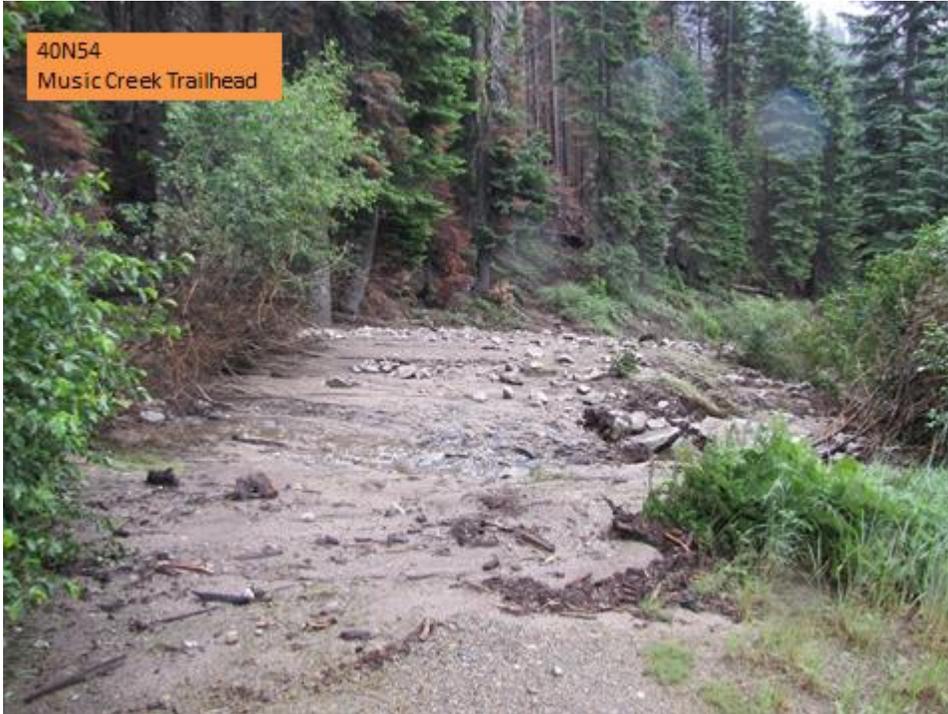
South Music Creek, KNF Road 40N54 Music Creek Trailhead. Storm flow materials deposited at the crossing.
