Storms of July and August, 2015

Preliminary Observations of Storm Effects Music, Walker, Grider, Beaver, and McGuffy Creeks and Little Deer Mountain

By: Juan de la Fuente

9-16-15

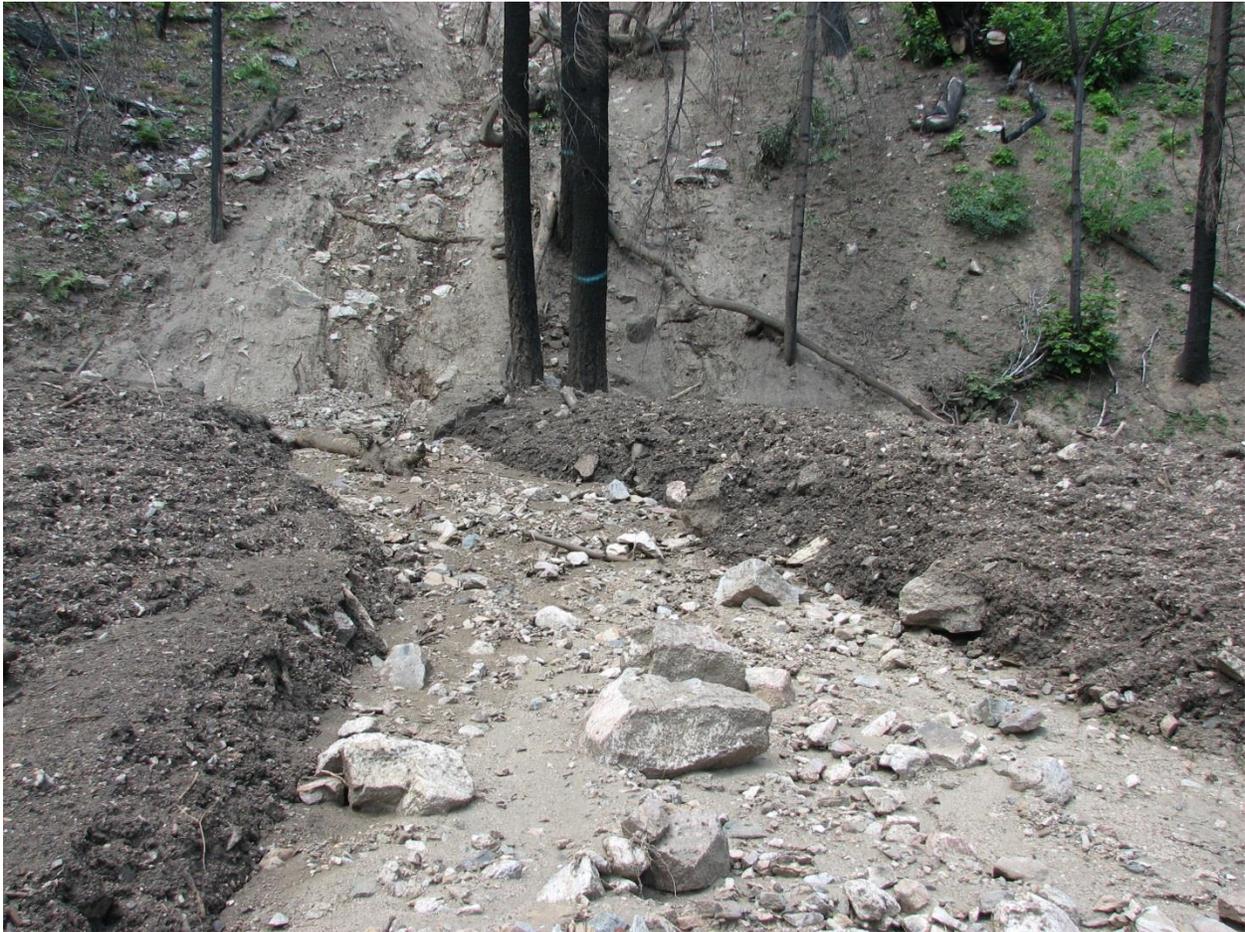
Road 46N64 buried to a depth of several feet by a debris flow on the west side of Walker Creek (rock in foreground is about 2' wide); View is uphill to the west; The road crosses the bottom of photo from left to right; 7-14-15

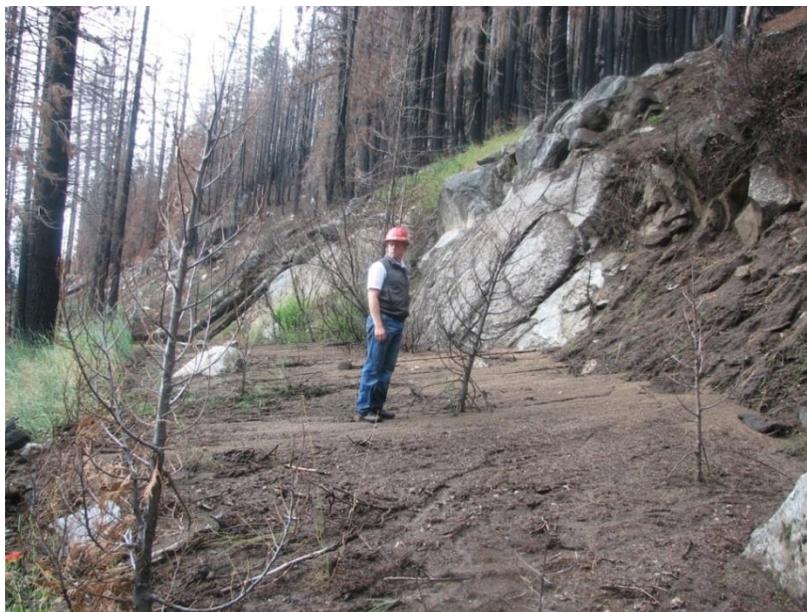
Music Creek: Sand deposits in decommissioned road bed 7-9-15

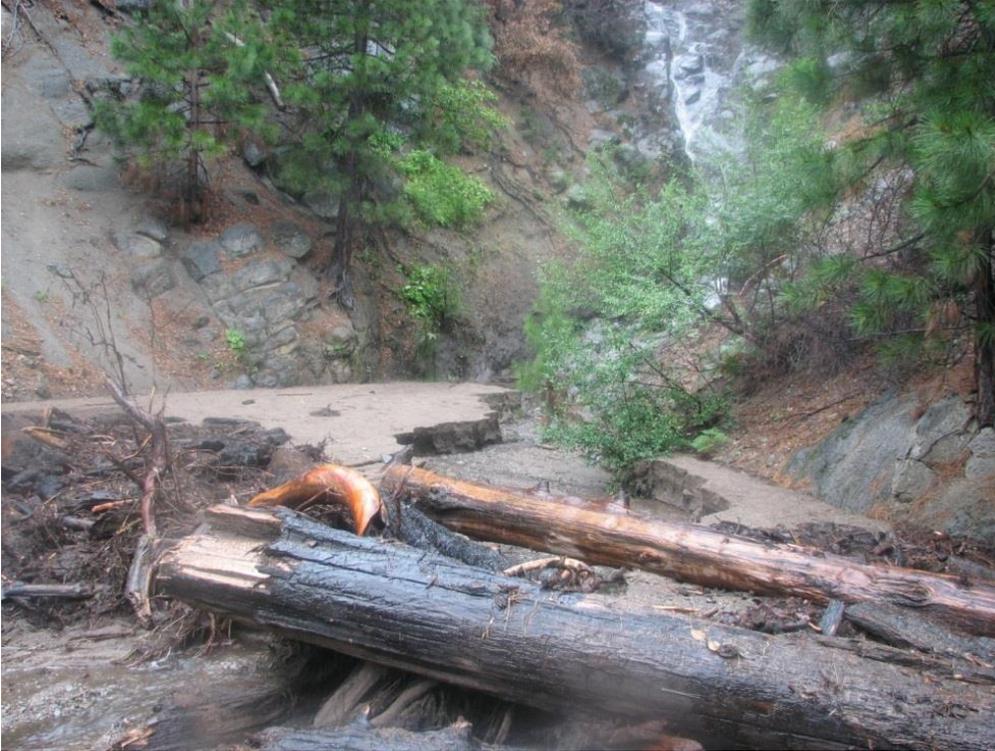
Music Creek: Debris deposit at stream crossing on Road 40N54 7-9-15

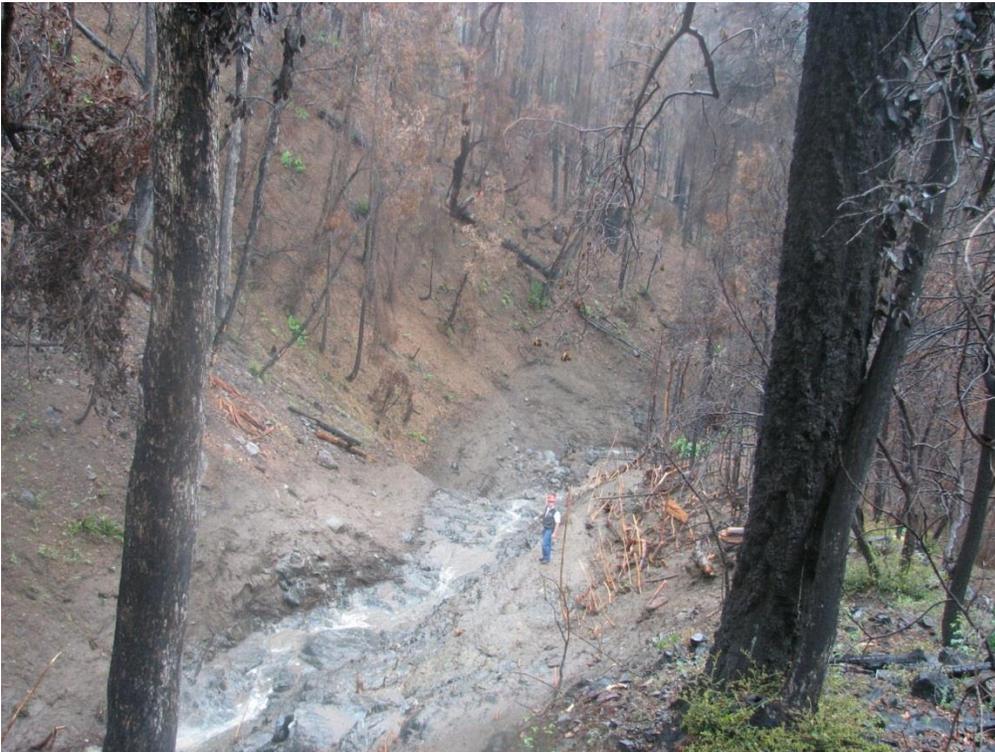
Music Creek- Debris flow in a tributary Highland Creek 7-9-15; Note mud and scour marks on channel banks, person provides scale;

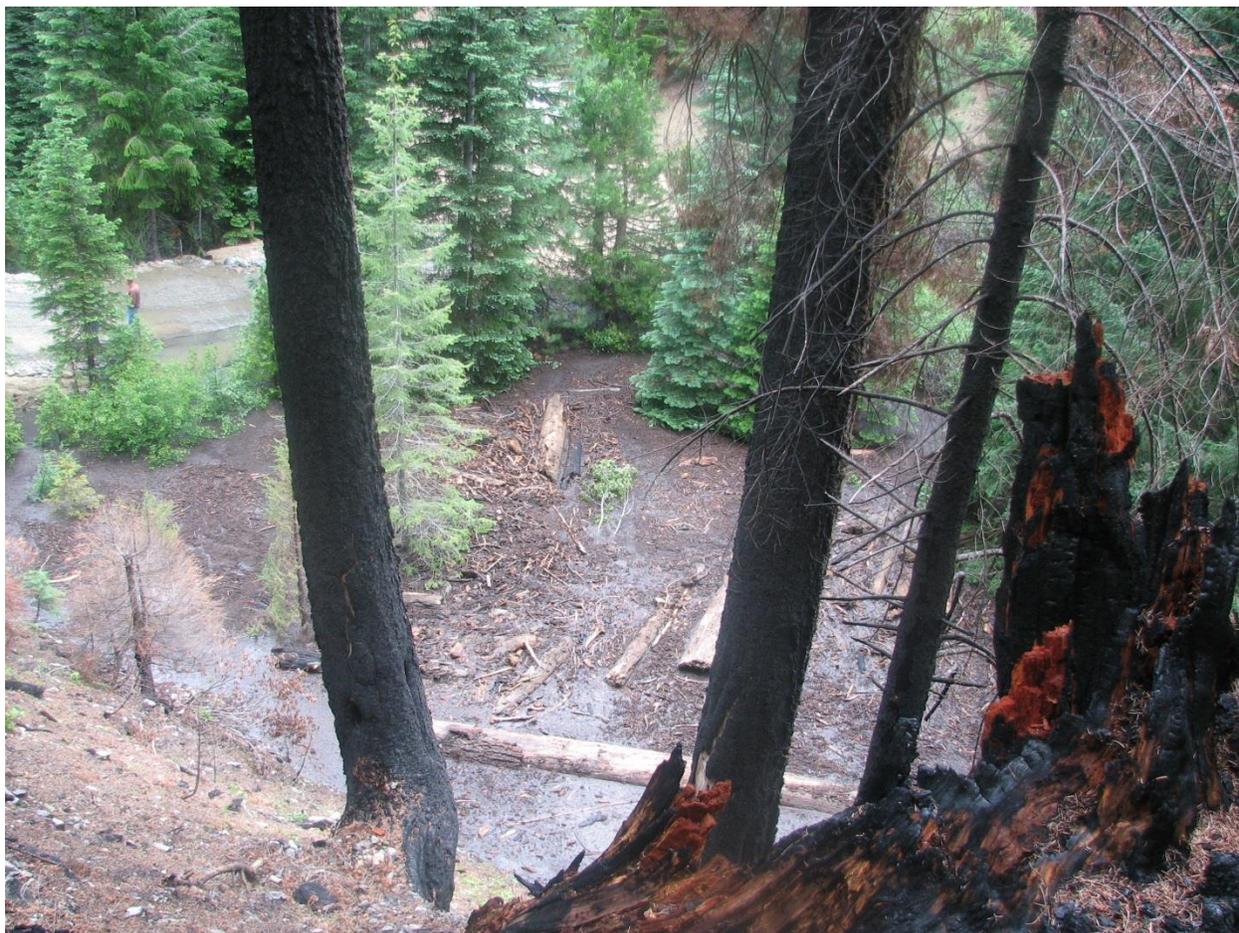
A large culvert (about 6' diameter) was blocked on Road 40N54 at the crossing on main Music Creek, forming a pond 200 feet long (Map 5). Water was spilling over the road and down the fill on July 9, 2015, and the culvert was opened around July 14 by the Forest Service Road Crew. It has backed up a triangular shaped pond about 200 feet long up the stream and about 100 feet wide at the road. A sand delta is forming at the upper end of the pond and considerable sand deposition occurred for another 200 feet up stream to the base of a bedrock cascade (Map 5). The fill is likely constructed of sandy granitic soil and could fail if the pond remains in place. It would also be prone to rapid downcutting should a new peak flow occur and top the road.

Music Creek: Blocked Culvert and resulting pond on Road 40N54 (Map 5) 7-9-15

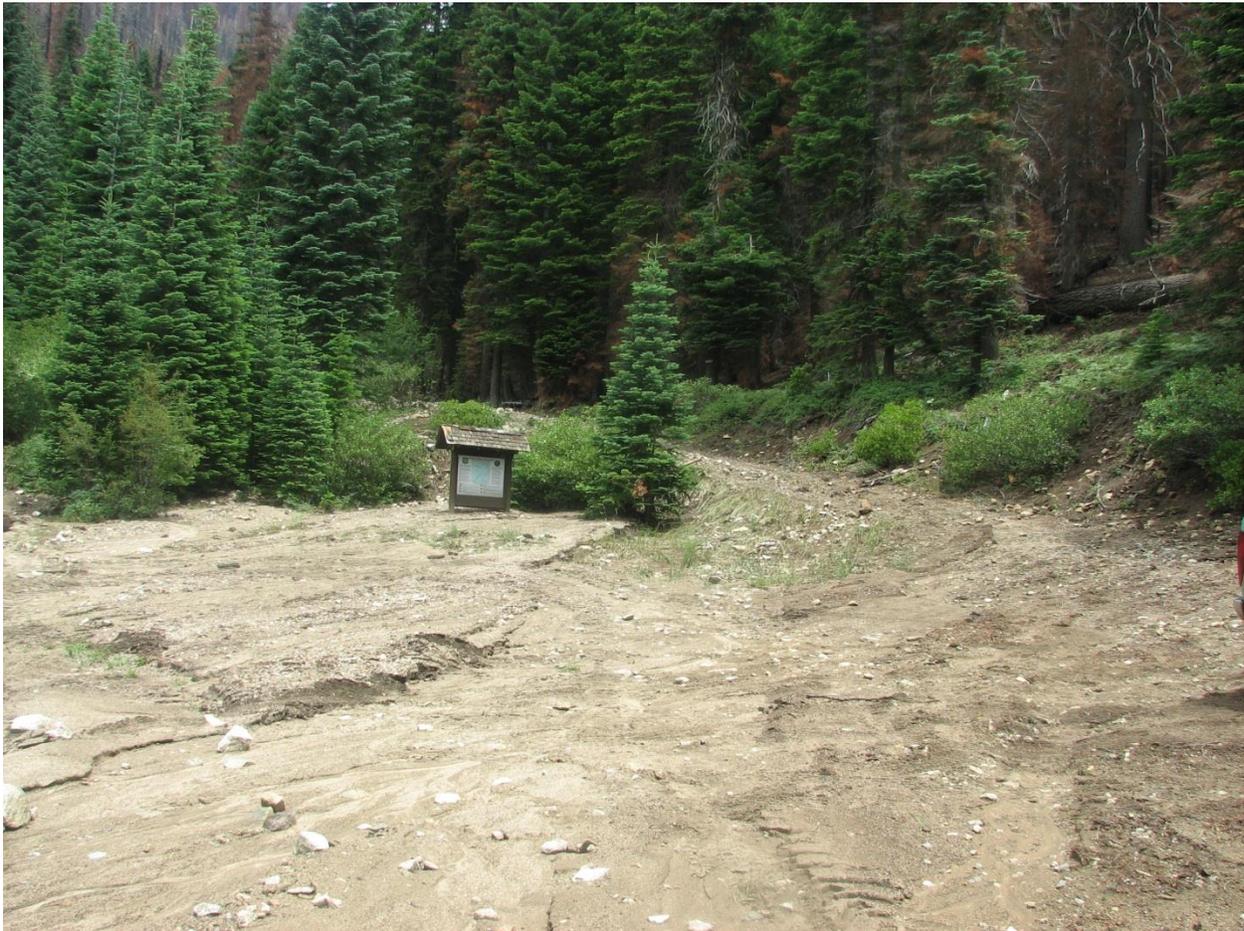
The Music Creek trailhead parking area at the end of Road 40N54 was flooded when a small stream in the headwaters of Music Creek was diverted down the road immediately north of the parking area (Map 6). Sediment laden flows came out of the easternmost of two channels, and buried the parking area with sand, gravel, and cobbles up to a foot in diameter. The area adjacent to the trail burned at low severity in the fire, yet it experienced severe sheet wash and rilling, despite being under a green timber canopy. This was likely caused by a large area of higher severity burn further upslope and to the east of the trail (see air reconnaissance photograph).

Music Creek: 7-9-15; Diverted stream traveled down Road 40N54 in center of photo above sign, then turned to the left where it buried the trailhead parking area is (lower left); View uphill;

There is a need to evaluate the short and long term use of this facility, and the public should be notified of the potential for future fire-related debris flows and flooding which could occur with either summer or winter storms.

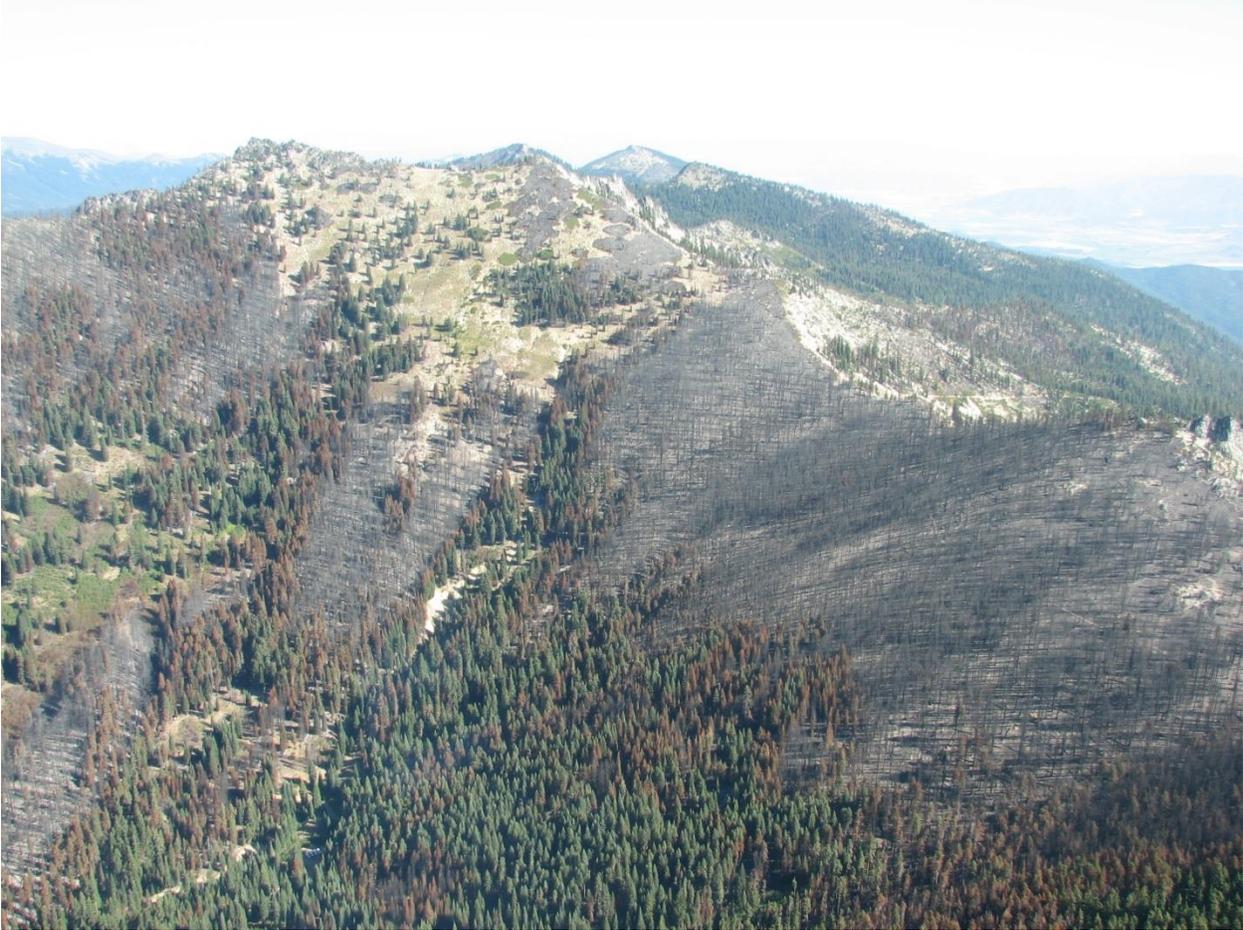
Headwaters of Music Creek 9-6-14: Parking area is obscured, but located in lower left corner near the bottom, and white linear feature in center is an older 1964 landslide; Note high severity burn in right half of photo which lies upslope of the damaged parking area.

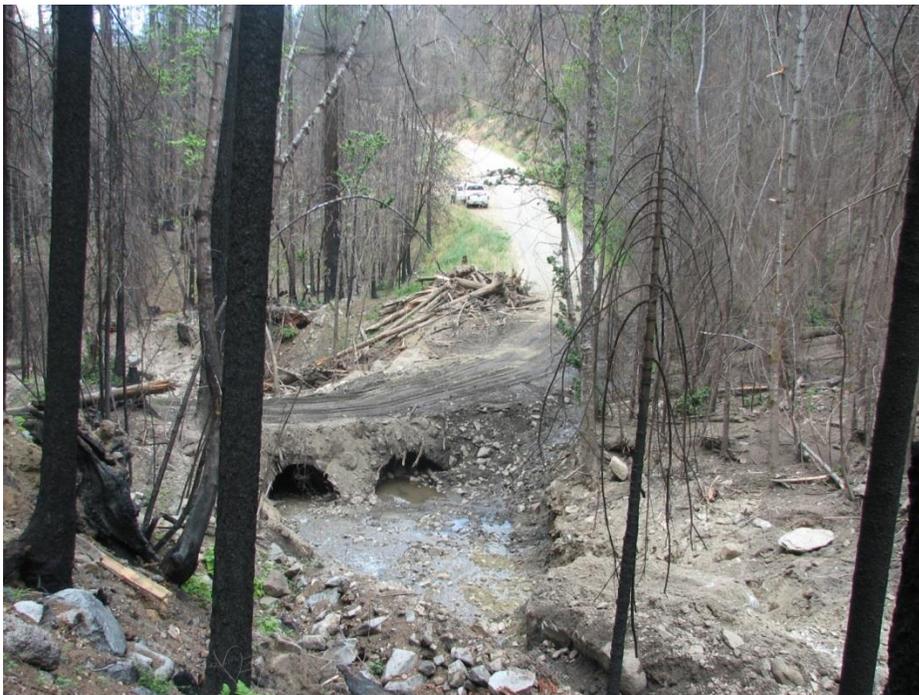
East Walker Creek- Crossing after partial cleanout of debris flow (logs in center of photo)

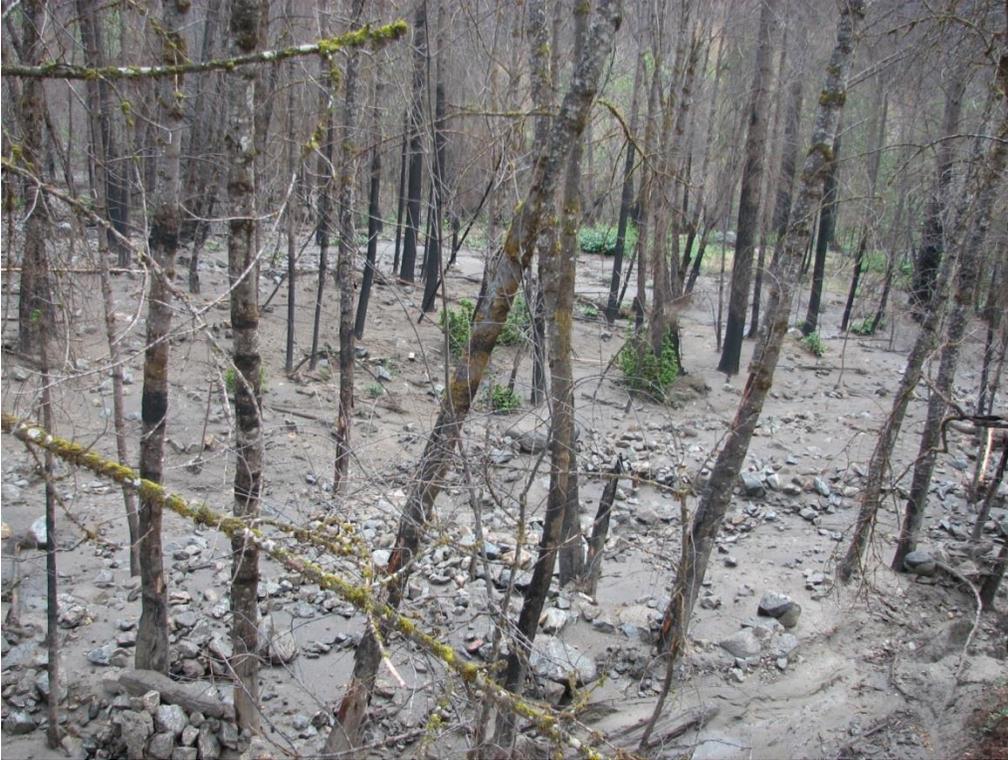
Debris flow fan at the mouth of **East Walker Creek**; View is toward the main stem of Walker Creek, which lies a short distance beyond the light colored deposits;

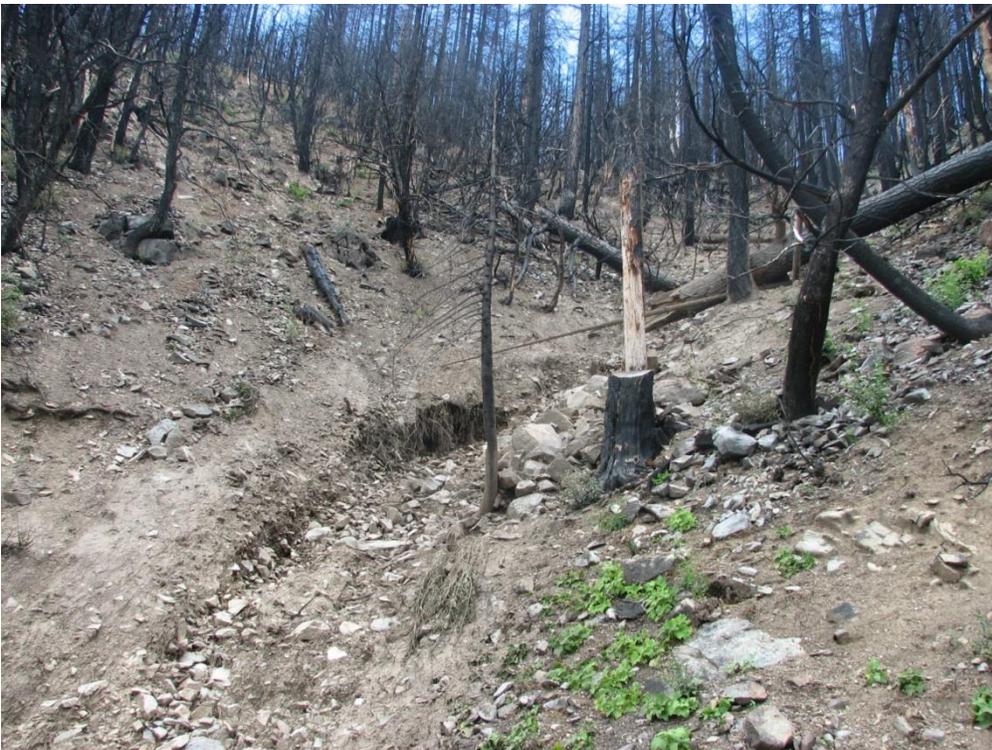
Debris flow above road in **East Walker** watershed

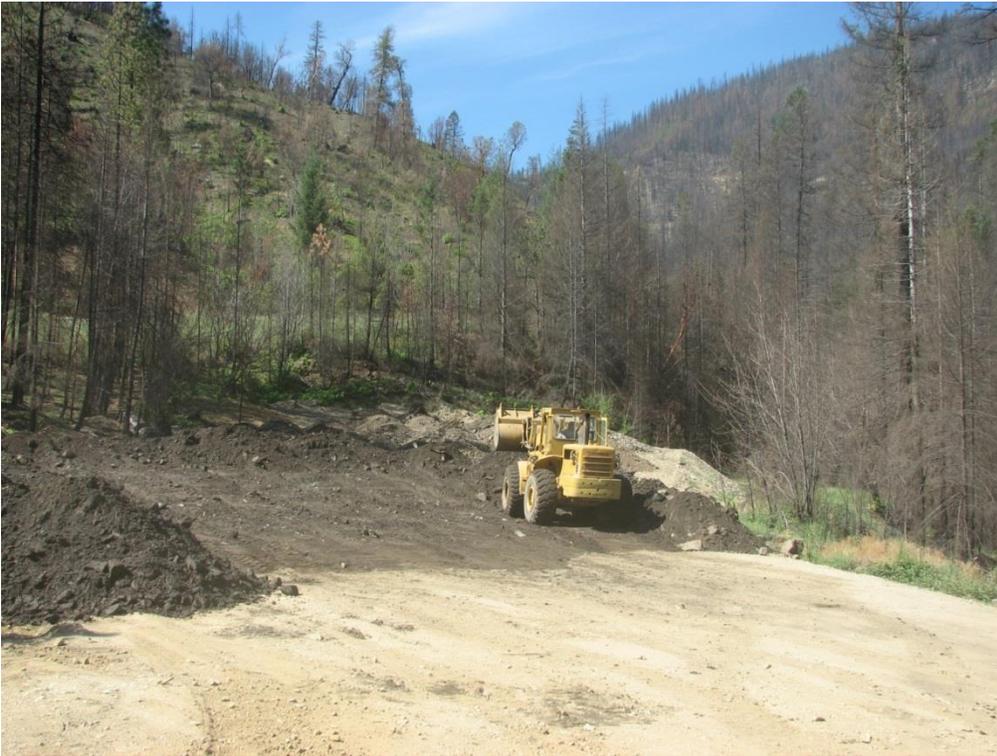
Waste Area on Road 46N64 above **Walker Creek**

Waste Areas- Disposal sites include the old helicopter landing on Road 47N64 along Walker Creek near its junction with East Walker Creek. This site is scheduled for re-use as a helicopter landing during the West Side project, and that factor will need to be considered in the erosion protection plan. Other sites include the switchback on Road 46N64 on the west side of Walker Creek, immediately adjacent to the channel. There is an old pile of cull logs at that location. Another site lies along Road 46N65 at the ridge crest south of Slinkard Peak. Additional material is being placed at wide spots along roads away from streams, and some of these may require erosion protection. As of July 17, around 1,000 cubic yards of material had been placed on waste areas along the Walker Creek Road (46N64) and other sites. Upon completion of cleanup, volume will likely exceed 2,000 cubic yards. **Earth Science and Engineering need to develop an erosion prevention plan for waste areas and implement it before the rainy season. Some are near streams and could deliver sediment if not stabilized.**

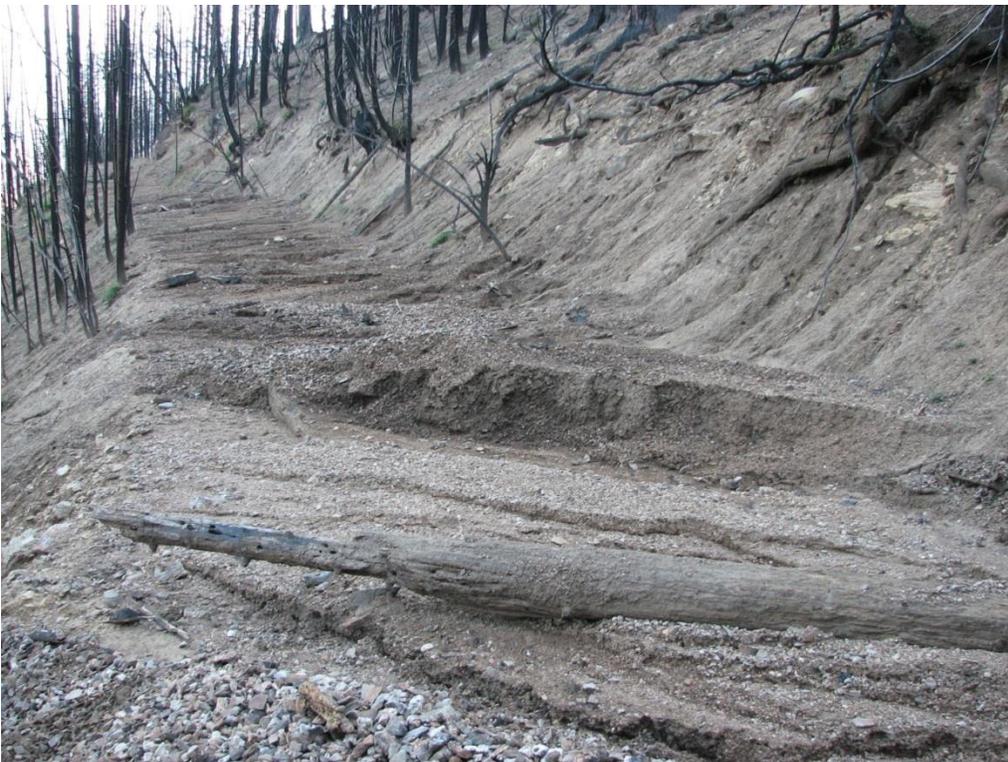
East Walker Creek: Road 46N61Y, sand and gravel fans up to a foot thick deposited on the road bed;

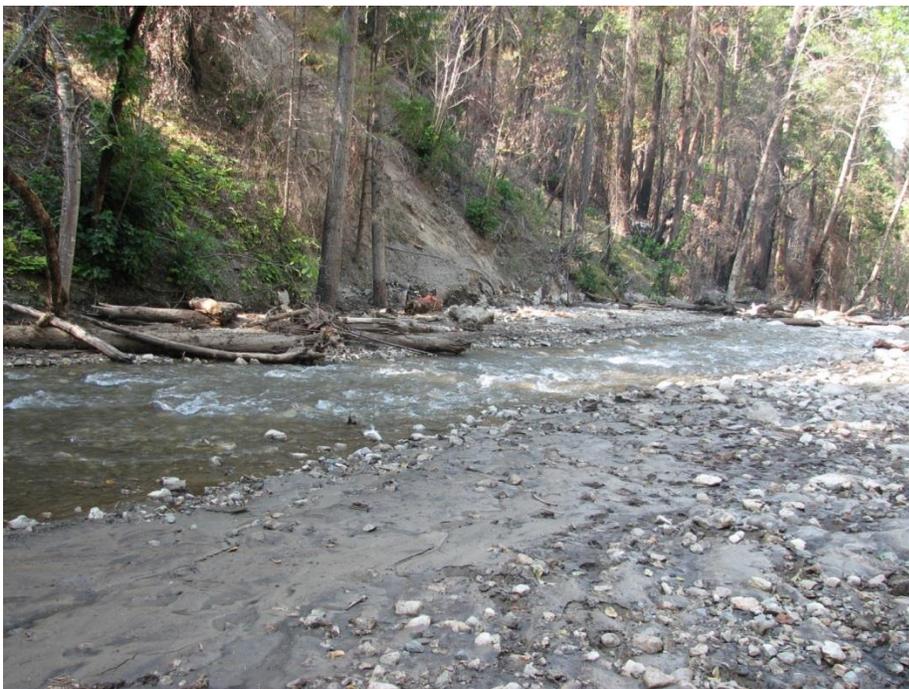
Grider Creek at Junction with No Name Creek; Deposits are from a debris flow in No Name Creek The following photograph shows the fine sediment backed up behind this deposit;

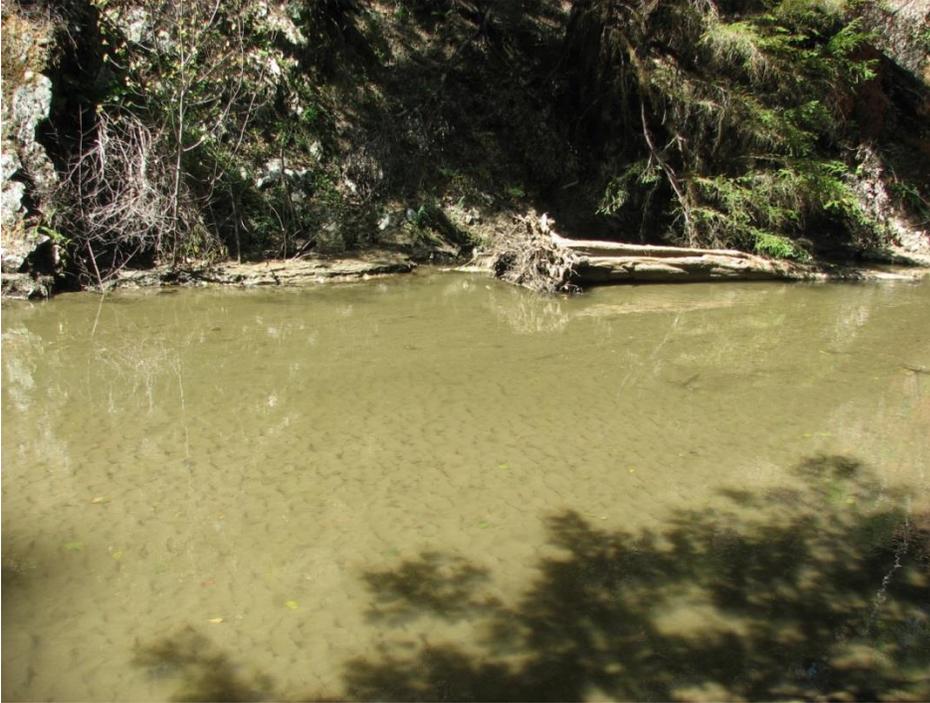
Grider Creek: Sediment-filled slack water reach; It was created when the debris flow in No Name Creek temporarily obstructed flow in Grider Creek. Preceding photograph shows the debris flow deposit immediately downstream from this photo.

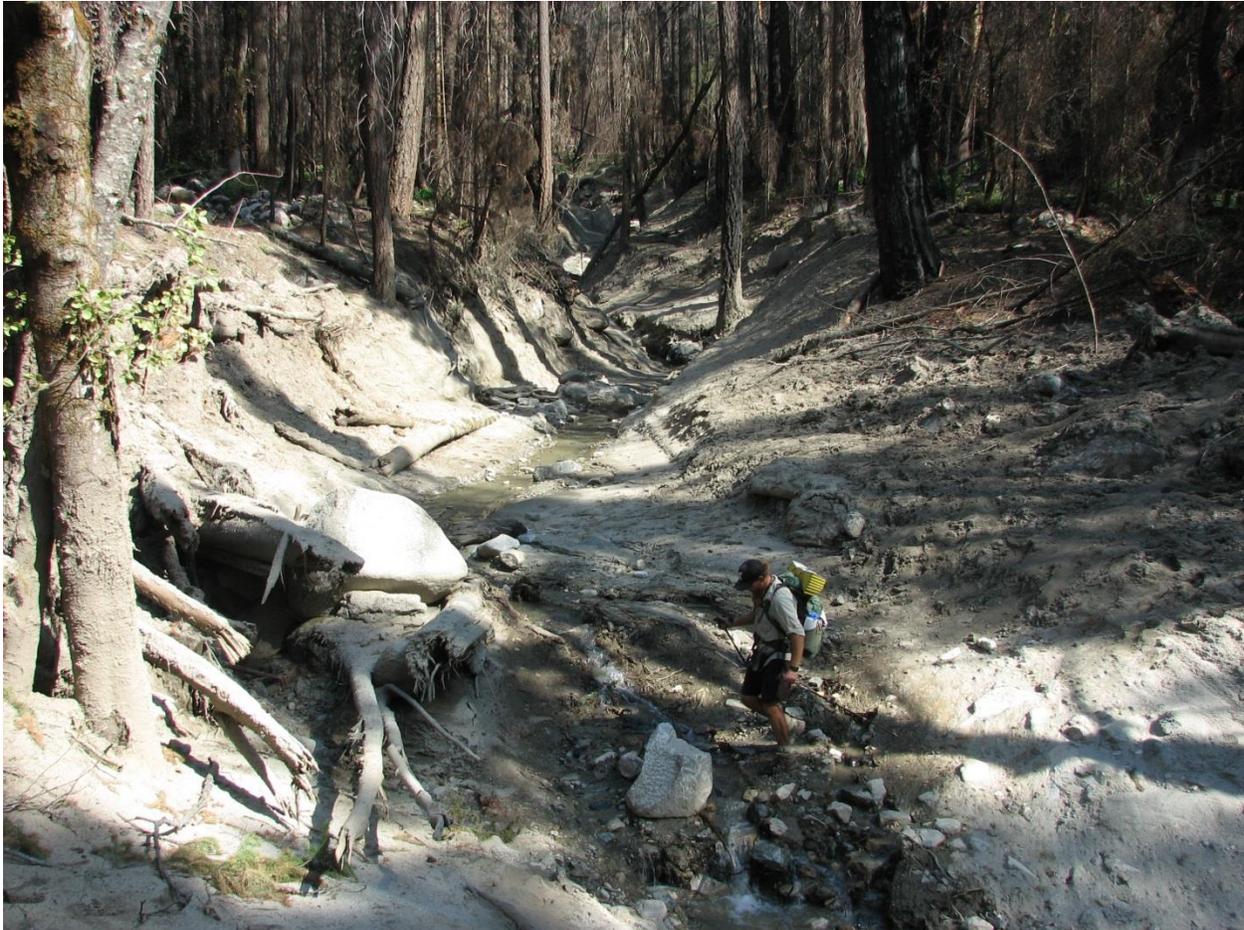
No Name Creek at Pacific Crest Trail Crossing: Large debris flow scoured channel'; Photo taken 7-20-15; View is upstream, PCT hiker provides scale;

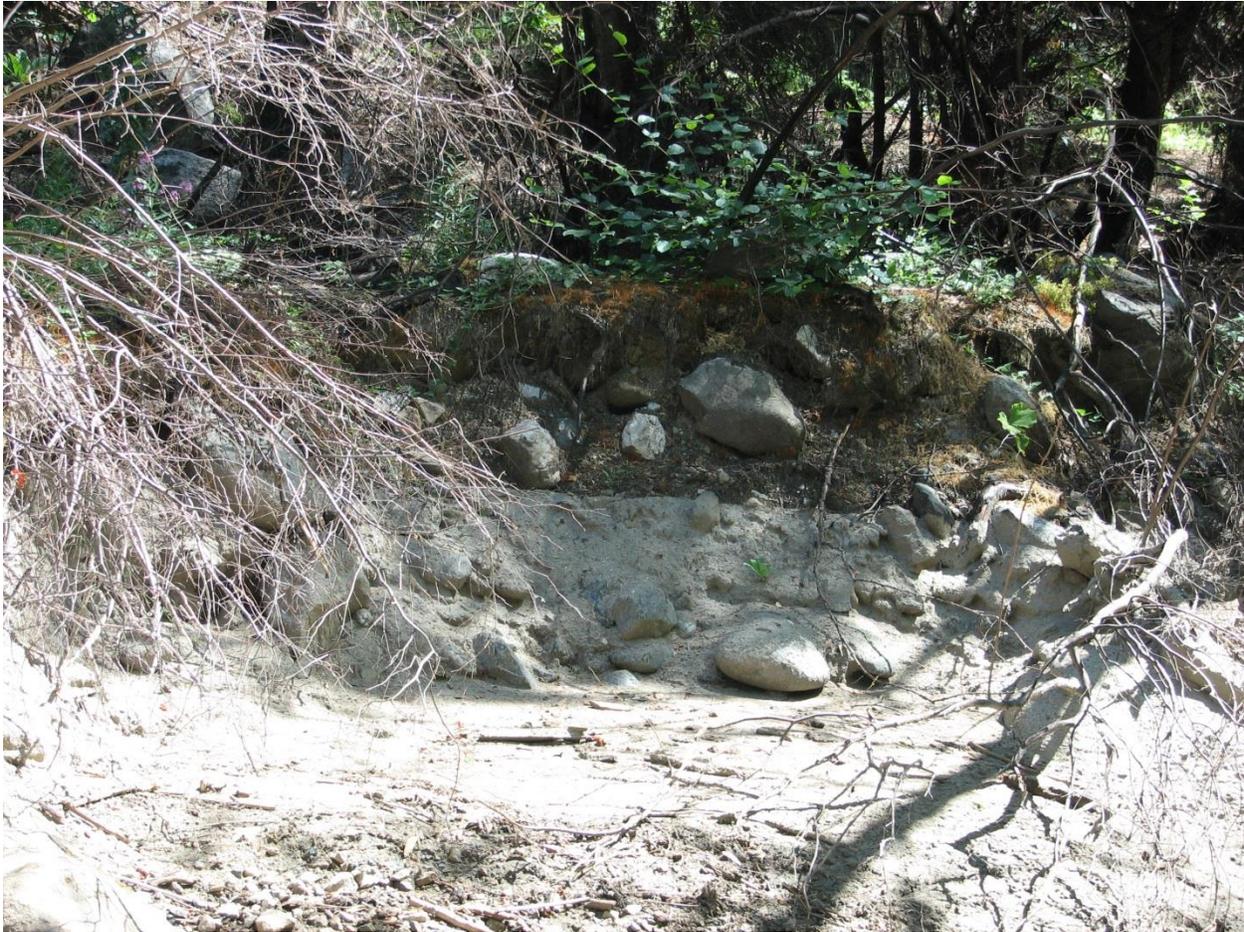
The debris flow continued down Grider Creek for at least $\frac{1}{2}$ mile, as indicated by mud marks and unsorted debris on the channel banks. Some of this material remains in the channel, raising the bed elevation. This condition will make the campground more susceptible to flooding than before the event. At the bridge on Road 46N65, the mud marks were no longer visible, so the debris flow likely dissipated upstream of this location. The junction of Salt Creek and Grider Creek a short distance above the road bridge was not examined. There were no indications at the bridge on Grider Creek that a large debris flow had occurred in Salt Creek.

Grider Creek-Downstream of PCT bridge; Note horizontal mud marks on the banks created by the debris flow originating in No Name Creek

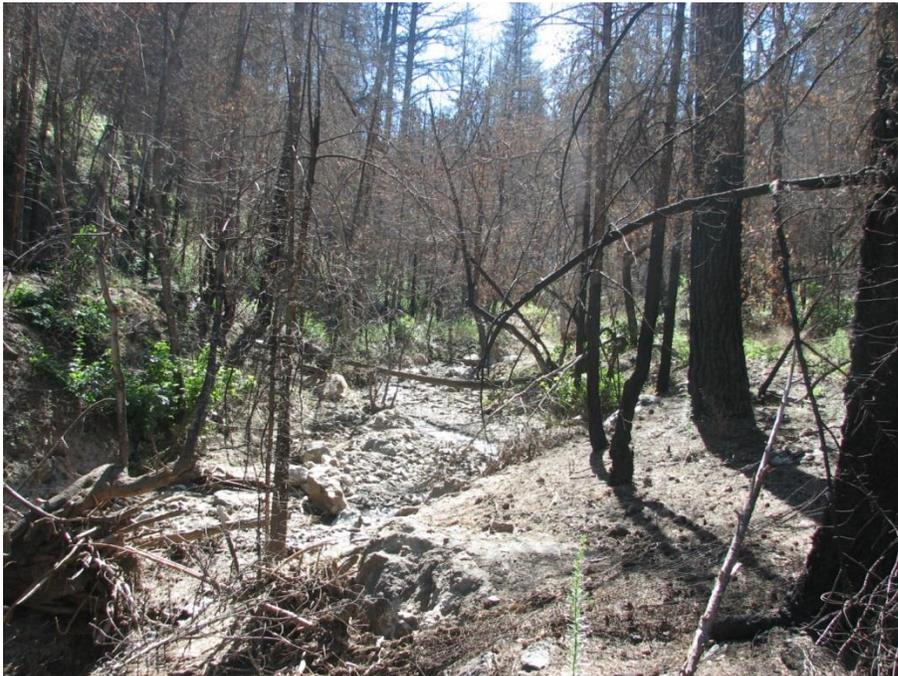
Fish Gulch Tributary to Beaver Creek; Above Beaver Creek Road;

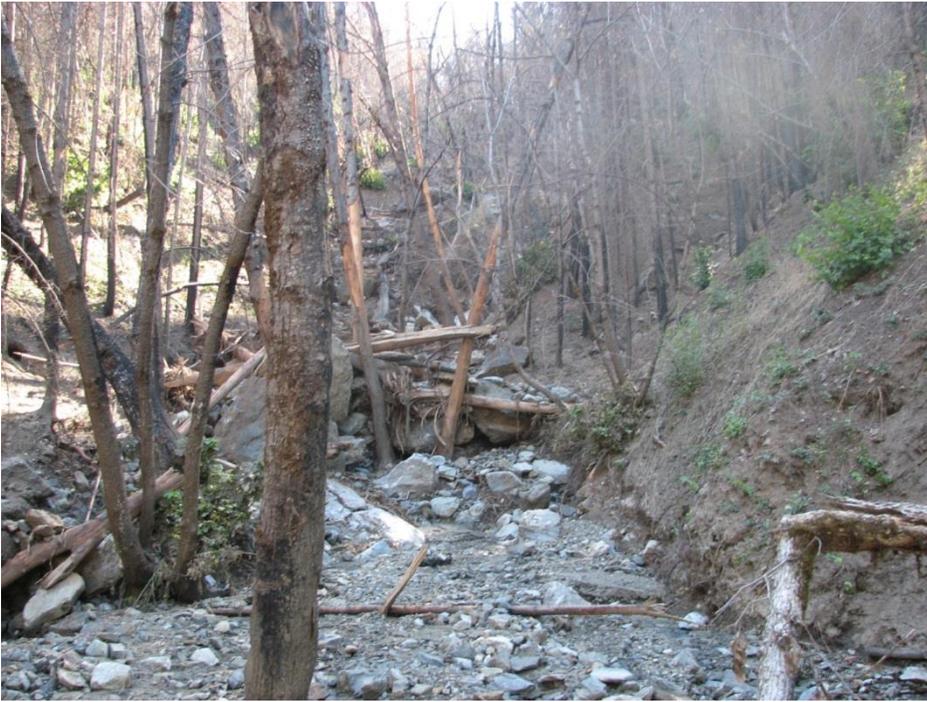
Marble Creek, tributary to Beaver Creek; Above Beaver Creek Road;

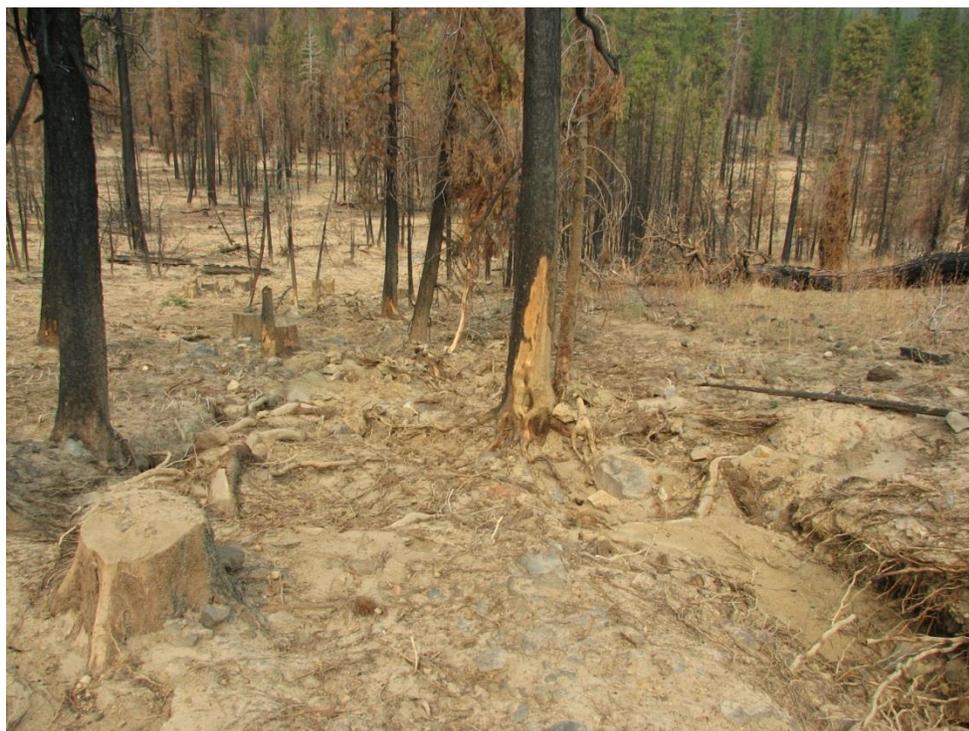
Gully on the north flank of **Little Deer Mountain**; Note debris on top of stump, and scour on tree trunks; View downhill toward depositional area on flats below

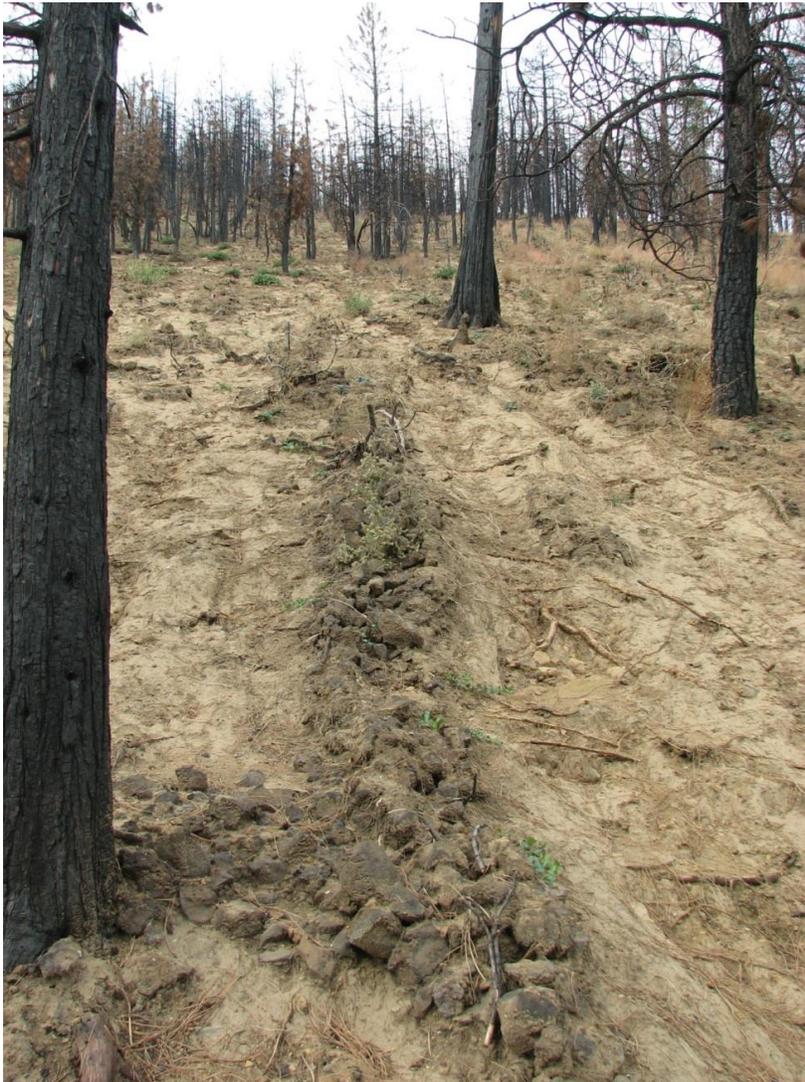
Rills and miniature debris flow tracks (2-8 inches deep) on the east flank of **Little Deer Mountain**; Note veneer of cobbles (2-6 inches in diameter), some of which have been swept away by debris flow and surface erosion processes; Photo 6270, view uphill;
