Executive Summary

In October 2014, the Surface Water Quality Bureau sampled Cold Spring Creek to determine if there had been negative impacts to water quality following flooding and erosion earlier in the year. Cold Spring Creek is listed as an impaired water of the State due to excessive concentrations of cadmium and lead. Historic mines in the upper watershed are the proximal source of the metal contamination, and the flooding caused significant erosion and mobilization of tailings that lie in the stream channel on both public and private land. The landowner, Ms. Karren Weathers, can no longer cross Cold Spring Creek to access a portion of the property that contains valuable equipment due to deep down cutting between the access road and the building. Ms. Weathers was concerned that any repairs to the road could mobilize additional tailings and sediment causing further water quality degradation. The sampling plan was developed to determine if there was a significant change to water quality following the flooding and erosion and gauge whether emergency repairs would further exacerbate water quality concerns.

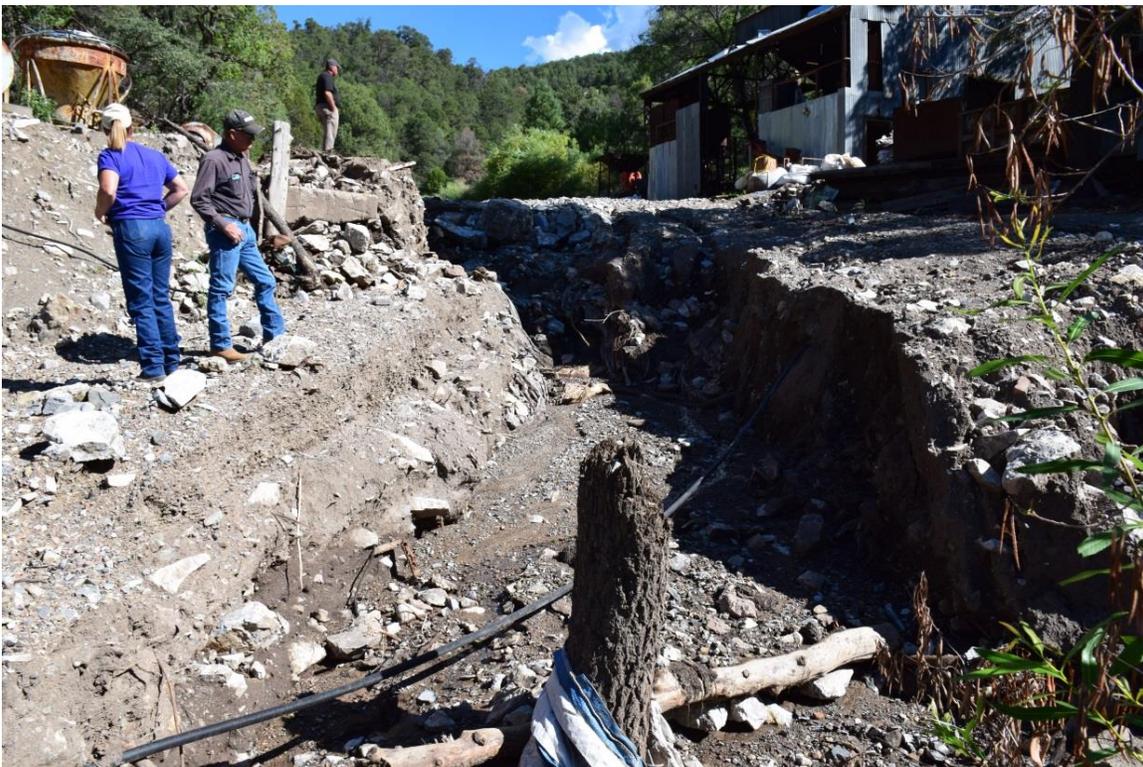
Figure 1. Area of erosion cutting through waste rock, tailings and river alluvium.

In 2009 the Surface Water Quality Bureau sampled Cold Spring Creek at the RJM7 location. This sampling predates the Silver Fire of 2013 and the watershed flooding and erosion in 2014 and lies approximately 0.5 miles downstream of the area of head cutting and erosion seen in figure 1. A direct comparison of these two sampling years at the same station gives an indication of water quality impacts that have resulted following the watershed perturbations in the past two years (table 4).

Significant watershed-level disturbances have created a highly unstable situation within the upper watershed of Cold Spring Creek. This has resulted in the failure of a 20 year-old settling pond with concomitant erosion and down cutting of the channel through public and private property. There are several areas of mine tailings that are now being mobilized into the stream channel and downstream. While the physical character of the stream and landscape has been significantly altered, it does not appear that the water quality within the stream has been significantly diminished as compared to conditions prior to 2014. Comparing the water quality data at the same location (RMJ7) in 2009 and 2014, metal contamination in the stream has not increased. At the RJM5 sampling location an acute exceedance of the water quality standard for zinc was recorded, but in downstream locations the zinc is within standards, suggesting that the zinc is a localized concern and not, at this time, a broad concern for residents, recreationists and livestock producers in the greater watershed.

While the New Mexico Environment Department is working with US Forest Service to prepare, fund and complete a comprehensive remediation effort, the timeline for this is still at least 1- 2 years out. In the meantime, the property owner is able to complete whatever construction activities are required to retrieve their equipment. The sampling results do not indicate that additional disturbance will result in deleterious effects on water quality. Construction activities would be covered under the US Army Corps of Engineers Nation-wide Permit #14 for linear transportation projects. If the total disturbance is less than 1/10th of an acre, the landowner does not need to contact the US Army Corps. Disturbances greater than 1/10th of an acre would require pre-construction notification to the Corps at the Las Cruces field office.

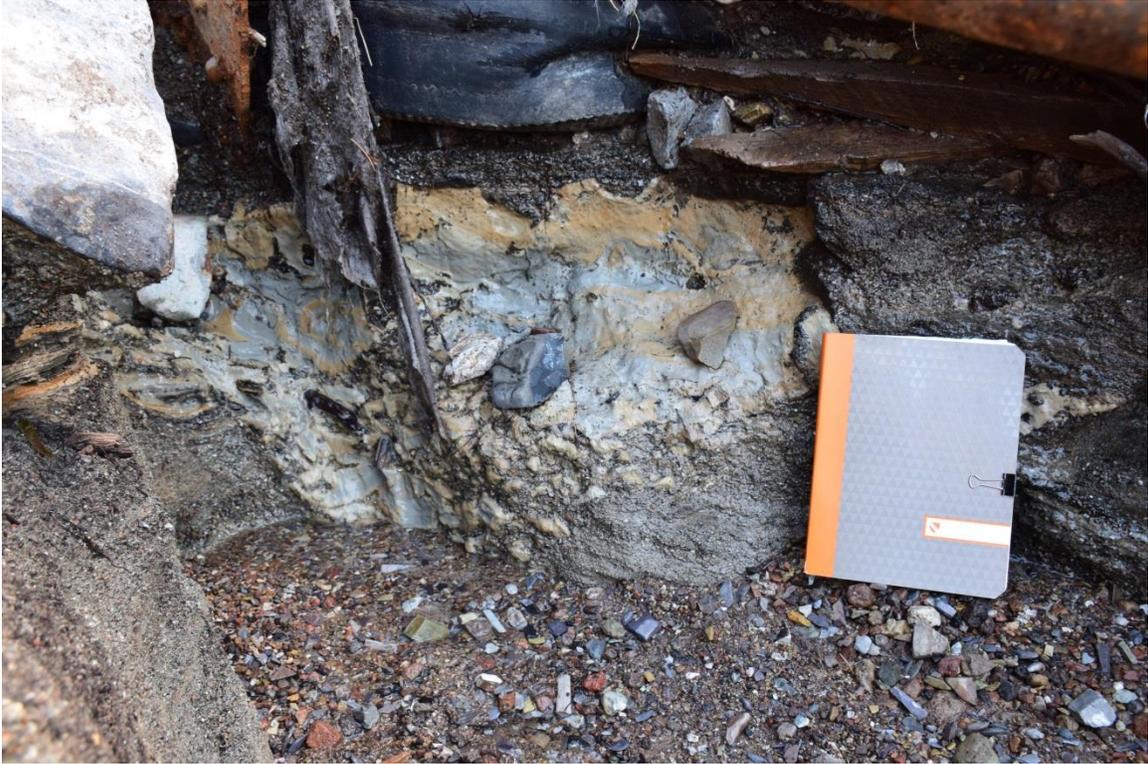
Figure 2. Fine grained tailings with high lead concentrations.

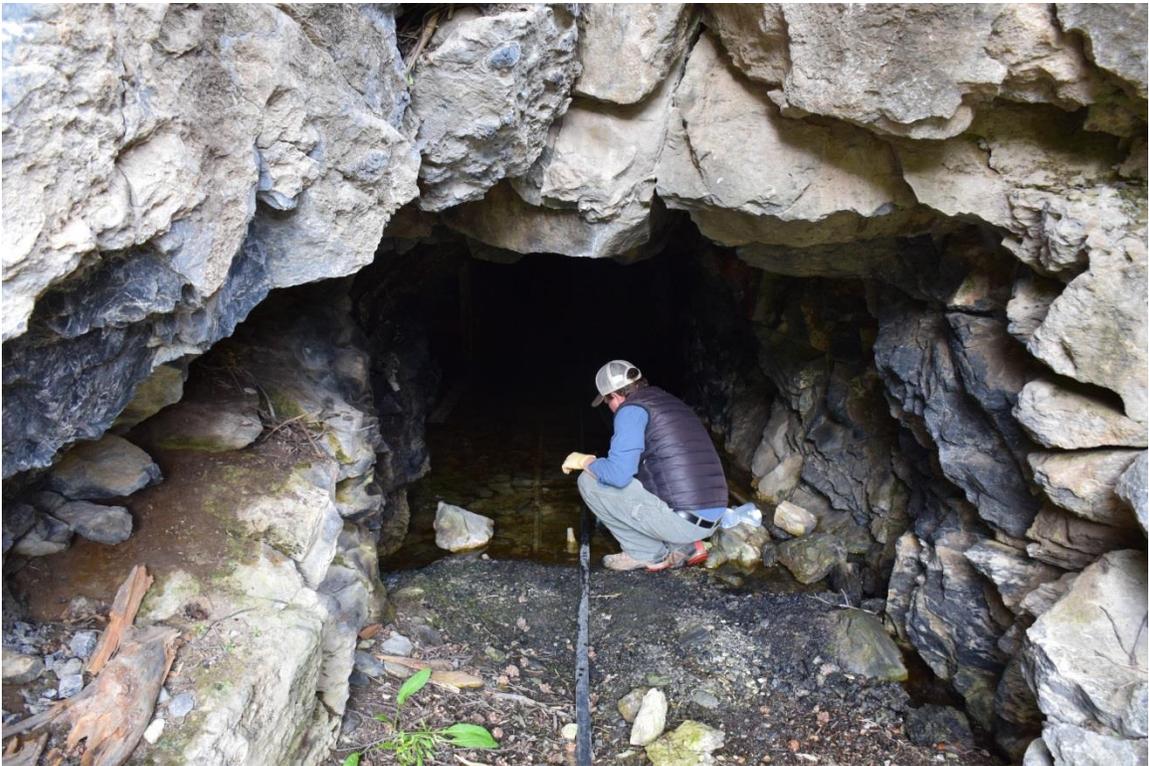
The RJM4 sampling location is at a mine opening above the Cold Spring Creek channel. Perennial water seeps out of the mine and is captured by the landowners for use as drinking water. The water quality analysis for this sample does not exceed either State surface water standards or EPA drinking water

standards. There is a small concentration of lead in the sample (0.004 mg/L) but this is well below the drinking water standard of 0.015 mg/L.

RJM 3 above, RJM4 below.

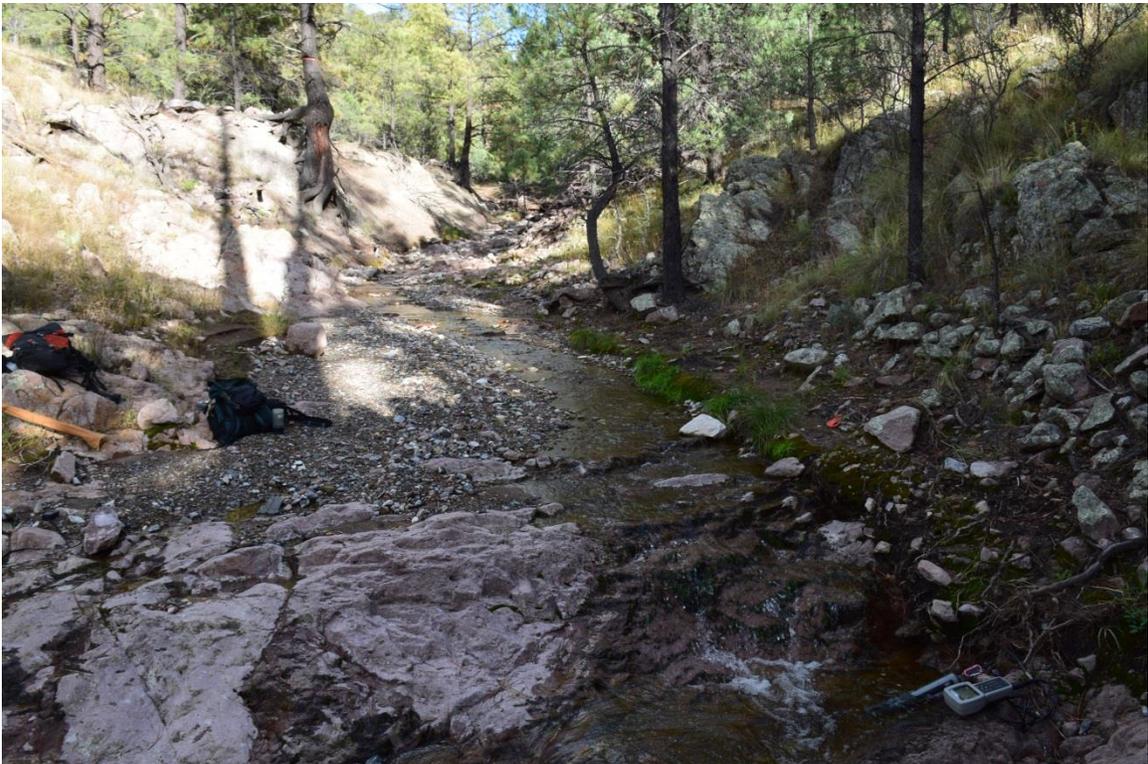
RJM 7 above, RJM8 below. Note lower tailings pile on left side of photo below.
