Date of Report: September 29, 2015

BURNED-AREA REPORT
(Reference FSH 2509.13)

- A. Fire Name:** Canyon Creek
- B. Fire Number:** OR-MAF-015292
- C. State:** Oregon
- D. County:** Grant
- E. Region:** Pacific Northwest (6)
- F. Forest:** Malheur
- G. District:** Blue Mountain / Prairie City
- H. Fire Incident Job Code:** P6JIK8 (0604)
- I. Date Fire Started:** 8/12/2015
- J. Date Fire Contained:** 95% contained as of 9/20/2015
- K. Suppression Cost:** \$21,133,082 as of 9/14/2015
- L. Fire Suppression Damages Repaired with Suppression Funds**
 - 1. Fireline waterbarred (miles): 114.7 miles
 - 2. Fireline seeded (miles): 114.7 miles
 - 3. Other (identify): Safety zones, staging areas and drop points are in the process of being rehabilitated. Road drainage work was installed where suppression activities warranted so.

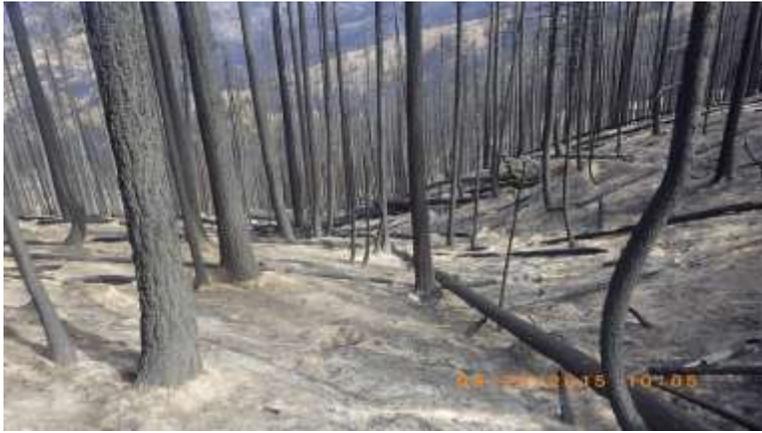
View of Rattlesnake Ridge looking down towards Berry Creek shows high severity burned soil accumulated in draws and prone to erosion.

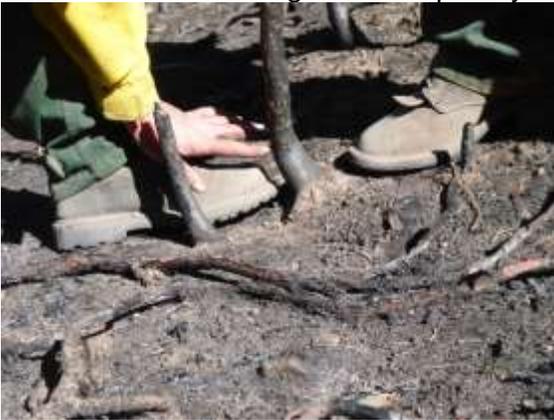
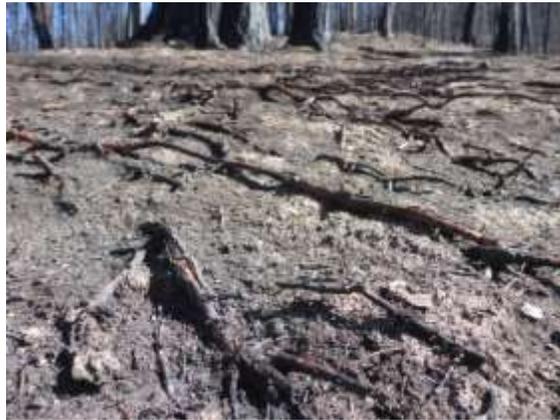
During the fire, one localized area of the Berry Creek drainage experienced winds of 50 mile per hour and greater due to its upwind canyon orientation. This localized area was observed to be primarily comprised of Mazama ash derived soils. Approximately 48% of the fire area is comprised of these types of soils. Portions of this area experienced significant wind erosion, where soil was removed from ridges and deposited in draws. Approximately 500-600 tons/acre was estimated as available for wind transport and erosion. A field check on September 25 indicated that much of the wind driven material remains in the drainage, but concentrated in the draw bottoms and hillside terrace features. It was determined that wood shred produced on-site would be the most effective treatment. Mulching will be most effective before another wind event, as the fine ash is very vulnerable to wind erosion.

Post-Fire wind erosion showing the susceptibility of A-Horizon Mazama derived soils in an area of the fire.

L3- Mulching – 2,449 acres (1,149 acres of non-wilderness and 1,300 acres of wilderness) of mostly high soil burn severity are proposed to be treated this fall within Berry Cr, Vance Cr, Pine Cr and Indian Cr. There is an additional spring mulch treatment proposed for 961 acres if monitoring shows the need.

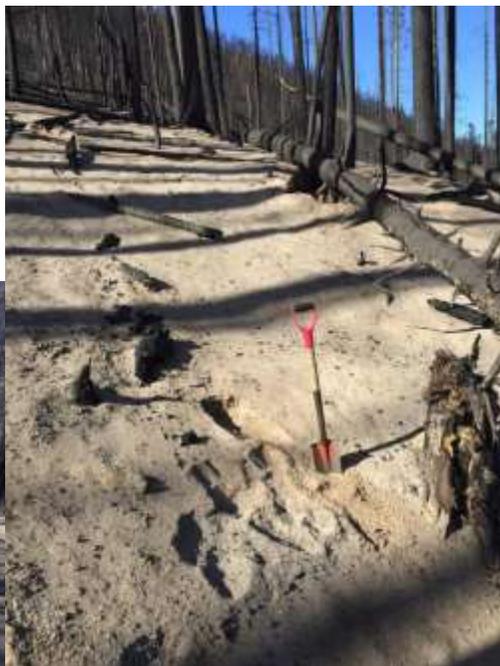
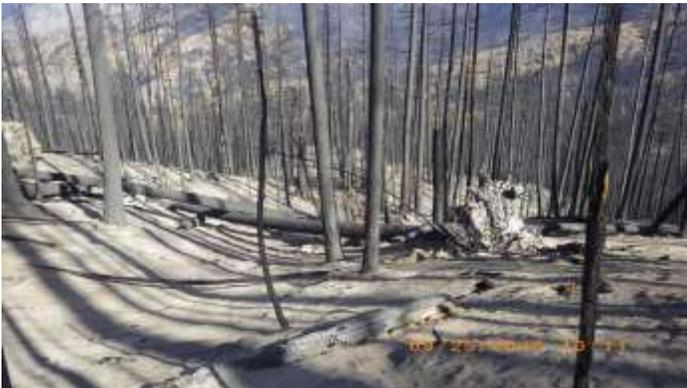
Photos below and to the right illustrate wind-blown burnt soil accumulations on the hillslopes and in the draws in the Mazama ash derived soils on Rattlesnake Ridge on 9/25/2015.

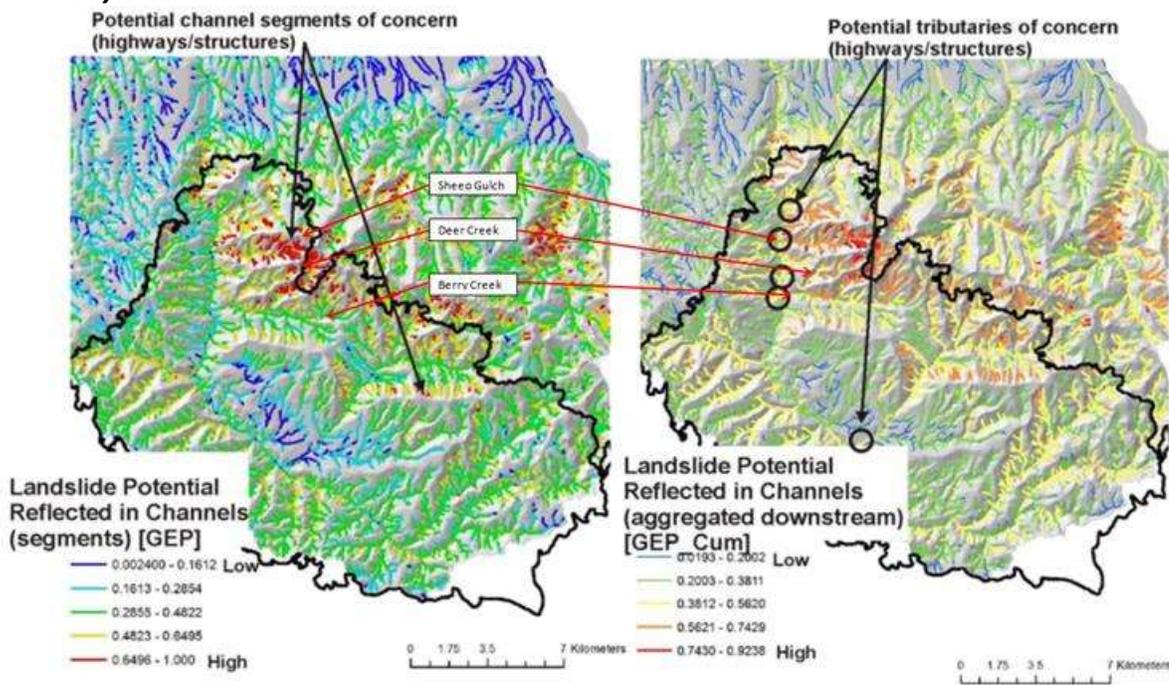
Figure 1. NetMap shallow failure landslide potential with red arrows pointing at Sheep Gulch, Deer and Berry Creeks.

Field observations indicate Berry Creek and Deer Creek debris flow modeling were underestimated with the USGS model. This suggests most of the hazard in the Canyon Creek drainages are underestimated. With a NetMap modeling (www.terrainworks.com) analysis based on GEP (Generic Erosion Potential), which is considered the universal driver of shallow failure, regardless of geology or climate, and used in this assessment as a predictor for shallow failure that drives debris flows, the NetMap tool predicts high risk of shallow failure in Sheep Gulch and Deer Creek, and lower risk in Berry Creek. The geologic characteristics, and observed debris flow deposits in the Berry Creek channel indicate the creek and its tributary channels are also at high risk for debris flow. The underlying geology in Berry Creek is the Clarno Formation, a lahar and debris flow lithology prone to landslides. The high potential for debris flows in Sheep Gulch, Deer Creek, and Berry Creek may contribute considerably to the sediment potential in the event of shallow failure and debris flow. Observations of a debris flow initiated from a small fire (approx 6400 acres) in 2011 within the Berry Creek drainage included loss of bridges, deposits of bedload on alluvial fans, and indicates similar behavior will likely occur at a larger scale with any significant precipitation event.

These images represent NetMap’s landslide and debris flow potential for Sheep, Deer and Berry Creeks.

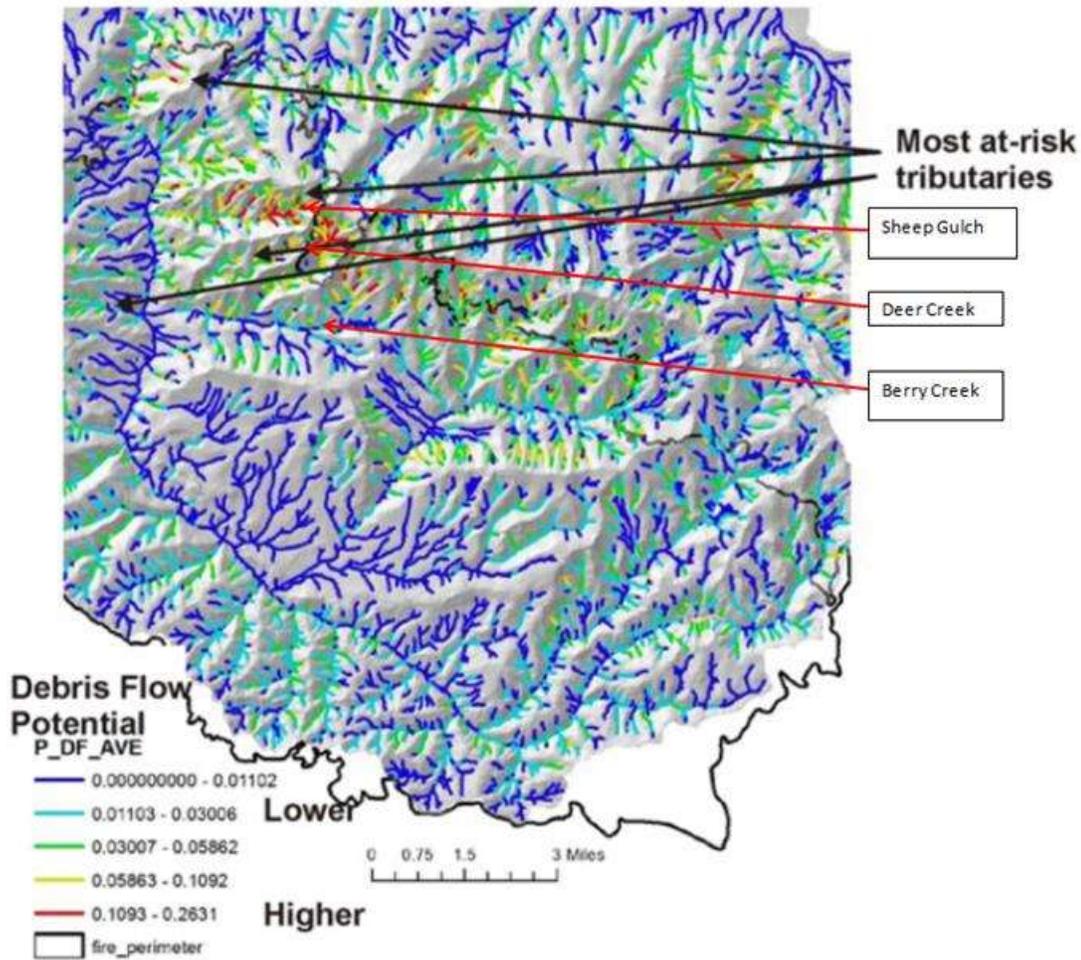
Figure 2. NetMap susceptibility of tributary debris flow with red arrows pointing at Sheep, Deer and Berry Creeks.

Tributaries of Canyon Creek that drain Canyon Mountain. Elevation changes from 8,000 to 4,000 feet within 2-3 miles.
