# Rio Guadalupe

## *Stream Inventory Report*

Santa Fe National Forest  
Surveyed: June – July 2004  
Forest Fisheries Crew

Santa Fe National Forest  
February 2006

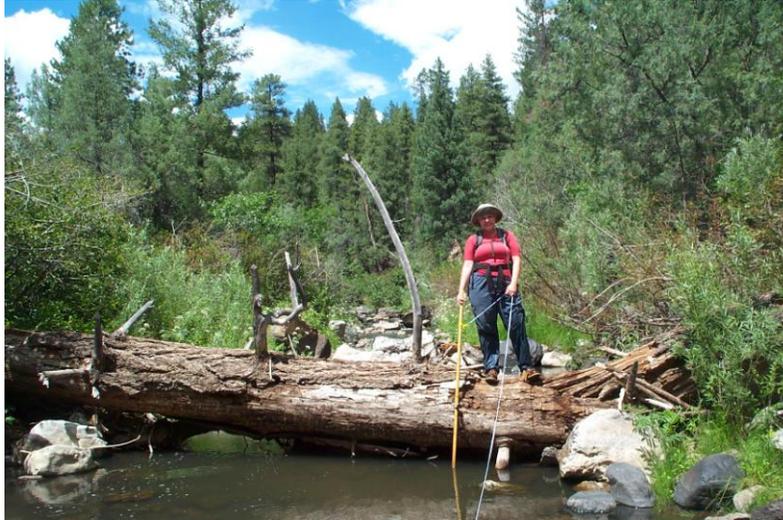
**Photo 3.** Reach 6, NSO 219, R117. The Rio Guadalupe with one of the few pieces of LWD (21-July-2004).

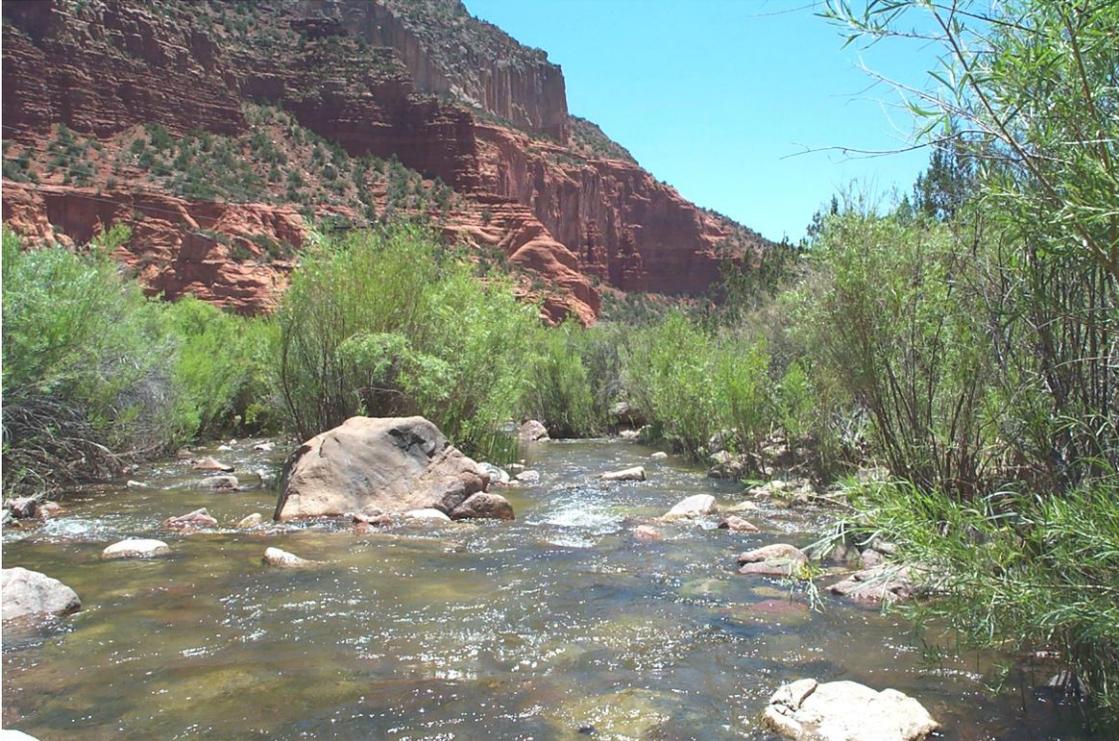
**Photo 2.** Reach 2, NSO 19, S1. Riparian vegetation in lower Rio Guadalupe. Notice the strong willow component and lack of over story shade cover (15-June-2004).

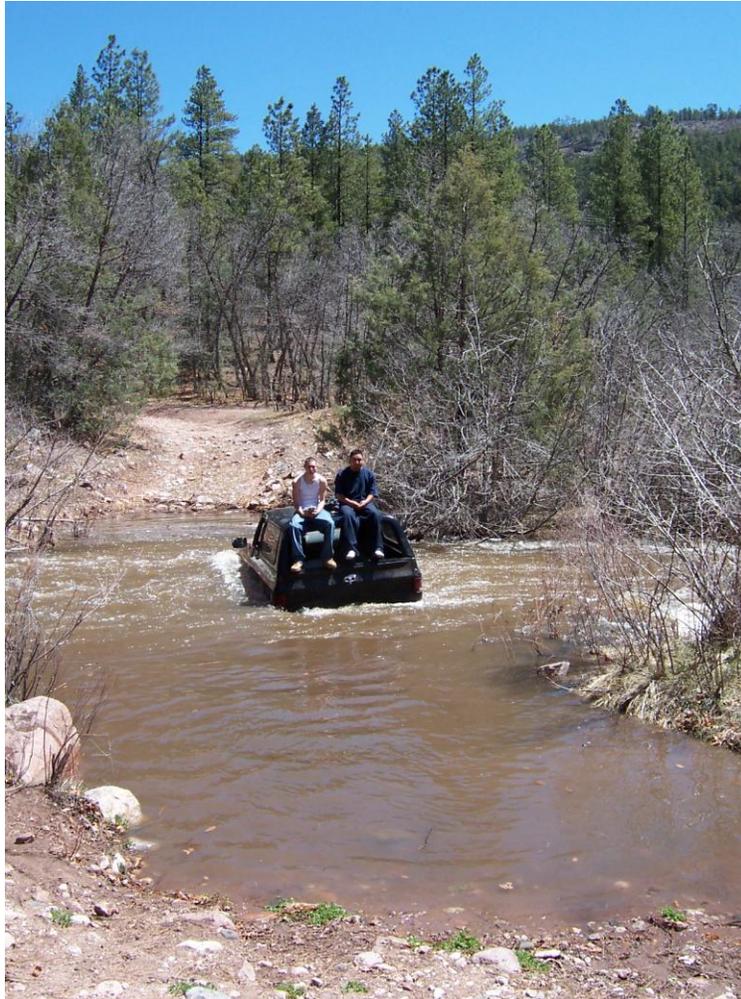
Specific problems related to the roads in the Rio Guadalupe Watershed were identified during the 2004 Stream Inventory. The Holiday Mesa Road fords Rio Guadalupe and is causing the stream channel to widen and shallow, causing thermal heating and evaporation as well as adding sediment to the creek (see Photo 14). The Holiday Mesa Road its self is in very poor condition and is supplying sediment into the creek. In the Guadalupe Box FR 376 encroaches on the left stream bank and is in places only a few feet from the water's edge. With the high amount of vehicle traffic and damage that was occurring along the Rio Guadalupe, a road to river vehicle closure was put in place in 2004 to help reduce the damage that was occurring along the banks. Analysis of specific road related issues is limited to the Rio Guadalupe and not the entire watershed.

**Photo 14.** Holiday Mesa FR 656 crossing during spring run-off (20-April- 2004).

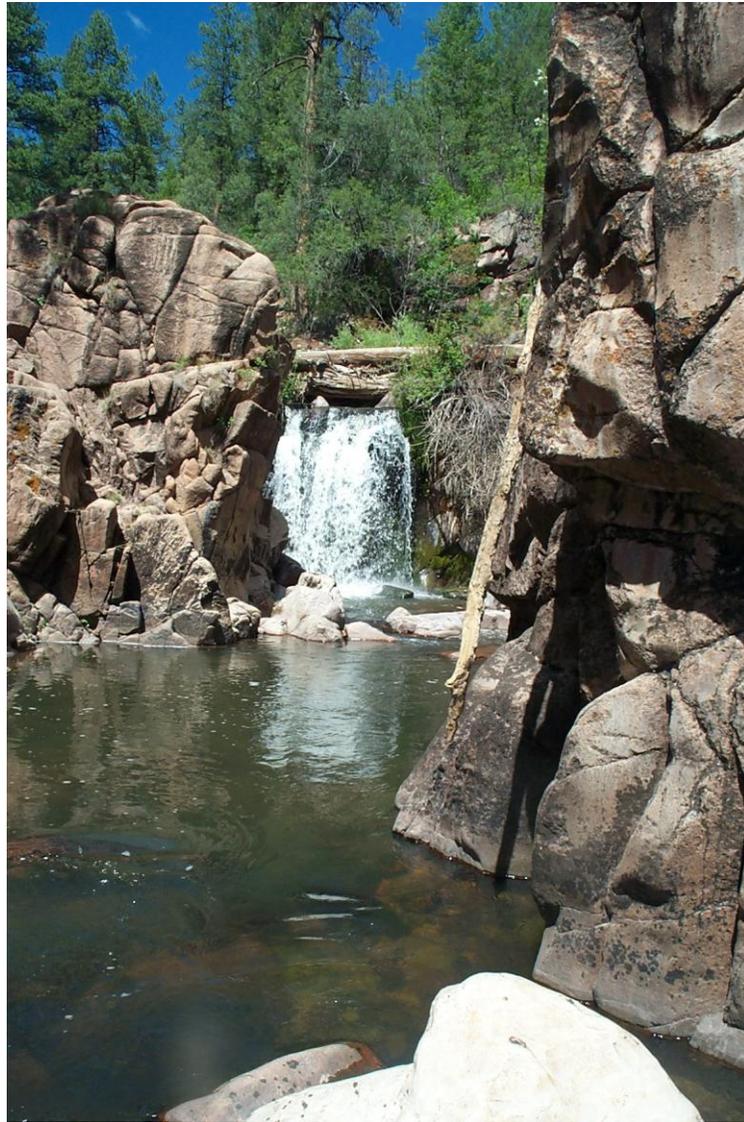
**Photo 17.** NOS 204, F15. Natural barrier and confinement that would make a good site for man-made barrier (8-July-2004).

Utilize natural barriers (Reach 3 and 5) or areas of confinement, such as bedrock canyons in Reaches 3 and 5 to minimize the construction of man-made barriers. The natural confinement and possible barriers in Reach 5 (see Photo 17) could be used as the first step of many in creating an expansive metapopulation.

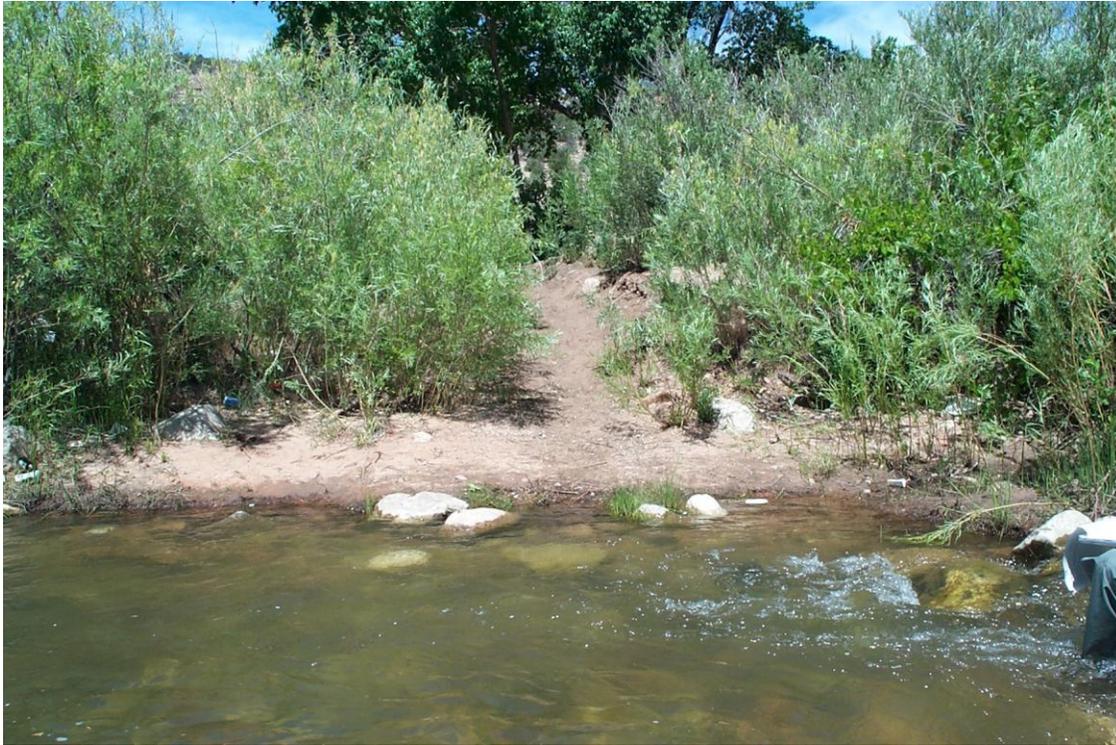
Human impacts along this reach were noted as user created roads, angler trails, and fords. Dispersed camping is prevalent along the left bank. These sites were inventoried in the summer of 2003. “Logging Camp” runs along the left bank from the beginning of Reach 2 and ends near NSO 18 (3737’ or 0.71 miles). The area related to Reach 2 on Forest Service land is designated Day Use Only. However, overnight camping is common practice in “Logging Camp”. This area is mainly used for fishing and swimming. There are angler trails that run along most of the left bank and parts of the right bank. Another dispersed site is found at the end of the reach, called “Gilman Peak,” which is commonly used by locals and recreationists as an illegal dumping site. There was a lot of trash found throughout the reach: fender from a car, cans and bottles, and clothing.

**Photo 21.** Reach 2, NSO 3, P1. Trail leading down to the water at “Logging Camp” (14-June-2004).

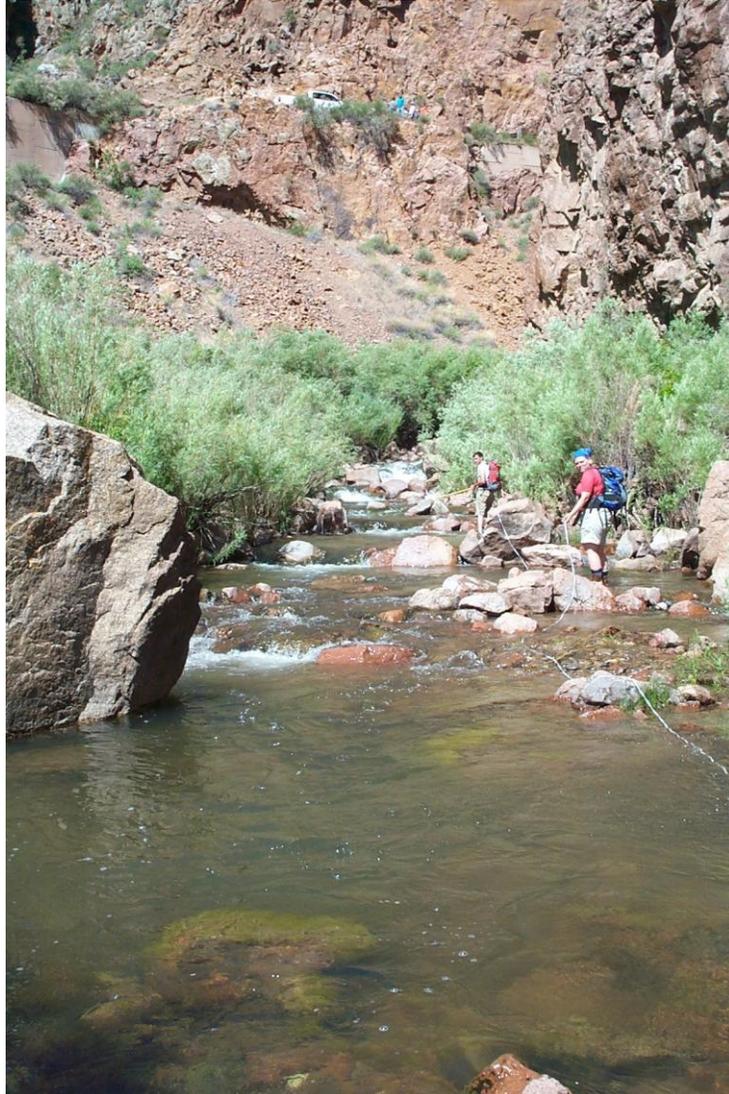
**Photo 23.** NSO 27, R20. Looking upstream at talus slope. Notice the lack of overstory (16-June-2004).

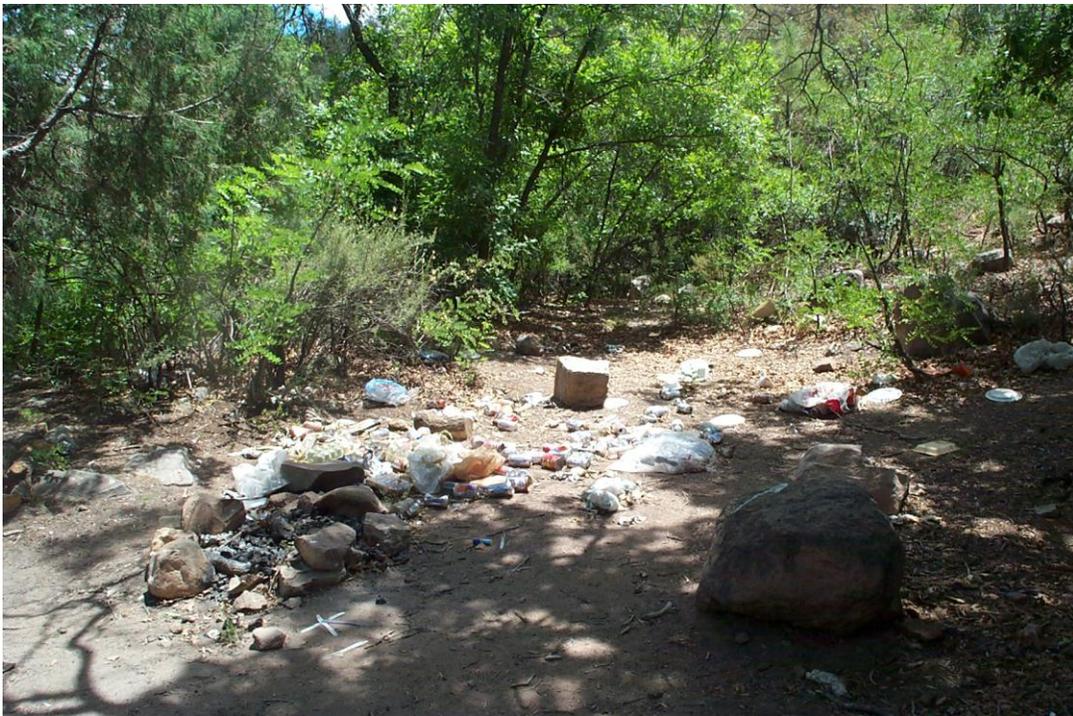
**Photo 26.** NSO 77, S4. Human Impacts on the Banks of the Guadalupe (22-June-2004).

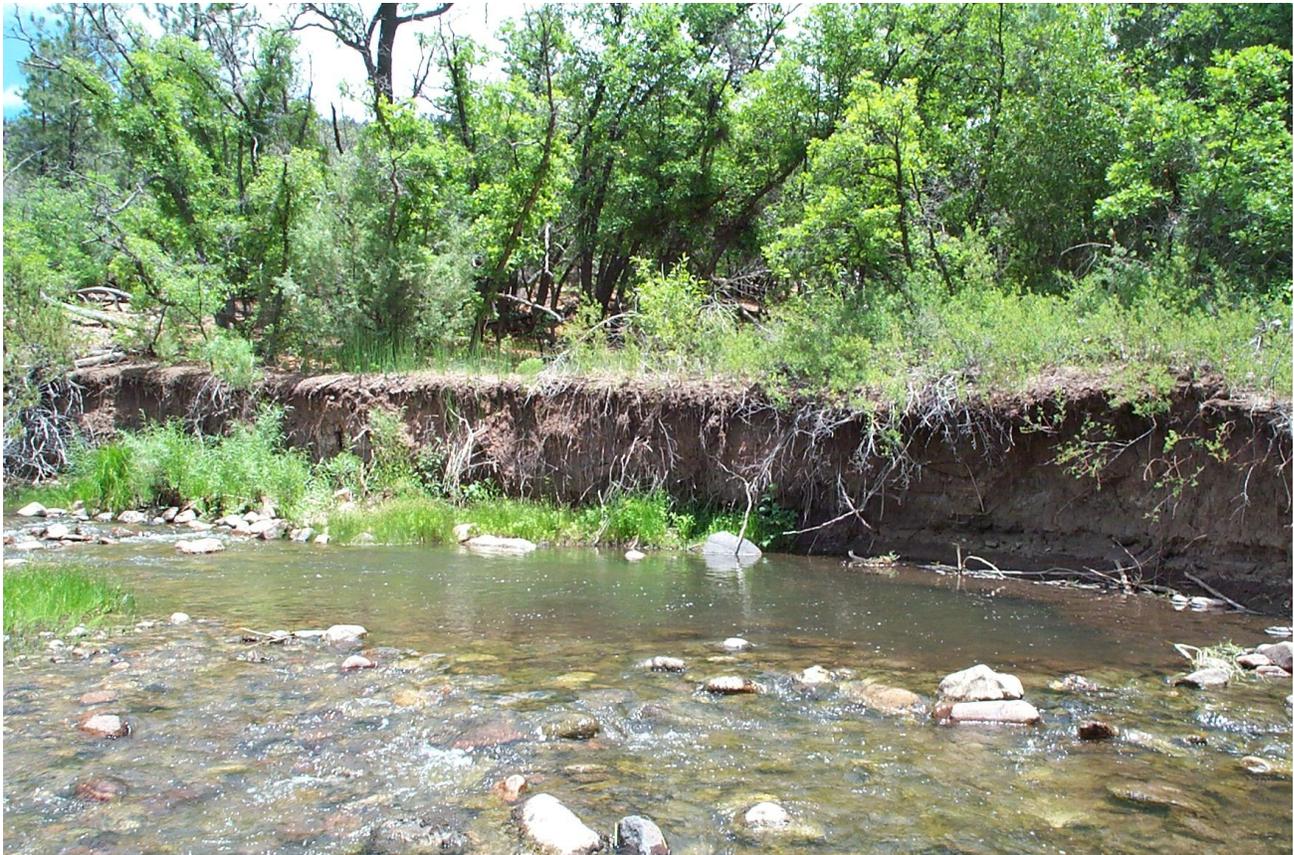
Streambank condition is **properly functioning** in Reach 4 with 0.6% unstable (see Table 29).

**Photo 28.** NSO 91, P26. Unstable bank (23-June-2004).

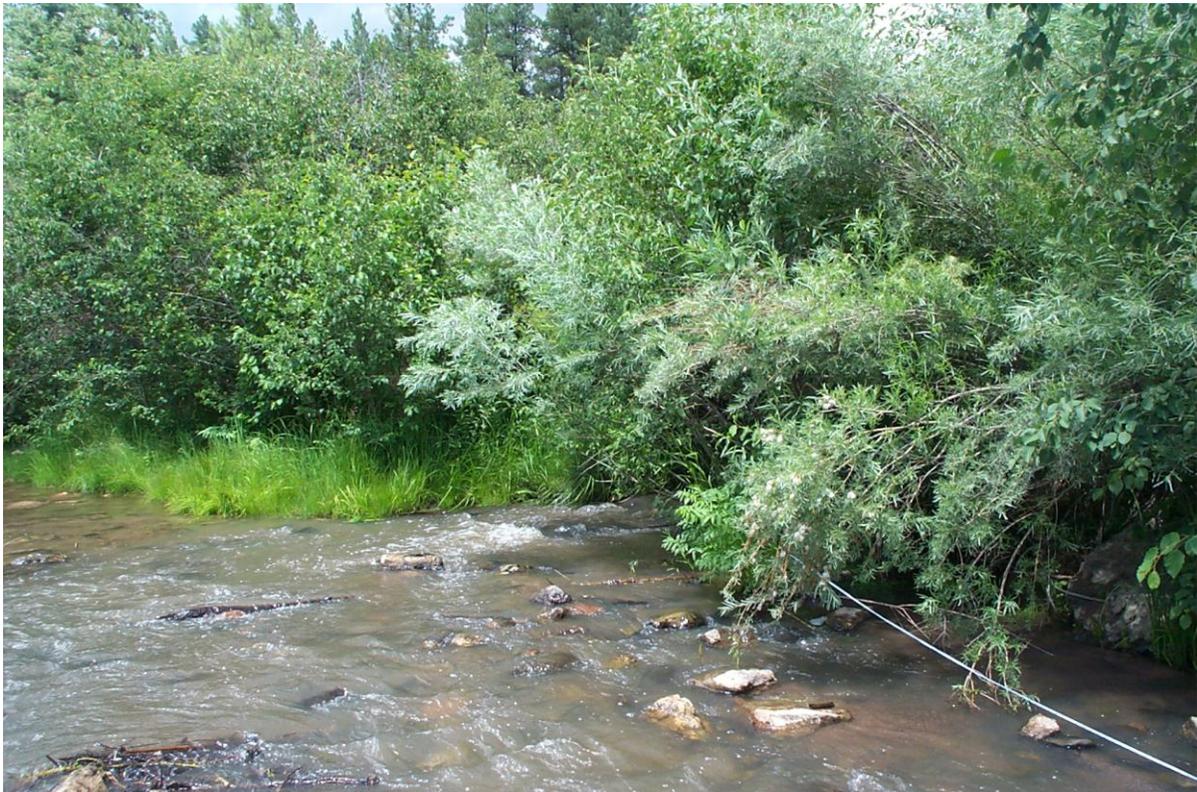
**Photo 3.** Reach 6, NSO 255, R138. The Rio Cebolla (right) and the Rio de las Vacas (left) joining to form the Rio Guadalupe. The upper thermograph site was located here. Notice the turbidity coming from the Rio Cebolla from the 2002 Lake Fire (21-July-2004).
