Appendix D. Best Management Practice Trip Reports

Corner Bay Facility Maintenance, Sitka Ranger District, Tongass National Forest

August 11, 2014

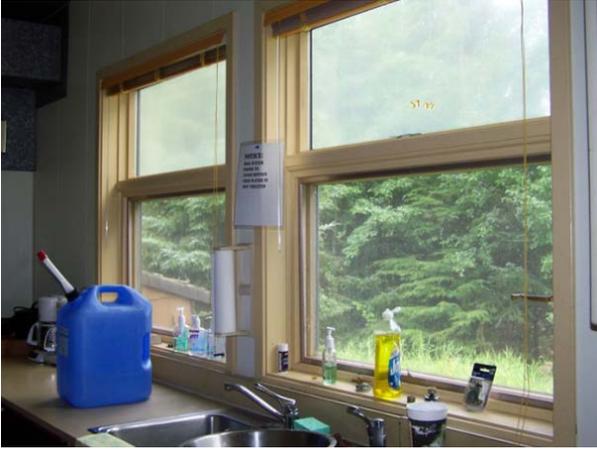
Corner Bay Photo 1. Water damage and mold due to roof leak, which has been repaired.

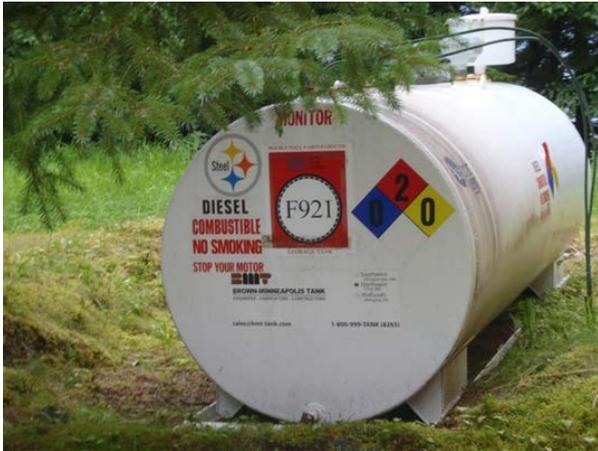
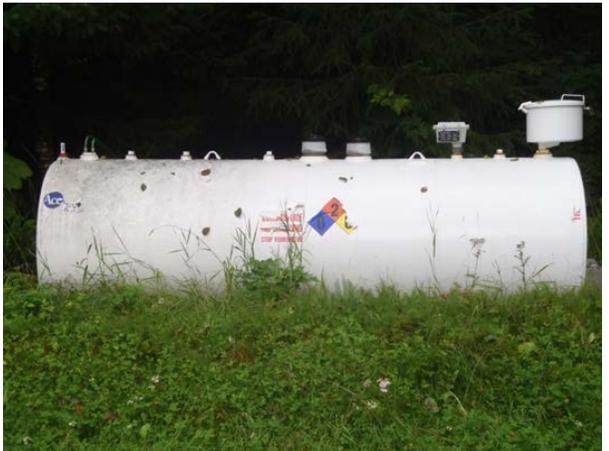
Corner Bay Photo 3. (a) and 3. (b). Fuel Tank (end view) and side view

The facility review found that there were two 1,000 gallon double walled fuel tanks filled with sludge. These tanks do not have the potential to affect water quality or aquatic health. There are no leaks from the tanks (Photo 3).

Corrective actions were not listed in the review.
