Raven Trail Construction, Petersburg Ranger District, Tongass National Forest

September 8, 2014

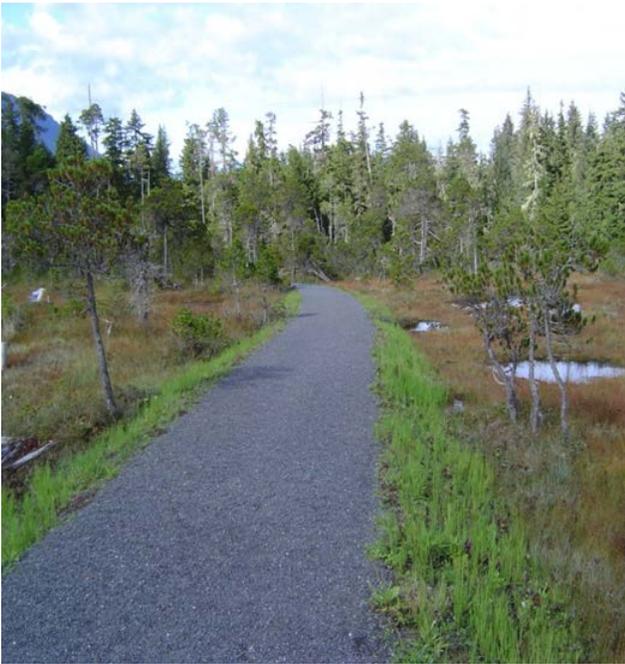
Raven Trail Photo 1. Trail surface is graded aggregate.

The newly constructed trail is 6.5 feet- to 8 feet-wide, graded aggregate with rest areas, benches, culverts and signposts (Photo 1). The contract of work included clearing and grubbing, excavation and construction including seven culverts. Impacts were minimized by including specific measures in the contract that included regular meetings with the COR for inspections and communication with both parties. Special care was taken to dispose of materials off-site, minimize rutting and erosion by using construction mats, installing corduroy or geotextile, grading trail bed and installing temporary drainage. To provide sediment control, filter cloth was installed during construction. The site was re-vegetated using plugs that were originally removed from site during the clearing and grubbing stage (Photo 3).

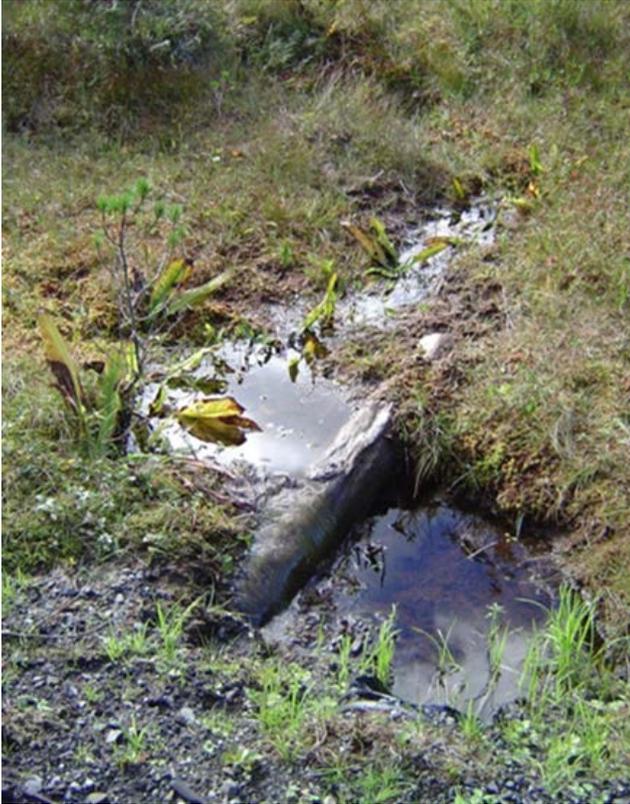
Raven Trail Photo 2. Low energy water body crossing with minor pedestal erosion.

At the minor intermittent stream, a culvert was installed to transport water across the trail. There was evidence of sediment transport as noted in very minor pedestal erosion in isolated locations adjacent to the water flow from the muskeg (Photo 2). The sediment transport amounted to an area two feet by one foot adjacent to a culvert on the fill slope. The low energy water did not transport the sediment beyond the immediate area. This erosion resulted from unhardened crossing approaches on the bare ground from heavy rains. No diversion potential was noted at this crossing. Soil was placed along the fill slope of the trail to provide soil structure for vegetation growth. Later, it was determined that soil contained residual amounts of non-native plant seed. No evidence of chemical or fuel spills were noted.

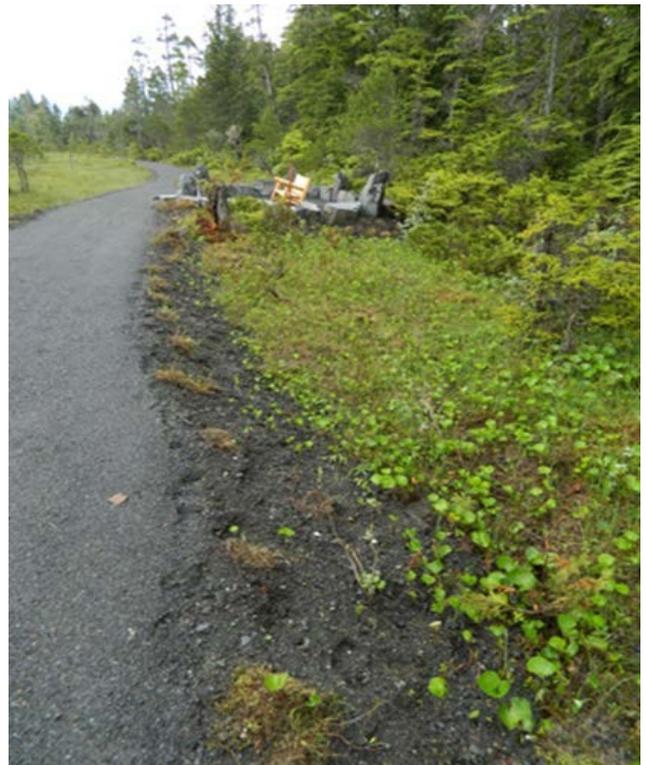
Raven Trail Photo 3. Vegetative plugs near the rest area.
