## Road 3015, MP 1.773 and 8.743, Thorne Bay Ranger District, Tongass National Forest

September 16, 2014

### Background

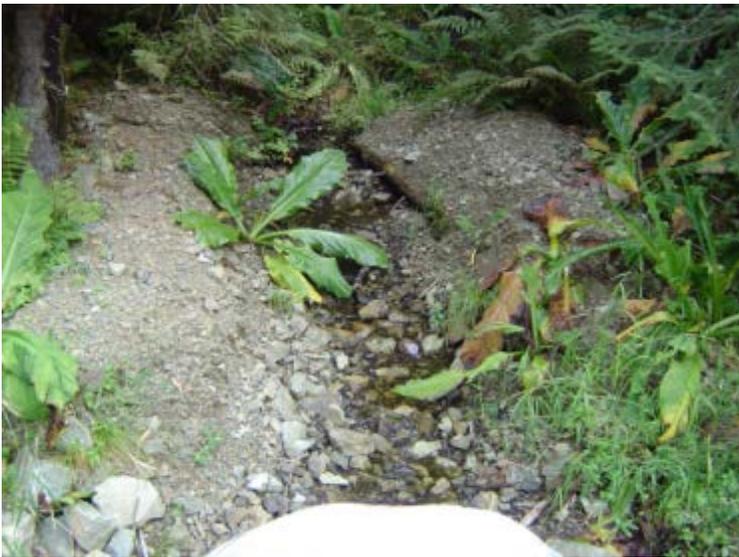
Road 3015 Photo 3. Milepost 1.773 CMP inlet

**MP 1.773** – This culvert is three years old and was graded this year (2014). The length of road evaluated was 0.5 mile. The length of the road segment near the aquatic management zone (AMZ) was 240 feet.

**MP 1.773** – It took a year or two for rock to get into the pipe. The simplified stream simulation surcharges sediment above the pipe and the stream moves it into the pipe. This one did not fill immediately.

**MP 1.773** – Surchage was placed on the banks instead of in the stream. It took two large flow events last winter and this spring to move the material into the pipe.

Place surcharge material in the stream or further down on the banks so it moves into the pipe at lower flow events.

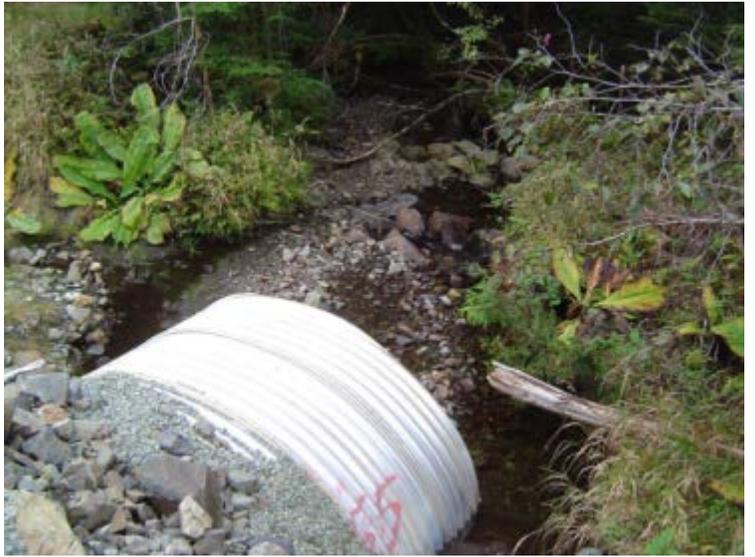
Road 3015 Photo 4. Milepost 8.743 CMP outlet

**MP 8.743** – Reconstruction on this pipe was completed in July. Small fish were present at the pipe during this review. The length of the road segment evaluated is 532 feet. The length of the road segment near the AMZ is 280 feet. Silt fencing was used downslope of the culvert during installation.

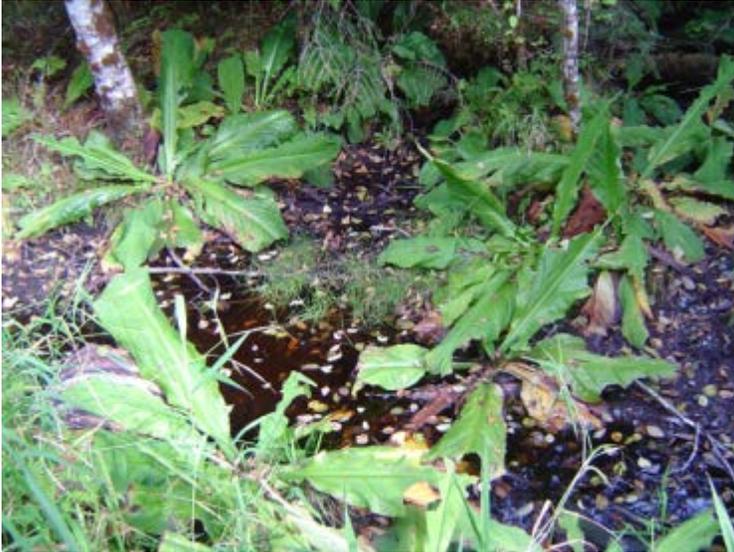
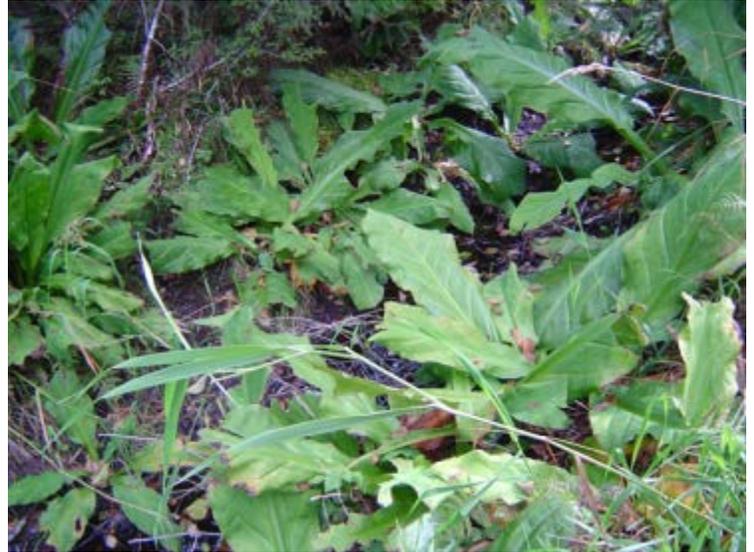
Road 3015 Photo 6. Two more views of a brushy low point at CMP mid-approach to the 8.743 milepost crossing.

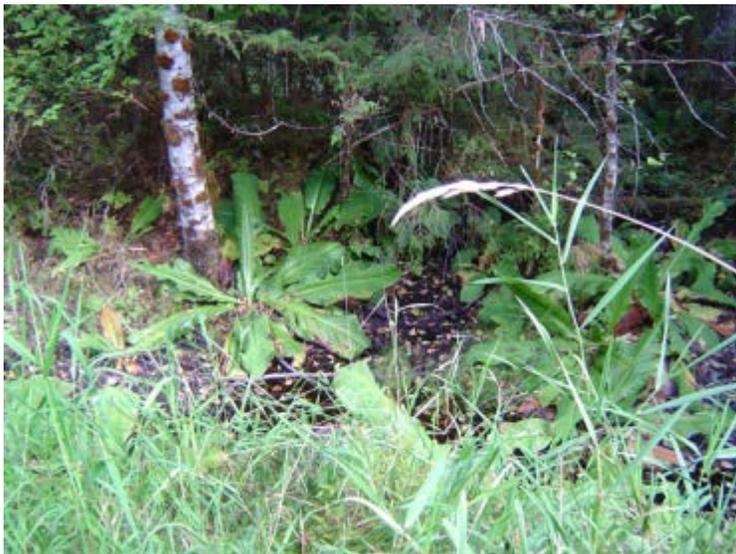
Road 3015 Photo 7. Brushy low point at CMP mid-approach to the 8.743 milepost crossing.

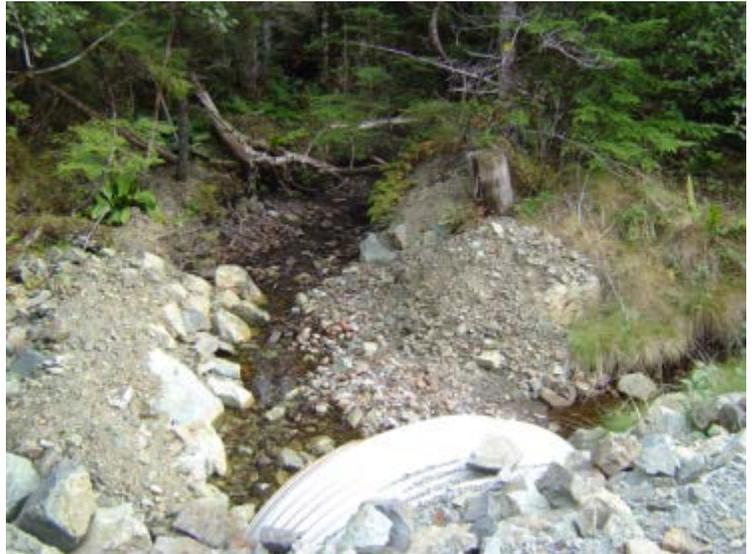
Road 3015 Photo 8. Milepost 8.743 CMP inlet

**MP 8.743** – Stream armored at inlet to direct water into corrugated metal pipe (CMP). Also note that armoring adjacent to ditch directs water into the culvert.
