Completed Waterbody Crossing Reconstruction, Road B Form, Road 8448, MP 0.380, Ketchikan-Misty Fiords Ranger District, Tongass National Forest

August 20, 2014

Summarized by Darin Silkworth

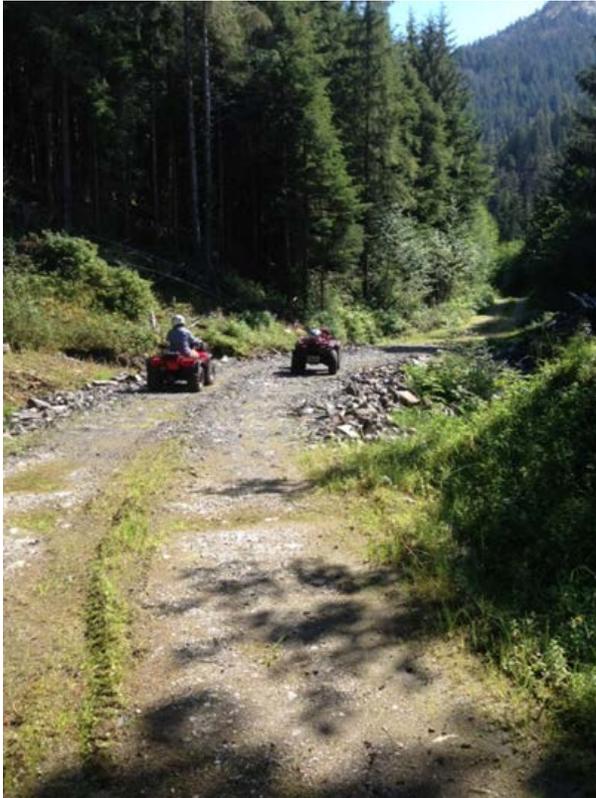
Upper Carroll Photo 1. Reconstructed road segment

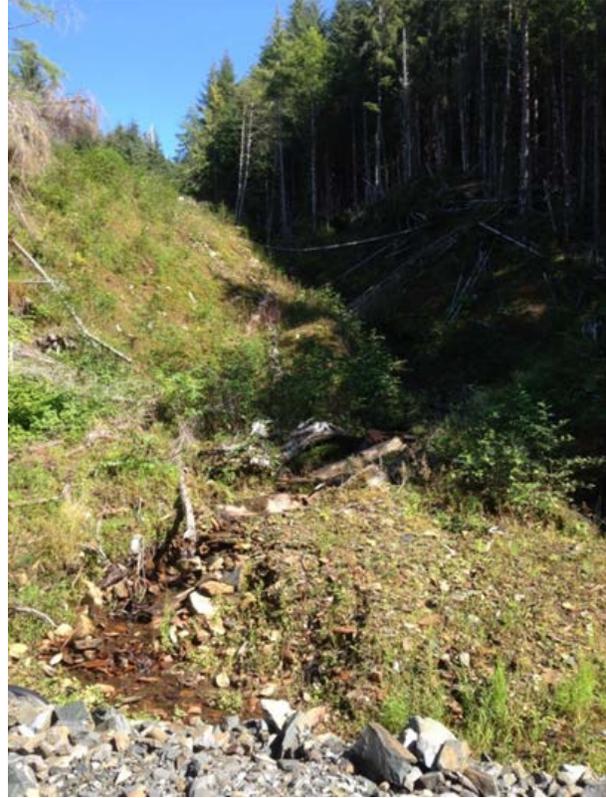
Upper Carroll Photo 2. Hillside above the road segment

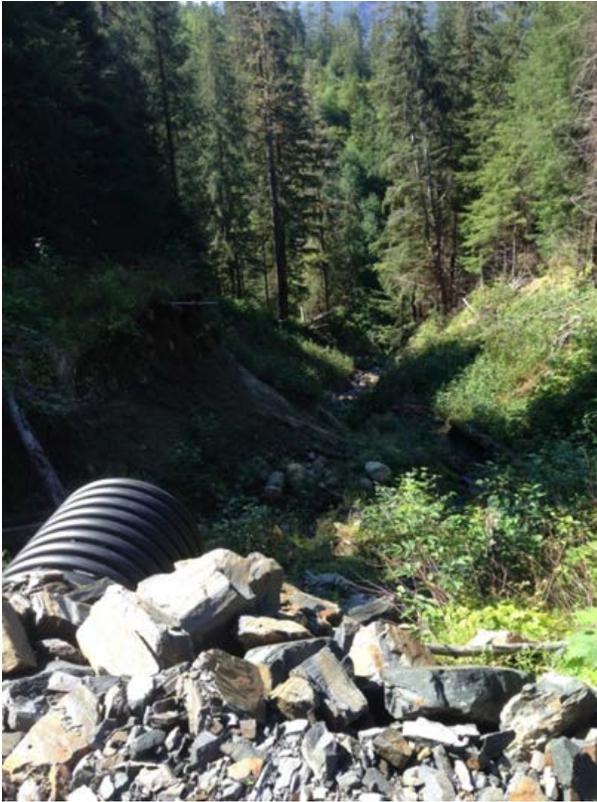
Upper Carroll Photo 3. Looking below the reconstructed road segment

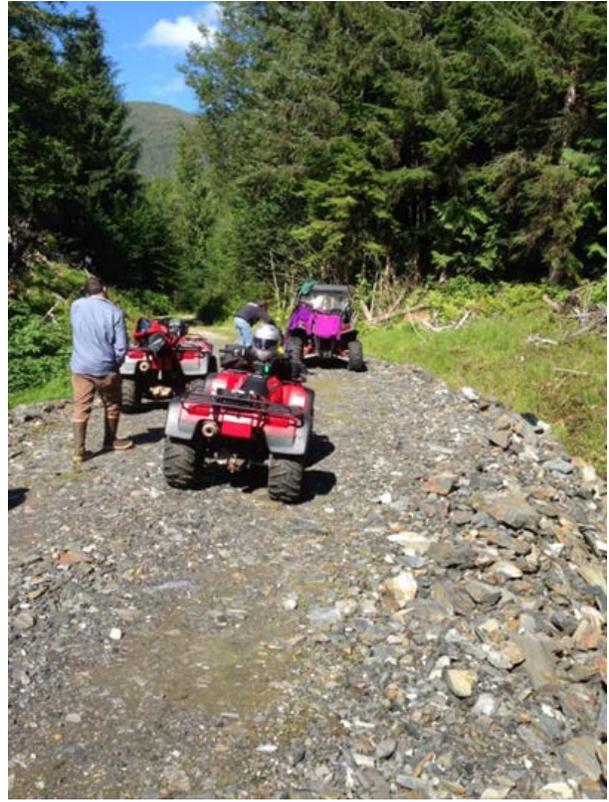
Upper Carroll Photo 4. West approach to the reconstructed road segment

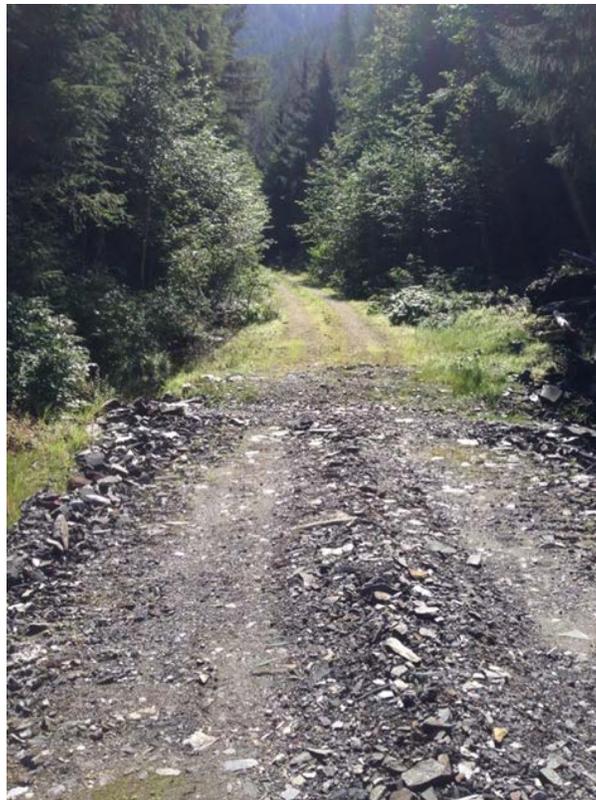
Implementation was effective. The waterbody crossing structure has no debris, sediment or damage. There is no evidence of erosion or sedimentation. All applicable inspections or administration were conducted at critical times, or activities were conducted to avoid critical times.

Upper Carroll Photo 5. Reconstructed crossing, looking east
