Starrigavan Road 7513, Sitka Ranger District, Tongass National Forest

August 11, 2014

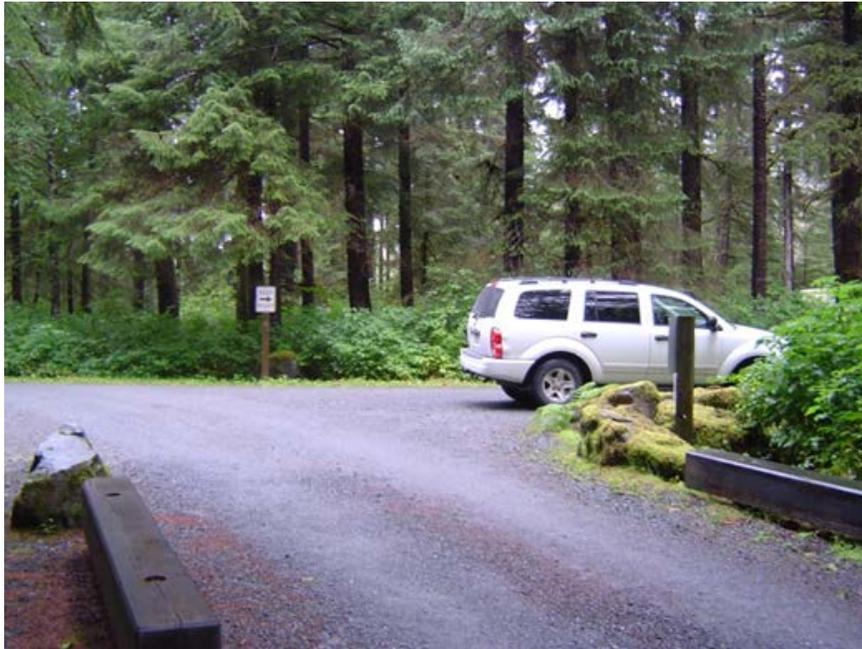
Starrigavan Road Photo 1. Starrigavan road surface

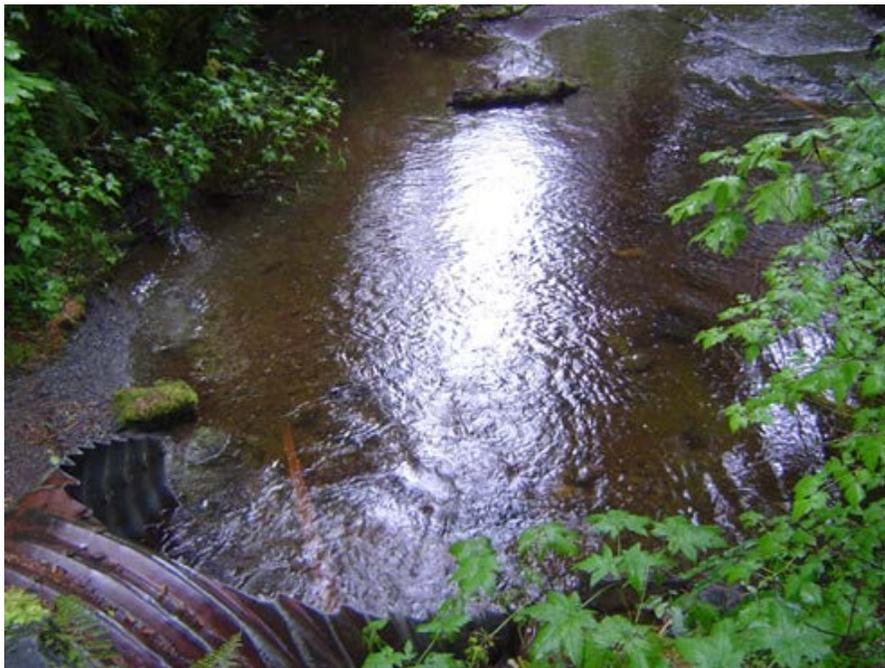
Starrigavan Road Photo 2. Downstream culvert

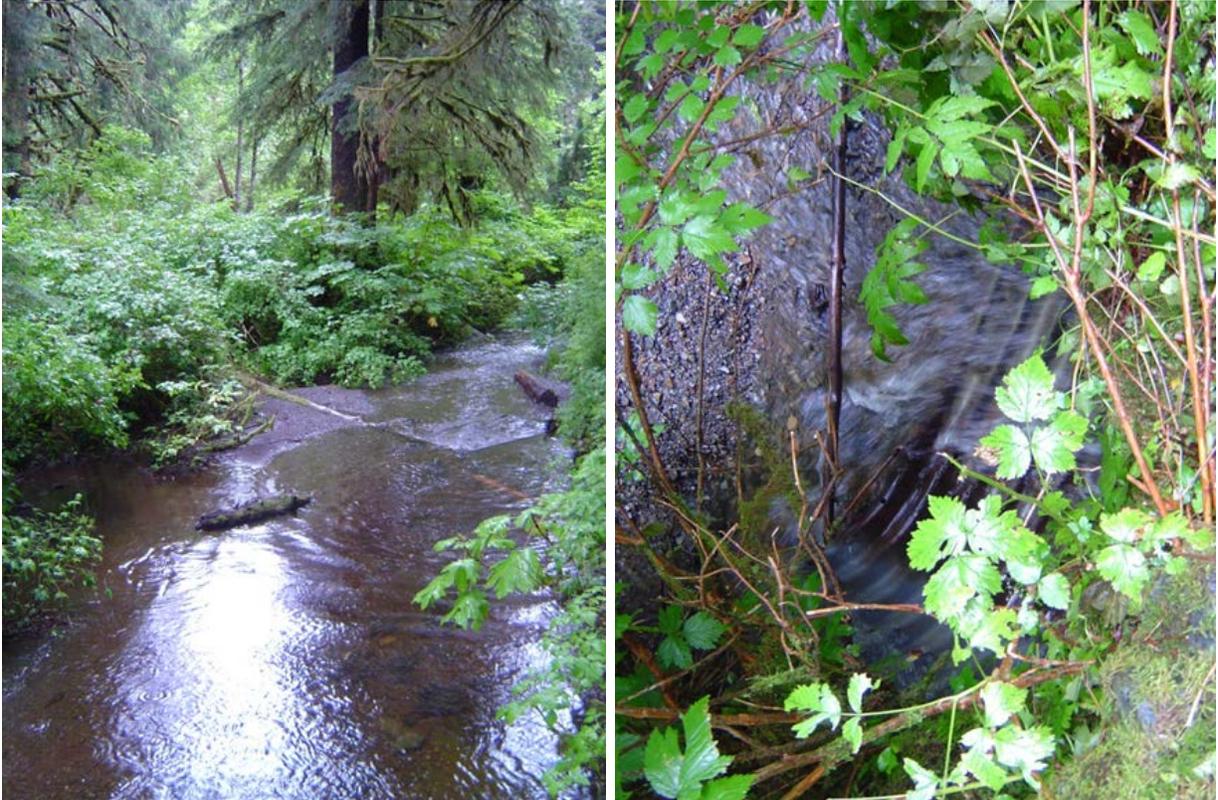
Starrigavan Road Photos 3 & 4. Downstream culvert

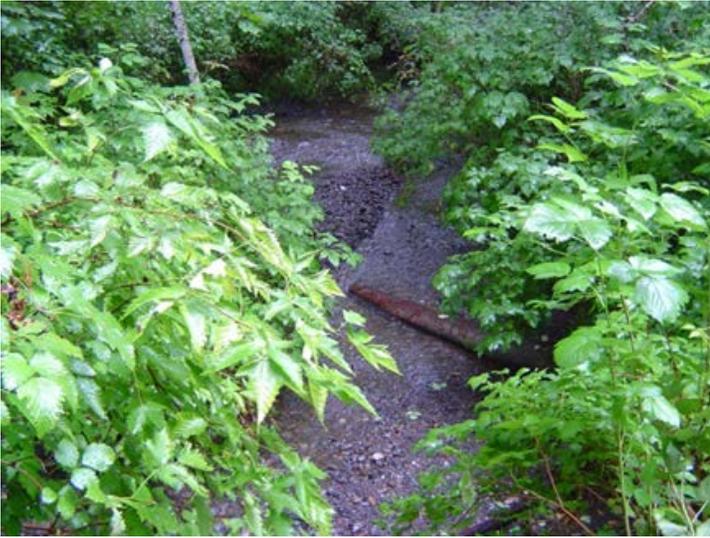
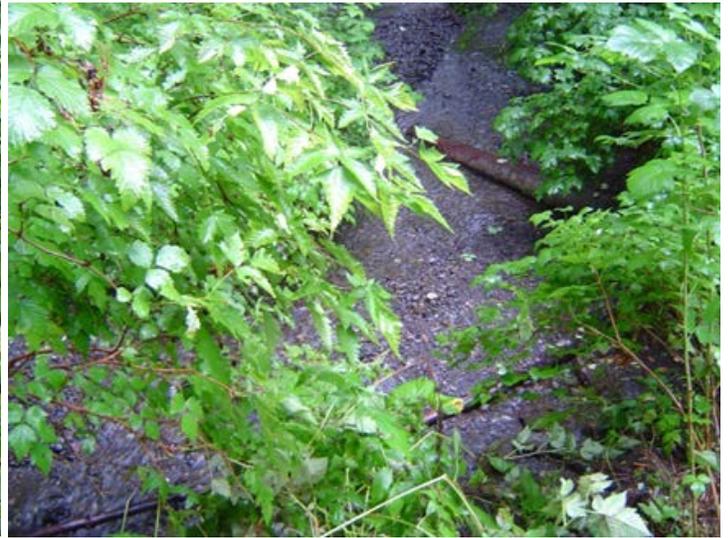
Starrigavan Road Photos 5 & 6. Upstream culvert

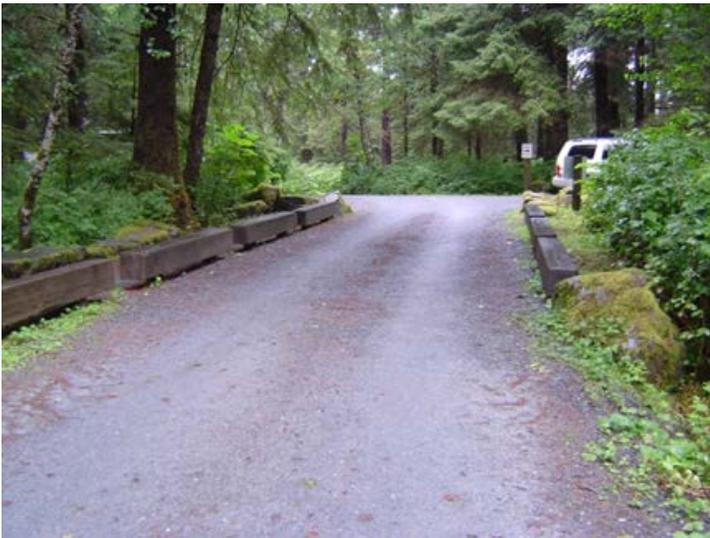
Starrigavan Road Photo 7. Starrigavan road looking west

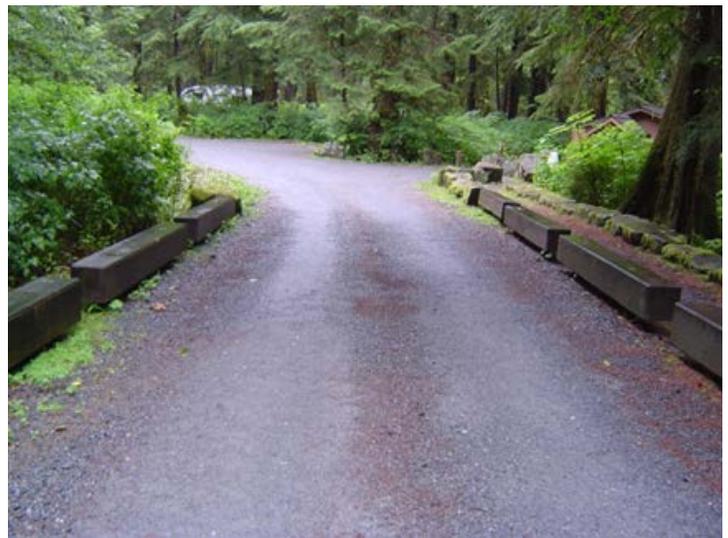
Starrigavan Road Photo 8. Starrigavan road looking east
