Restoration Effectiveness Blackwood Creek – Reach 1

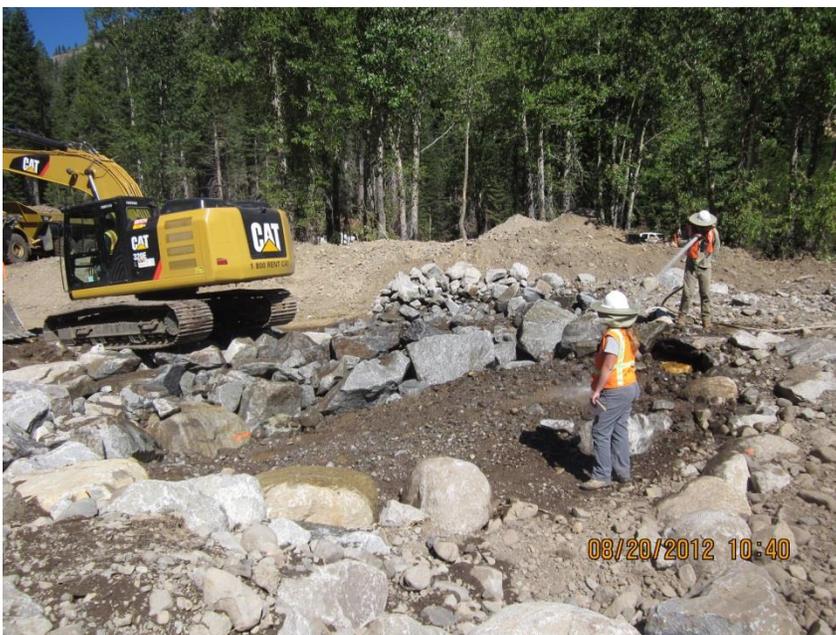
Construction of boulder grade control weir in Blackwood Creek

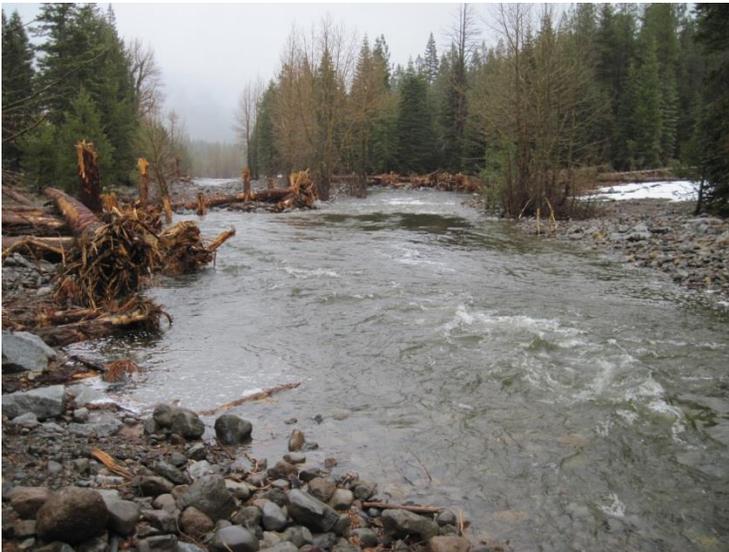
On December 3, 2012, two months after completion of the project, a rain on snow event resulted in flows within the project reach ranging between 700 to 900 CFS, estimated to be an 8 to 10 year frequency precipitation event. This event produced expected patterns of channel scour and deposition, including raising the base level of the stream channel above the restored reach, as desired. There were no observed failures within the restored areas.

December 3, 2012 Flood in Blackwood Creek Reach 1
