Steele Creek Community Structure A Rehabilitation, 2006

Prepared by: Robin O. Mills, Archaeologist, BLM-FDO, Fairbanks, AK, December 2006

Location: Steele Creek Community (EAG-00144), Fortymile National Wild and Scenic River corridor.

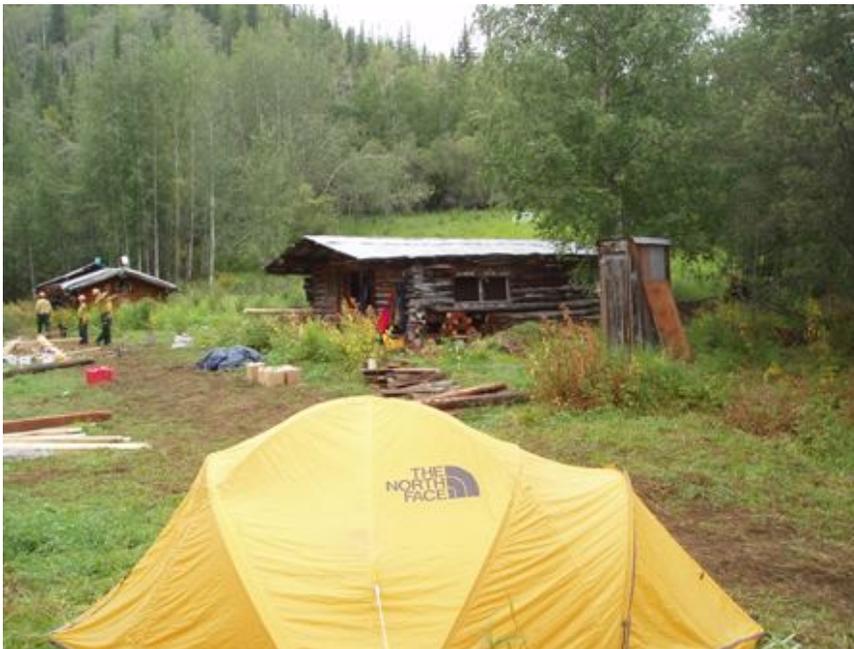
FIGURE 3. Steele Creek Community's "Structure A", a single room historic log cabin about 100 years old, and the focus of the 2006 lower courses of rotten logs rehabilitation project. Note "Structure B" in the background.

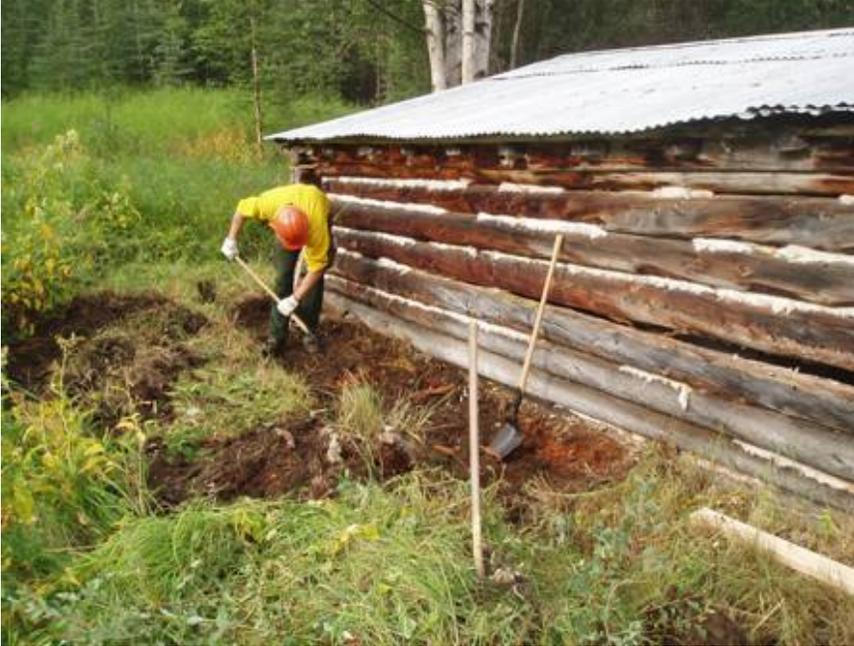
FIGURE 4. The first thing that needed to be done was to dig out the earthen insulation berm that covered over the lower courses of logs on three sides of the log cabin.

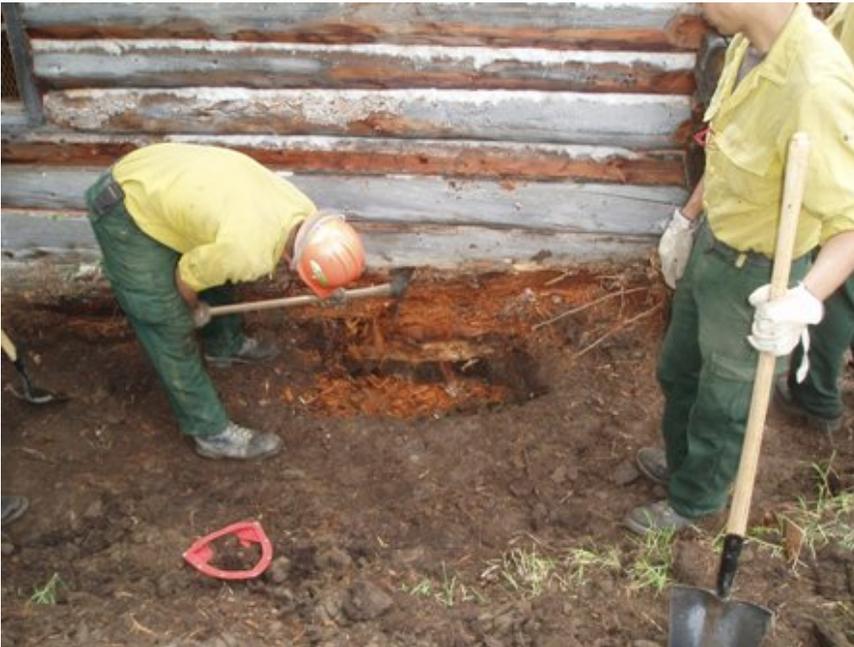
FIGURE 5. Digging out the earthen insulation berm that covered over the lower courses of logs on three sides of the log cabin.

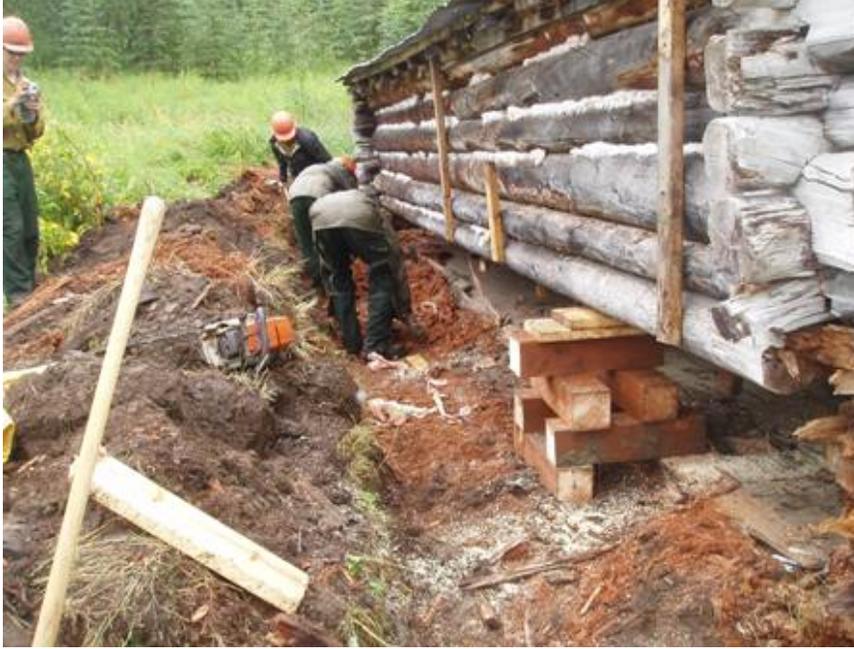
FIGURE 6. Work continues on digging out the earthen insulation berms that covered over the lower courses of logs on three sides of the log cabin, but now also includes elevating the cabin in preparation for new logs.

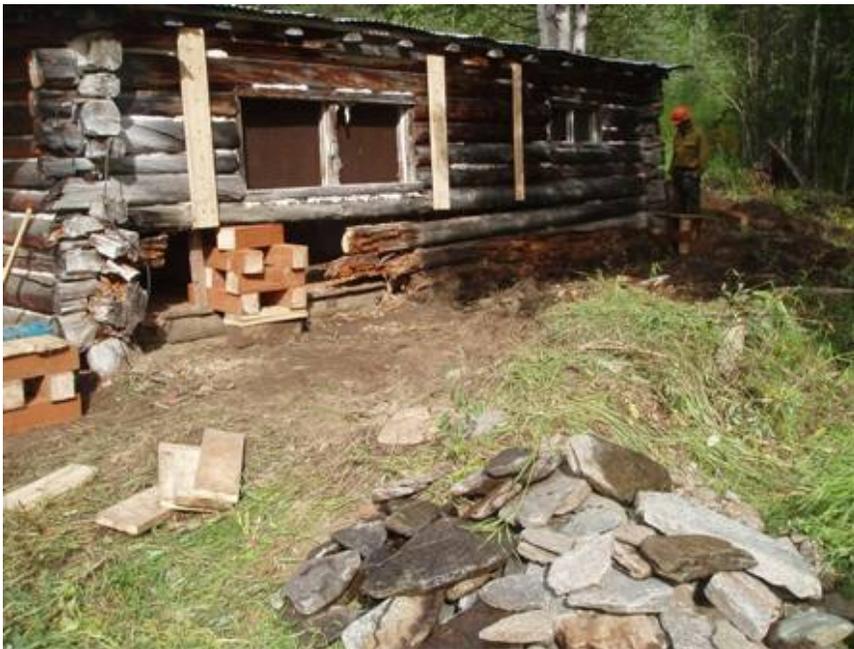
FIGURE 7. Work continues on digging out the earthen insulation berms removing the rotten logs, and elevating the cabin in advance of log replacement. Note the piles of creek cobbles brought to the cabin site, used to underlie the new sill logs for better drainage.

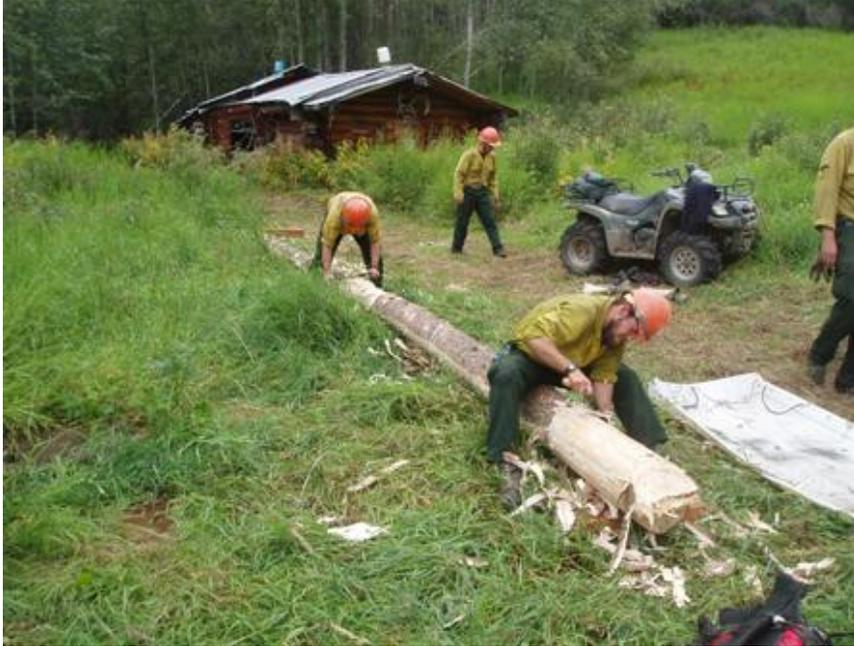
FIGURE 8. White spruce trees were harvested locally, dragged to the site by means of four-wheelers and sleds, and had their bark removed by means of draw knives. Local spruce trees were used in the original cabin construction.

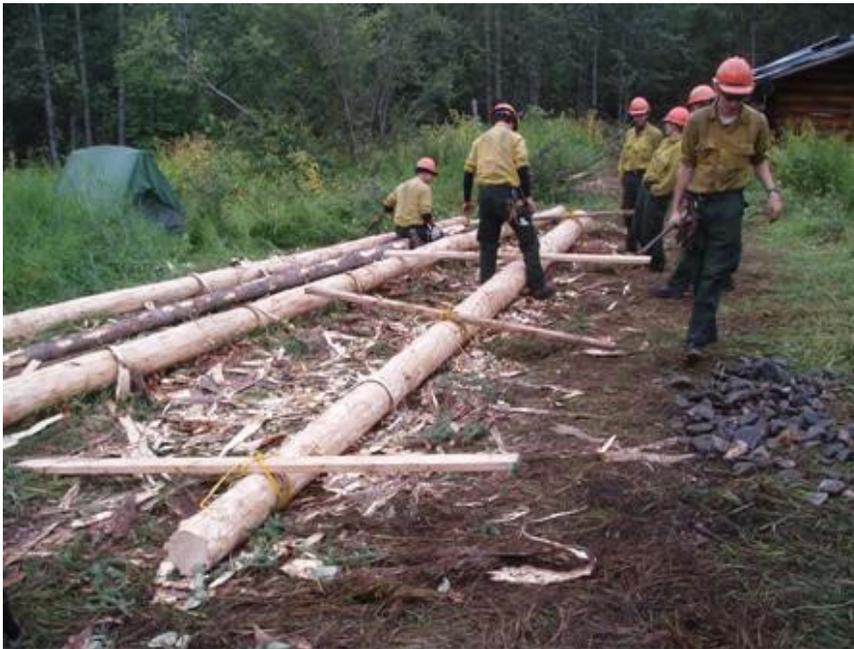
FIGURE 9. After bark removal, spruce trees were then carried to the cabin.

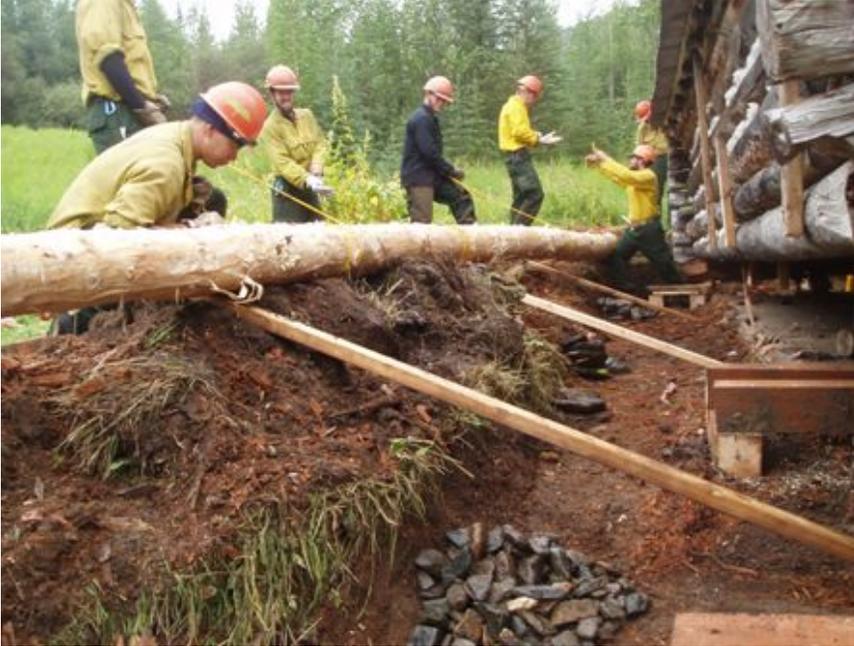
FIGURE 10. A peeled spruce log being put in place under the elevated cabin.

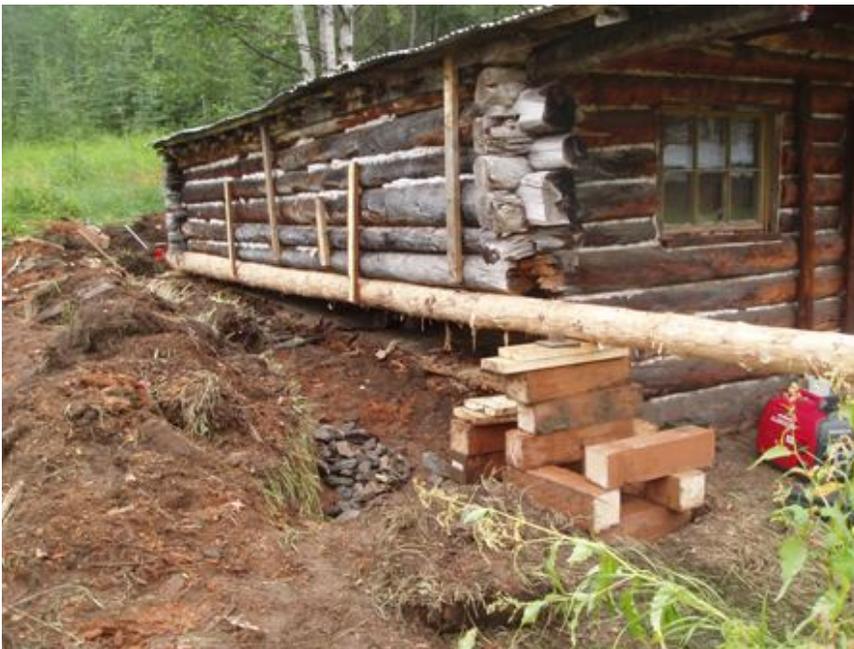
FIGURE 11. Peeled spruce logs being placed under the elevated cabin.

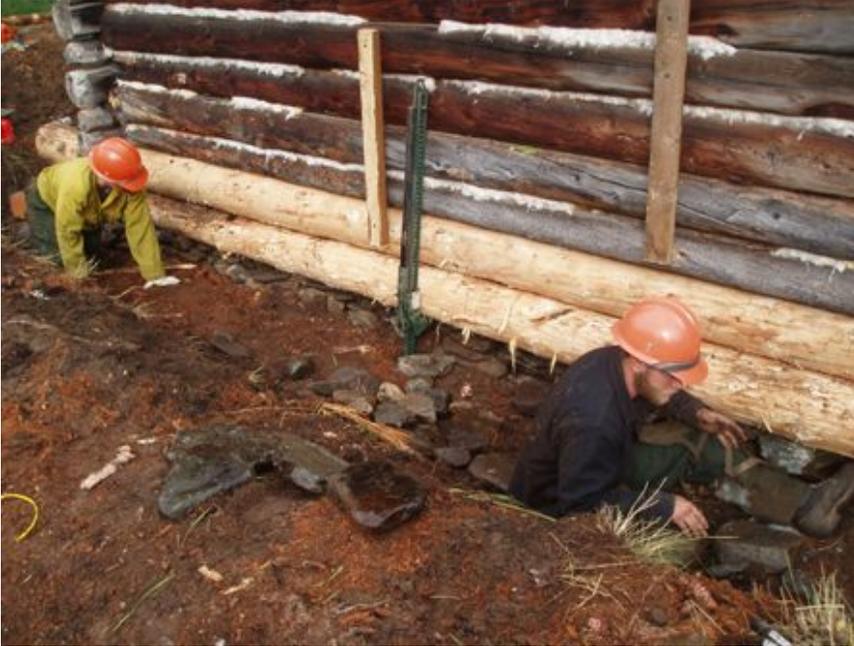
FIGURE 12. Peeled spruce logs being placed under the elevated cabin. Note the creek cobbles underlying the lower-most sill log.

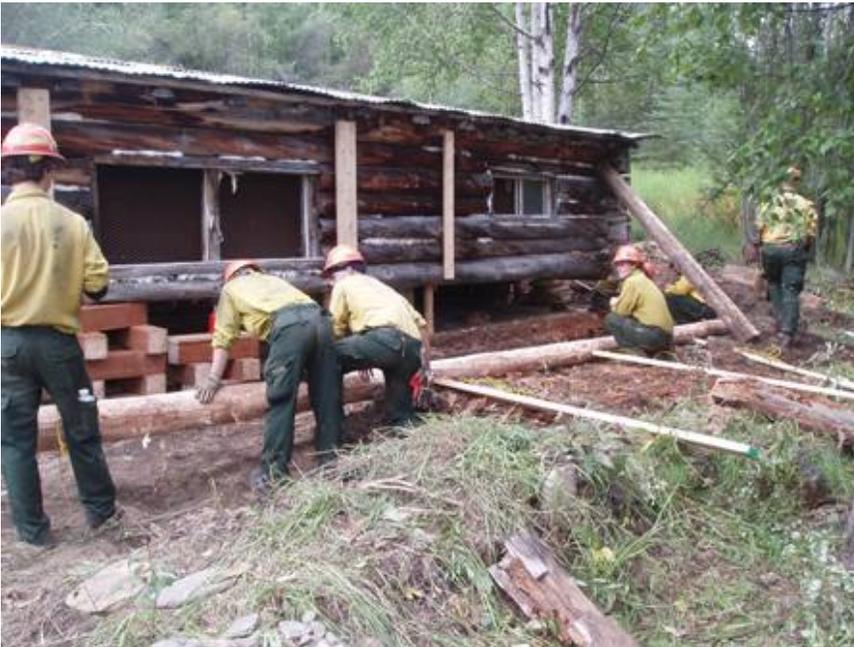
FIGURE 13. Peeled spruce logs being placed under the elevated cabin.

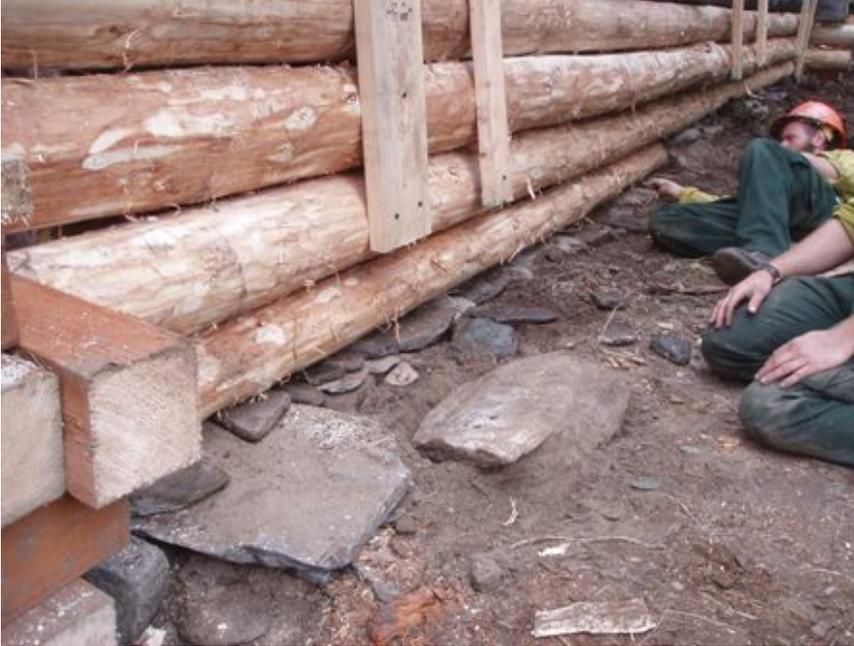
FIGURE 14. Peeled spruce logs being placed under the elevated cabin. Note the creek cobbles underlying the lower-most sill log.

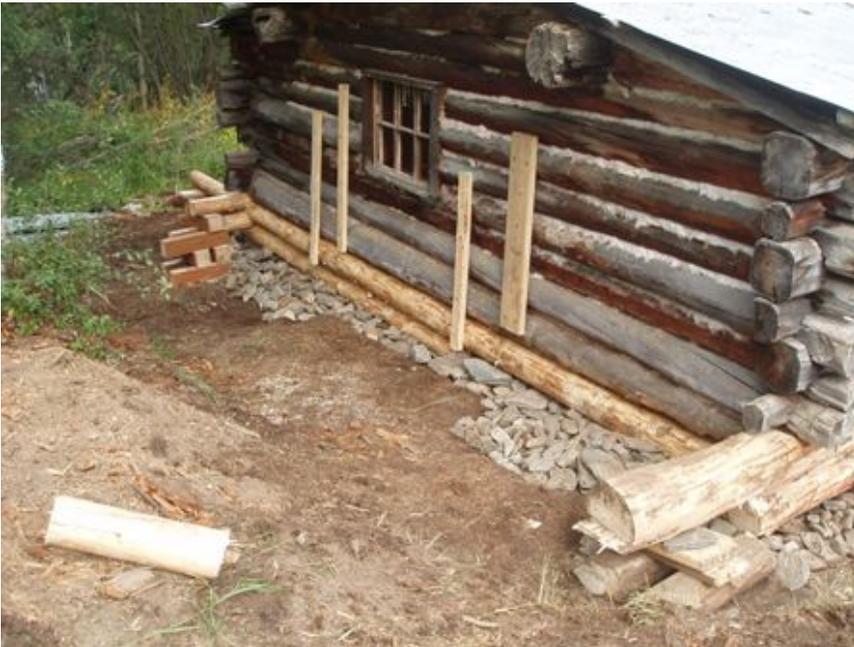
FIGURE 15. Peeled spruce logs placed under the cabin. Note the creek cobbles underlying the lower-most sill logs.

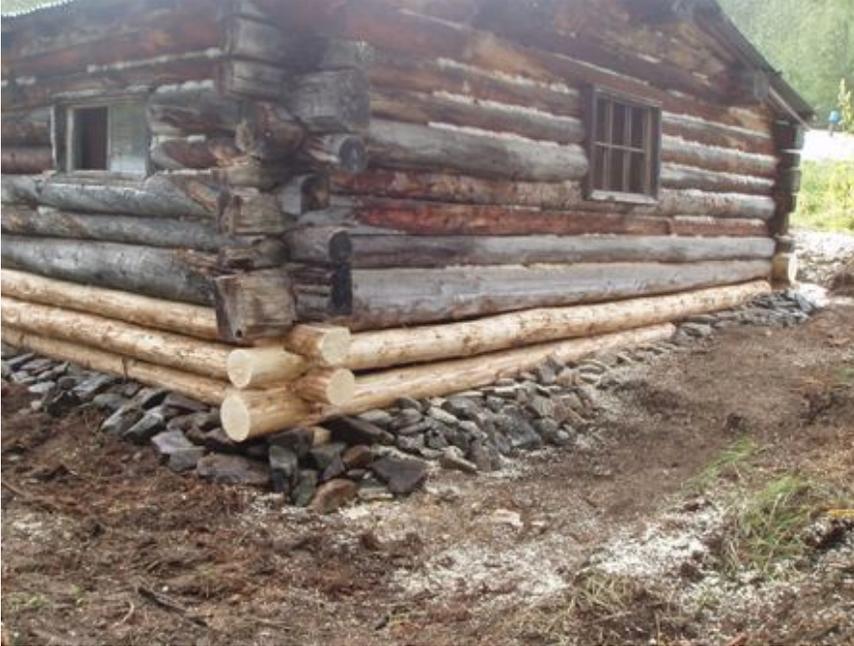
FIGURE 16. Two walls completed. Note the creek cobbles underlying the lower-most sill logs.

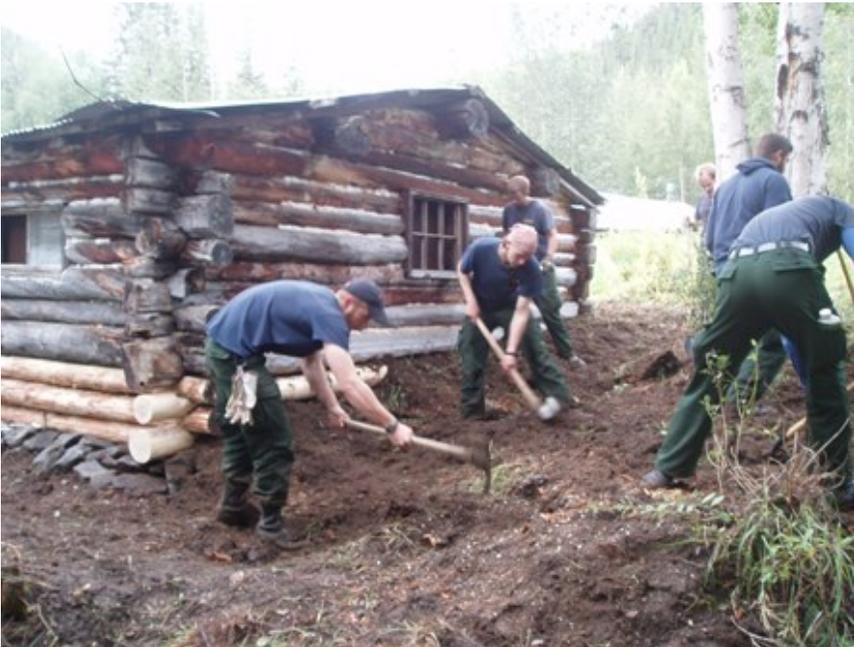
FIGURE 17. After painting the replaced logs with a preservative, spoil was placed back over the lower portions of the work (cobbles; lower logs).

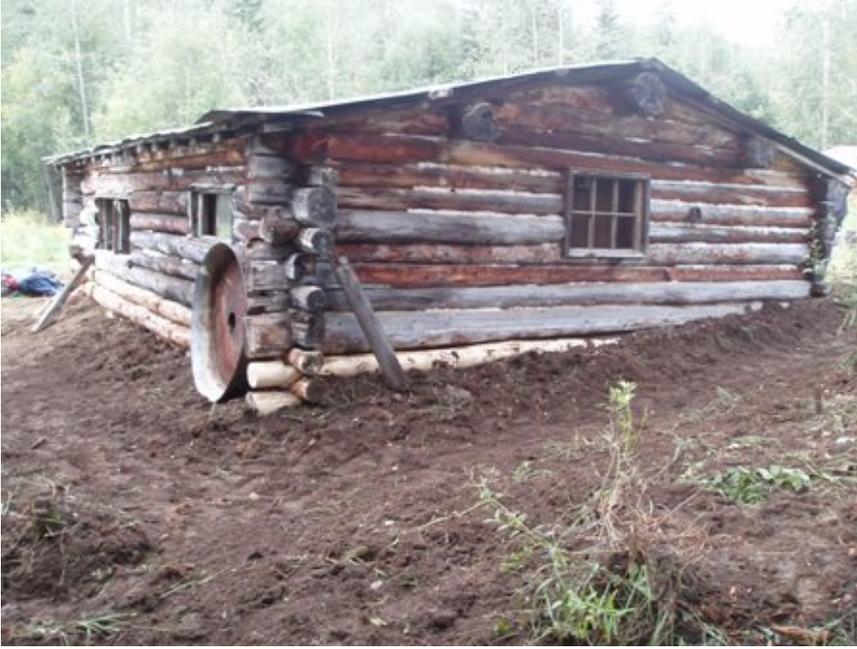
FIGURE 18. Steele Creek Community's Structure A after the completion of the project.
