Steele Creek Community, Structure C Rehabilitation, July 2011

Location: Steele Creek Community (49-EAG-00144), Fortymile river mile 22.8R

Date(s): July 19 – July 22, 2011

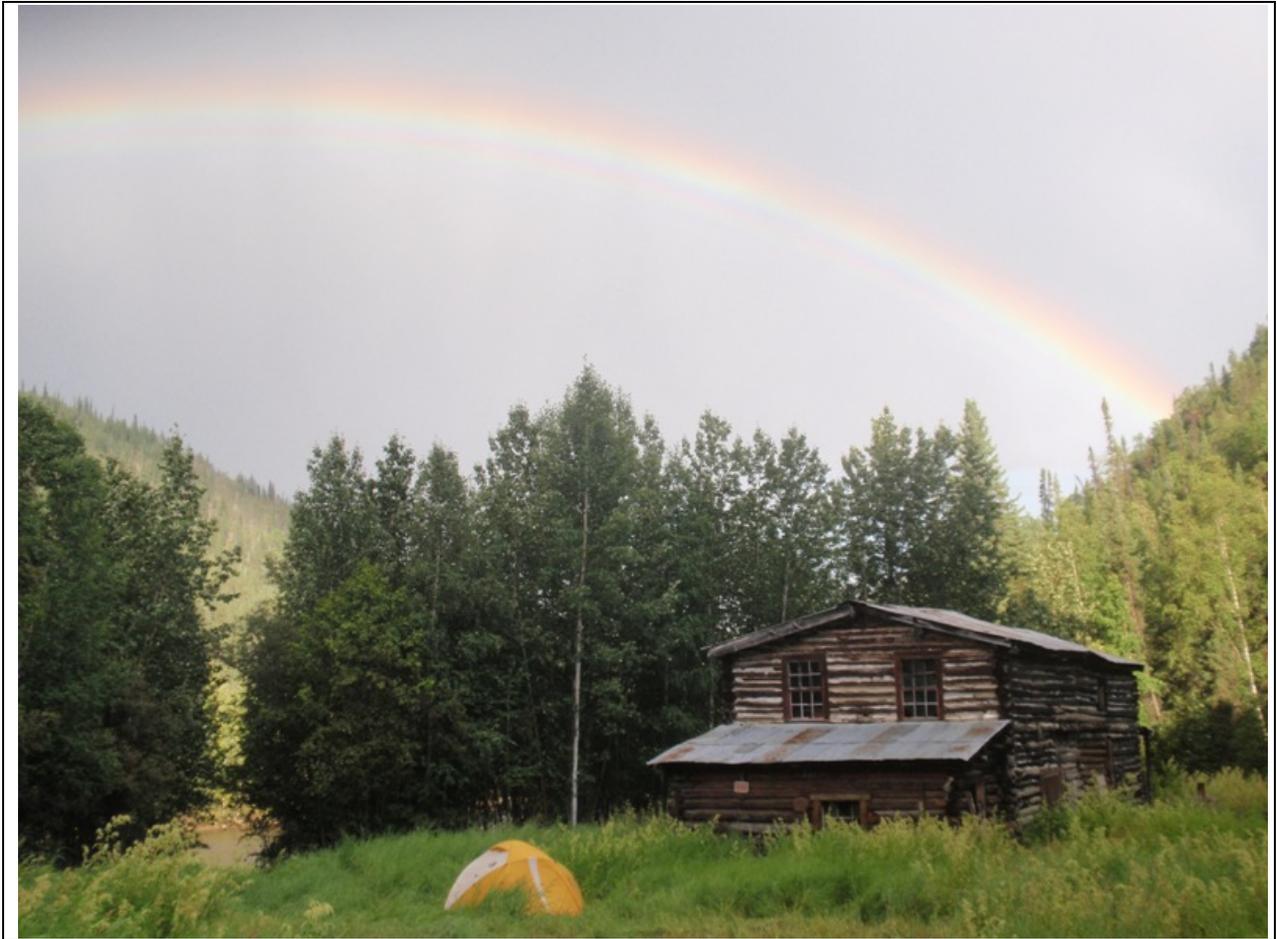
Cover: Steele Creek Community, Structure C, July 2011, after rehabilitation efforts.

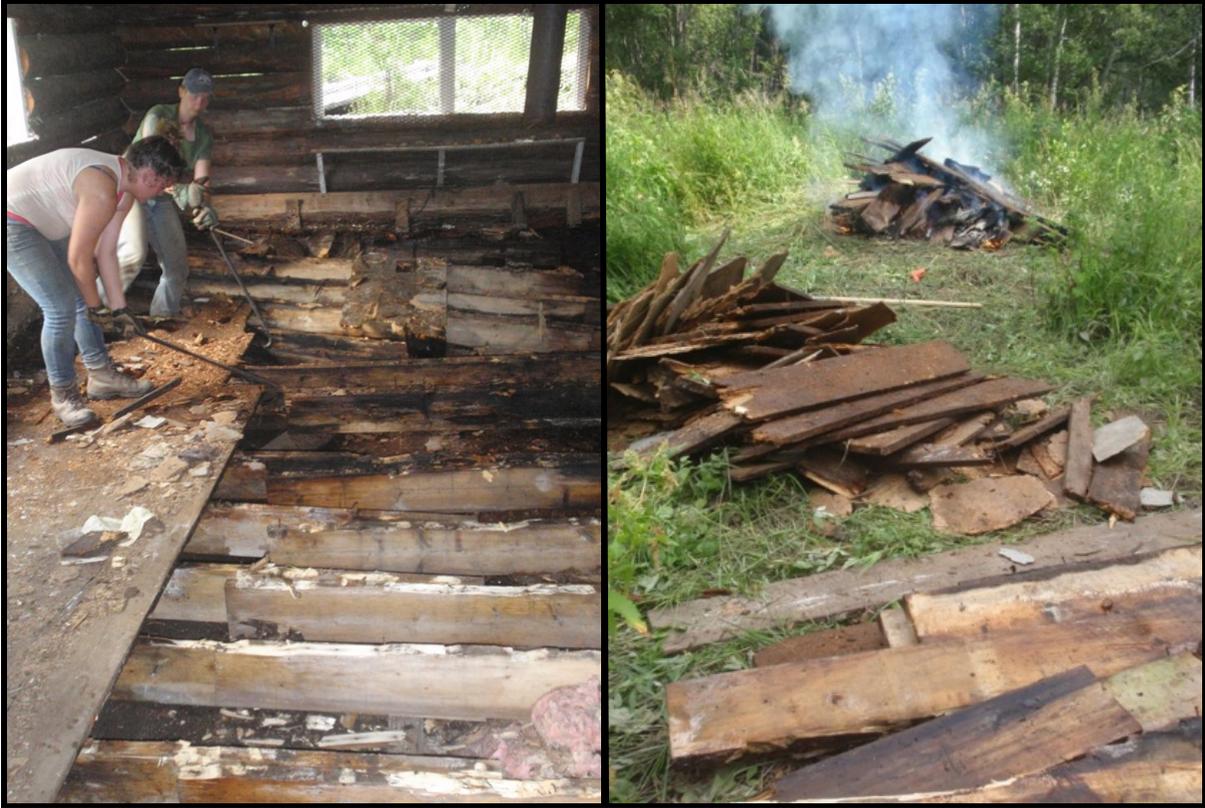
Figures 3 and 4. Ripping out (3) and burning (4) the 1970s-1980s era rotten dimensional lumber joist and plywood floor inside Structure C, Steele Creek townsite. July 2010.

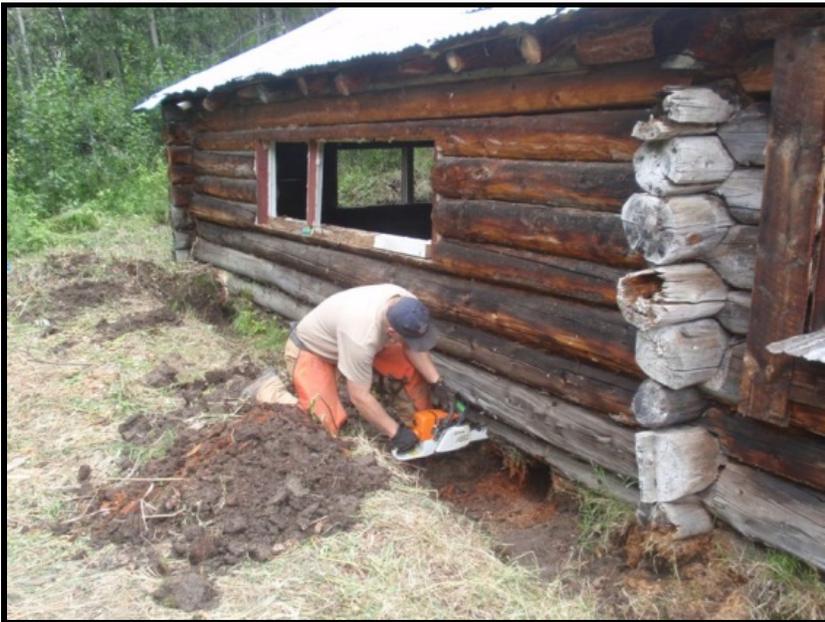
Figure 5. Removing the rotten sill and lower courses of wall logs of Structure C, Steele Creek townsite. July 2010.

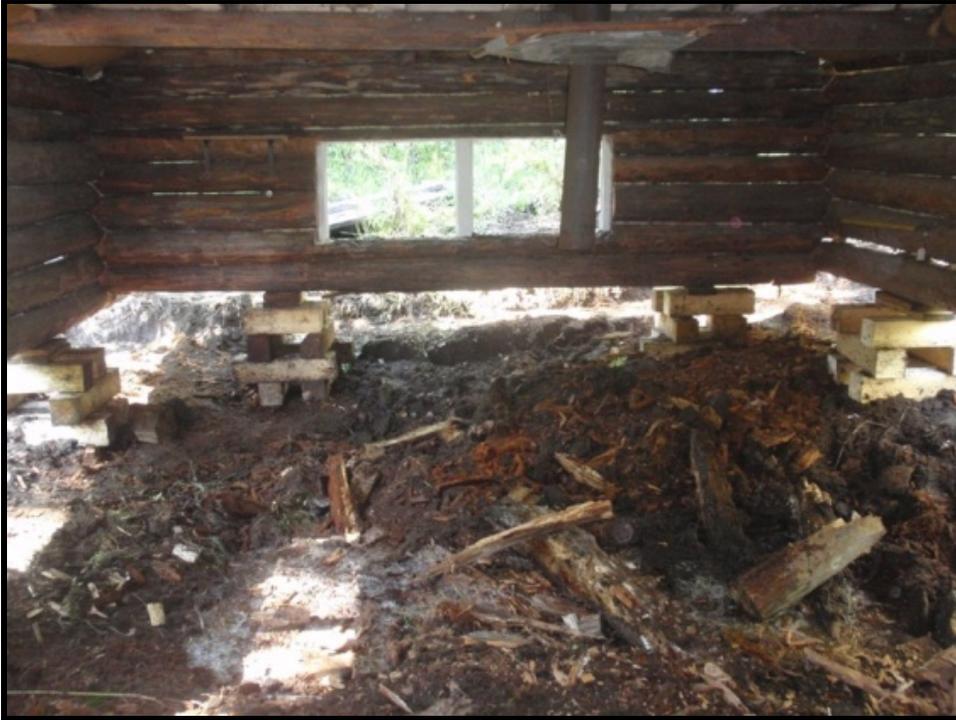
Figure 6. Rotten floor, sill logs, and lower courses of wall logs of Structure C have been removed, and the building is set upon a series of wooden pier blocks for the winter. July 2010.

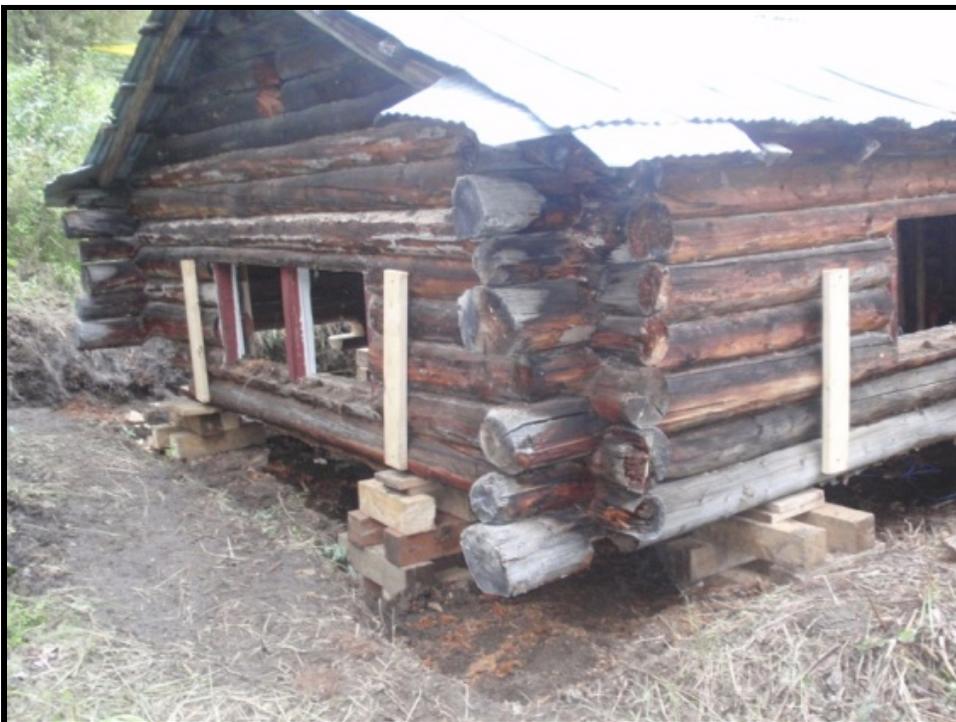
Figure 7. Rotten floor, sill logs, and lower courses of wall logs of Structure C have been removed, and the building is set upon a series of wooden pier blocks for the winter. July 2010.

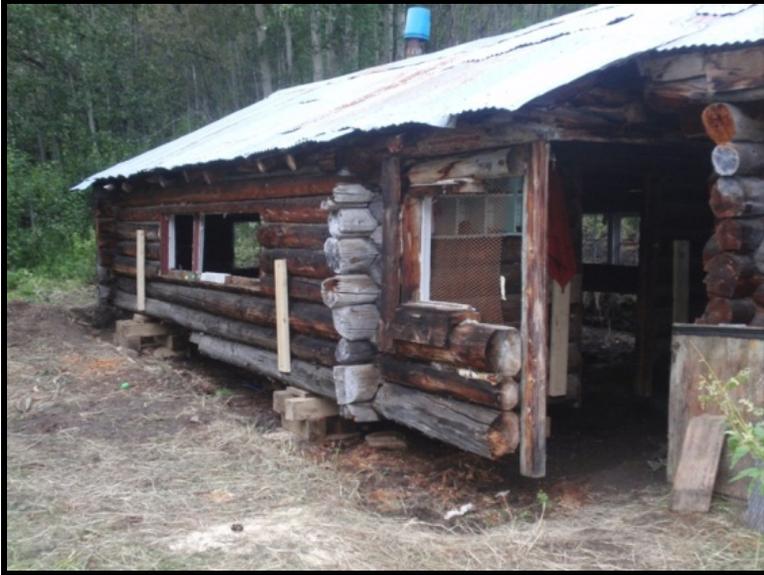
Figure 8. Rotten floor, sill logs, and lower courses of wall logs of Structure C have been removed, and the building is set upon a series of wooden pier blocks for the winter. July 2010.

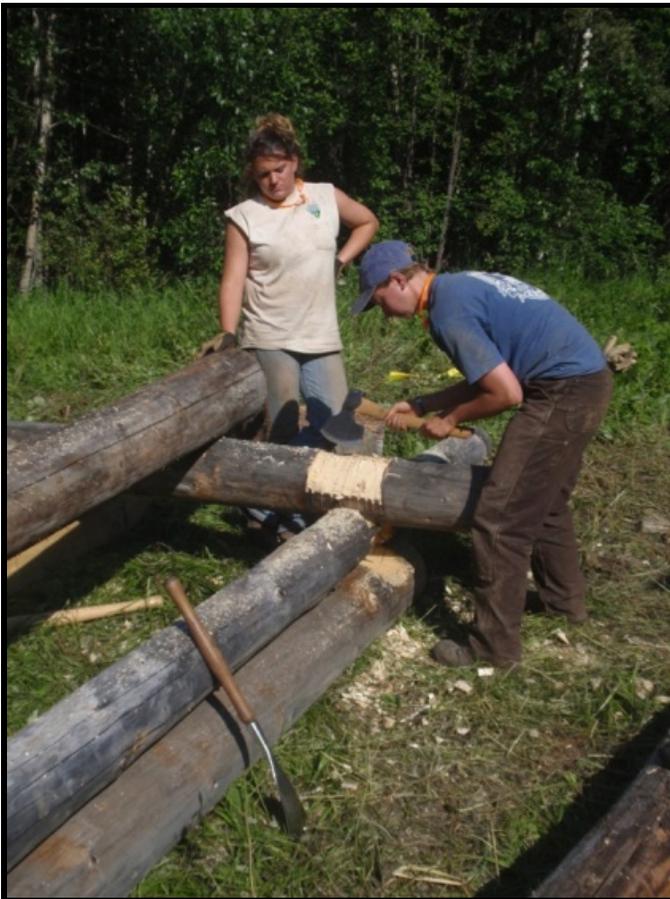
Figure 9. Cutting and notching replacement logs. July 2010.

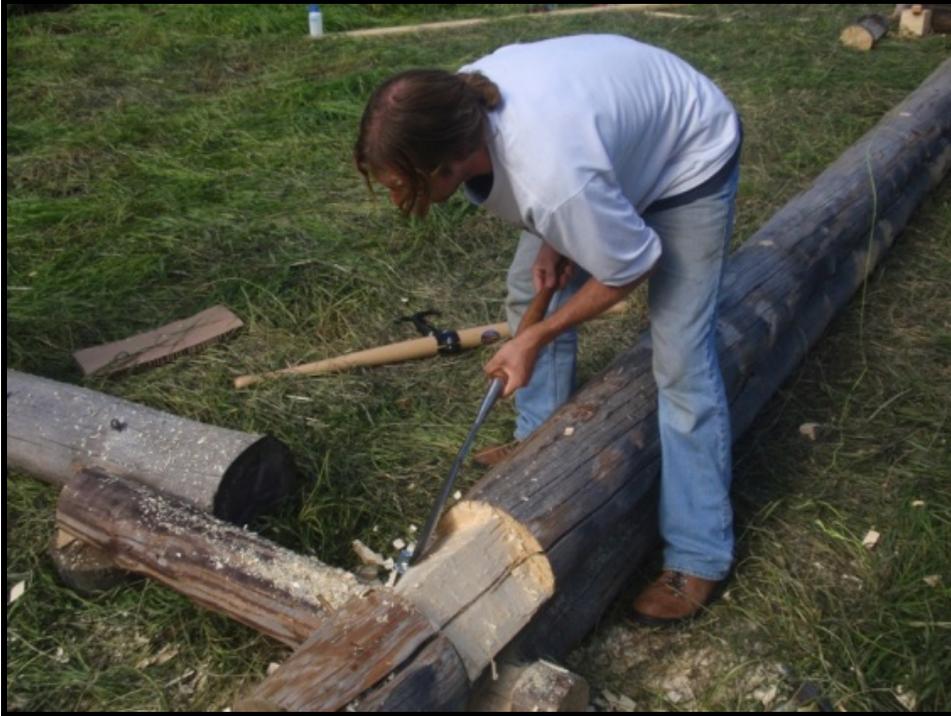
Figure 10. Cutting and notching replacement logs. July 2010.

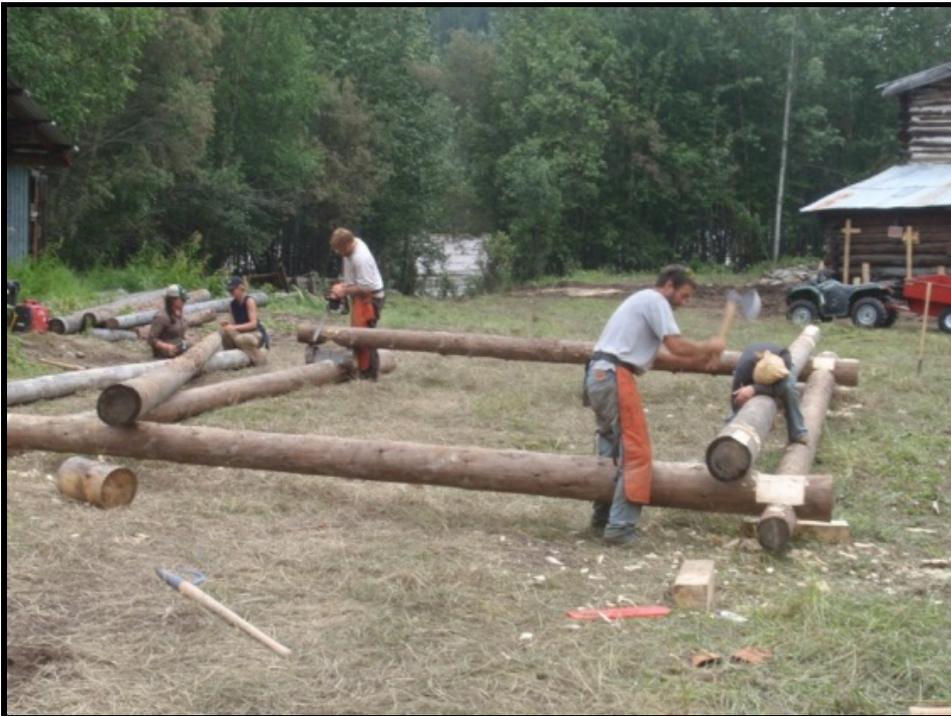
Figure 11. Cutting, notching and beginning to assemble the replacement logs. July 2010.

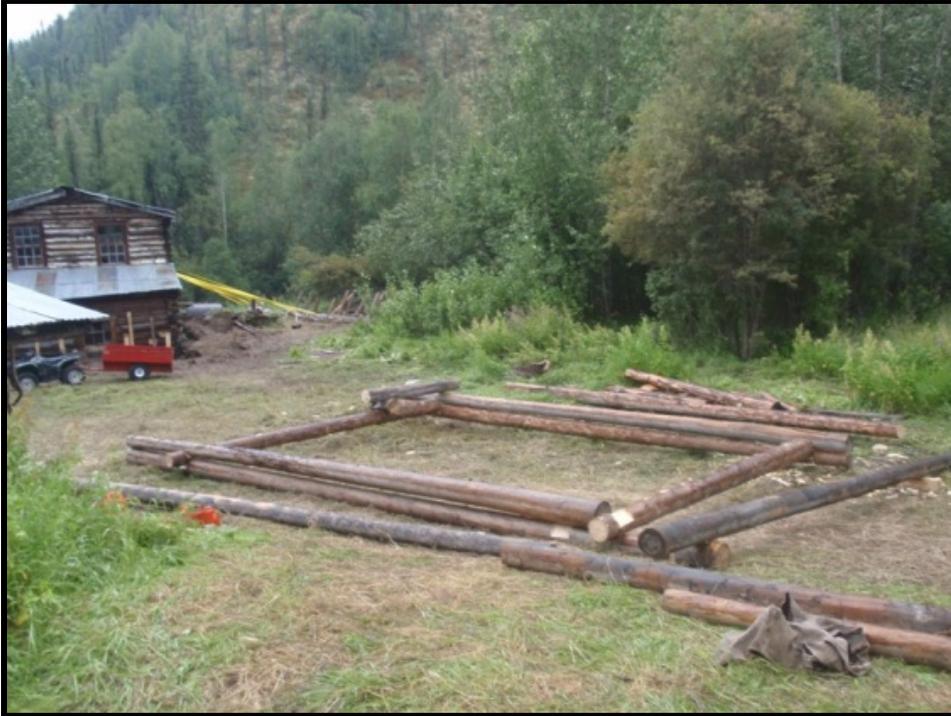
Figure 12. Cutting, notching, and assembling the replacement logs. July 2010.

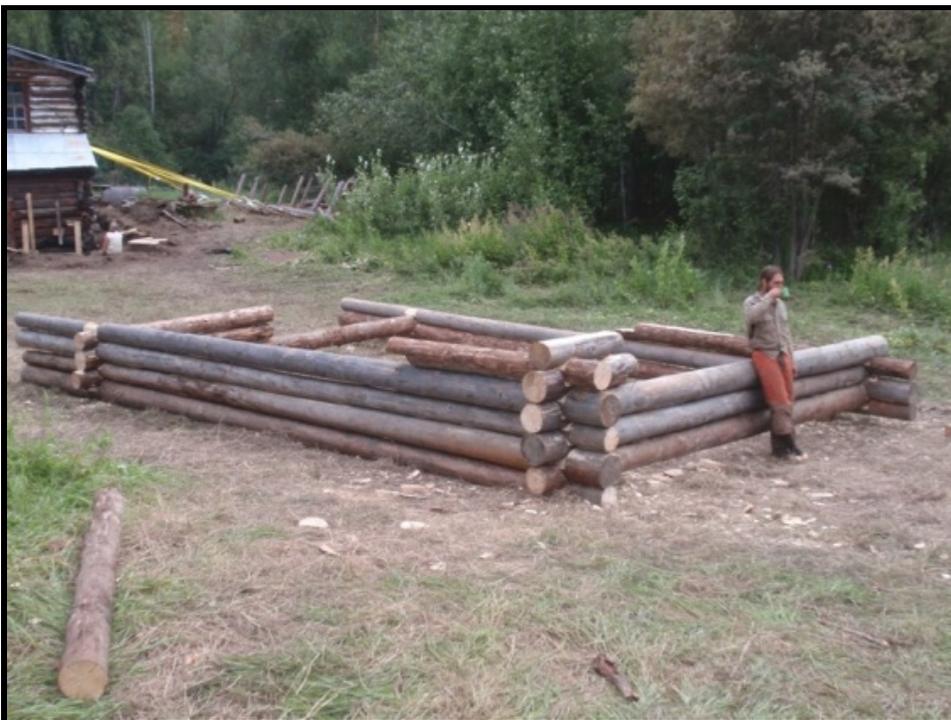
Figure 13. Sixteen partial and complete replacement logs for Structure C are all assembled and ready for insertion under the building. July 2010.

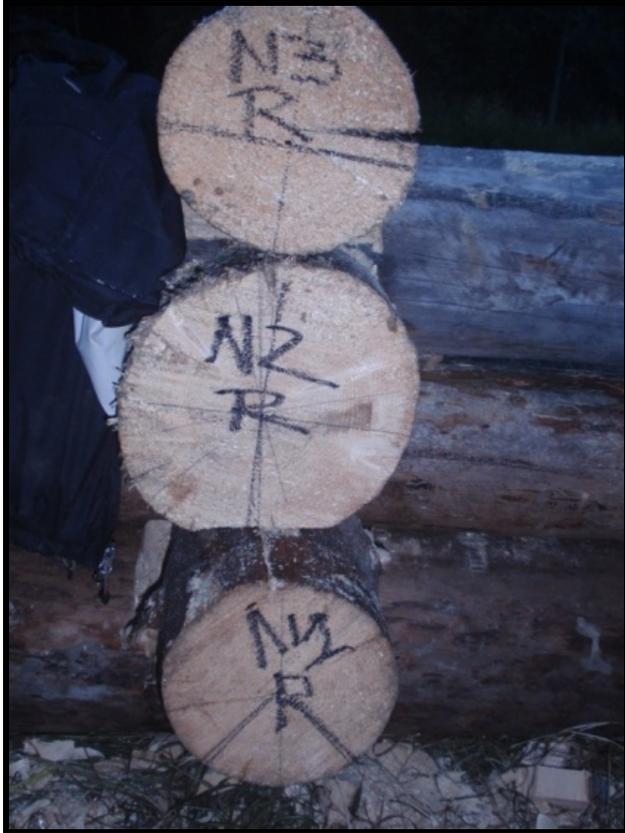
Figure 14. The replacement logs were all clearly identified, and then dismantled and laid to one side of the site, set off of the ground on other log sections, for future placement under Structure C, Steele Creek townsite. July 2011.

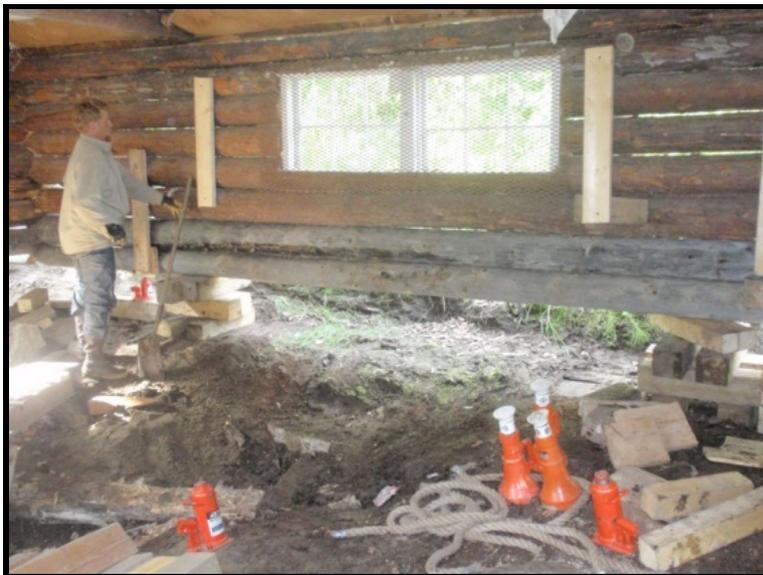
Figure 15. Replacement logs being inserted, in order from the top to the bottom sill logs, under Structure C, Steele Creek townsite. July 2011.

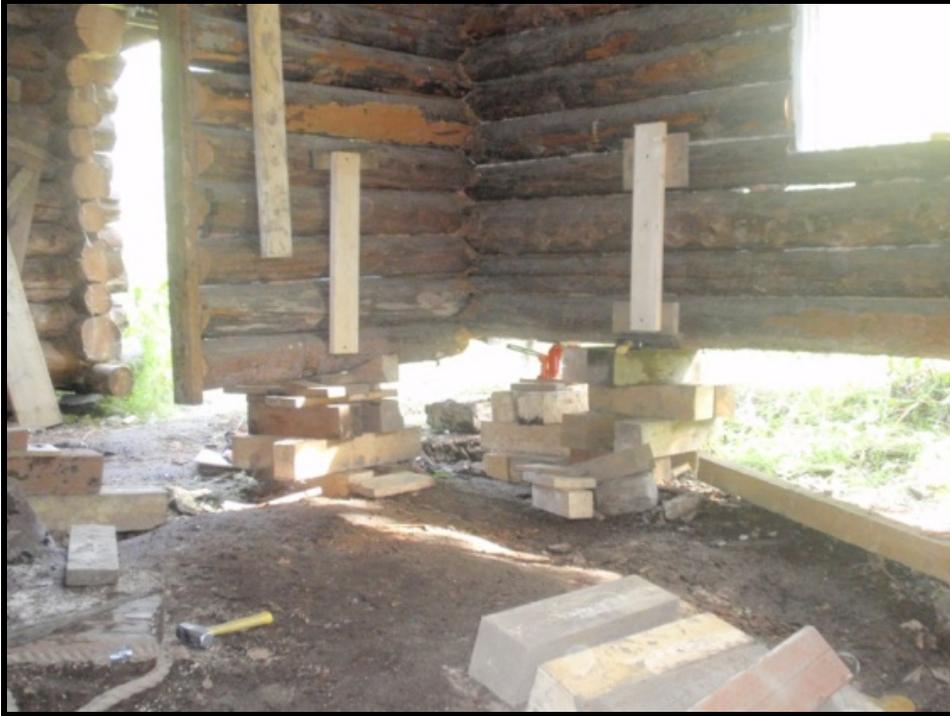
Figure 16. Replacement logs being inserted, in order from the top to the bottom sill logs, under Structure C, Steele Creek townsite. July 2011.

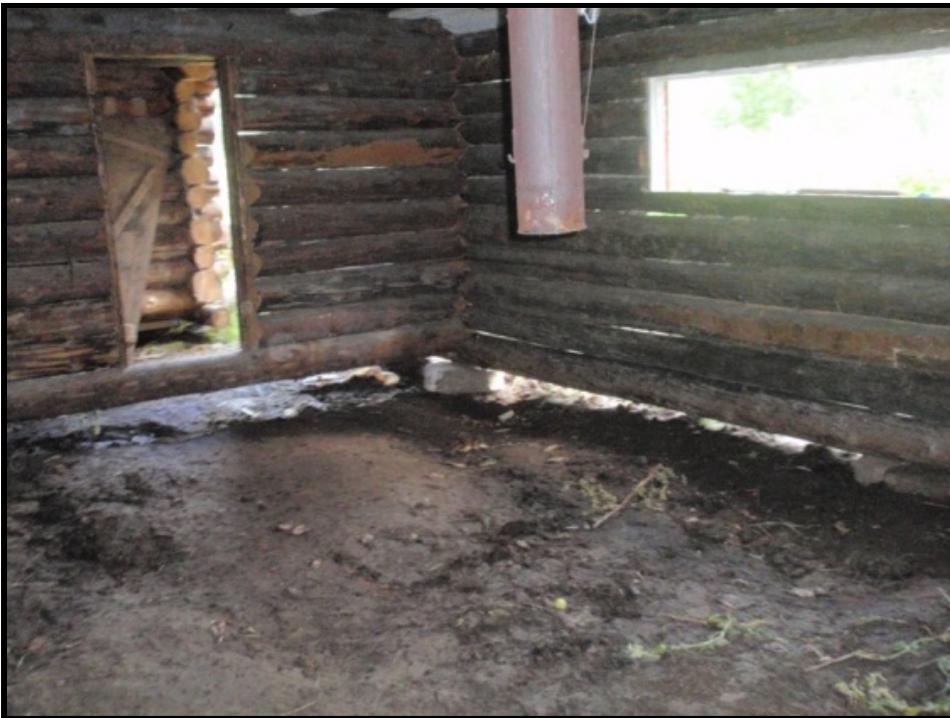
Figure 17. All replacement logs placed under Structure C, Steele Creek townsite. Corners and middle of long axes placed upon large, flat boulders. July 2011.

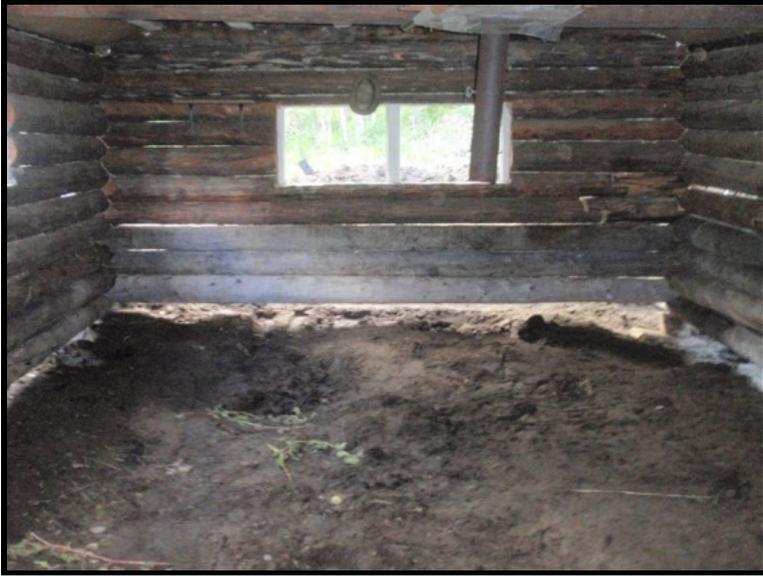
Figure 18. All replacement logs placed under Structure C, Steele Creek townsite. Corners and middle of long axes placed upon large, flat boulders. July 2011.

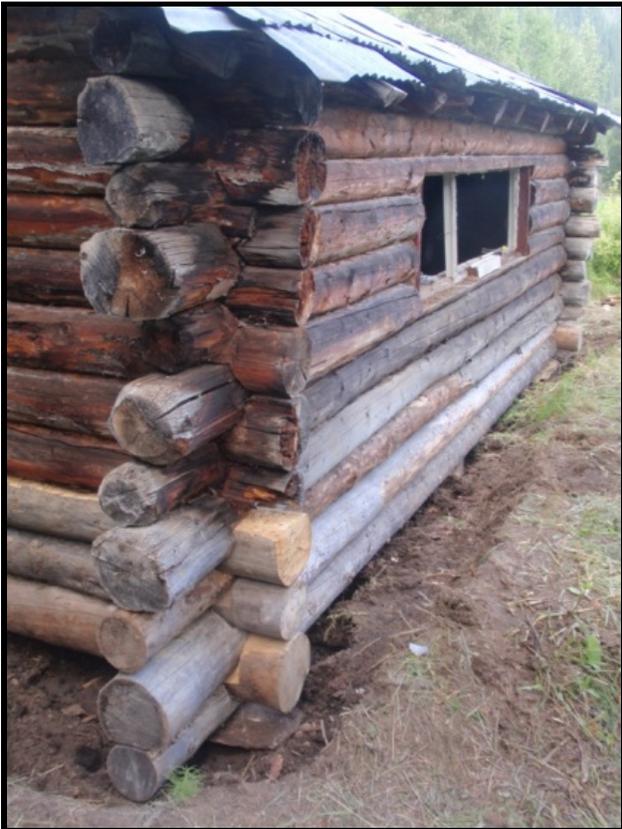
Figure 19. All replacement logs placed under Structure C, Steele Creek townsite. Corners and middle of long axes placed upon large, flat boulders. July 2011.

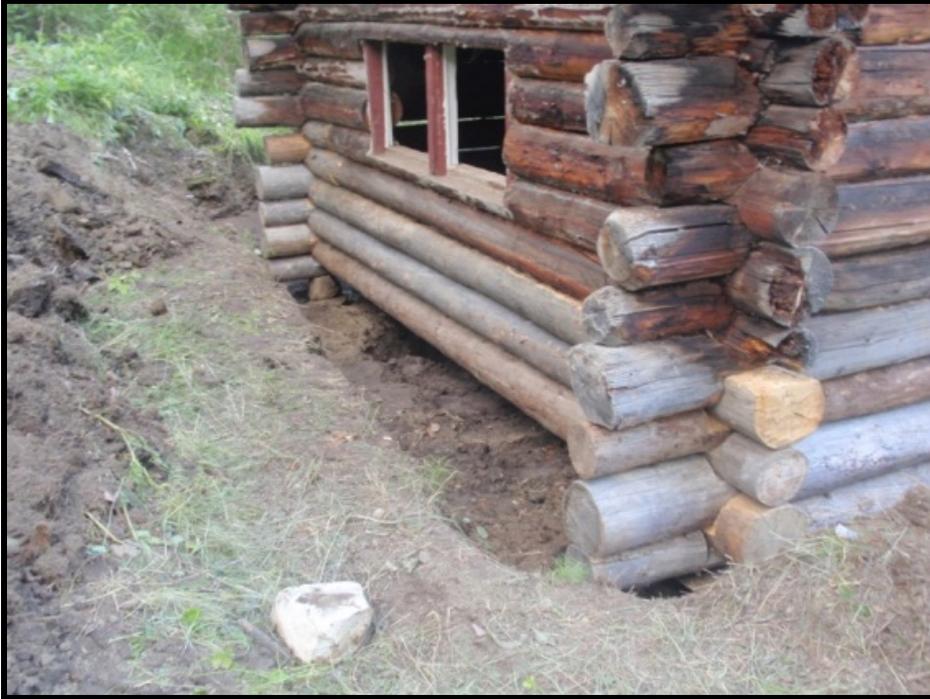
Figure 20. All replacement logs placed under Structure C, Steele Creek townsite. Corners and middle of long axes placed upon large, flat boulders. July 2011.

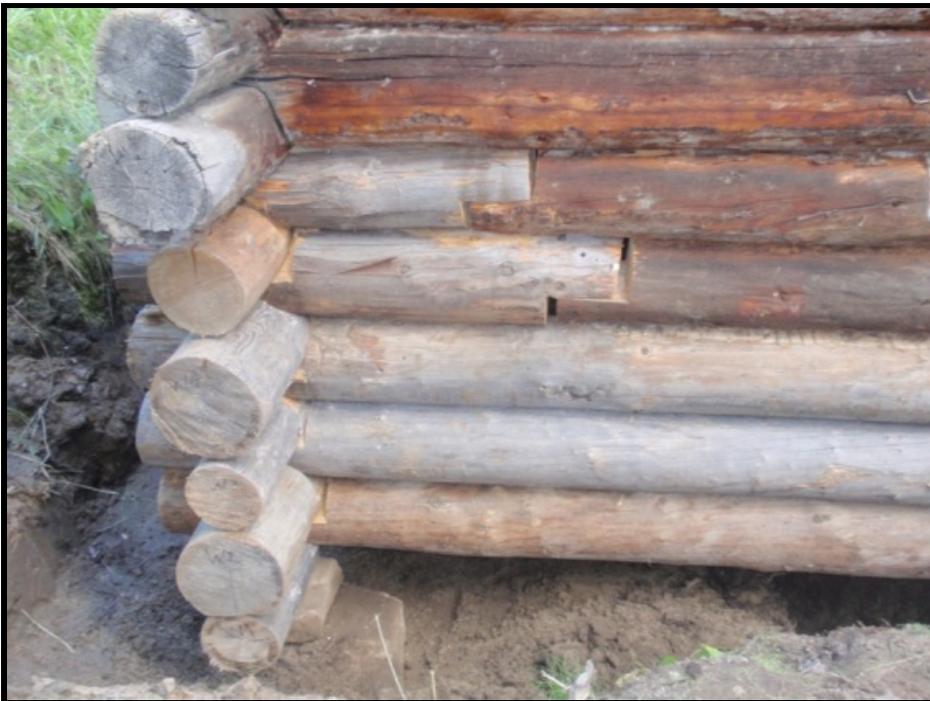
Figure 21. All replacement logs placed under Structure C, Steele Creek townsite. Corners and middle of long axes placed upon large, flat boulders. Close up of "splicing in" partial log sections. July 2011.

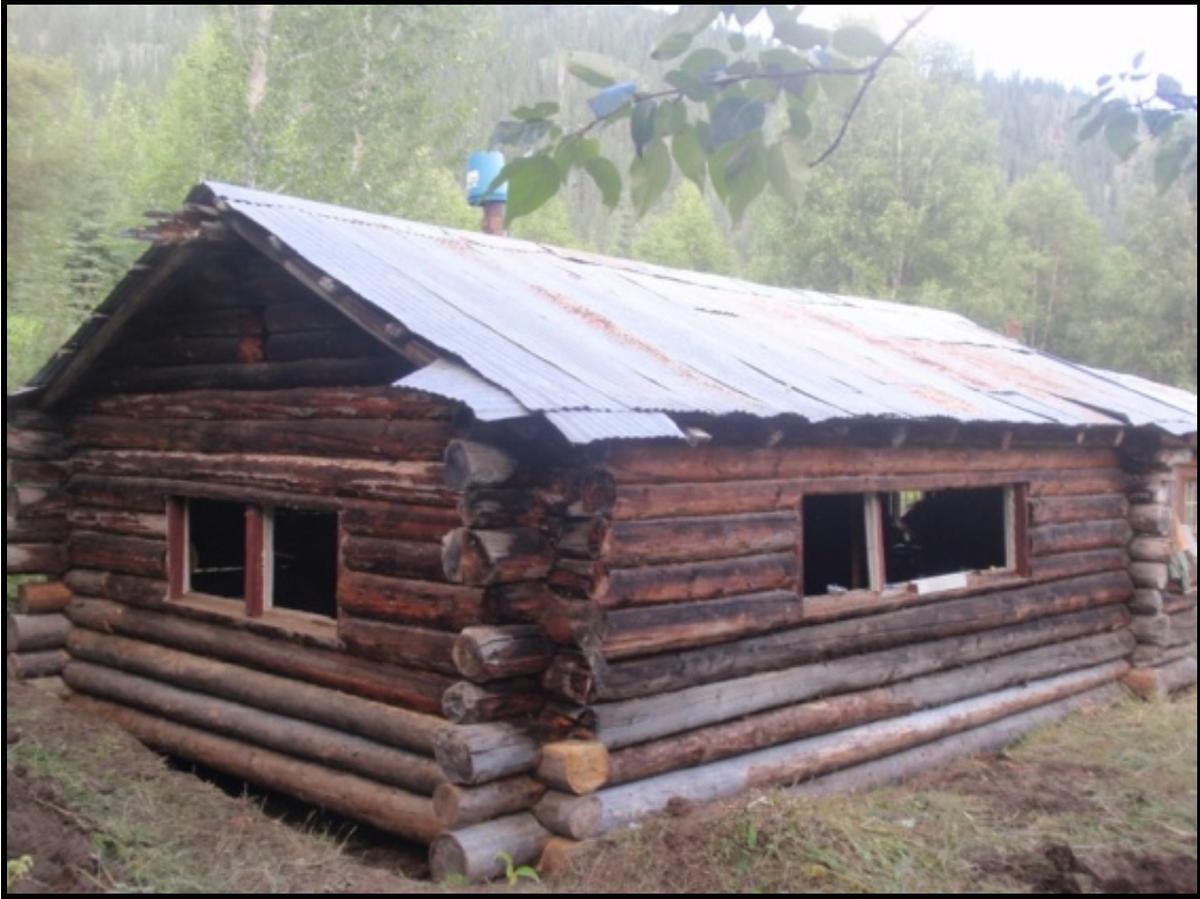
Figure 22. All replacement logs placed under Structure C, Steele Creek townsite. July 2011.
