**Steele Creek Roadhouse & Community Rehabilitation, July 2012**

Robin O. Mills, Archaeologist  
Bureau of Land Management, Fairbanks District Office, Fairbanks, AK  
December 2012

Location: Steele Creek Community (49-EAG-00144), Fortymile river mile 22.8R

Date(s): July 14 – July 20, 2012

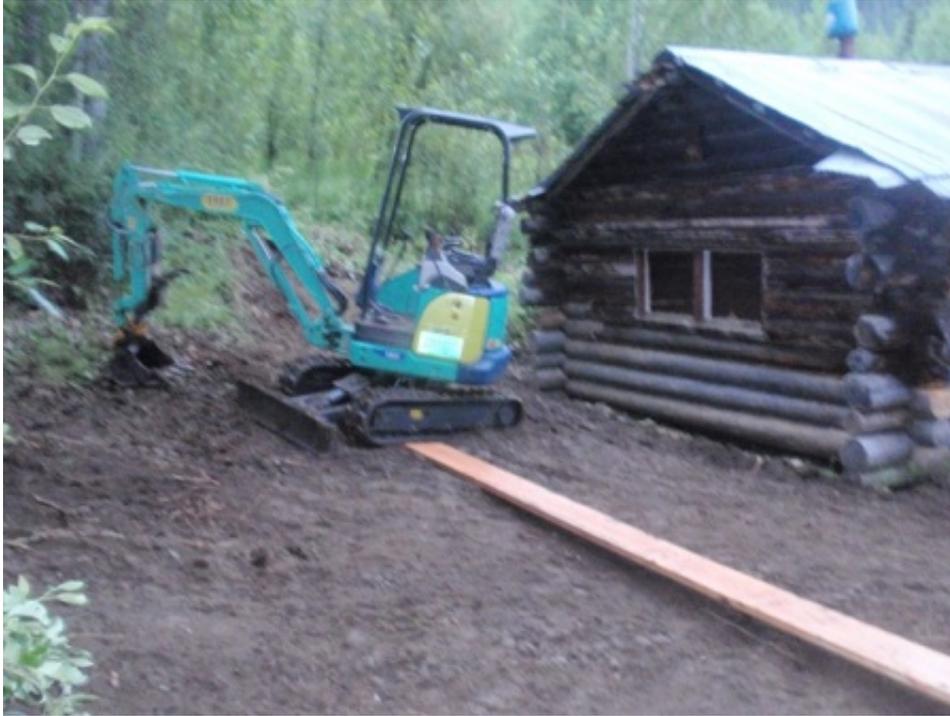
Figure 3. Removing soil and recontouring around the southern back side of Structure C.

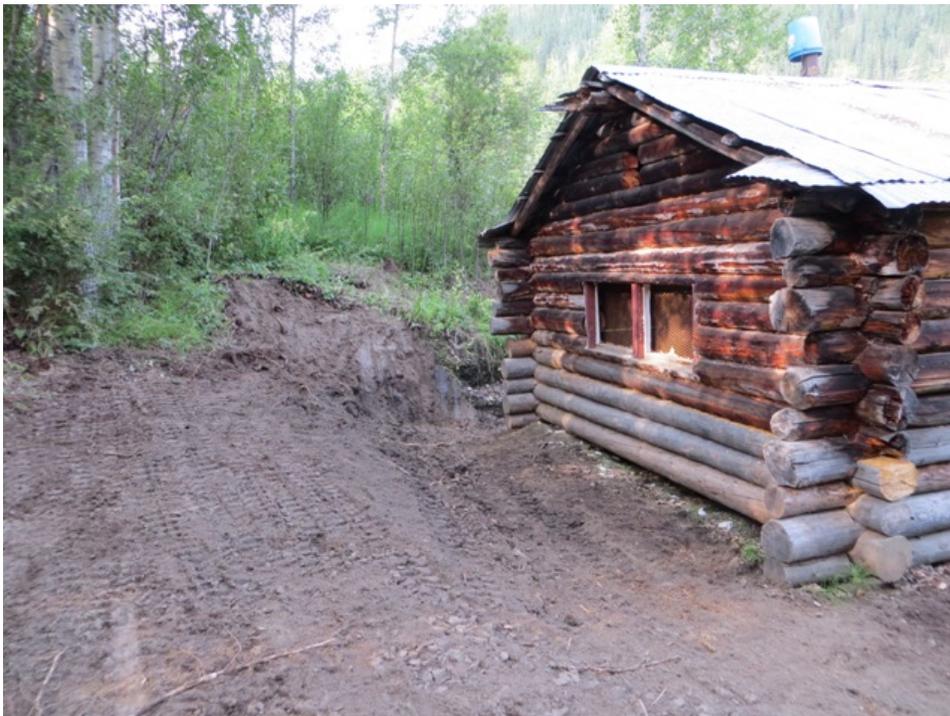
Figure 4. Ground recontouring around the southern back side of Structure C.

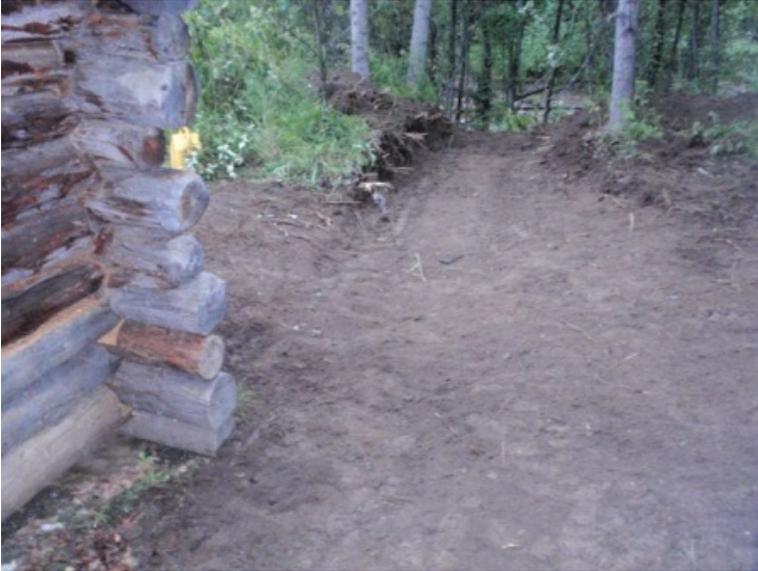
Figure 5. Ground recontoured downslope of Structure C to direct water away from the building and into Steele Creek.

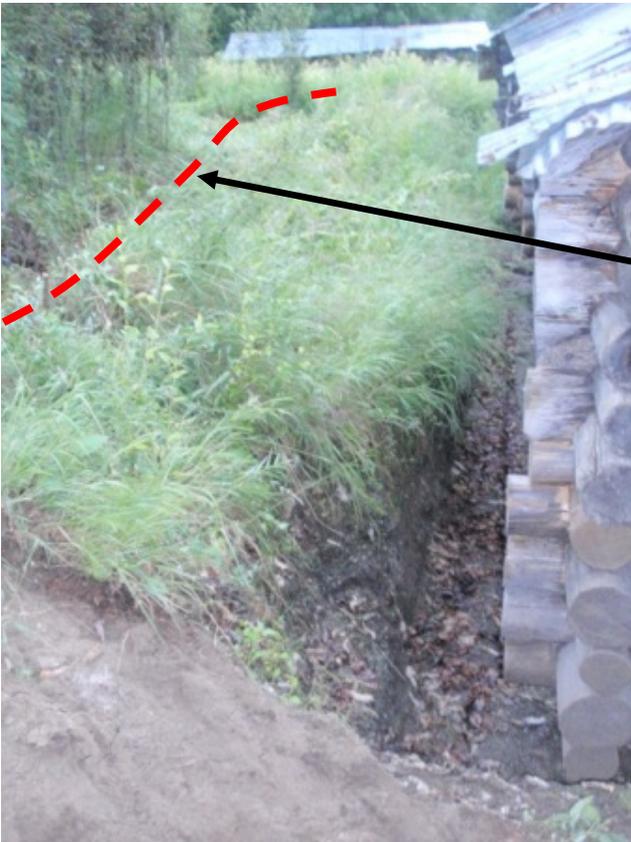
Diversion ditch dug here to divert water around Structures C and B.

Figure 6. Slope abutting up against the west side of Structure C.

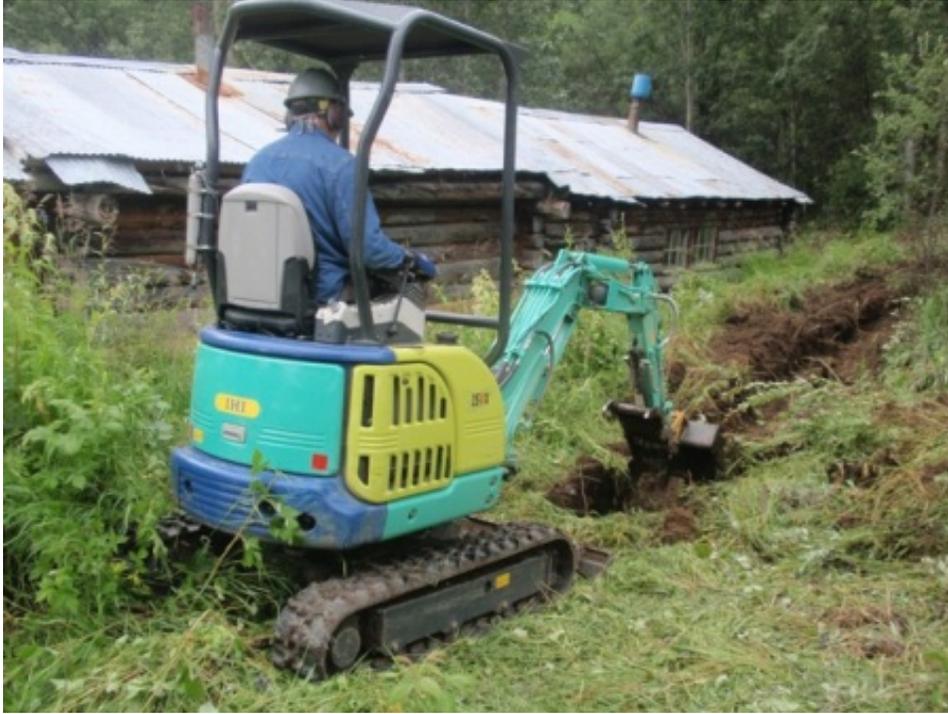
Figure 7. Digging diversion ditch upslope of Structures B and C.

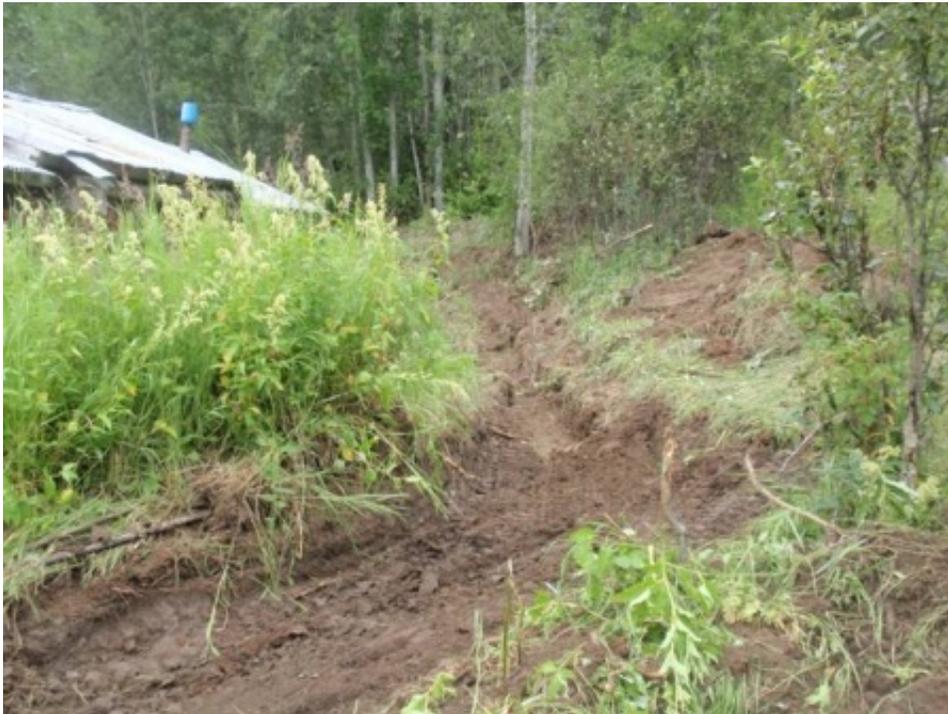
Figure 8. Water diversion ditch dug upslope of Structures B and C.

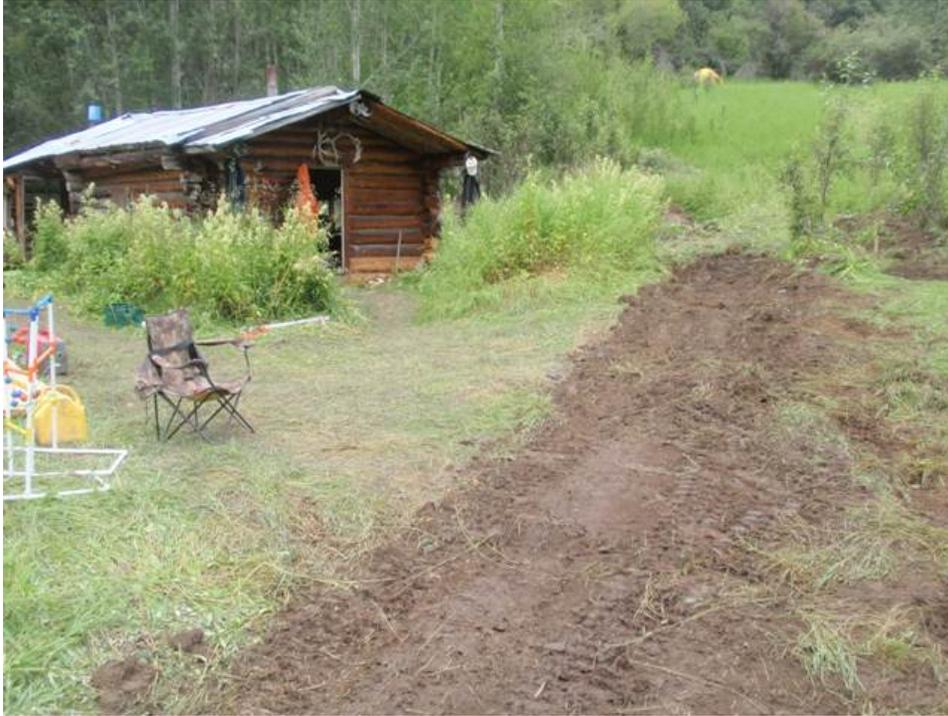
Figure 9. Finishing off water route from the end of the ditch to the north side of Structure B.

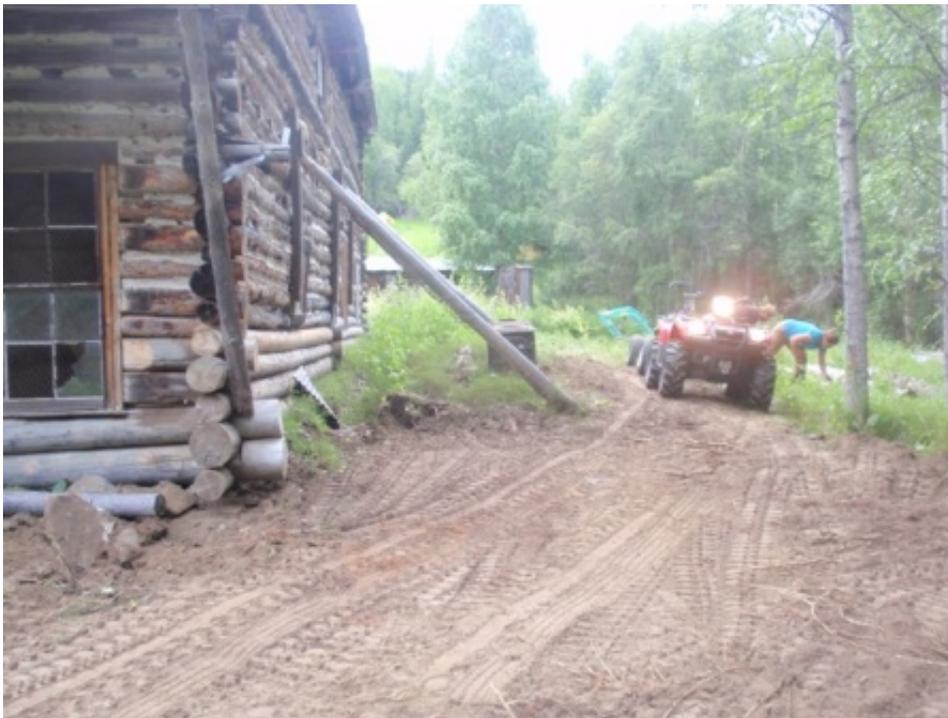
Figure 10. Soil removal and contouring of ground on the north side of the Roadhouse.

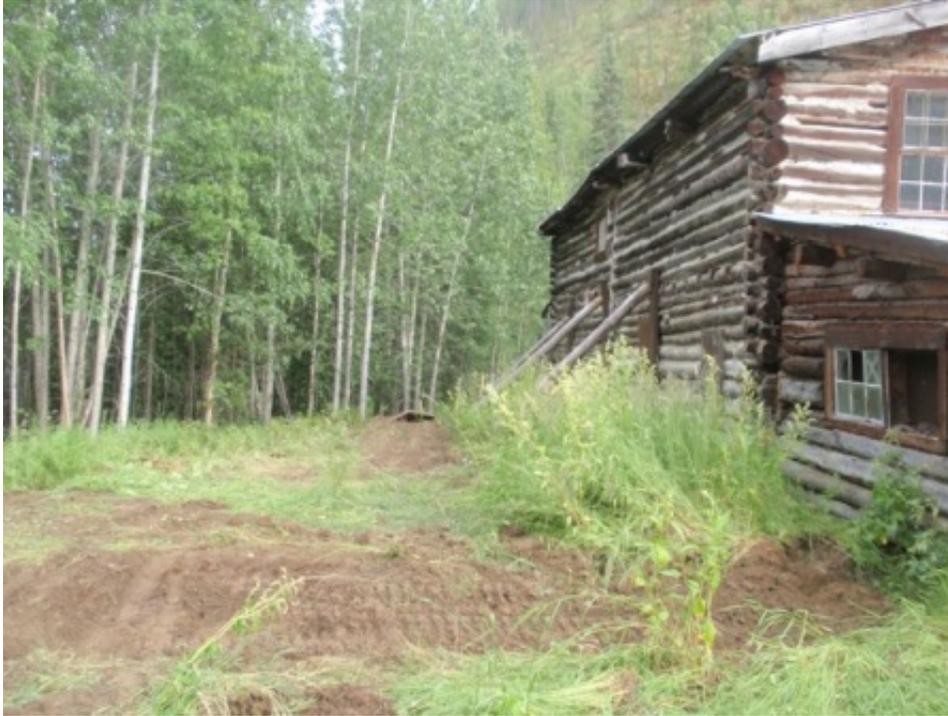
Figure 11. Soil removal and contouring of ground on the north side of the Roadhouse.

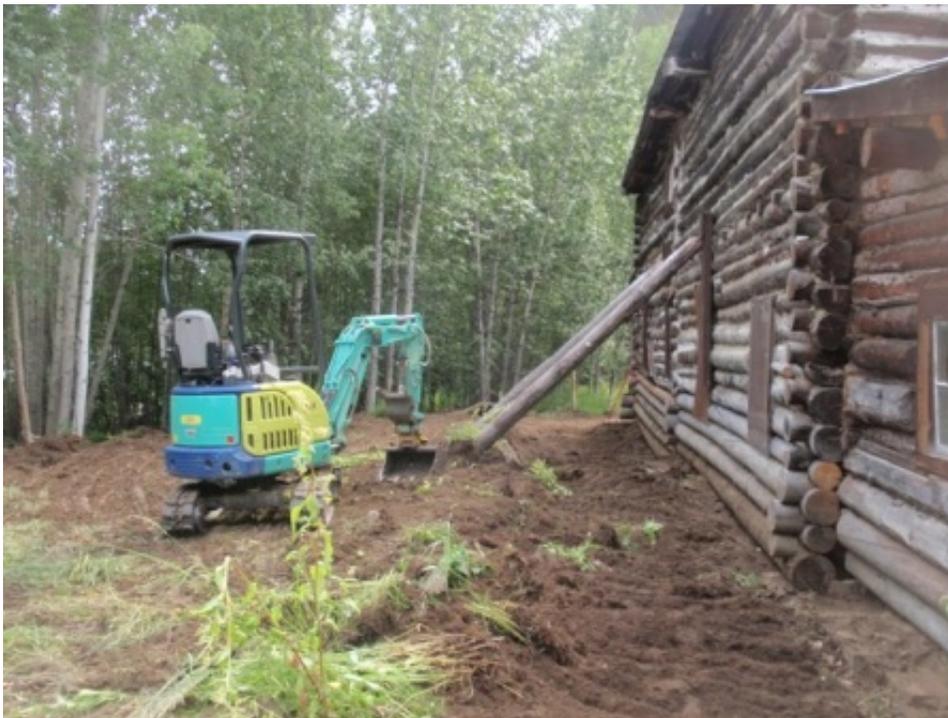
Figure 12. Soil removal and contouring of ground on the north side of the Roadhouse.

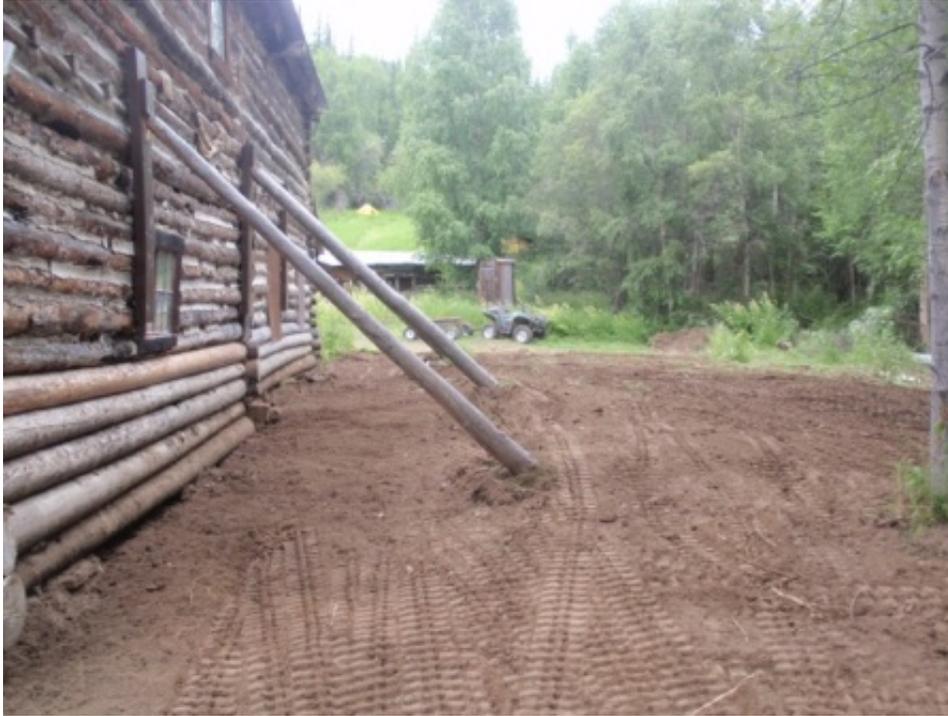
Figure 13. Finished recontoured ground on the north side of the Roadhouse.

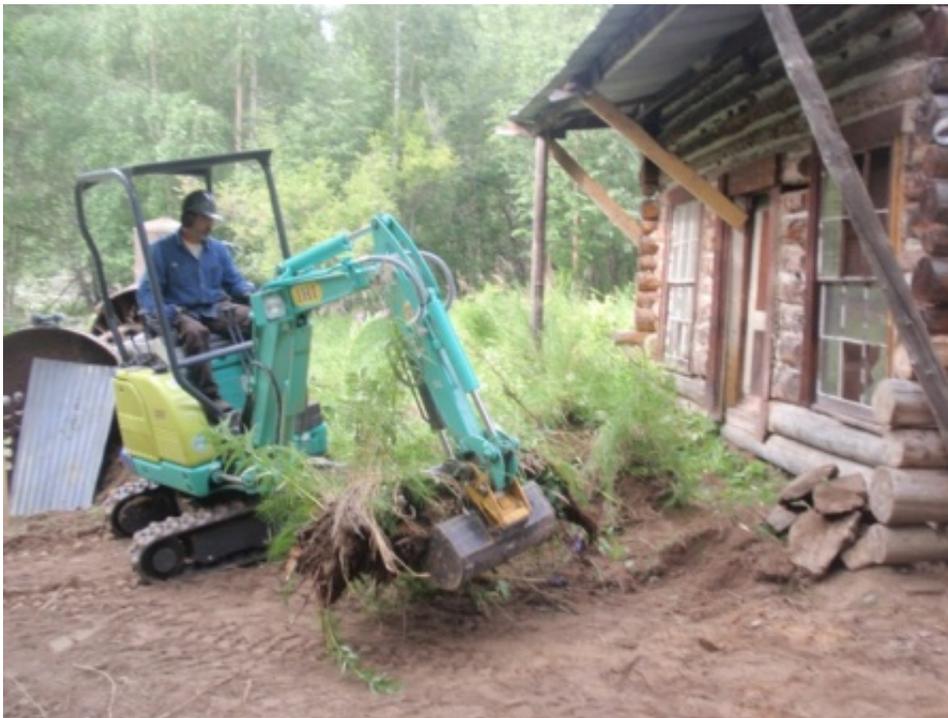
Figure 14. Soil removal and contouring of ground on the east side of the Roadhouse.

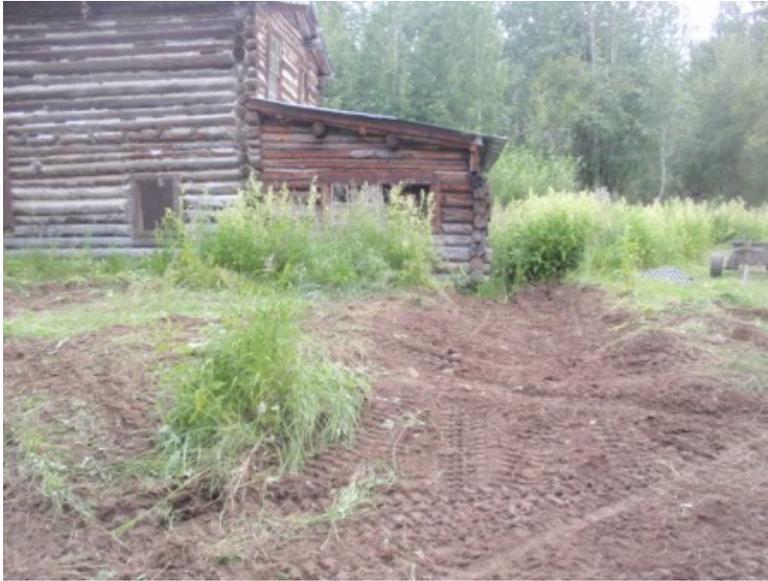
Figure 15. Finishing up a wide, contouring drainage chute away from the northwest corner of the Roadhouse.

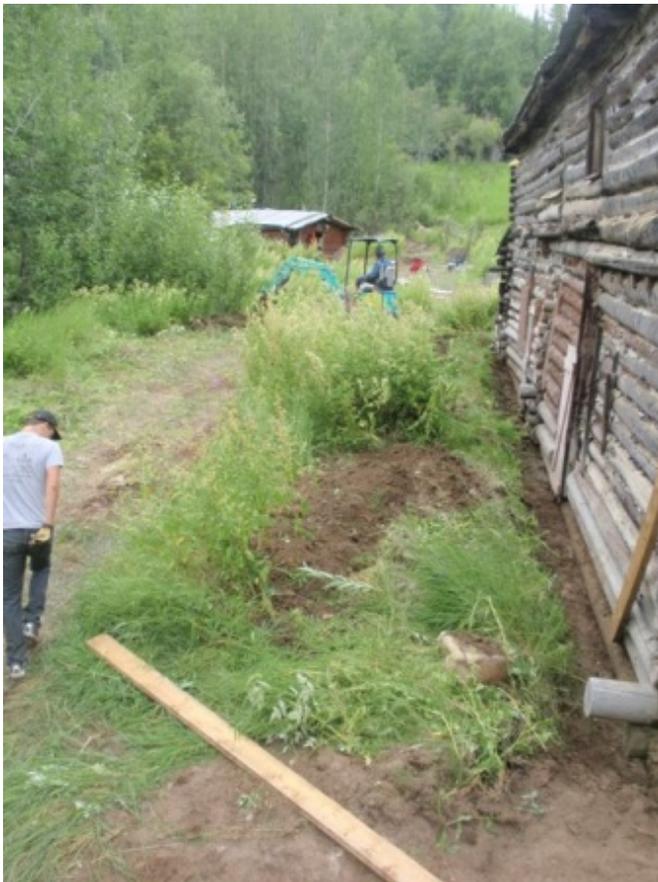
Figure 16. Soil removal and contouring of ground on the south side of the Roadhouse.

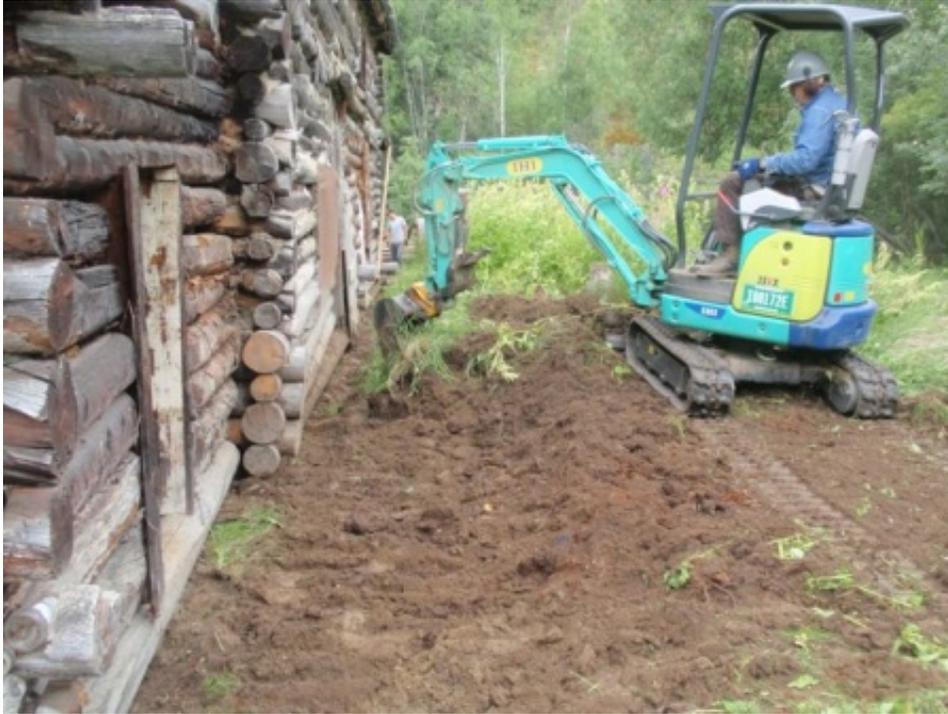
Figure 17. Soil removal and contouring of ground on the south side of the Roadhouse.

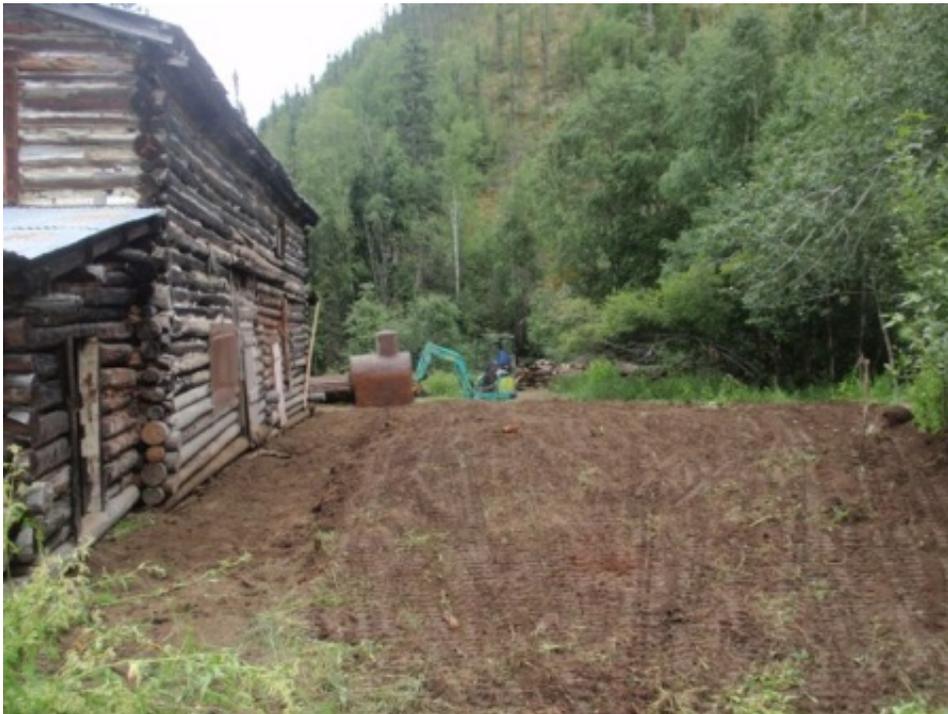
Figure 18. Finished recontoured ground on the south side of the Roadhouse.

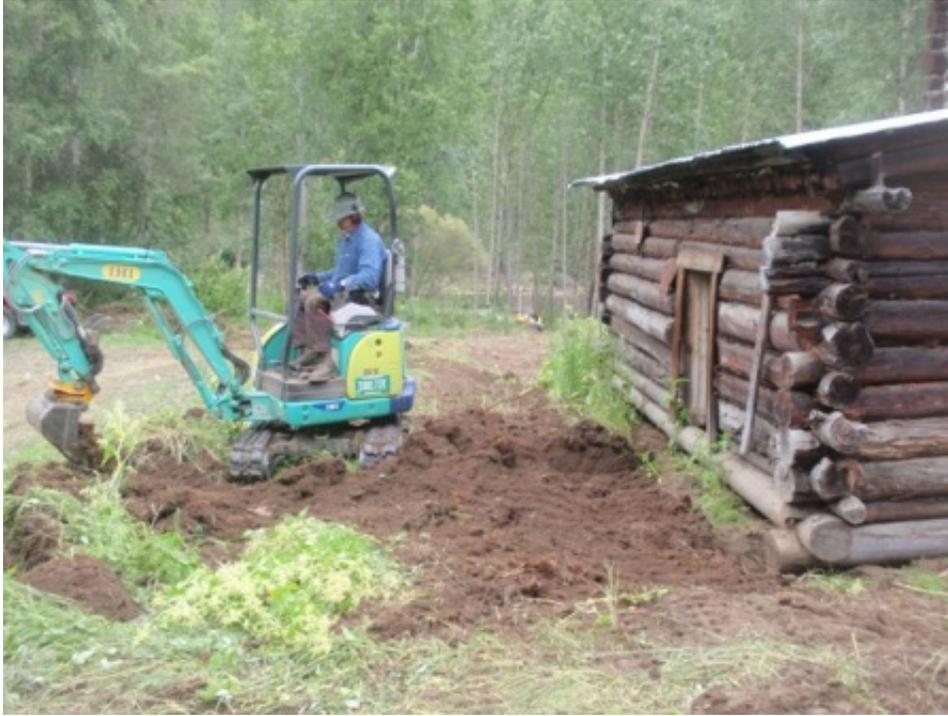
Figure 19. Soil removal and contouring of ground on the west side of the Roadhouse.

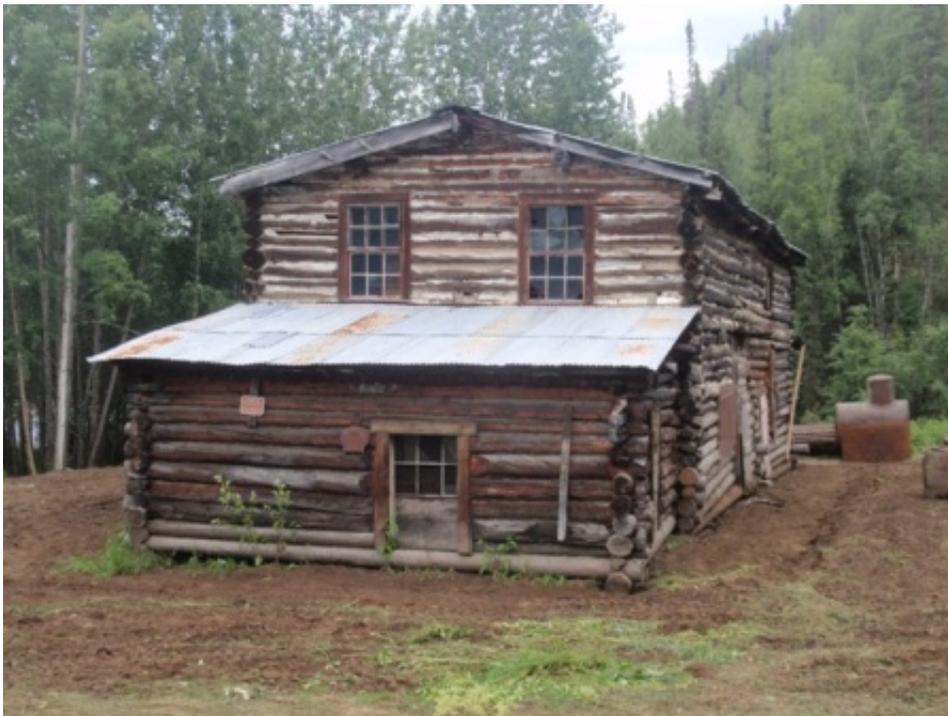
Figure 20. Finished recontoured ground around the Roadhouse. View from the west.

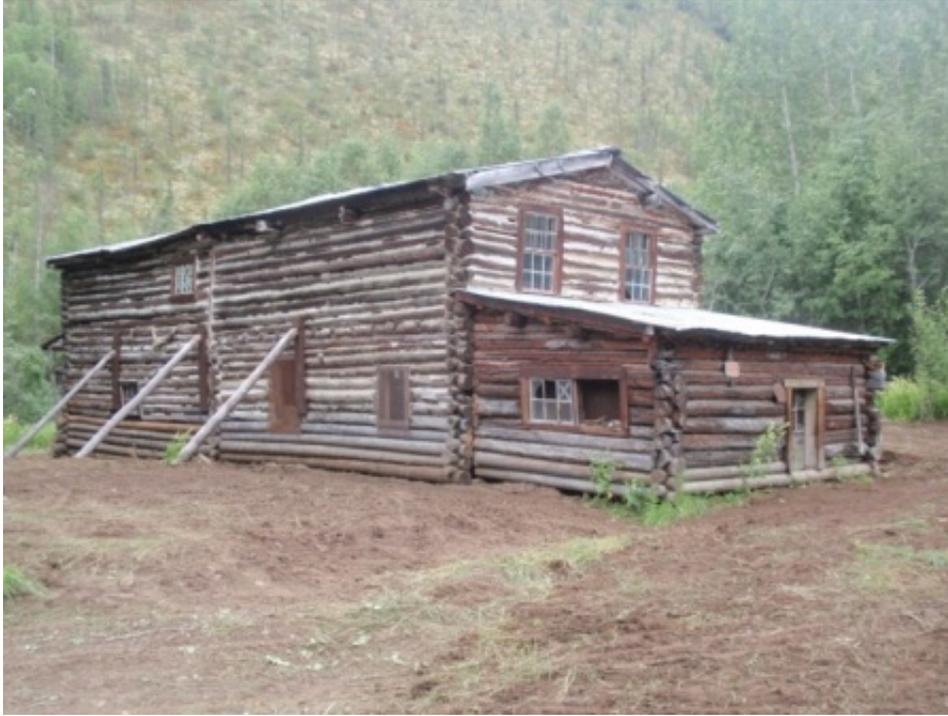
Figure 21. Finished recontoured ground around the Roadhouse. View from the northwest.

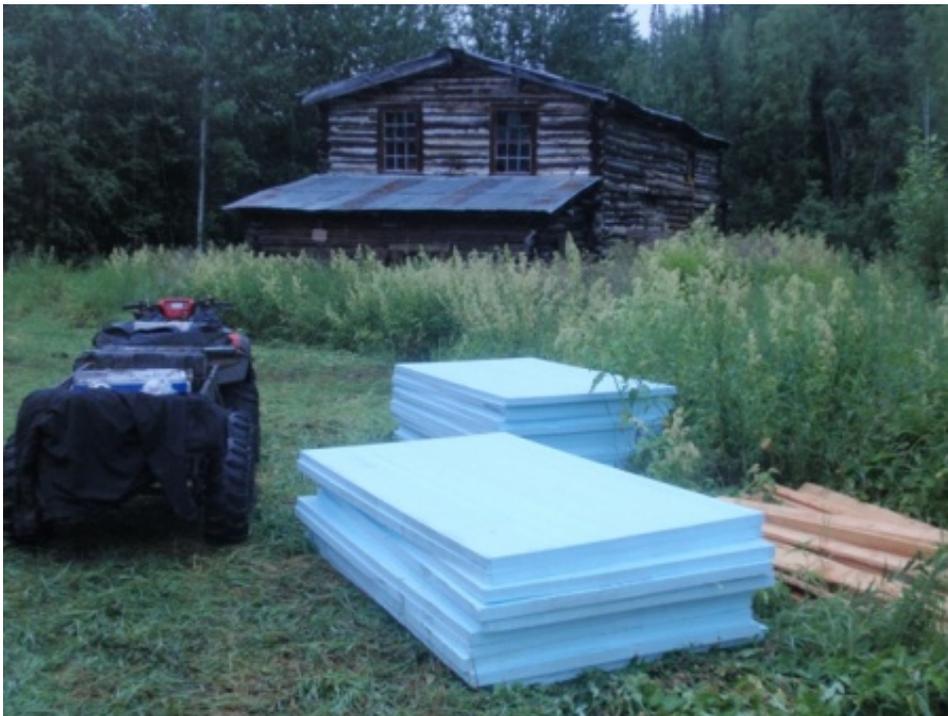
Figure 22. Insulation and joists for the new floor in Structure C.

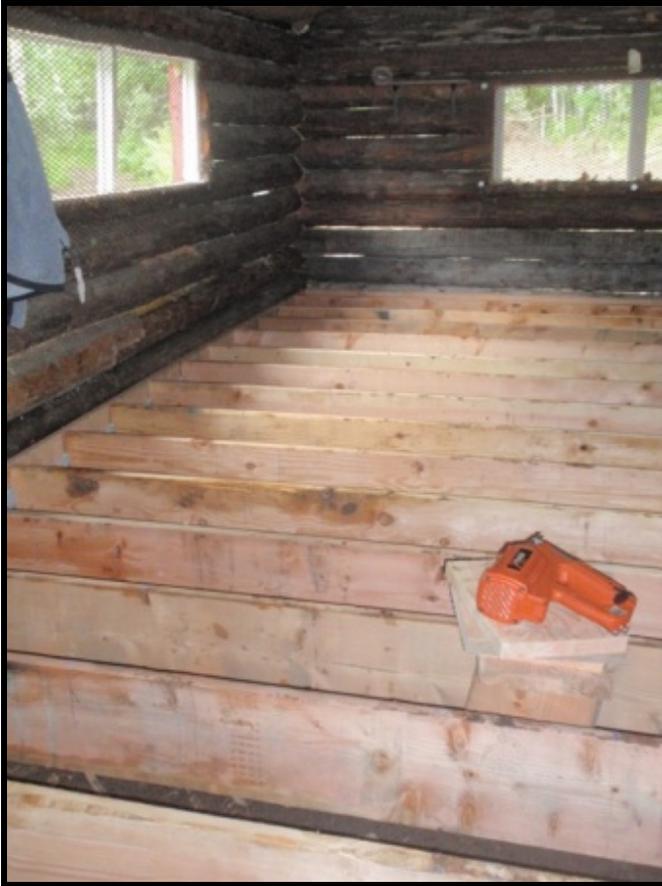
Figure 23. Installing the hanging joists for the new floor in Structure C.

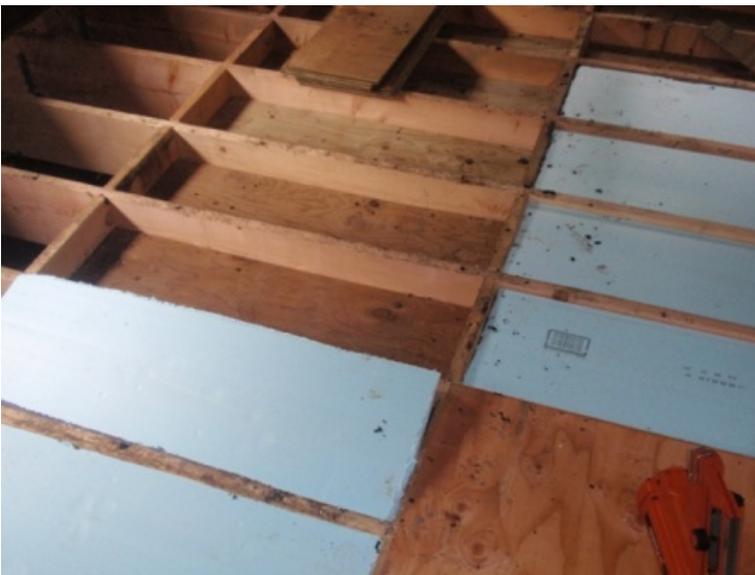
Figure 24. Installing blueboard insulation between the hanging joists for the new floor in Structure C.

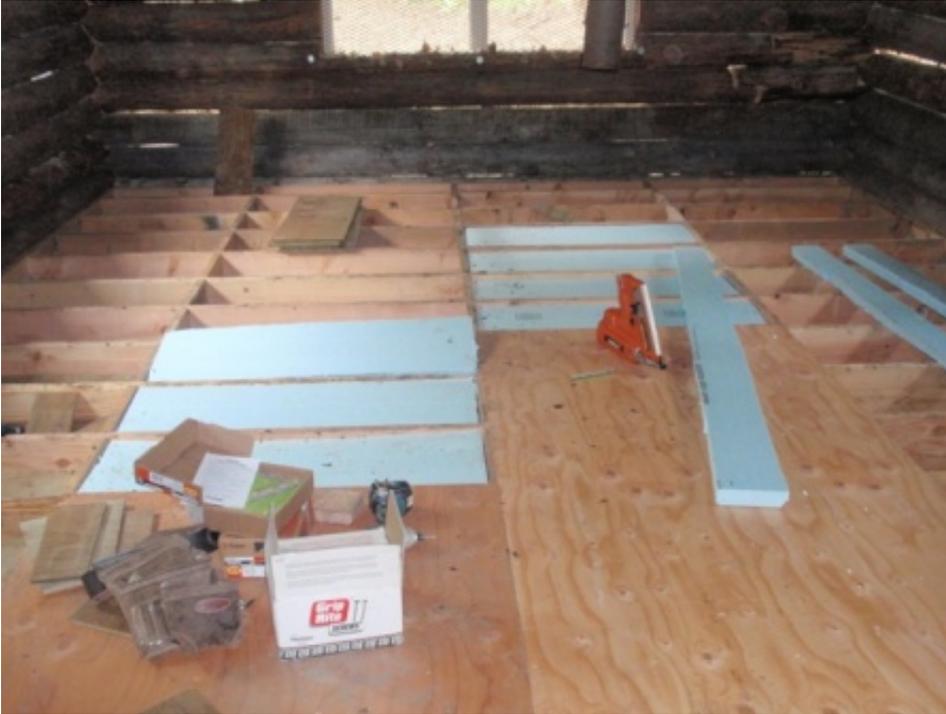
Figure 25. Installing blueboard insulation and the upper plywood flooring in Structure C.

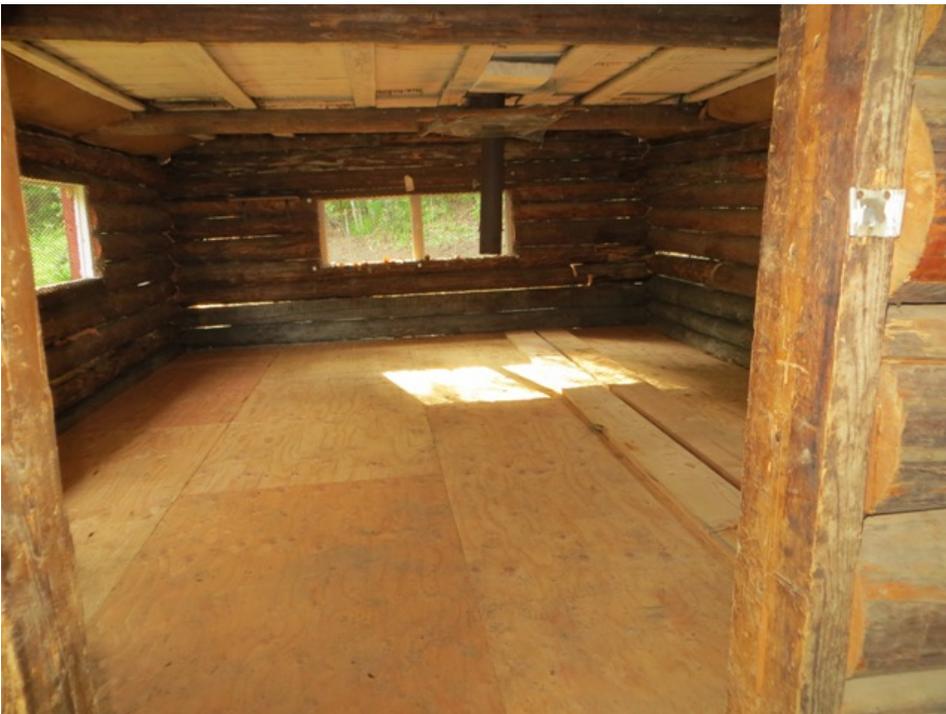
Figure 26. The finished floor in Structure C.

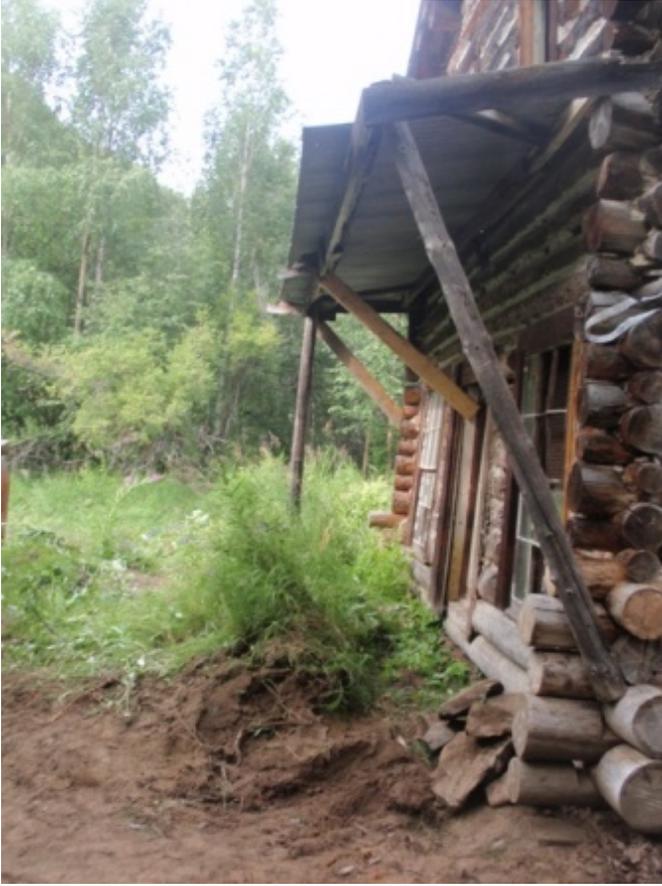
Figure 27. Location of the new porch on the east end of the Roadhouse.

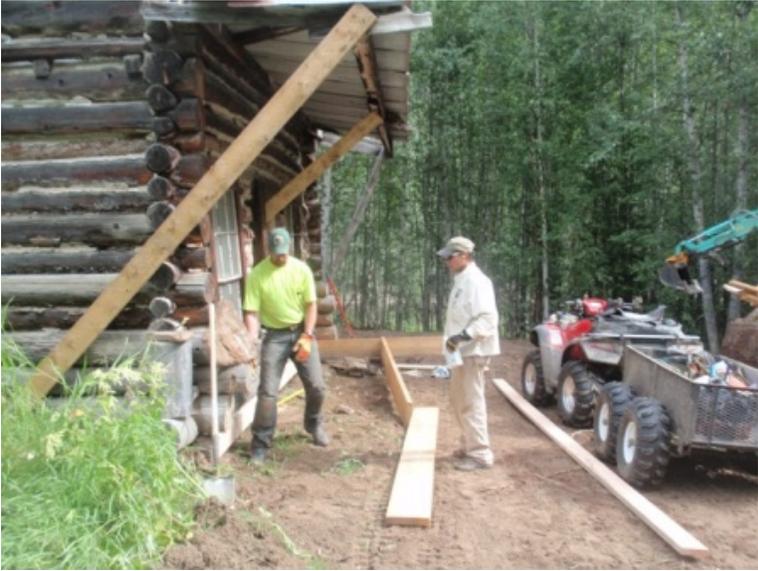
Figure 28. Building the new porch on the east end of the Roadhouse.

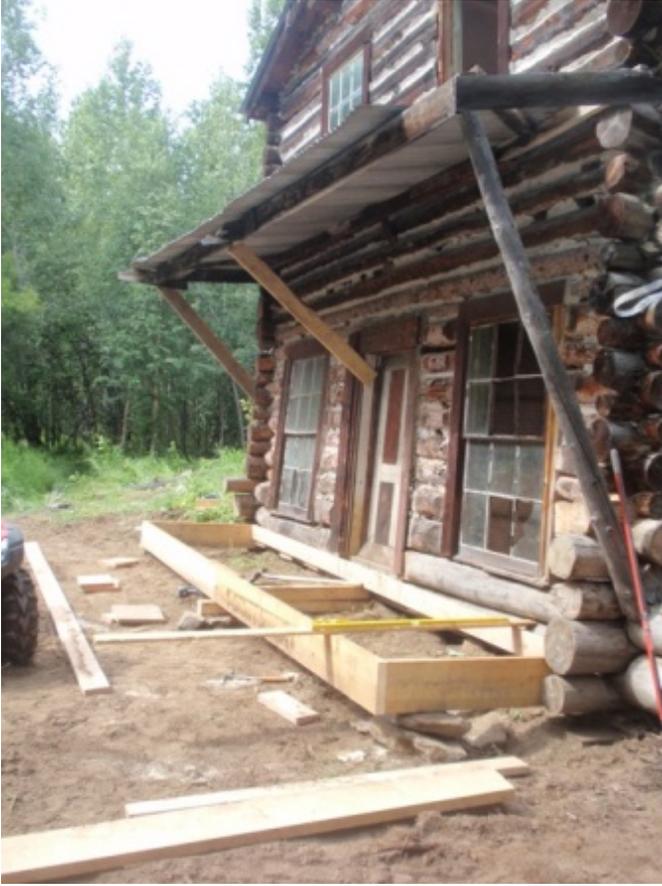
Figure 29. Building the new porch on the east end of the Roadhouse.

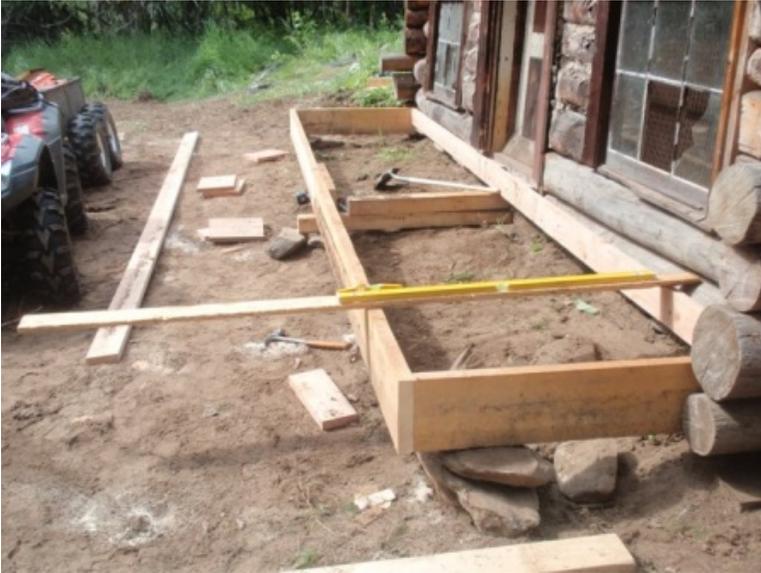
Figure 30. Building the new porch on the east end of the Roadhouse.

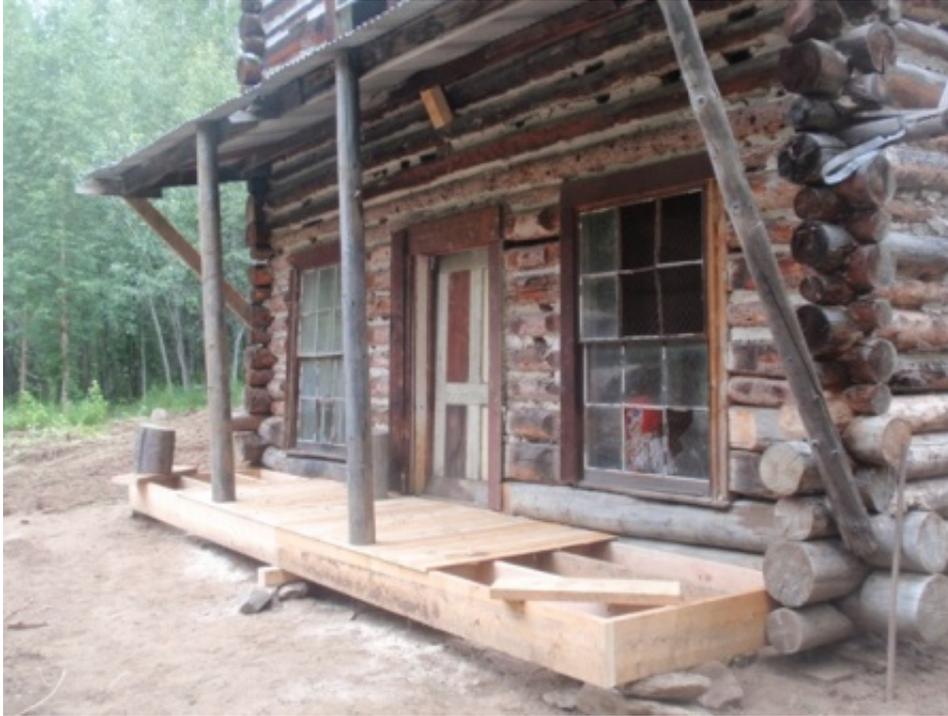
Figure 31. Nearing completion of the new porch on the east end of the Roadhouse.

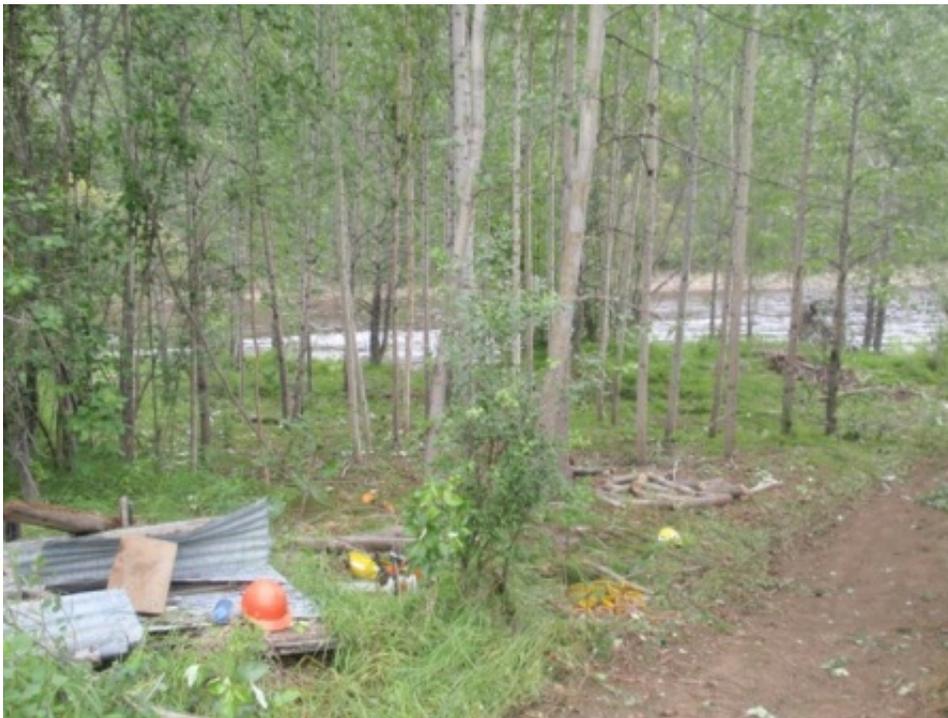
Figure 32. Thinning of trees between the Roadhouse and the Fortymile River. Area already thinned, and river visible.

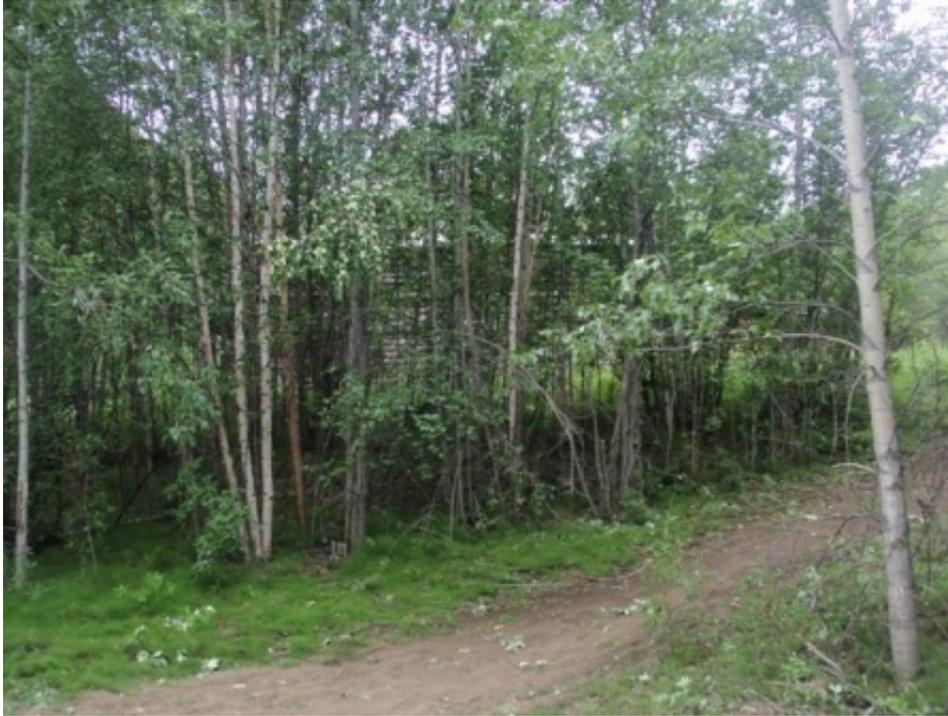
Figure 33. Thinning of trees between the Roadhouse and the Fortymile River. View towards the Roadhouse, pre-thinning. Contrast with Figure 34.

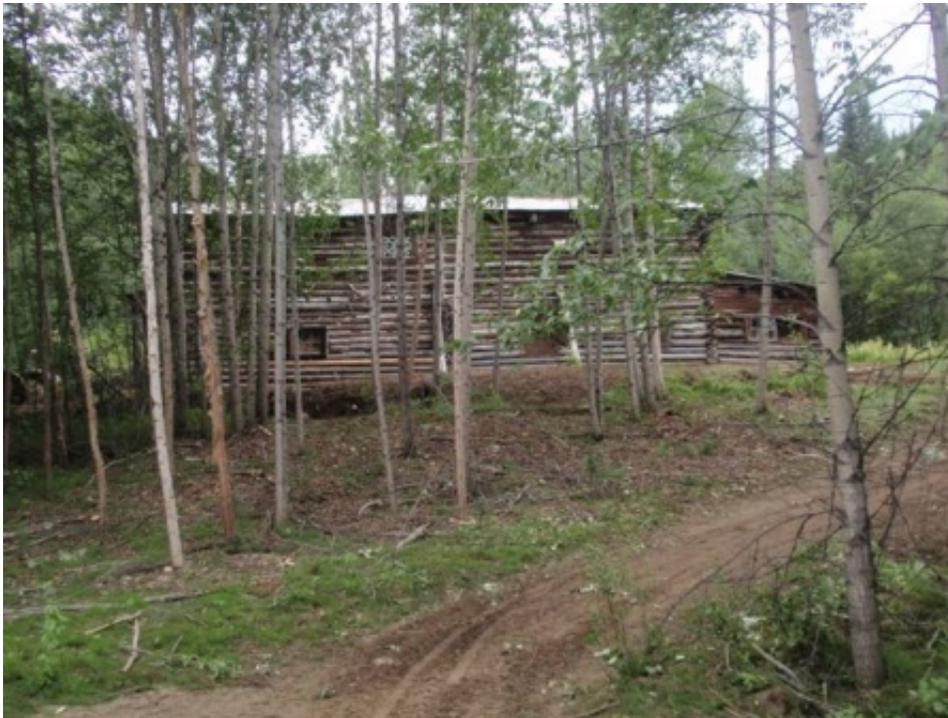
Figure 34. Thinning of trees between the Roadhouse and the Fortymile River. View towards the Roadhouse, post-thinning. Contrast with Figure 33.
