**Steele Creek Roadhouse Rehabilitation, June-July 2009**

Robin O. Mills, Archaeologist  
Bureau of Land Management, Fairbanks District Office, Fairbanks, AK  
December 2009

Location: Steele Creek Roadhouse (49-EAG-00019), Fortymile river mile 22.8R

Date(s): June 25 – July 8, 2009

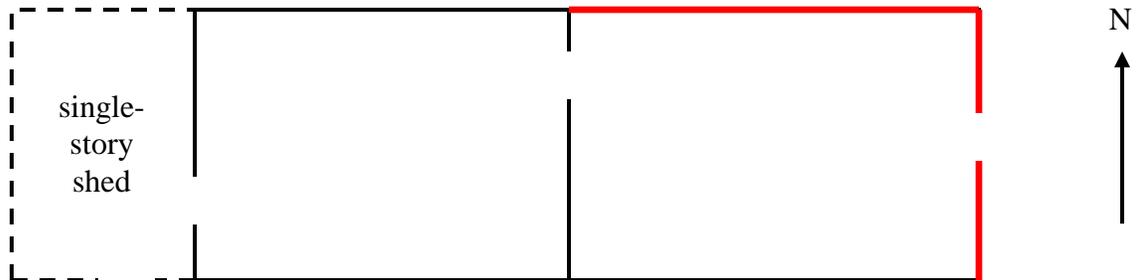
Figure 2. Plan view of Steele Creek Roadhouse, not to scale. Main building (excluding shed) is 52' long and 21' wide. The walls whose lower courses of rotten logs were replaced in 2009 are highlighted in red.

Again, the specific goals of the project this summer included: (1) replacing all rotten sill and lower courses of wall logs of the roadhouse, and (2) straightening the building which was leaning a couple of feet out of plumb to the northward. These goals were partially met. In the span of the one week that the full field crew was at the site, they were able to accomplish about 1/3 of the log replacing, and 1/2 of the building straightening (Figure 2, red highlight). Since the walls that needed log replacement included portions of two rectangular rooms situated side-by-side, there were six external weight-bearing walls that needed their lower rotten logs replaced: two short-axis walls (at the opposite ends of the building), and four long-axis walls, corresponding to the long walls of the two rooms (see Figure 2). The assembled field crew was able to excavate out and replace the rotten logs associated with the eastern short axis wall, along with those of the adjoining north wall of the eastern-most of the two side-by-side rooms (Figures 9-10). Thus, two of the six walls were fully stabilized (Figures 13-14). Also, the eastern half of the roadhouse was straightened via a system of come-alongs anchored on the south side of the building, which were attached to straps that passed through the building and were attached to long, vertical logs vertically abutting the full height on the north side of the building (Figures 11-12). In this manner, and by working all come-alongs at once, the crew was able to pull the eastern half of the roadhouse into proper alignment.

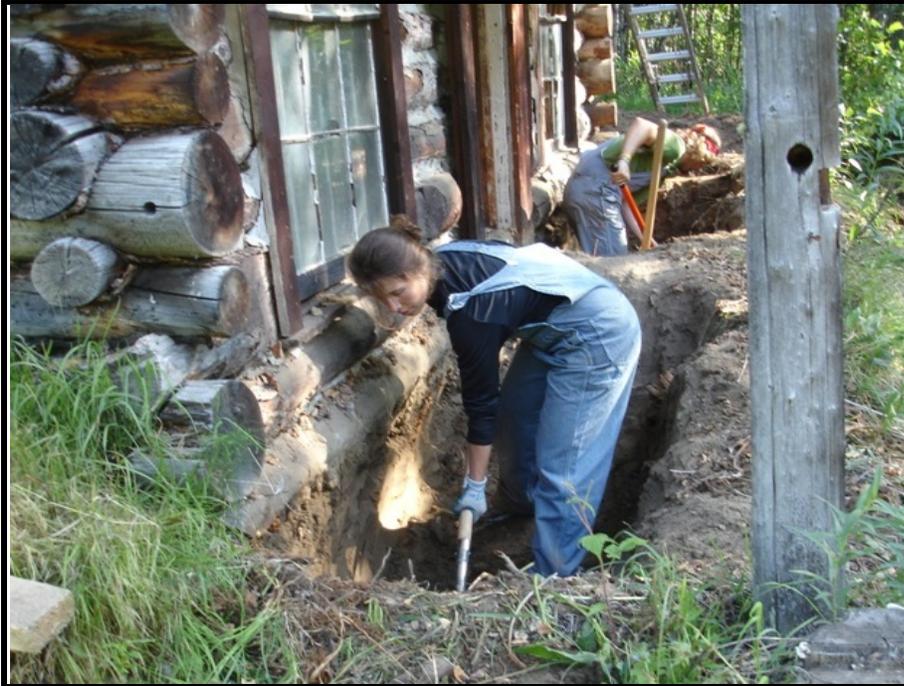
Figure 9. The rest of the crew arrived in early July, and dug out the rotten lower logs of two of the six walls that needed log replacement. View north, on the short-axis wall at the east end of the building.

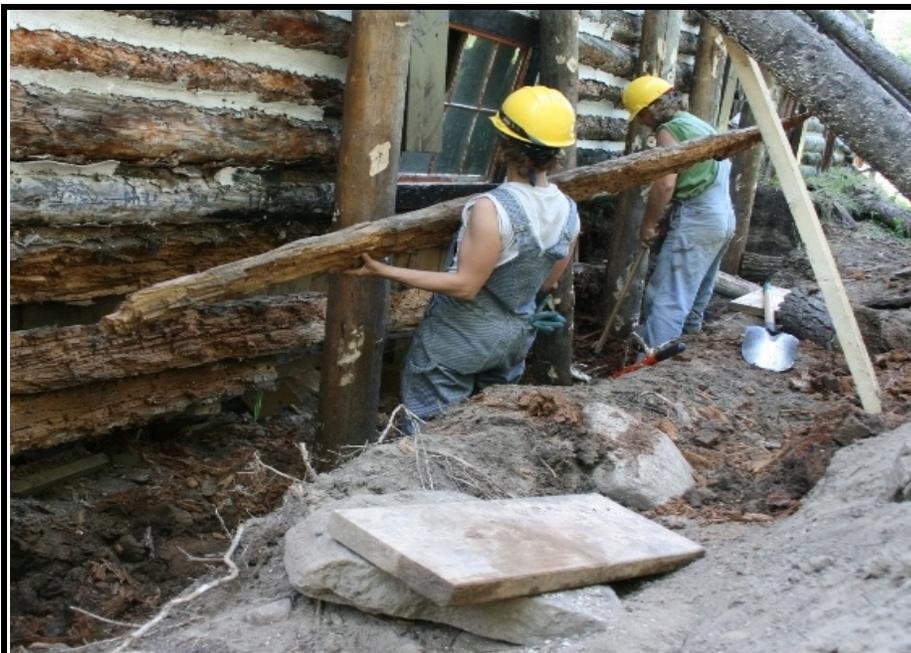
Figure 10. View west, digging out the rotten logs on the long axis wall, north side of the eastern room of the roadhouse.

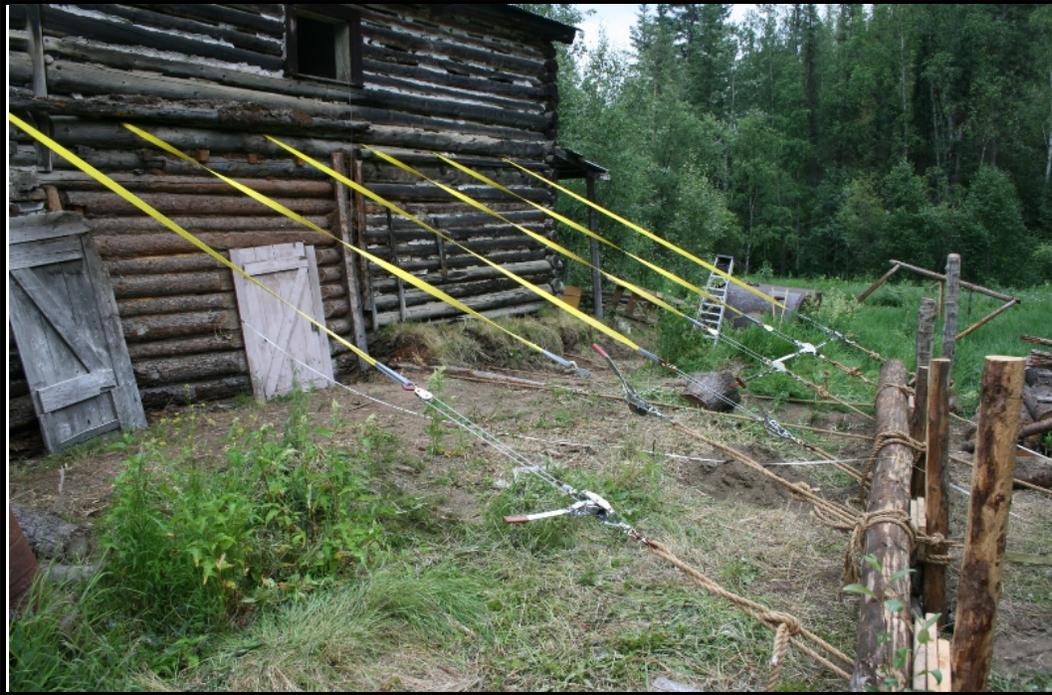
Figure 11. [View east on the south side of the roadhouse]. The come-along system anchored on the south side of the building. The straps passed through the building and ....

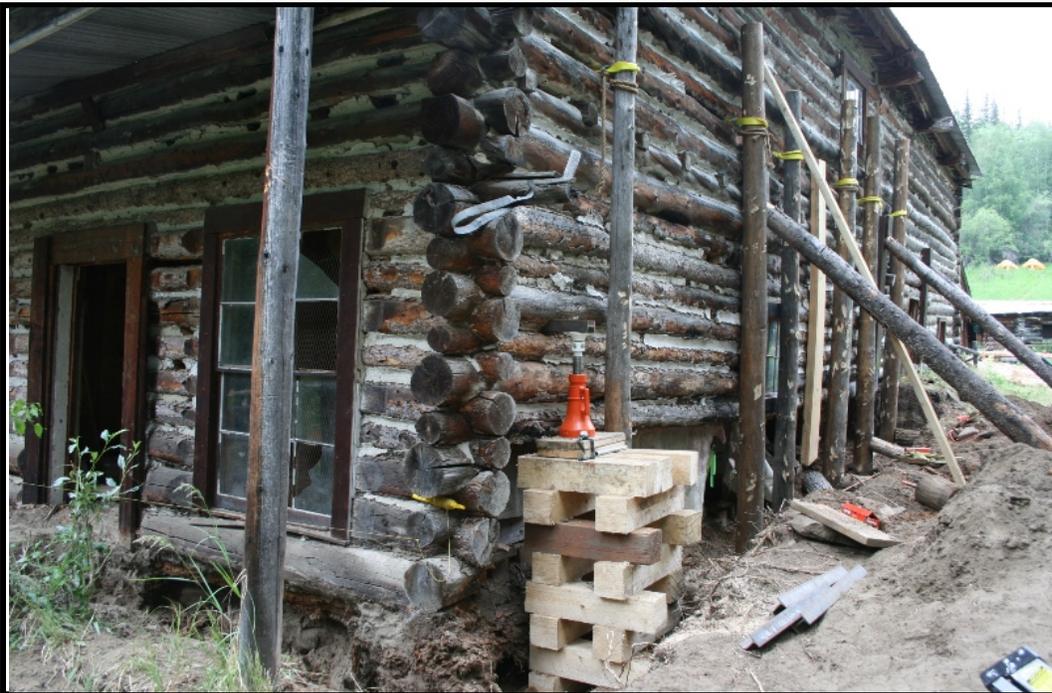
Figure 12. .... were attached to vertical logs on the north side of the building. The system helped pull the leaning building back into proper alignment. View west on the north side of the roadhouse. Note also the blocking and hydraulic jacks used to support the roadhouse. A larger system of blocking, supports, and jacks were placed inside of the building.

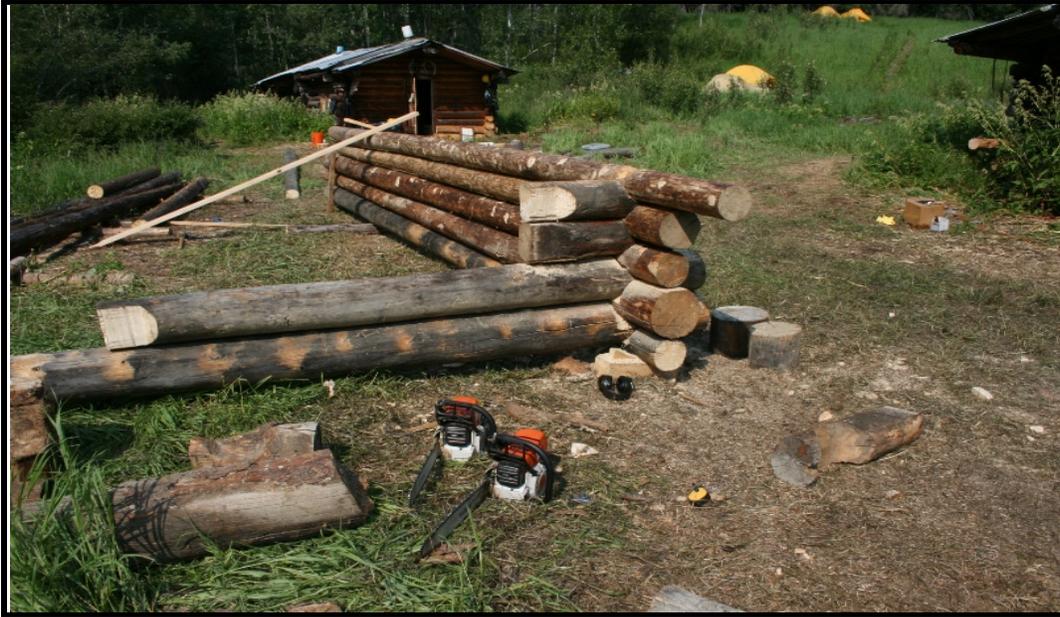
Figure 13. The replacement logs were cut to proper length, notched, matched to fit, and assembled in an open area in the center of the site prior to installment under the roadhouse.

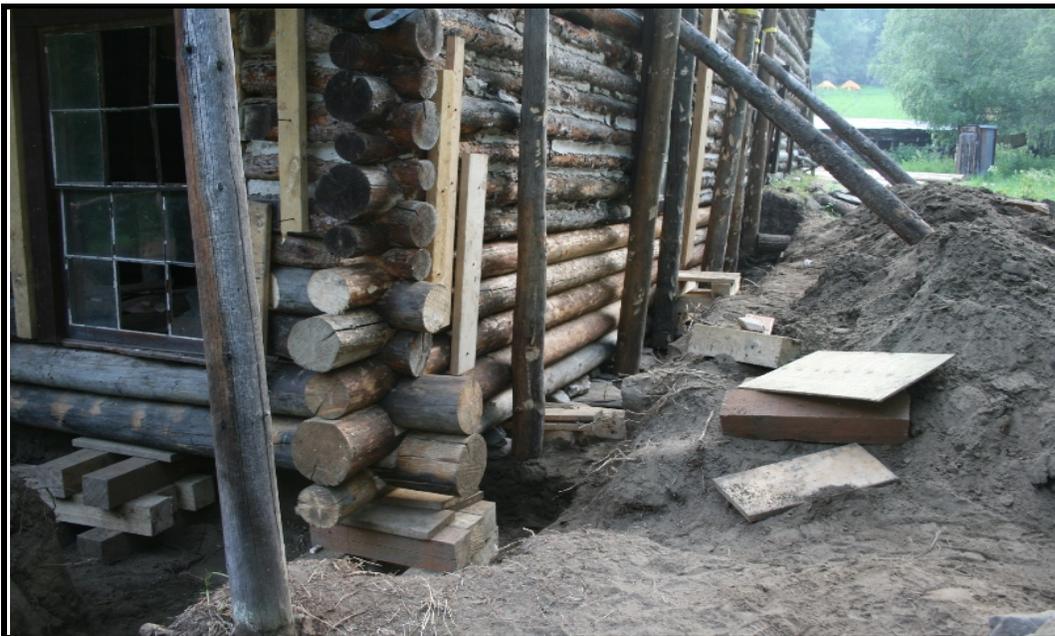
Figure 14. The replacement logs assembled into place. The new sill logs were placed onto a layer of river cobbles. Prior to backfilling, the outer layer of logs were layered in plastic, so no soil is touching the new logs.
