# Klamath National Forest Best Management Practices

EVALUATION PROGRAM

MONITORING REPORT

2015 Fiscal Year

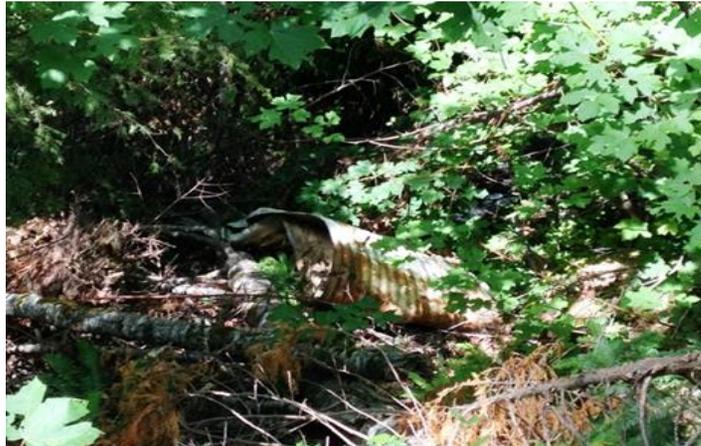
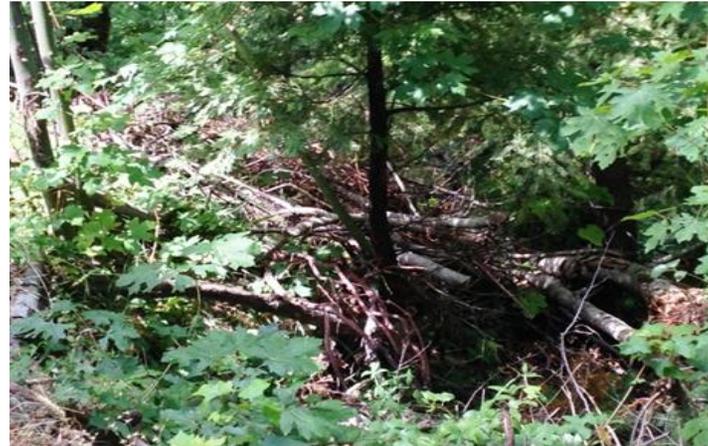
**Seiad Road Rehab - Road 48N20 MP 4.77**

The sidecast material is mainly vegetation, potential effects to water quality are minor. Engineering plans did not specifically prohibit sidecasting or disposal areas. This is a standard practice, but was not caught in inspection of contract. The 2014 BMPEP Report stated that is recommended that maintenance crews go out to this site and pull back the sidecast material. This was not completed at the time of visit.

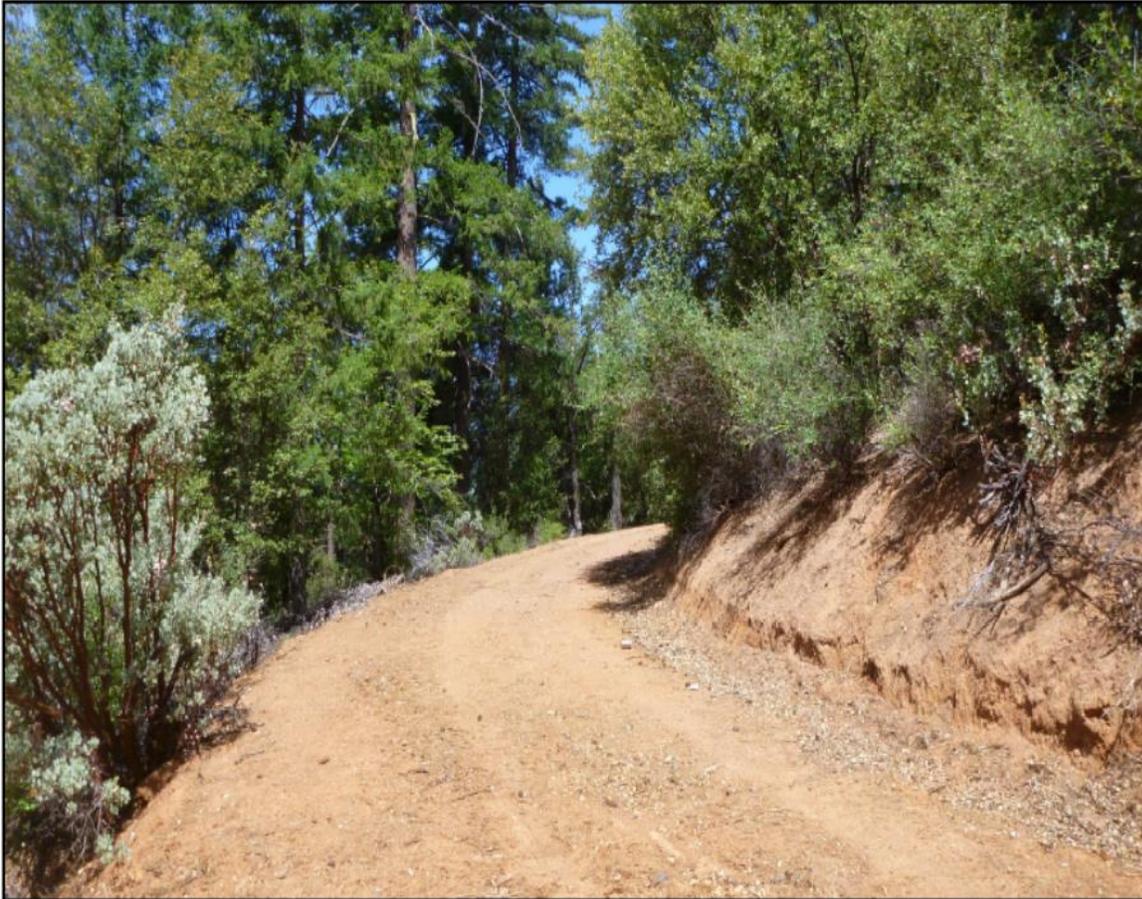
This road is no longer in decom status. It is in active (or recent) use for a thinning project. The road currently has no blockage and appears to have been recently used (see Photo 1). The vegetation noted in the 2010 follow up is gone. Additional features such as rolling dips for water control are gone. There is no closure/traffic control obstruction at take-off. Only way to access is from locked gate on 38N40 road.

**Photo 1: Rd 38N40B.** 07/22/15. Take-off from road 38N40. Although this road is supposed to have been officially decommissioned, it has no blockage and looks to have been very recently bladed.

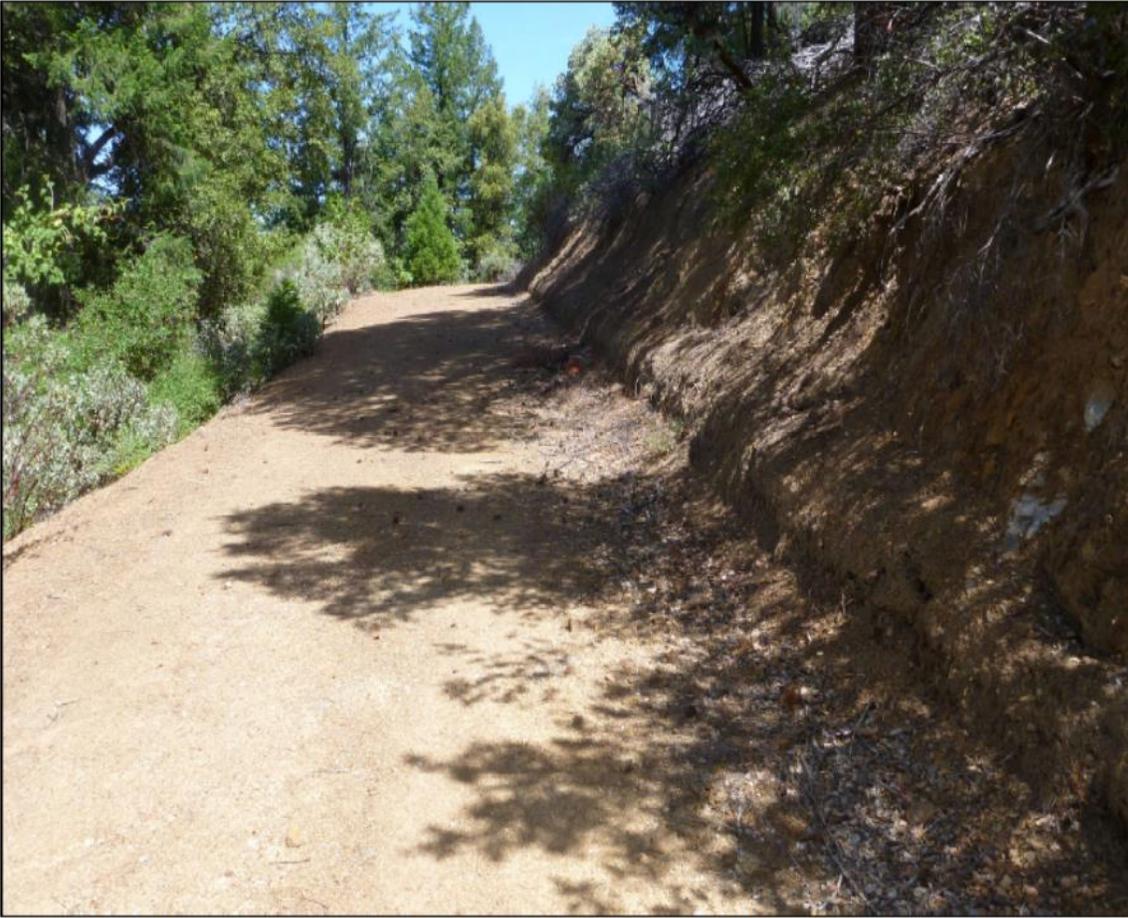
**Photo 2: Rd 38N40B.** 07/22/15. Further evidence of recent blading, including into hillslope.

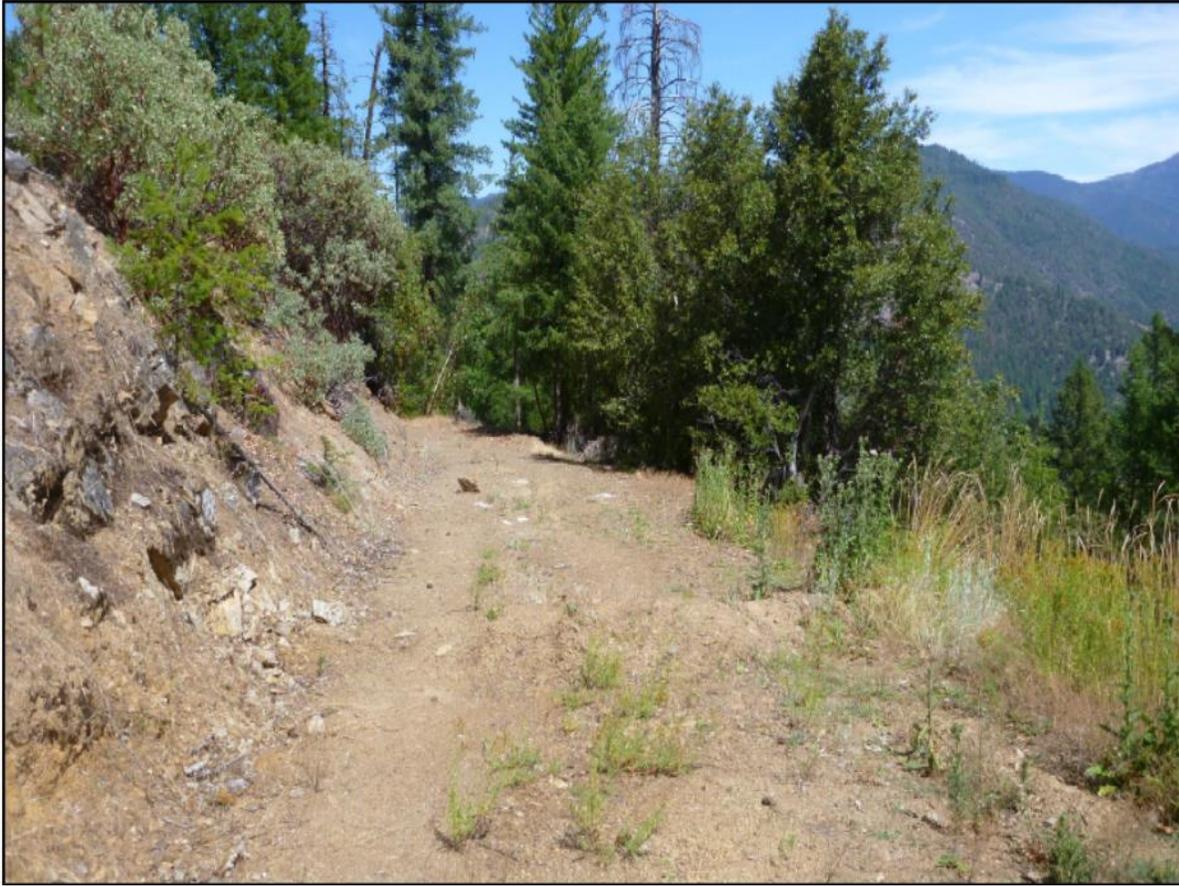
**Photo 3: Rd 38N40B.** 07/22/15. One of the three waterbars on the road. If any others were present, they were bladed out of existence.

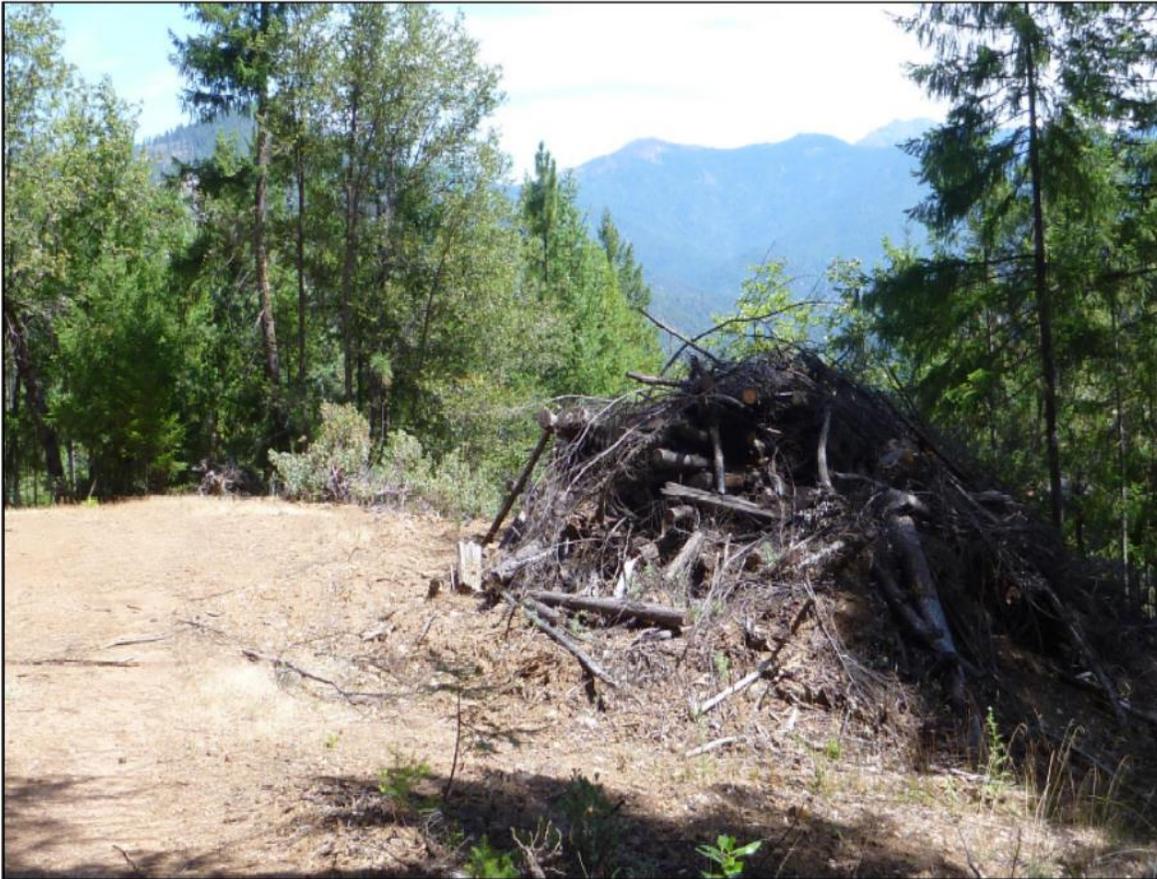
**Photo 4: Rd 38N40B.** 07/22/15. One of many debris piles at the edge of the road.
