PHOTOGRAPH LOG
Mingus Area

Project Name: USFS Preliminary Assessment/Site Inspection (PA/SI)	Site Location: Prescott National Forest, Yavapai County, Arizona	Project No. 12767.204.001
---	--	-------------------------------------

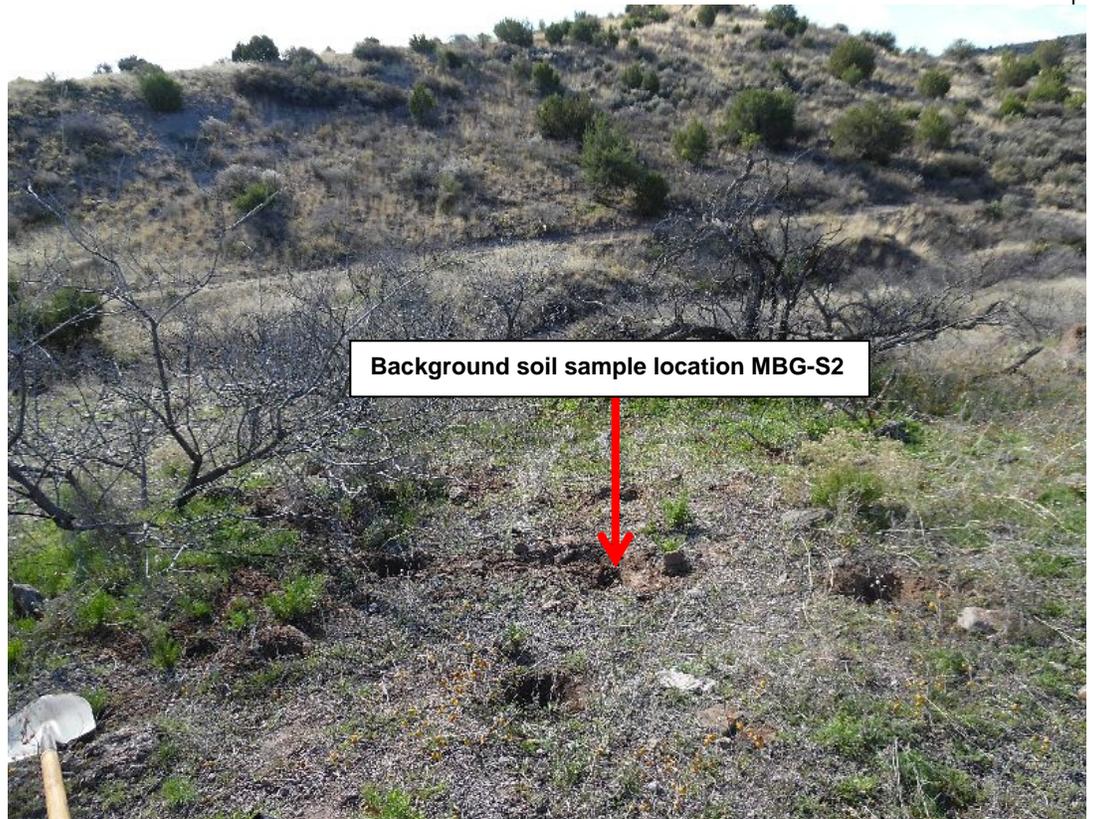
Photo No. 2	Date: 3/9/2015
------------------------------	--------------------------

Description: Background soil sample location MBG-S2.
--

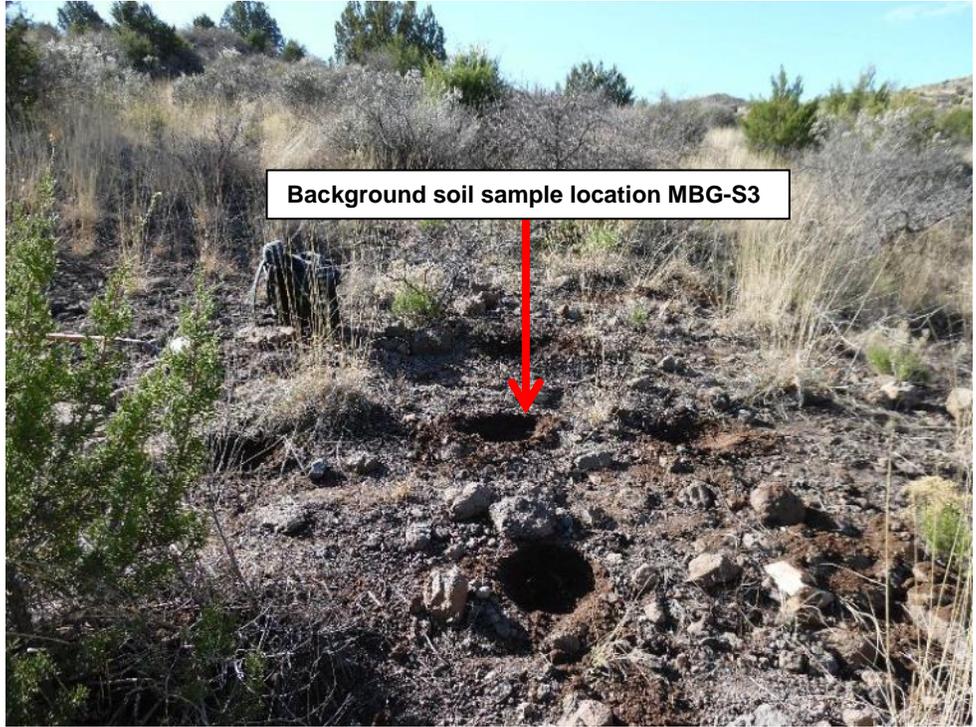
Photo No. 3	Date: 3/9/2015
------------------------------	--------------------------

Description:
Background soil sample location MBG-S3.

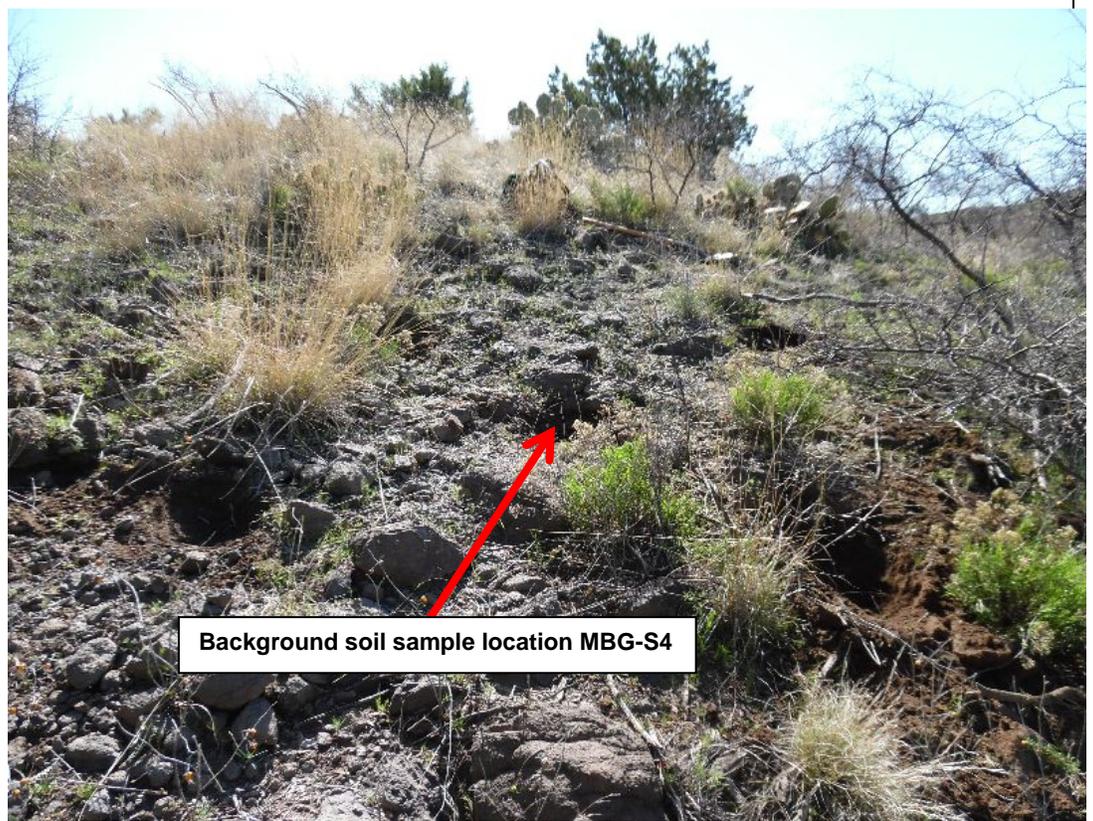
Photo No. 4	Date: 3/9/2015
------------------------------	--------------------------

Description:
Background soil sample location MBG-S4.

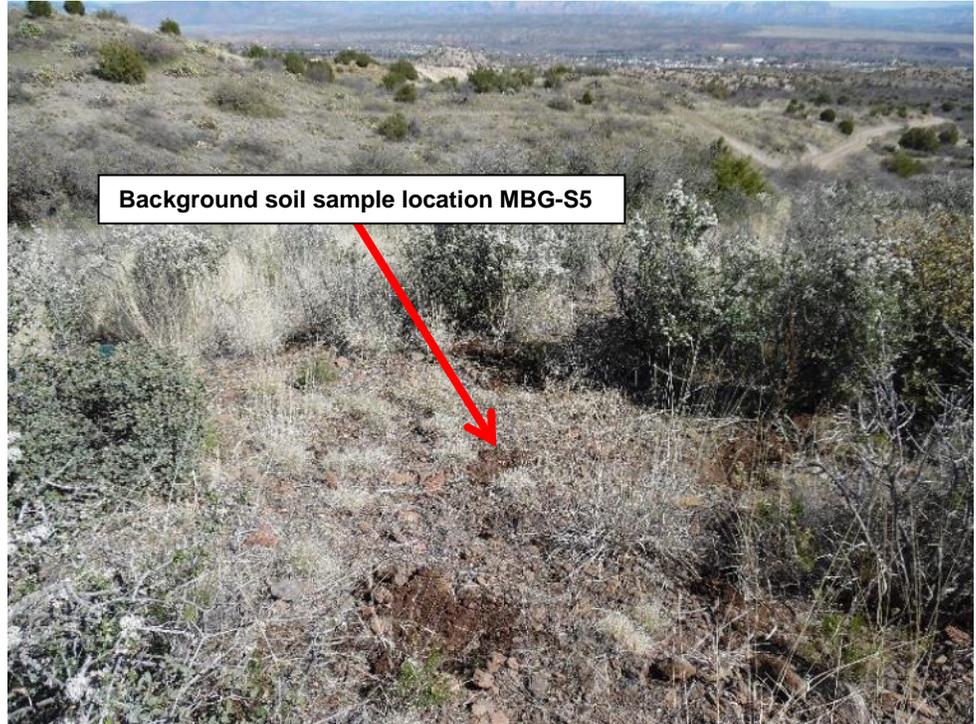
Photo No.
5

Background soil sample location MBG-S5.

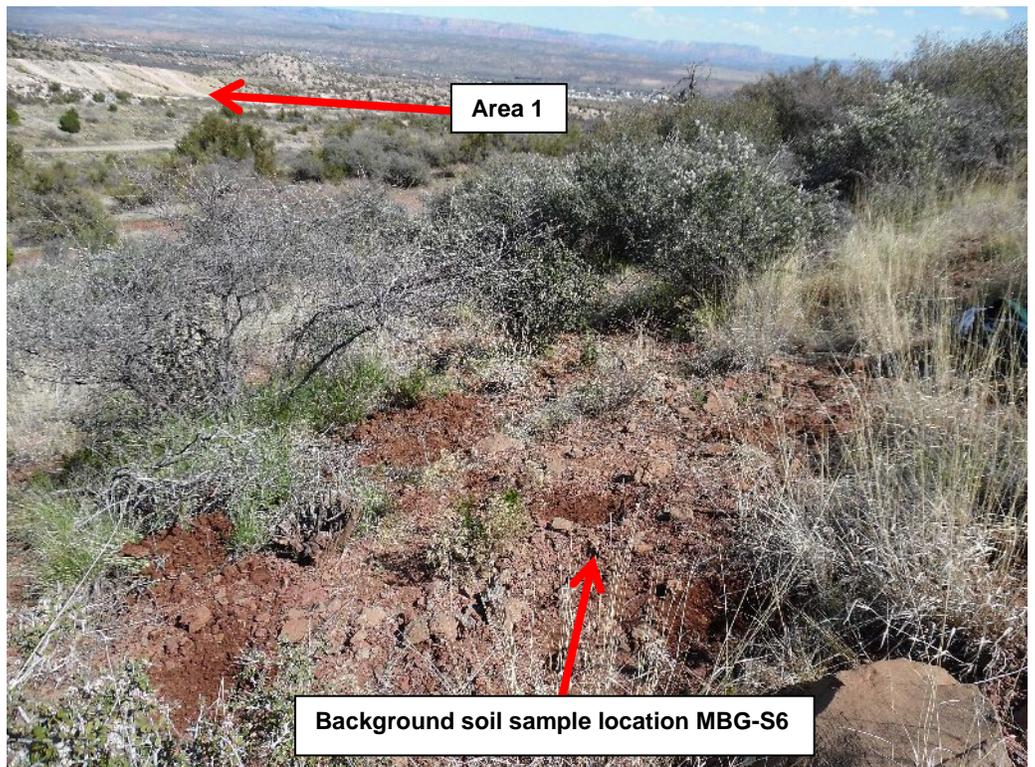
Photo No.
6

Background soil sample location MBG-S6. Area 1 is visible in the background.

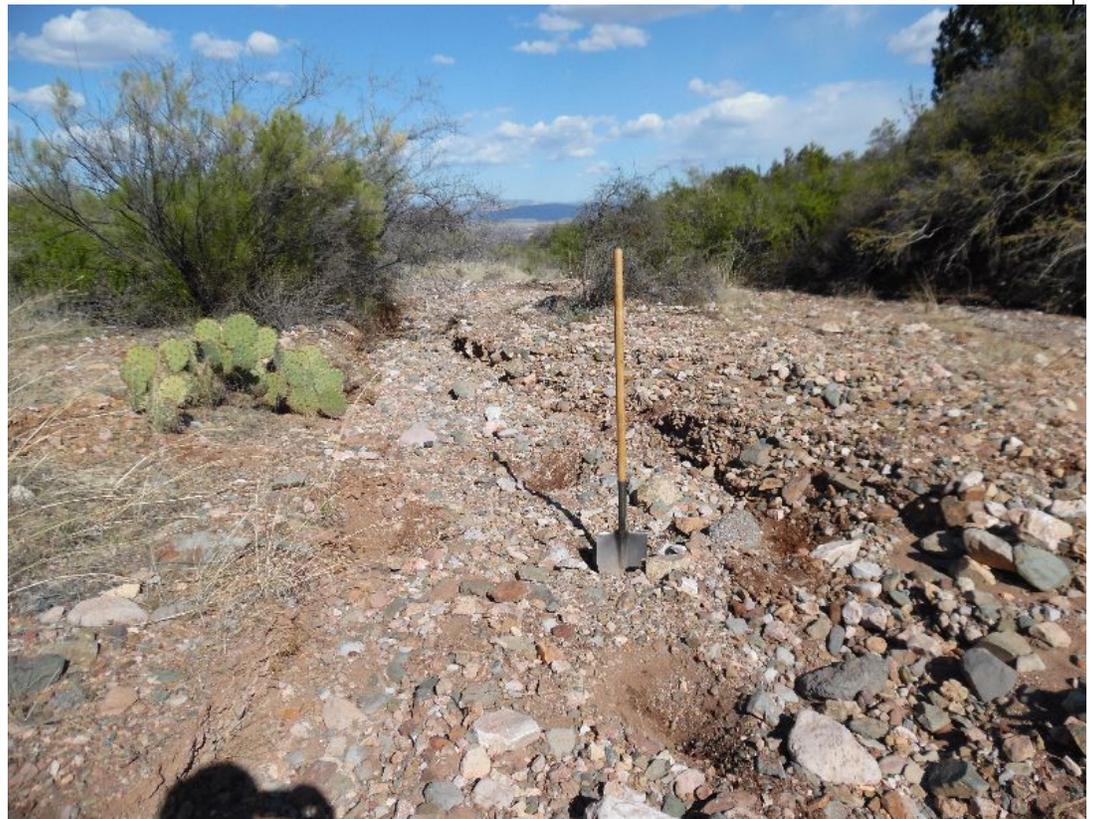
Photo No. 8	Date: 3/9/2015
Direction Photo Taken: Northeast

Description:
Background sediment sample location MBG-Sed2, marked by the shovel.

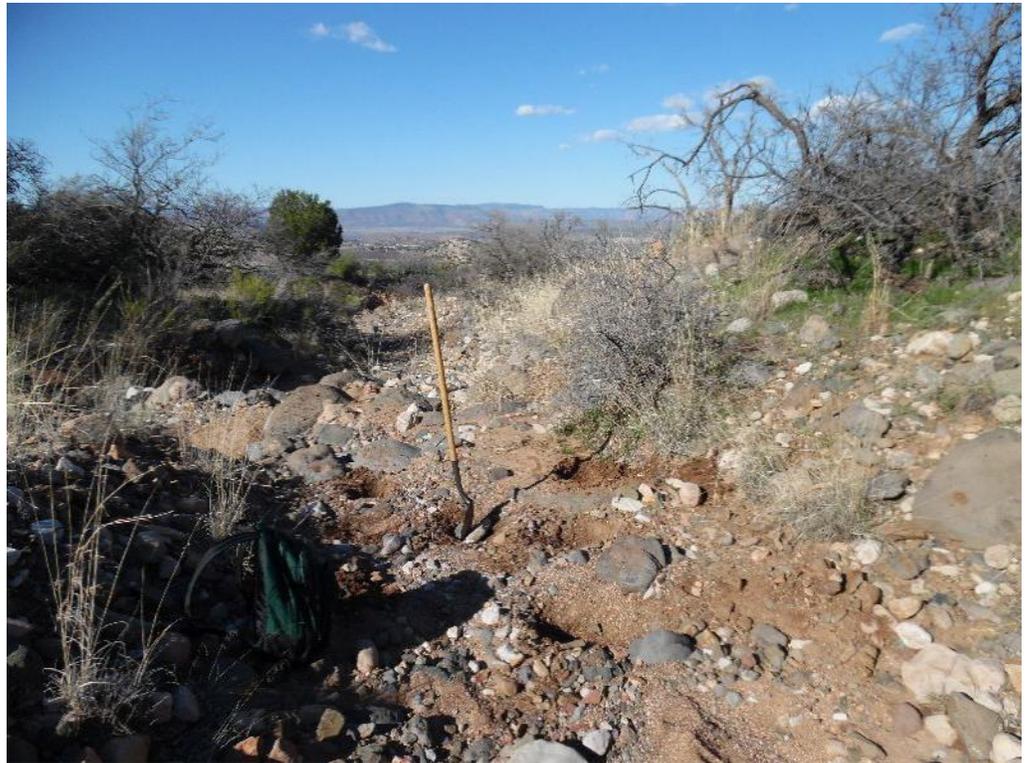
Photo No. 9	Date: 3/9/2015
------------------------------	--------------------------

Description:
Background sediment sample location MBG-Sed3, marked by the shovel.

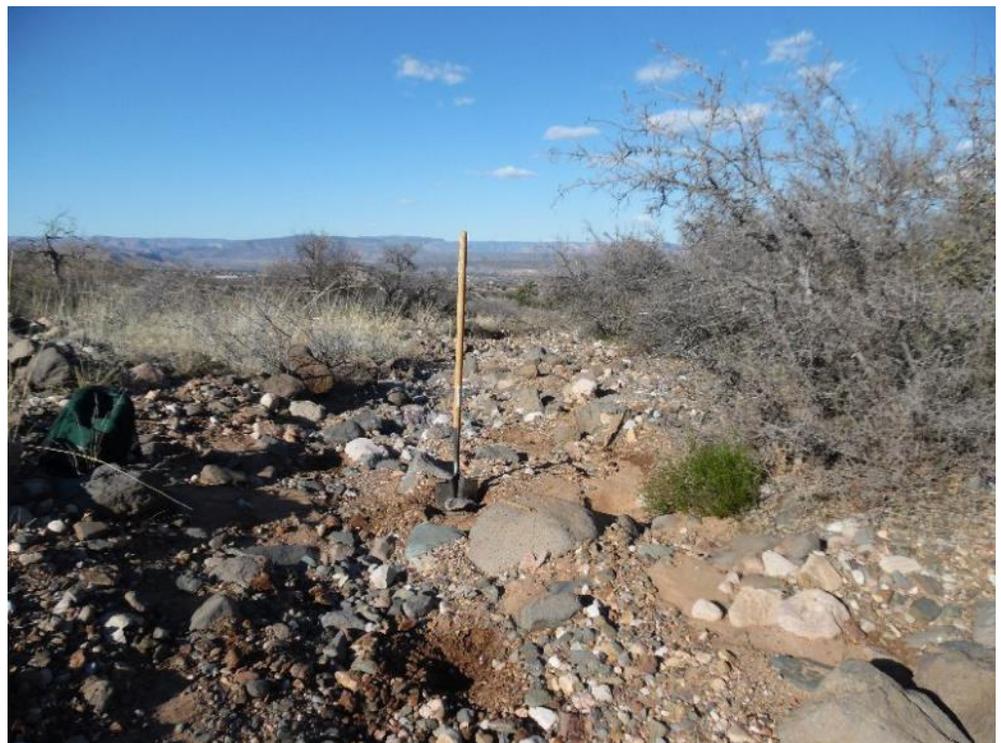
Photo No. 10	Date: 3/9/2015
-------------------------------	--------------------------

Description:
Background sediment sample location MBG-Sed4, marked by the shovel.

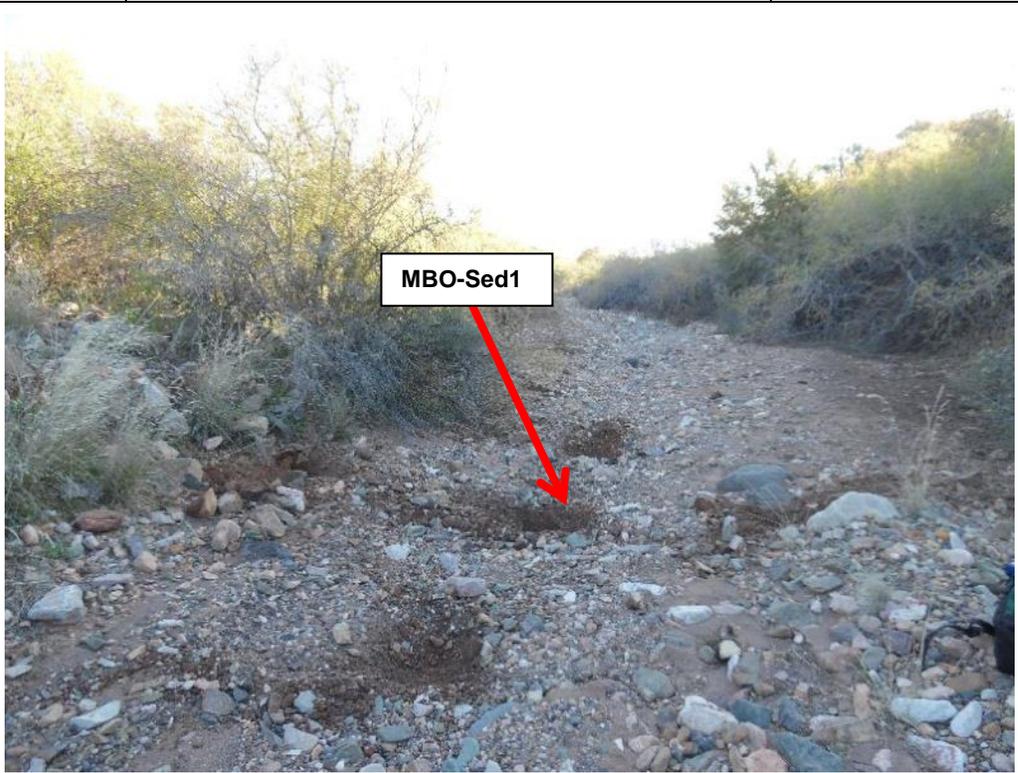
Photo No. 11	Date: 3/10/2015
-------------------------------	---------------------------

Description:
Sediment sample location MBO-Sed1, located in Blowout Creek, adjacent to Area 2 and upstream of Area 3.

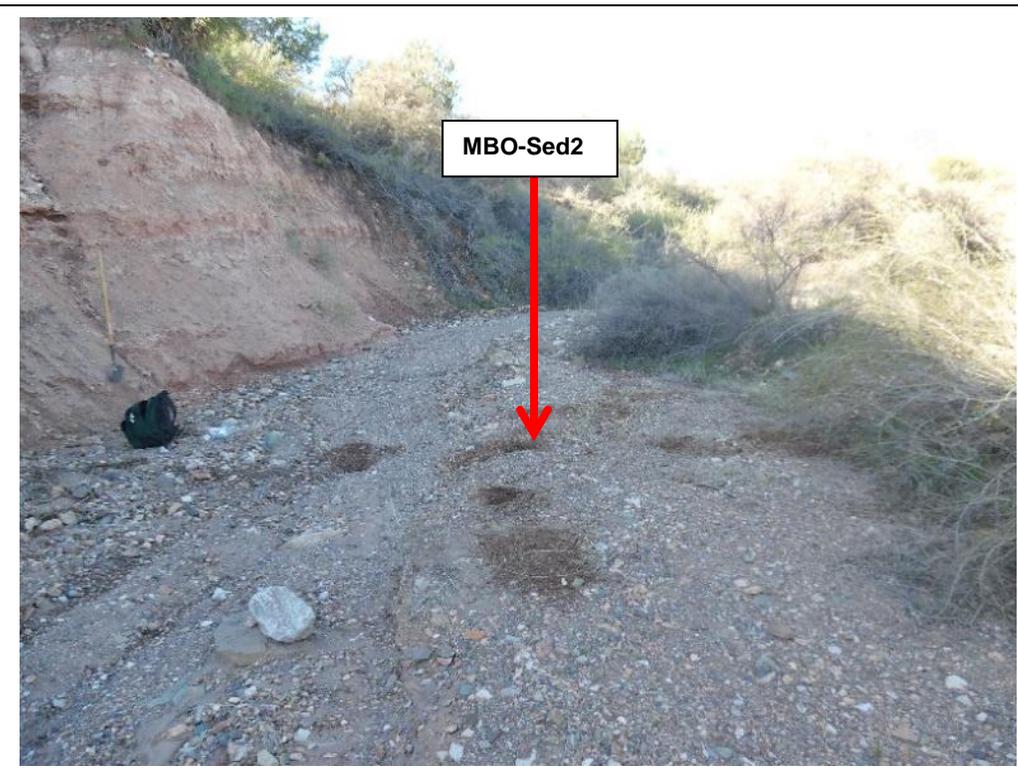
Photo No. 12	Date: 3/10/2015
-------------------------------	---------------------------

Description:
Sediment sample location MBO-Sed2, located in Blowout Creek, adjacent to Areas 2 and 3.

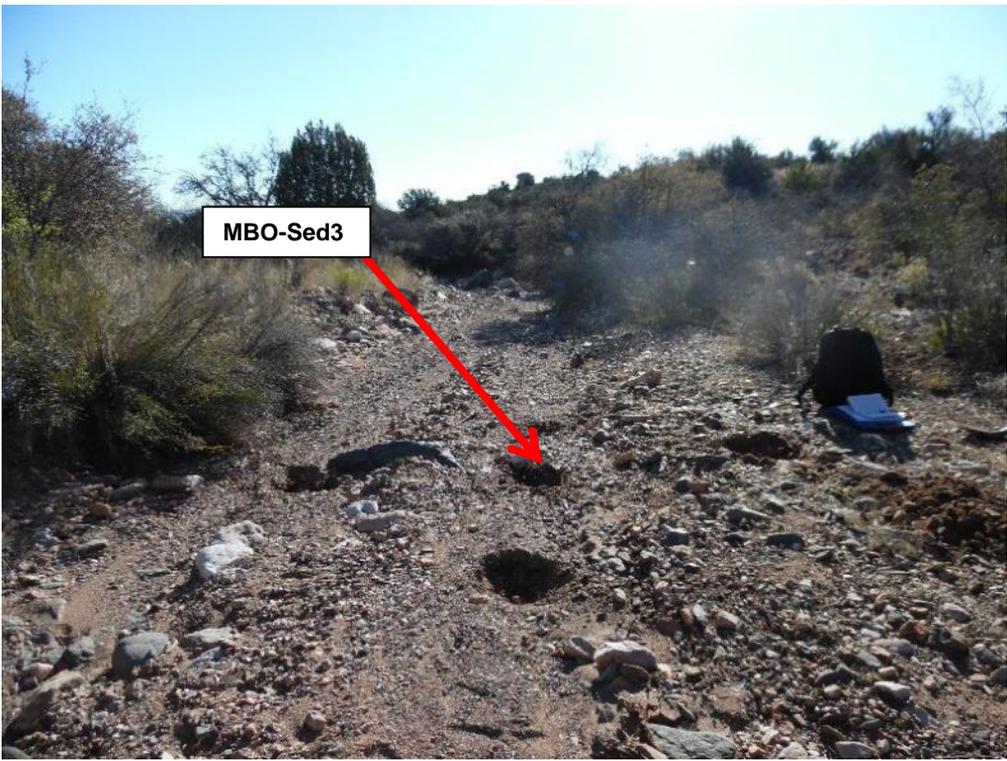
Photo No. 13	Date: 3/10/2015
-------------------------------	---------------------------

Description:
Sediment sample location MBO-Sed3, located in Blowout Creek, downstream of Area 3.

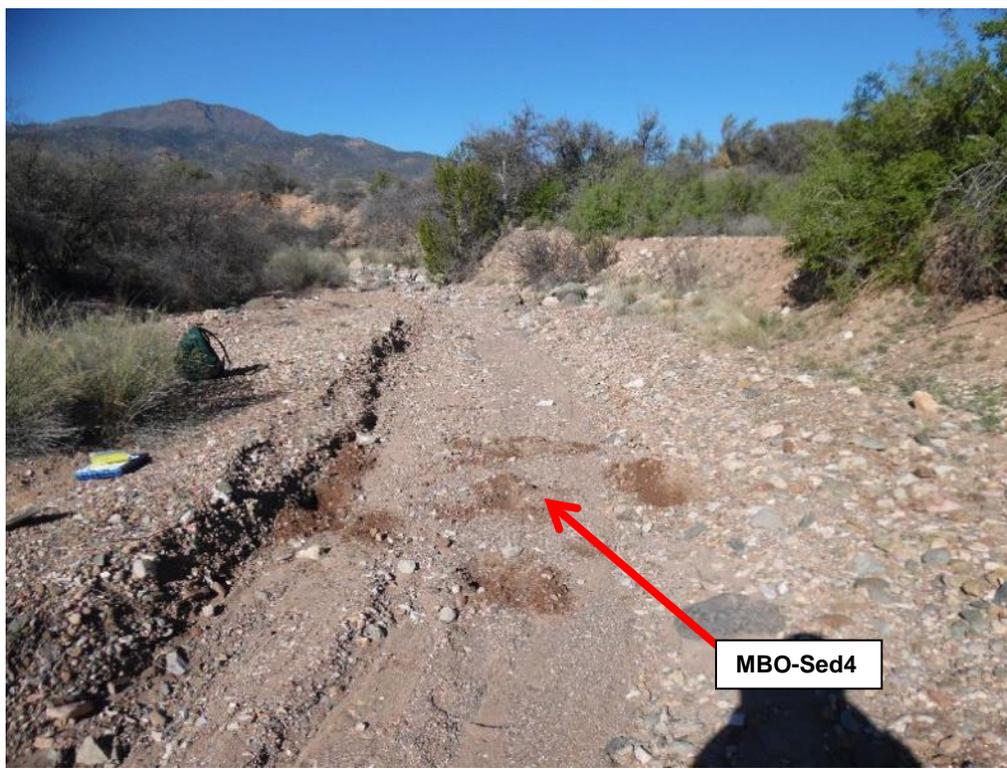
Photo No. 14	Date: 3/10/2015
-------------------------------	---------------------------

Description:
Sediment sample location MBO-Sed4, located in Blowout Creek, downstream of sediment sample location MBO-Sed3.

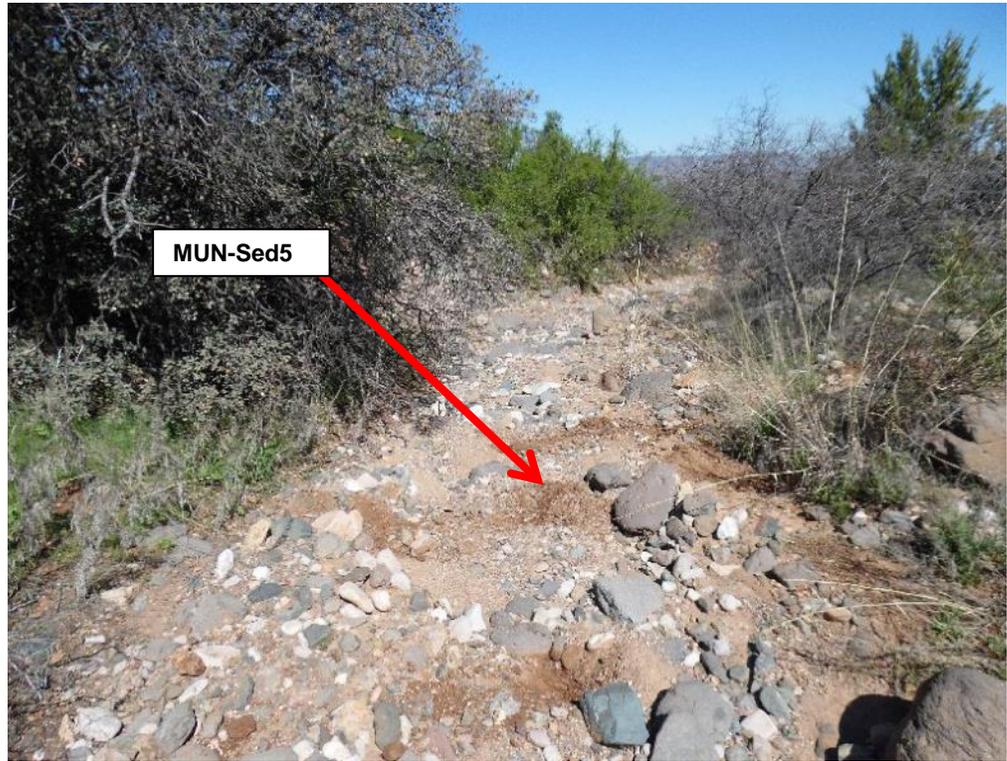
Photo No. 15	Date: 3/10/2015
-------------------------------	---------------------------

Description:
Sediment sample location MUN-Sed5, located in the unnamed wash, adjacent to Area 1.

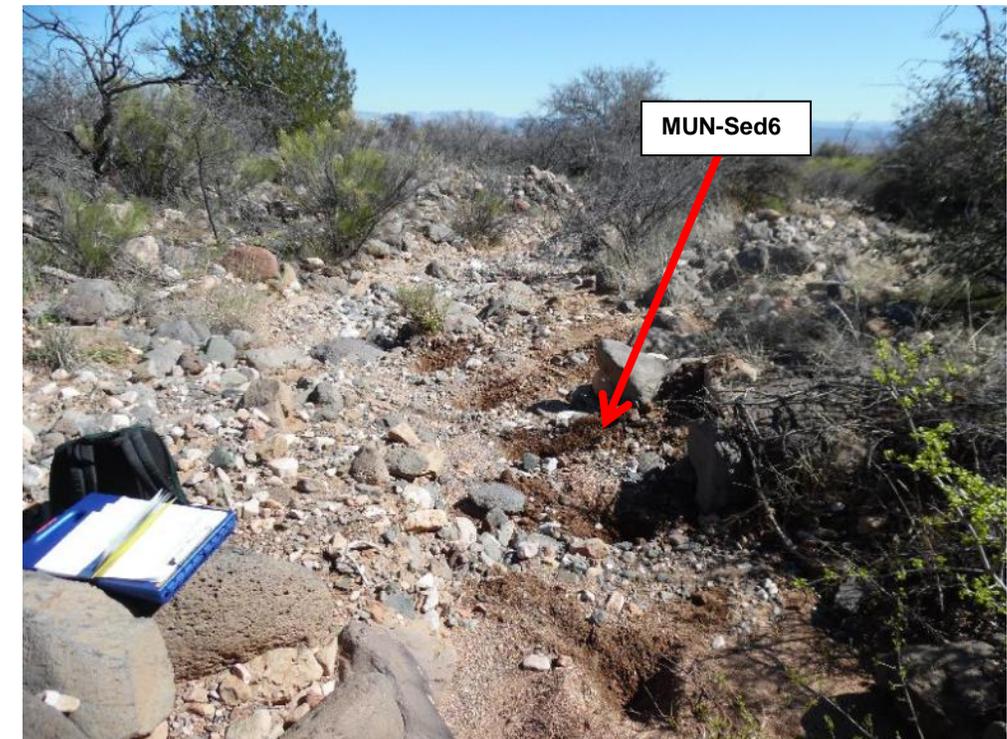
Photo No. 16	Date: 3/10/2015
-------------------------------	---------------------------

Description:
Sediment sample location MUN-Sed6, located in the unnamed wash, downstream of Area 1.

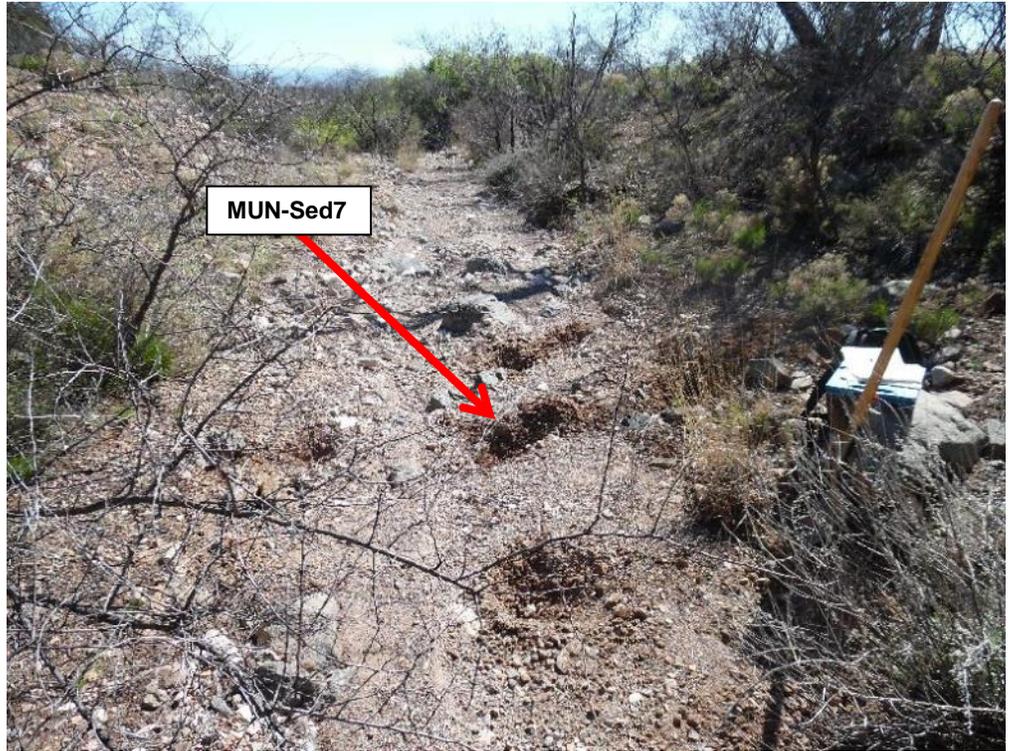
Photo No.
17

Sediment sample location MUN-Sed7, located in the smaller drainage, downstream of Area 1.

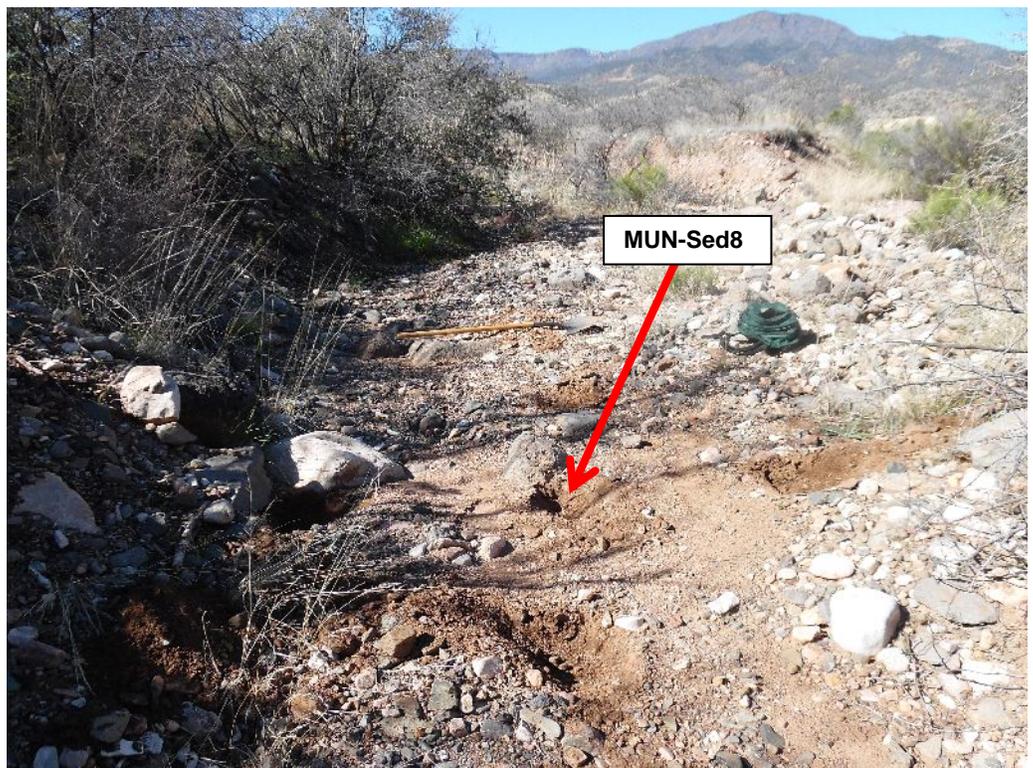
Photo No.
18

Sediment sample location MUN-Sed8, located in the unnamed wash, downstream of MUN-Sed7.

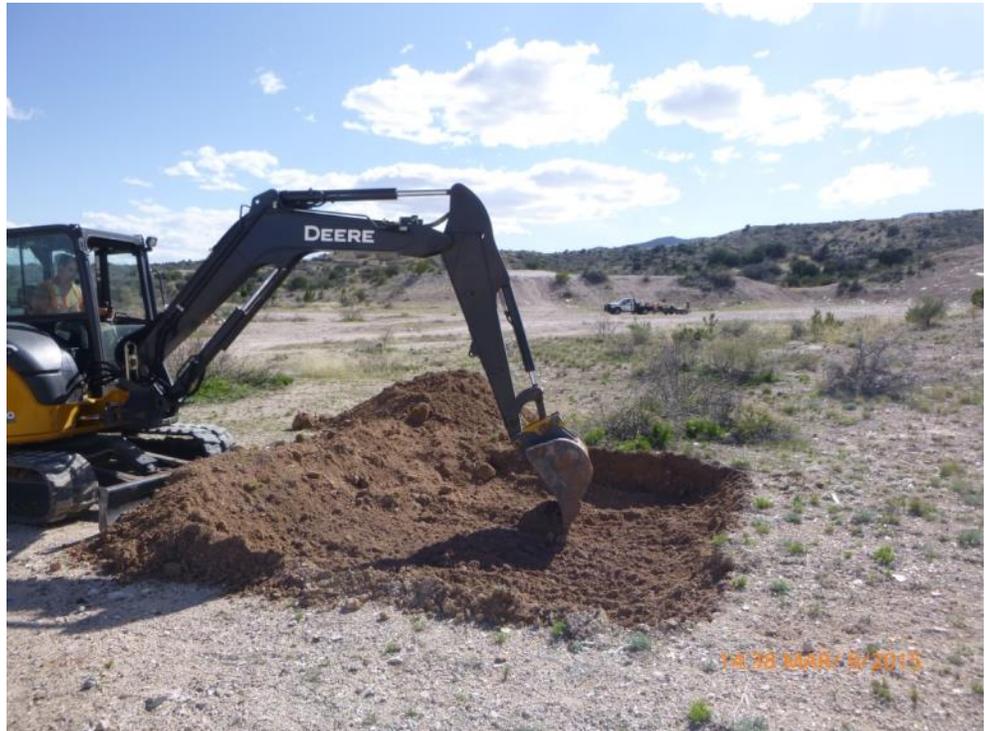
Photo No.
19

Excavation at MA1-ES1, Area 1.

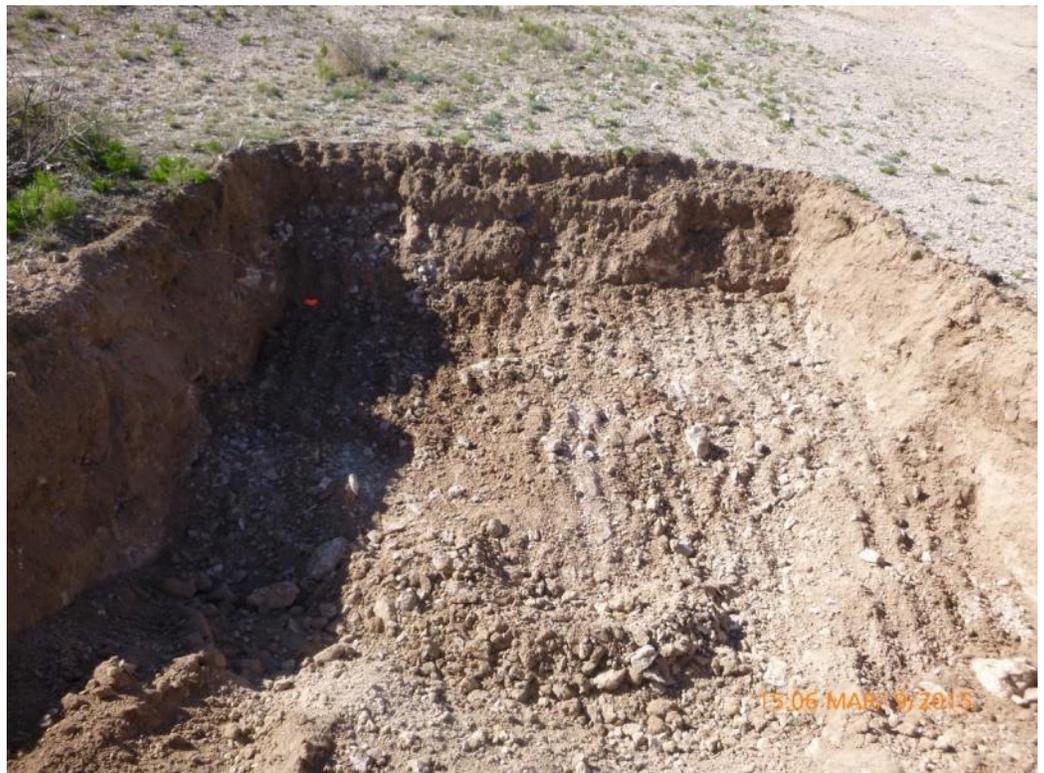
Photo No.
20

The west wall of MA1-ES1, Area 1. Refusal (bedrock) was reached at 4 feet bgs; only samples MA1-ES1-1 and MA1-ES1-3 collected. No trash/debris was observed in the excavation.

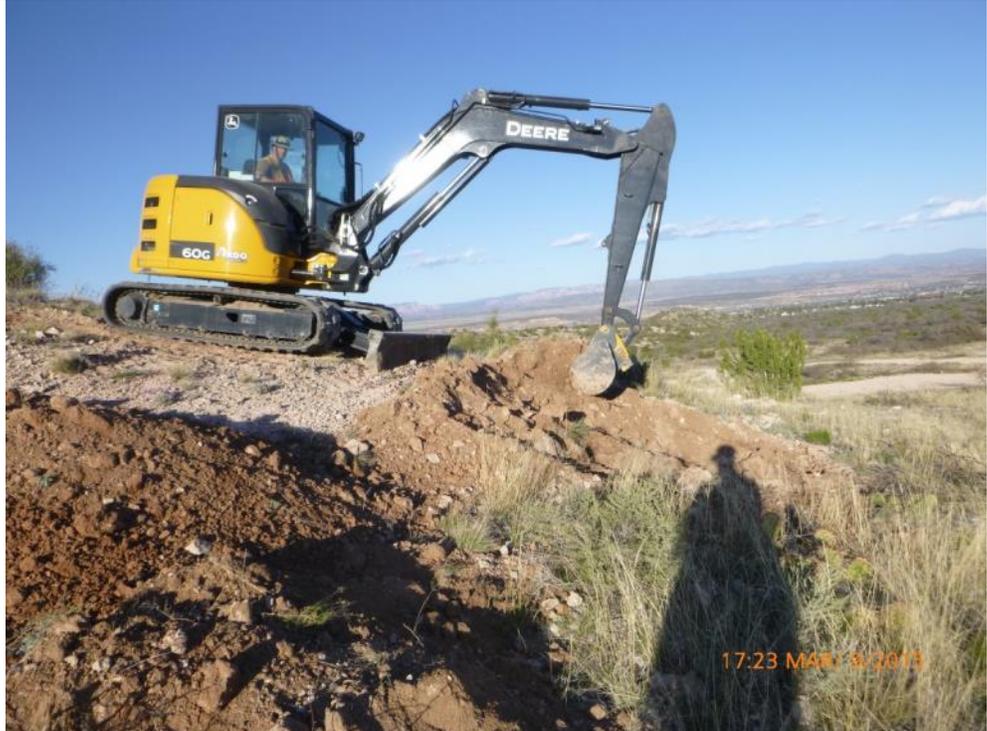
Photo No.
21

The south wall of MA1-ES2, Area 1. No surface trash observed other than shooting debris; no trash observed down to 1 foot bgs.

Excavator hit refusal at 1 foot bgs. No samples collected at 3 and 5 feet bgs.

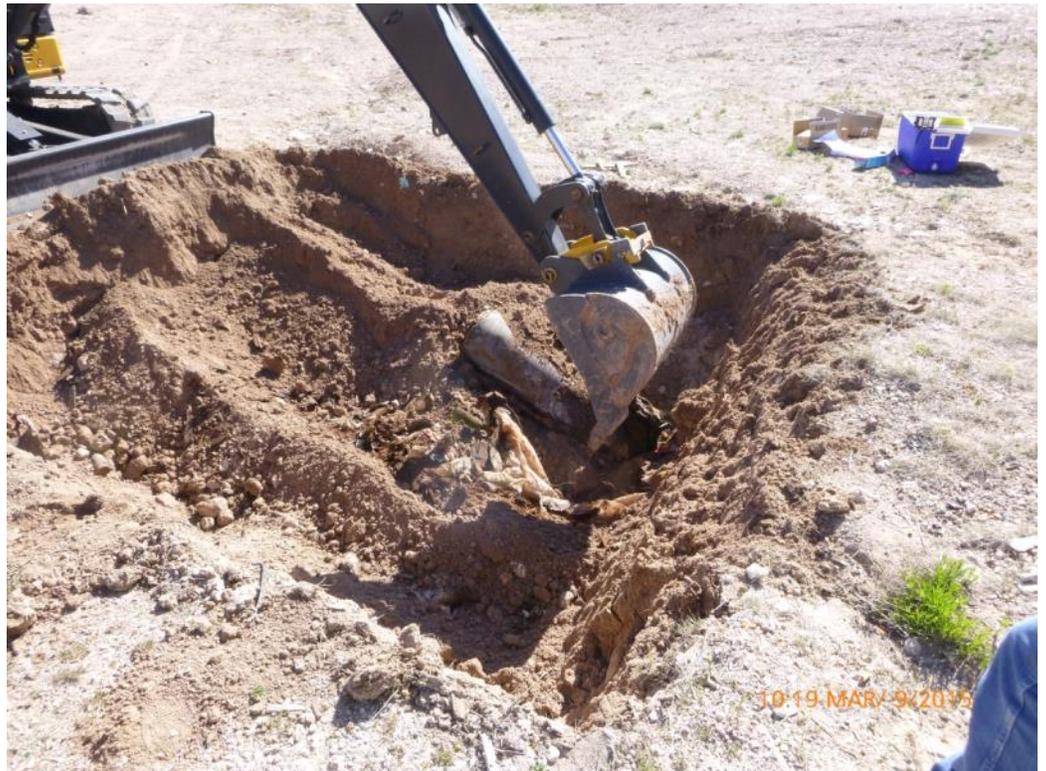
Photo No.
22

Excavation at MA1-ES3, Area 1. Different bottles and other trash, as well as a tank, are observed in the pothole.

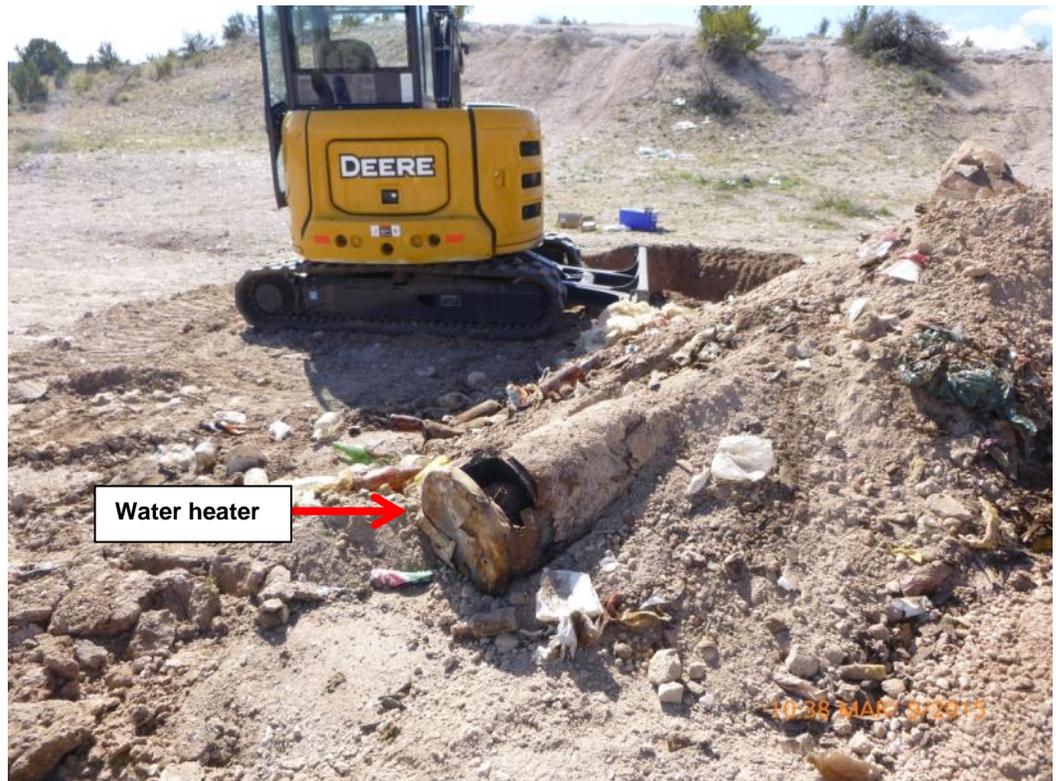
Photo No.
24

Water heater excavated from MA1-ES3. Water heater was removed from the Site by the USFS and disposed at the local landfill.

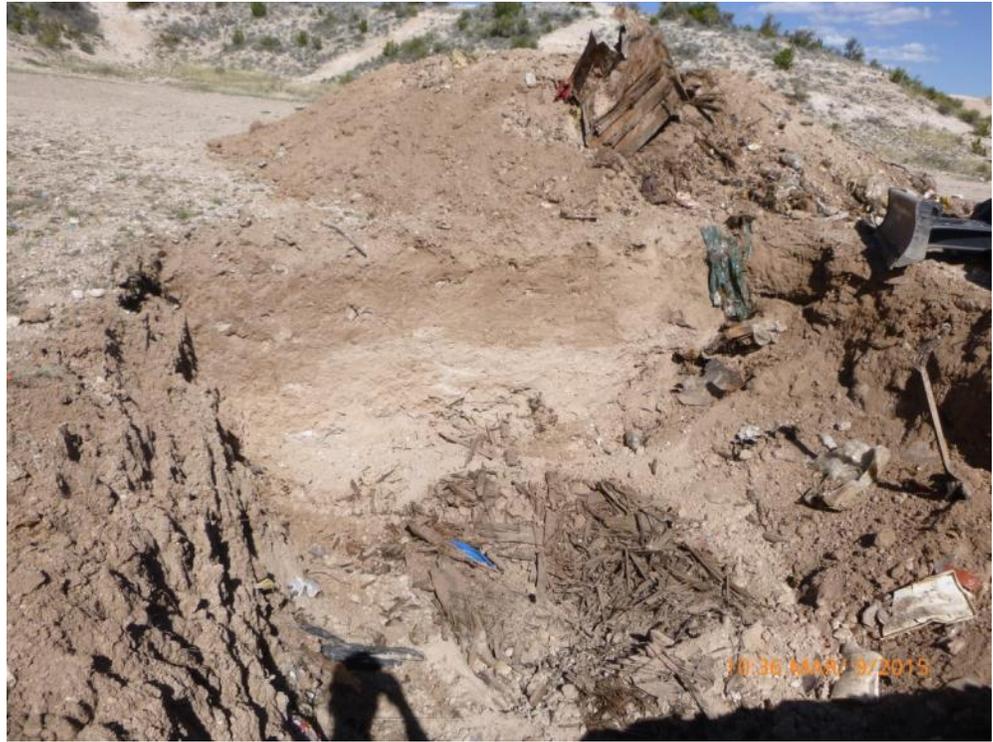
Photo No.
25

The west wall of MA1-ES3, Area 1. Wood enclosure with metal protruding from center visible in the upper right portion of the photograph.

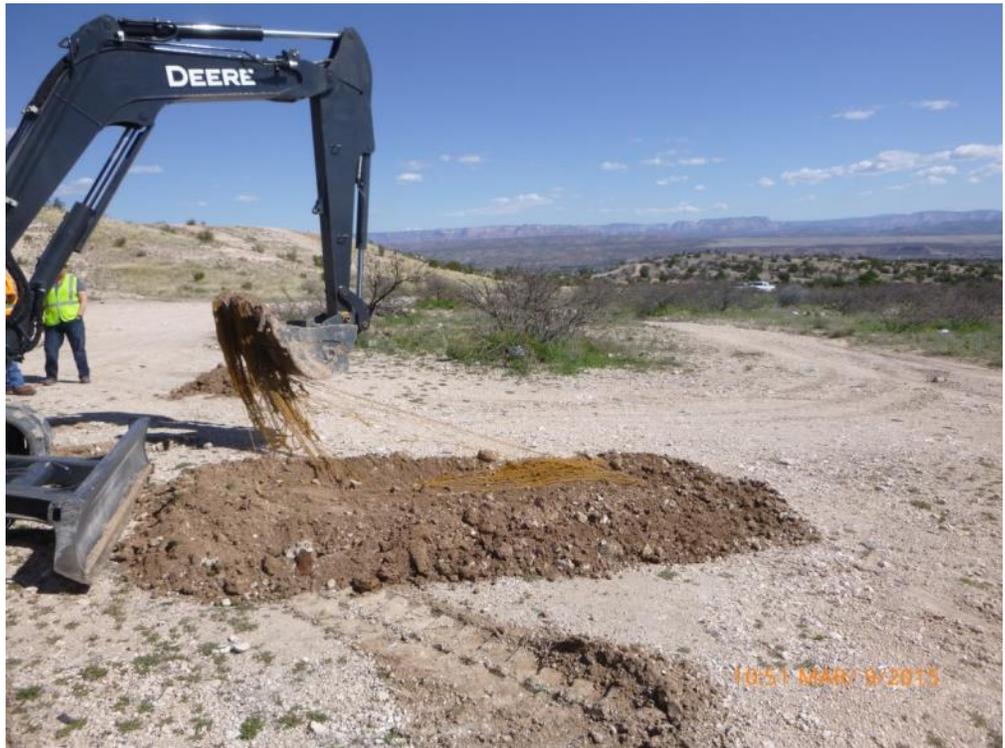
Photo No.
26

A large pile of trash/debris excavated at sample location MA1-ES4, Area 1. Trash/debris included bottles, plastic bags, tires and cardboard.

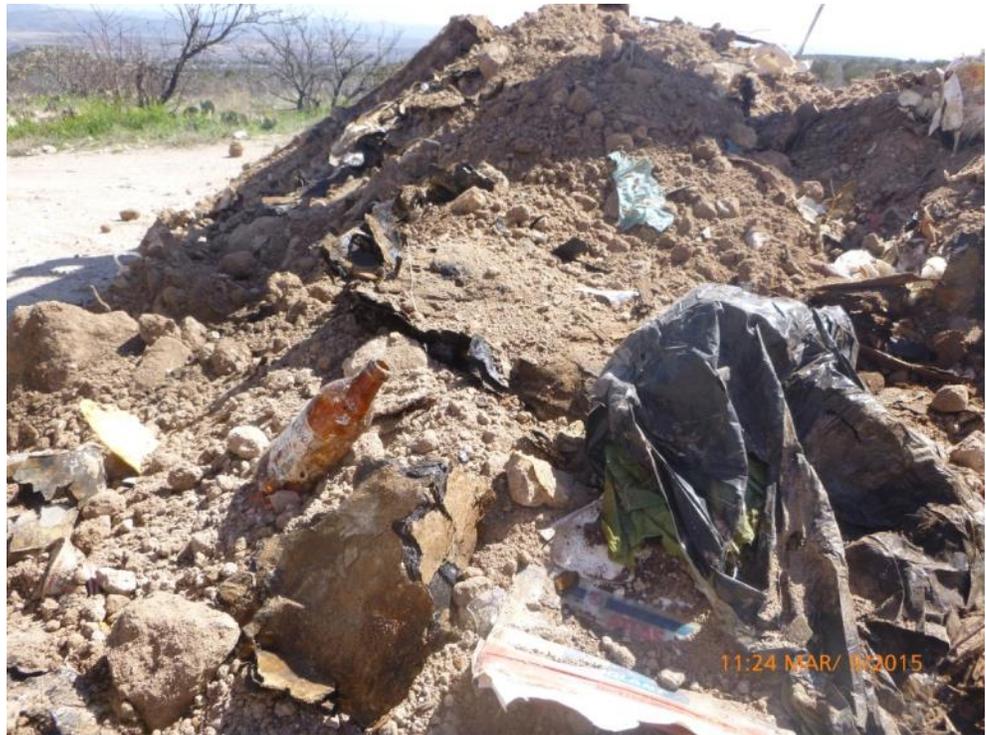
Photo No.
27

Debris excavated from MA1-ES4, including glass bottles and plastic bags.

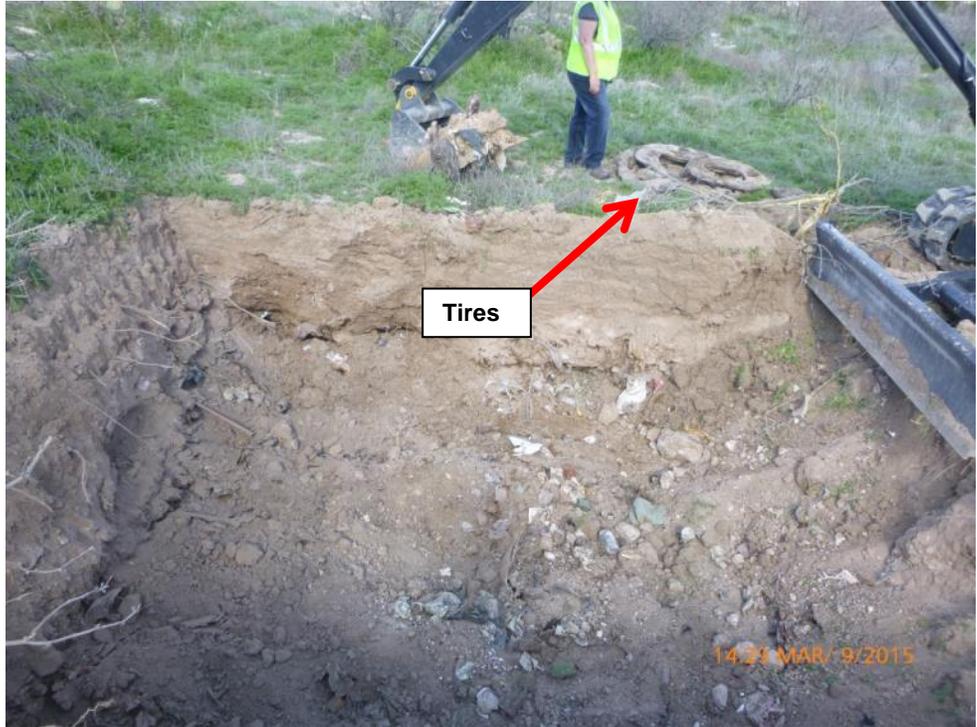
Photo No.
29

The north wall of MA1-ES5, Area 1. Several tires were recovered.

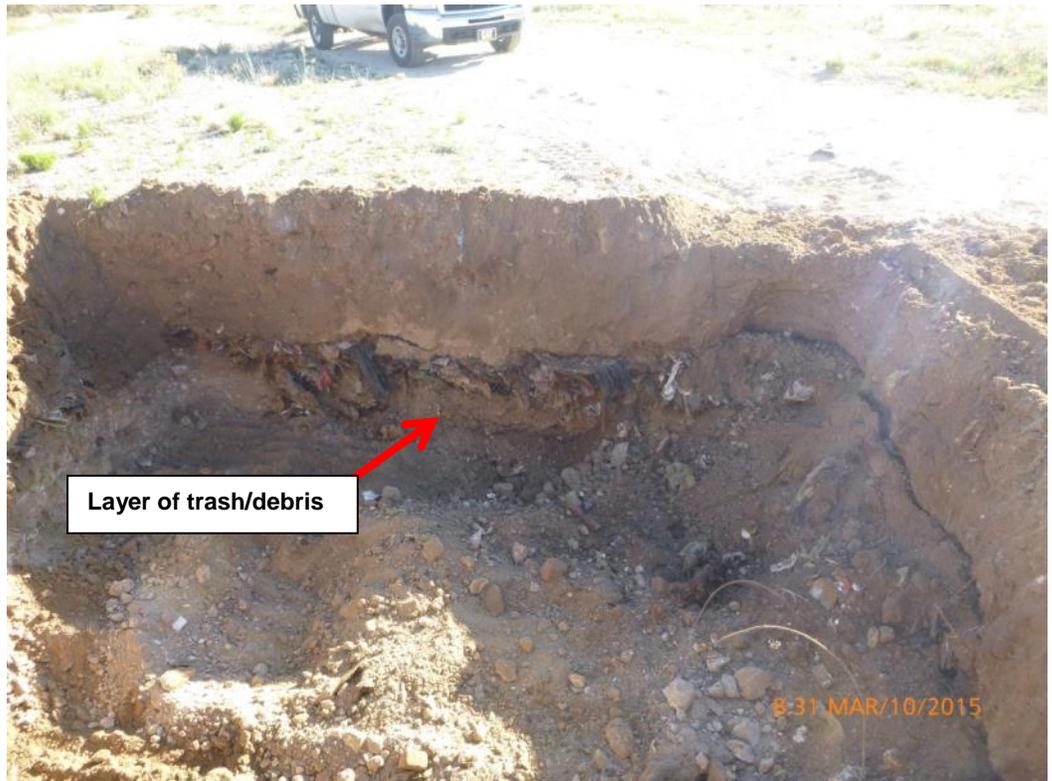
Photo No.
30

The north wall of MA1-ES6, Area 1. Layer of trash/debris is visible at a depth of 3.5 to 4 feet in the north wall of the test pothole and may extend further beyond the pothole. Trash/debris included assorted glass and plastic bottles, tires, and general household trash.

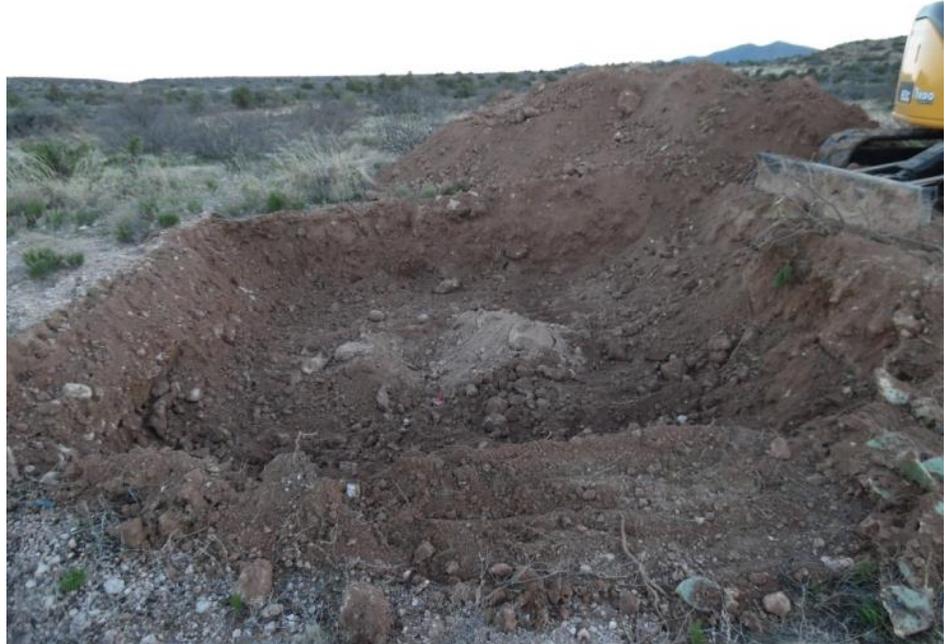
Photo No. 31	Date: 3/9/2015
-------------------------------	--------------------------

Description:
South wall of MA1-ES7, Area 1. Only a single metal can be observed in this excavation.

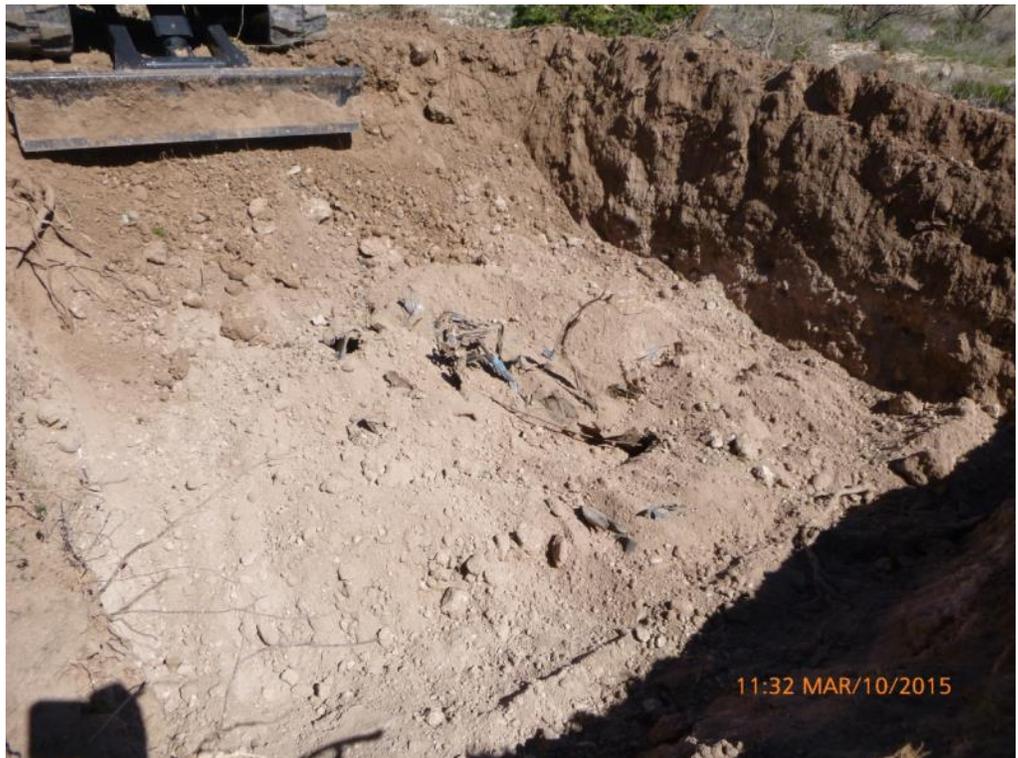
Photo No. 32	Date: 3/10/2015
-------------------------------	---------------------------

Description:
Looking into the excavated sample location MA1-ES8, Area 1. Several pieces of scrap metal are visible in the center of the test pothole at 5 feet bgs.
