PHOTOGRAPH LOG
Mingus Area

Project Name: USFS Preliminary Assessment/Site Inspection (PA/SI)	Site Location: Prescott National Forest, Yavapai County, Arizona	Project No. 12767.204.001
---	--	-------------------------------------

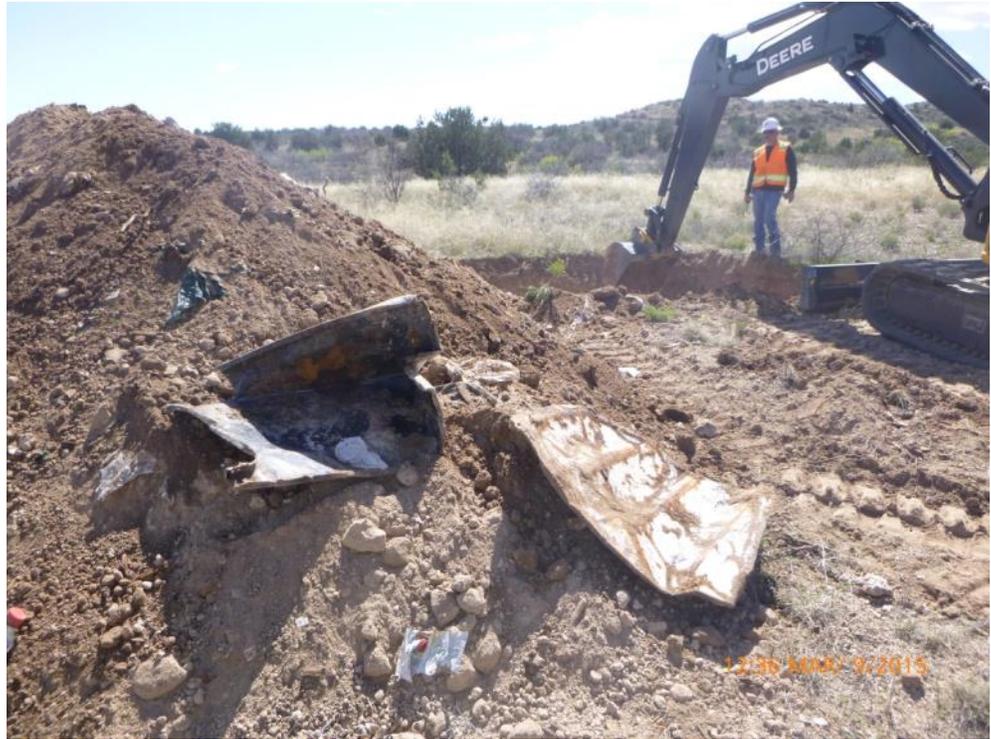
Photo No.
33

Excavated pieces of scrap metal from sample location MA1-ES9, Area 1.

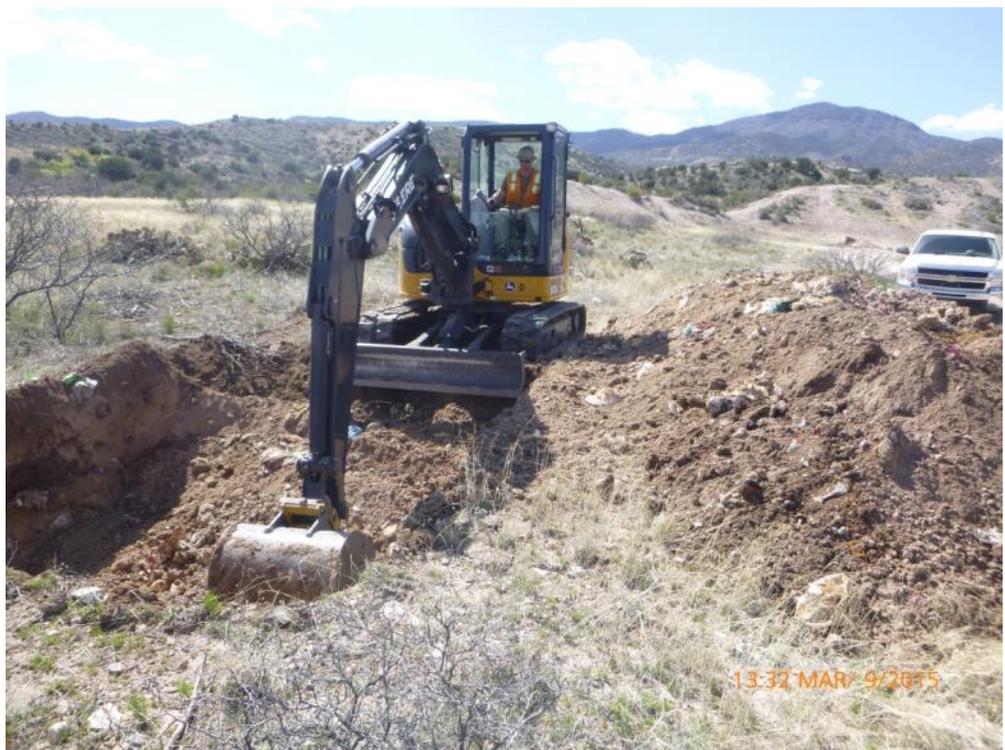
Photo No.
34

Looking south at excavated sample location MA1-ES10, Area 1. Moderate trash/debris is visible in the test pothole and at the excavated pile to the right.

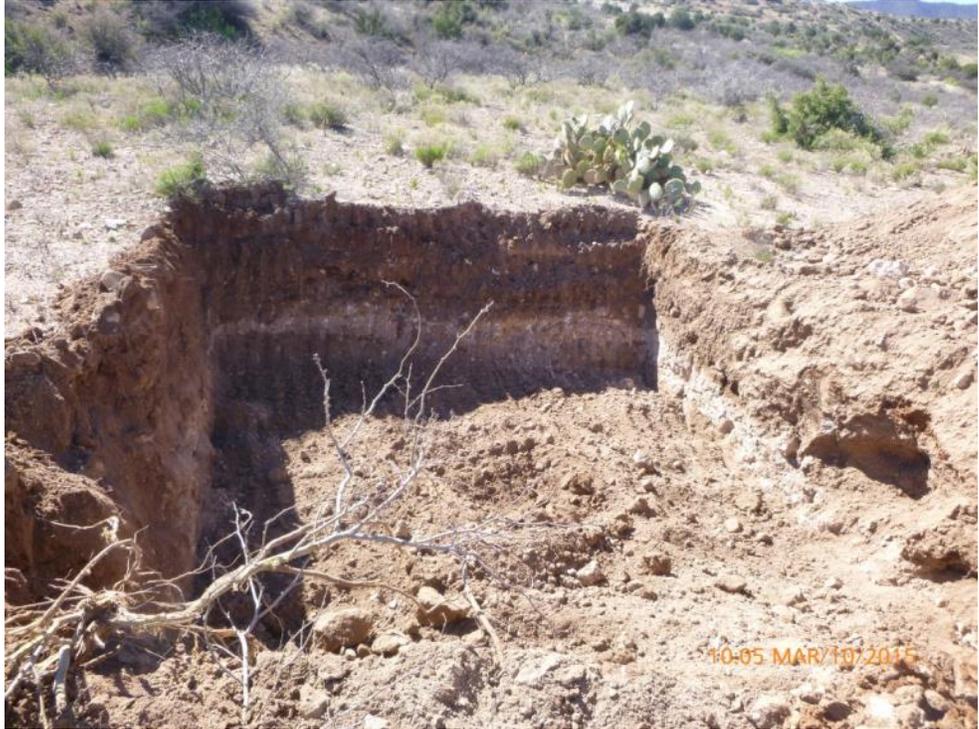
Photo No.
35 **Date:**
3/10/2015

Description:
Looking east at excavated sample location MA1-ES11, Area 1. Minimal to no trash/debris excavated at this location.

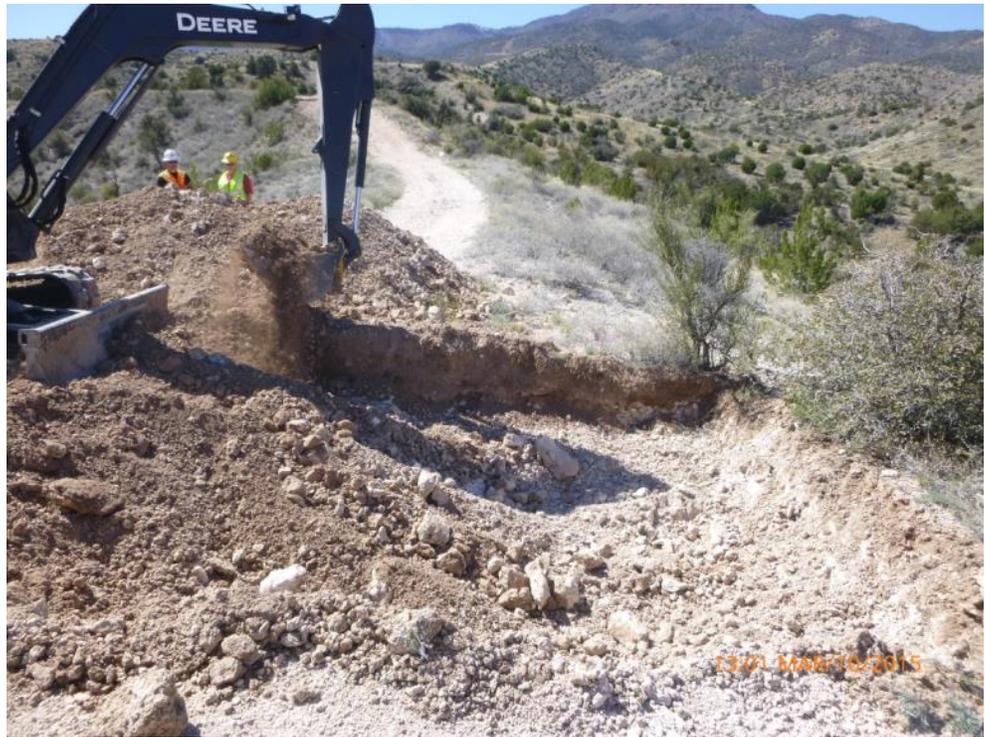
Photo No.
57

Looking south at excavated sample location MA2-ES1, Area 2. Minimal to no trash/debris present.

Crew hit refusal at 3 feet bgs due to the amount of rocks in the area.

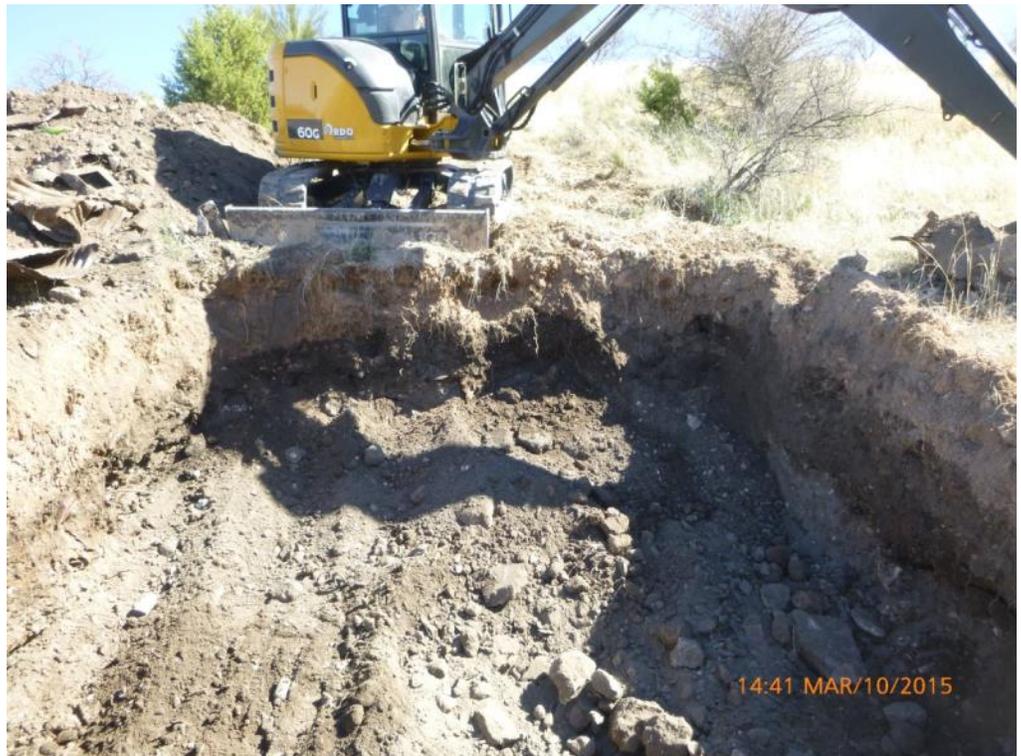
Photo No.
58

Looking at the east wall of excavated sample location MA2-ES2, Area 2. Moderate to high amount of trash/debris excavated, including sheet metal and other various scrap metal, wood, various glass bottles and a hot water tank.

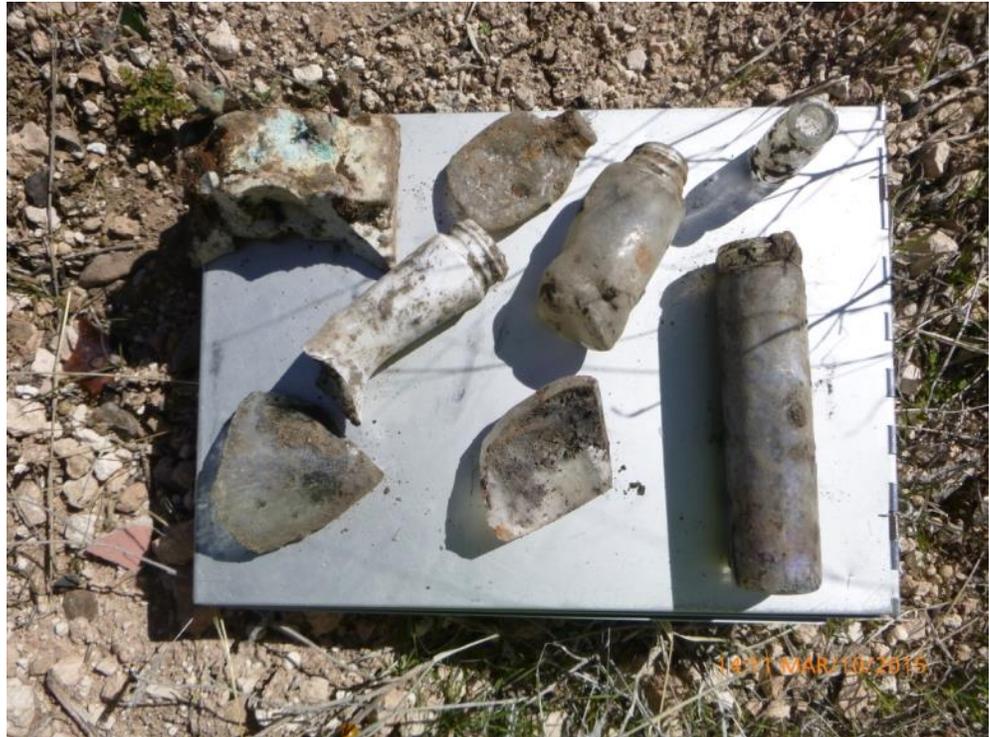
Photo No.
59

Various glass jars recovered from MA2-ES2, Area 2. These items were removed from the Site by the USFS OSC and taken to a USFS archaeologist for dating.

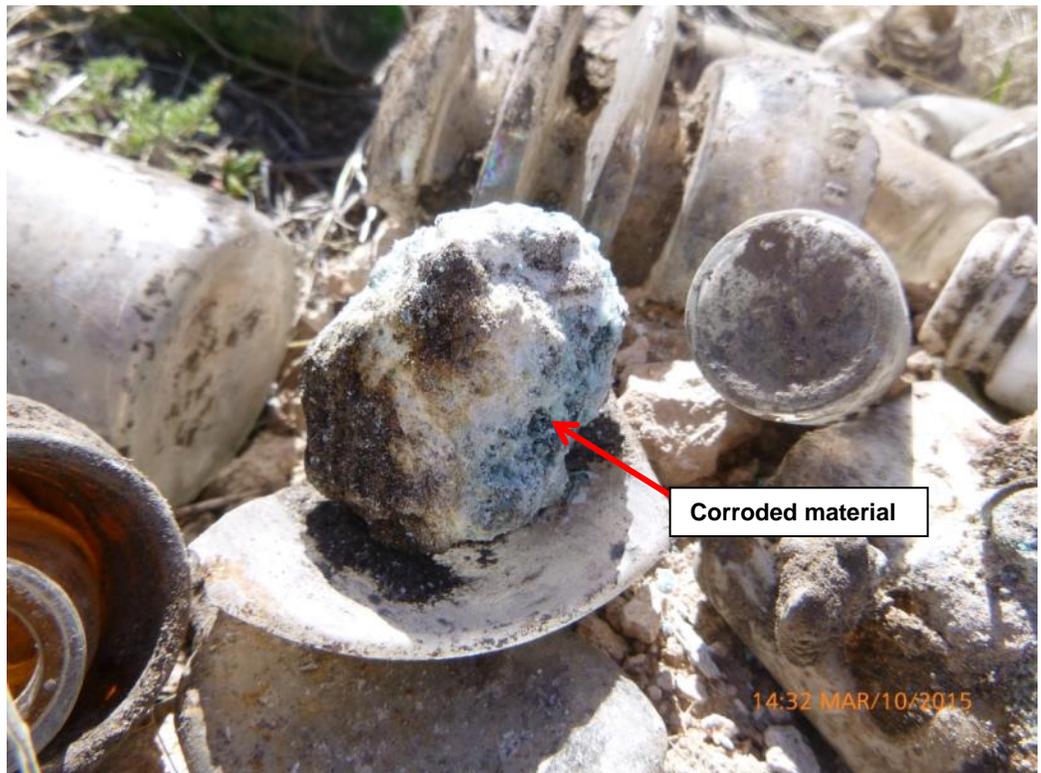
Photo No.
60

Various glass jars recovered from MA2-ES2, Area 2.

The item in the center appears to be a corroded piece of copper.

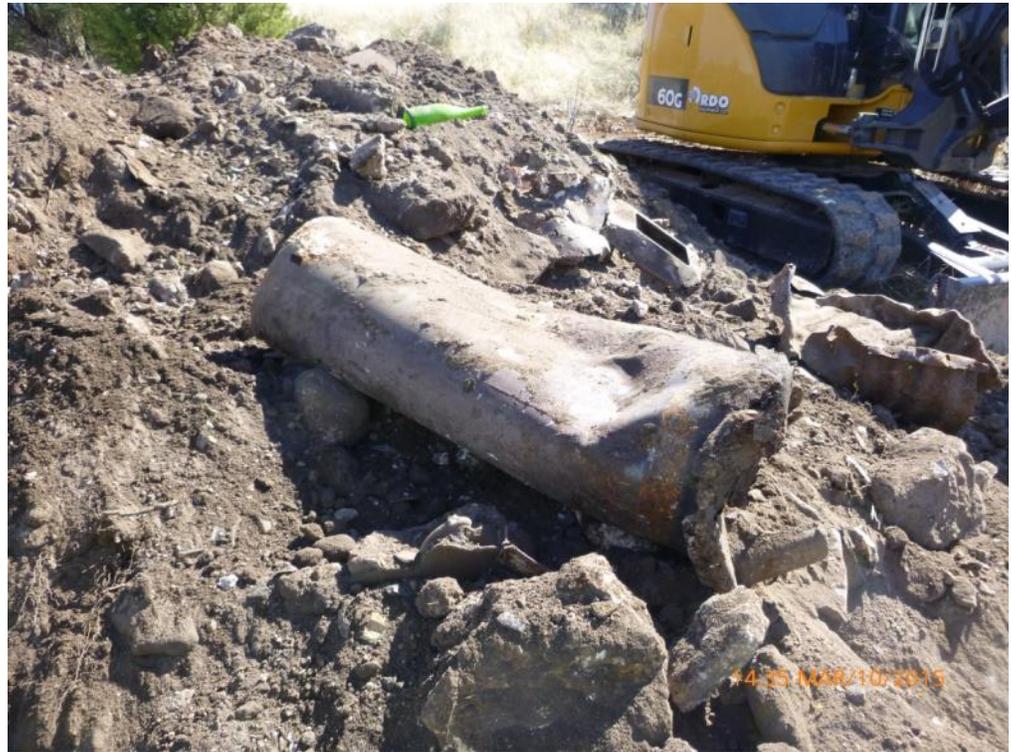
Photo No.
61

Hot water tank excavated at location MA2-ES2, Area 2.

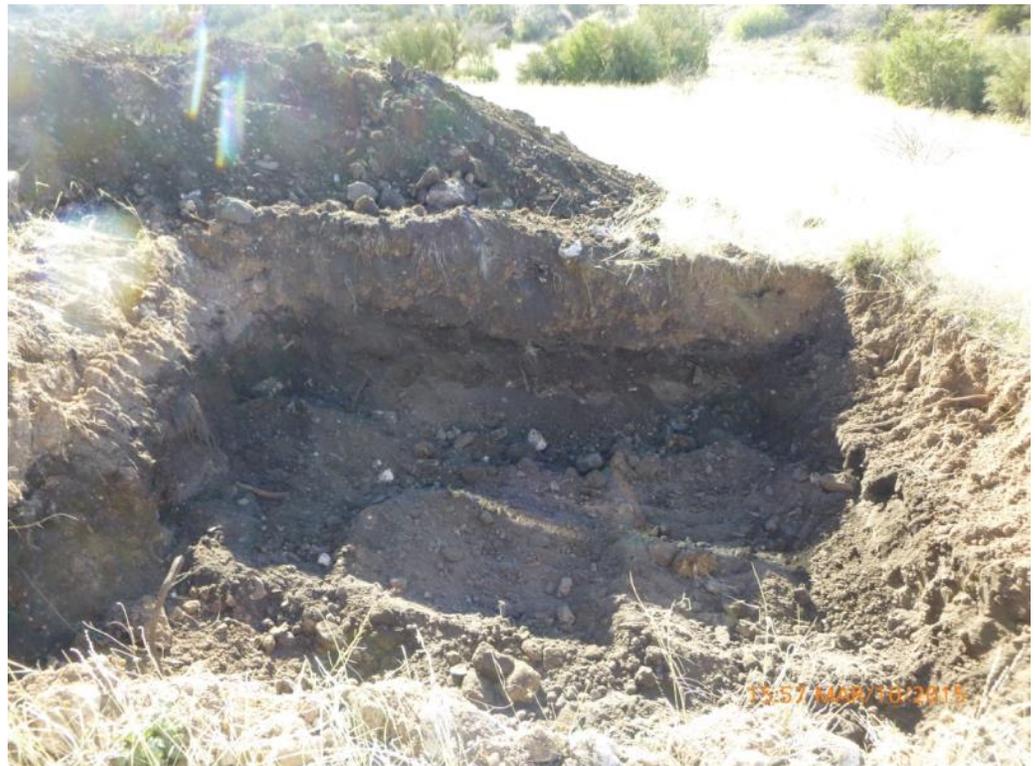
Photo No.
62

Looking at the south wall of excavated sample location MA2-ES3, Area 2. Low to moderate amount of trash/debris excavated, including sheet metal, pipes and various small jars.

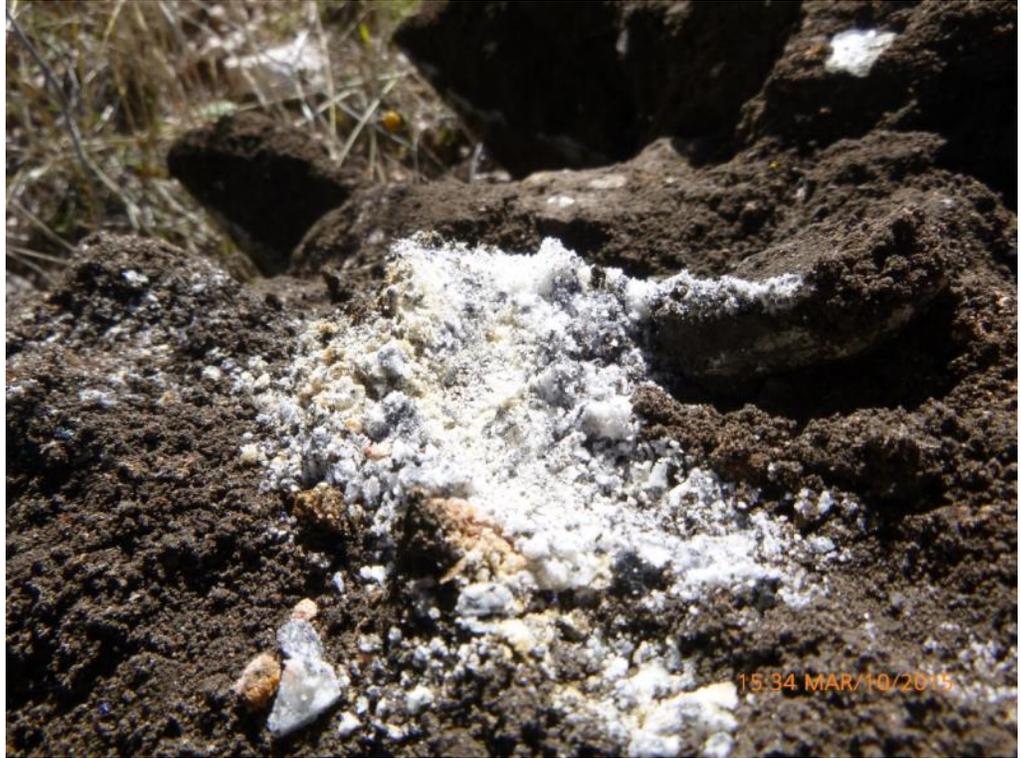
Photo No.
63

White powdery material recovered from MA2-ES3, Area 2.

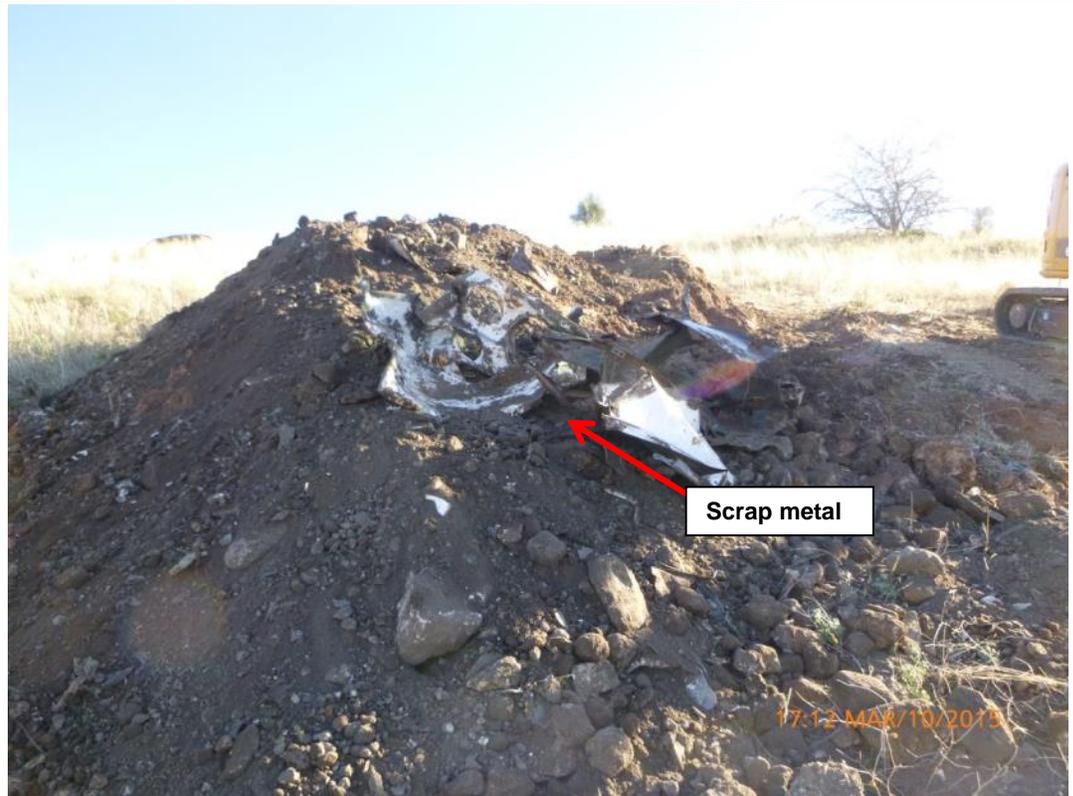
Photo No.
64

Scrap metal recovered from excavated sample location MA2-ES4, Area 2.

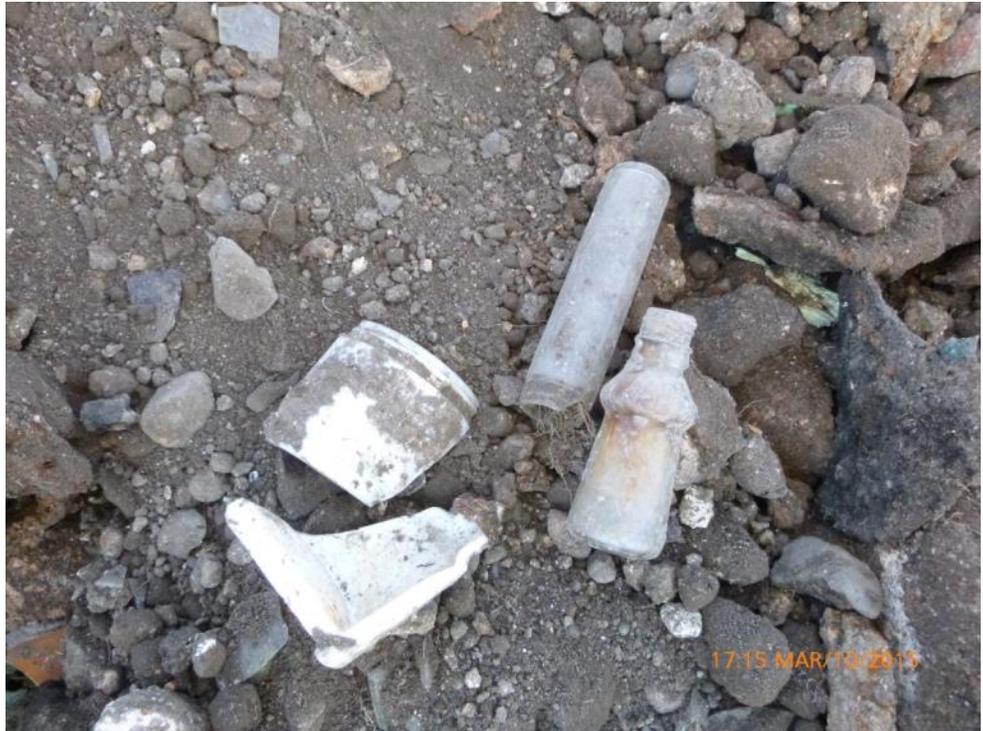
Photo No.
65

Various small glass bottles recovered from excavated sample location MA2-ES4, Area 2.

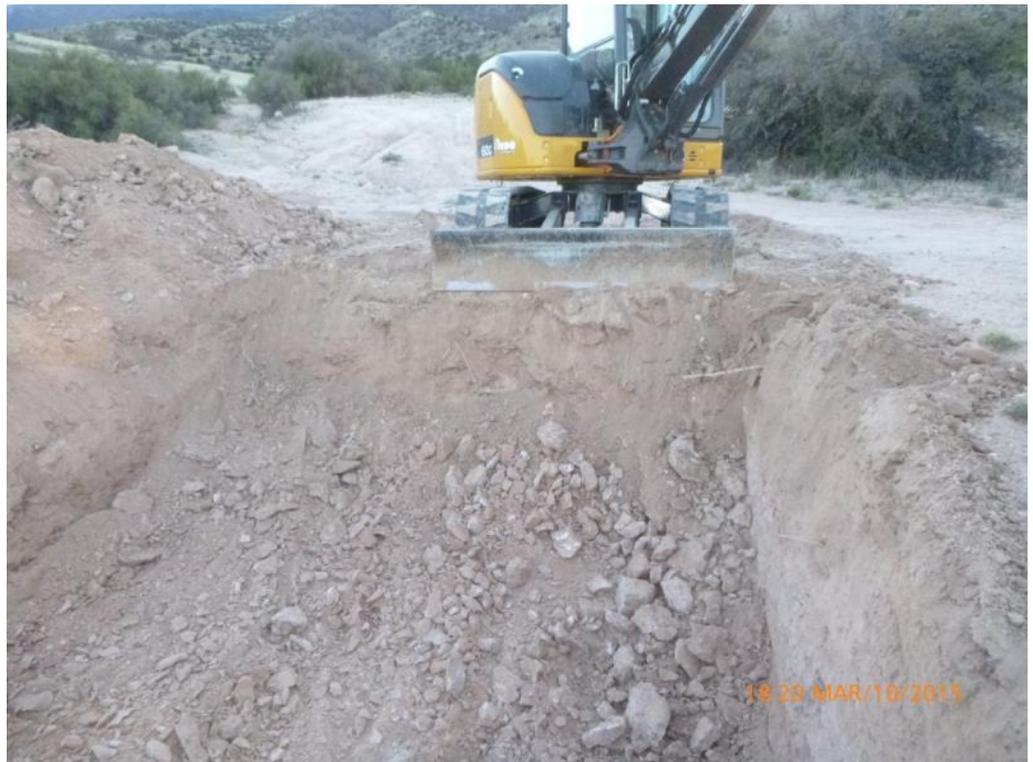
Photo No.
66

Looking south at excavated sample location MA2-ES5, Area 2. No trash/debris present.

Crew hit refusal at 4 feet bgs due to the amount of rocks in the area.

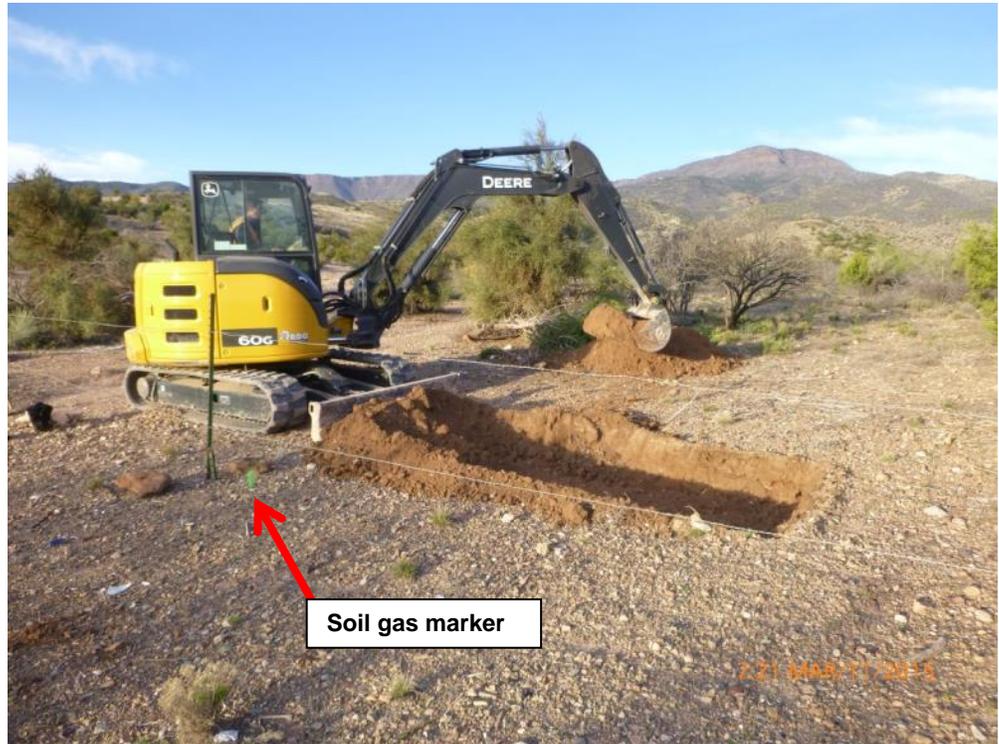
Photo No.
67

Excavator working on sample location MA2-ES6, Area 2. No trash/debris present.

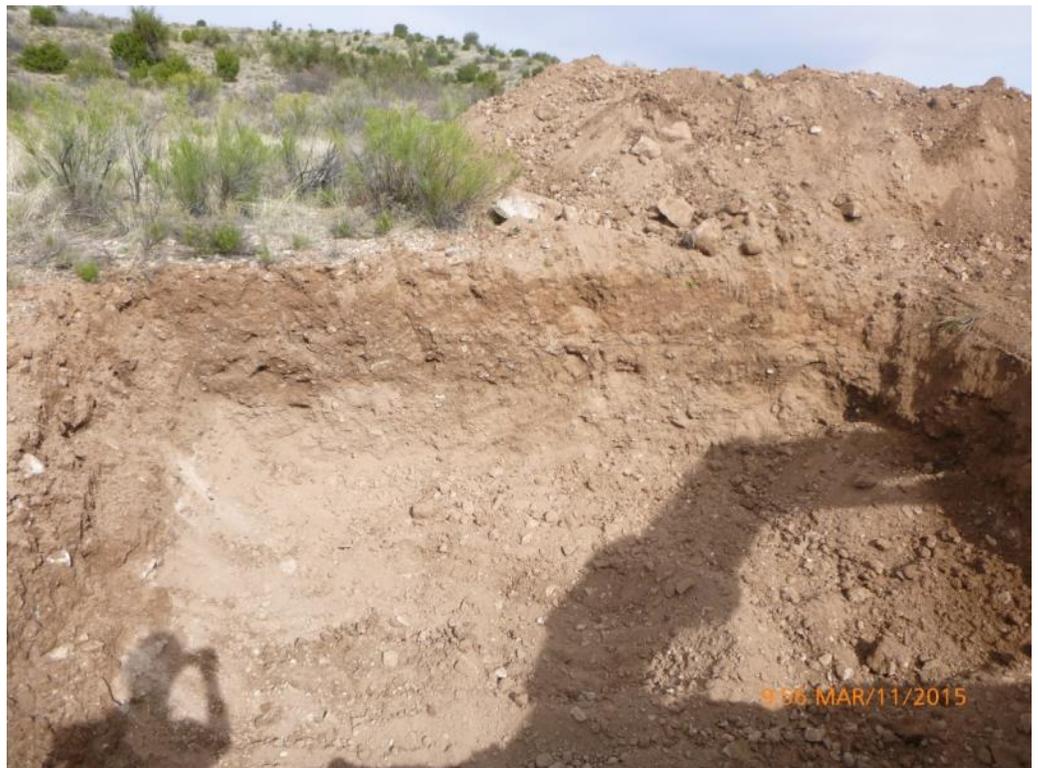
Photo No.
68

Looking west at excavated sample location MA3-ES1, Area 3. No trash/debris present.

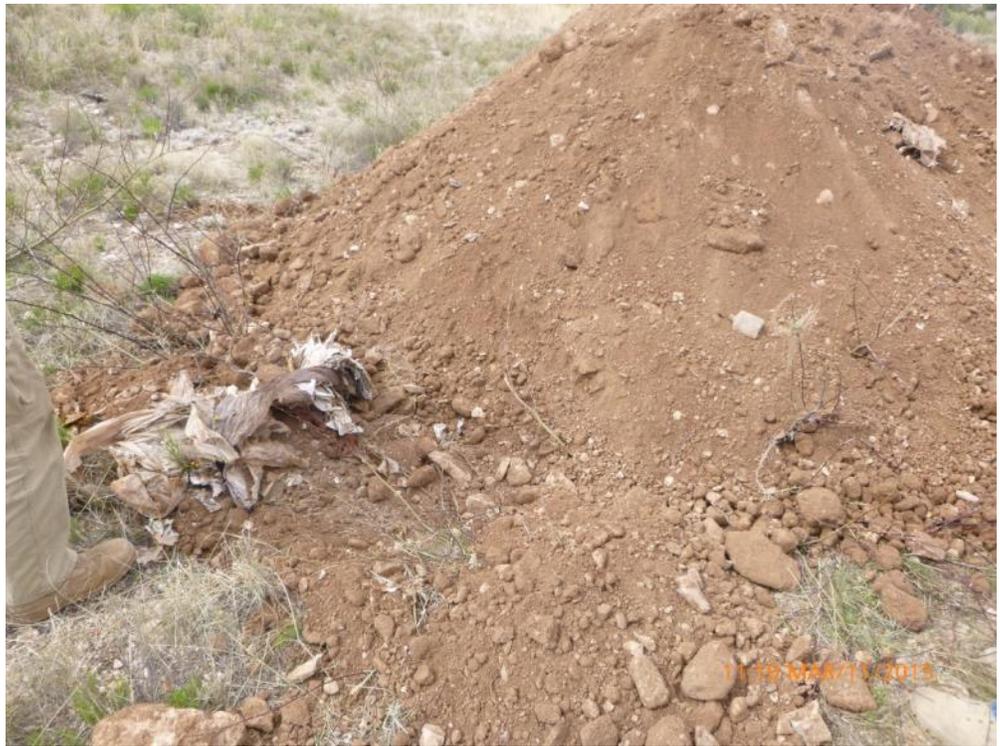
Plastic bags recovered at excavated sample location MA3-ES2, Area 3.

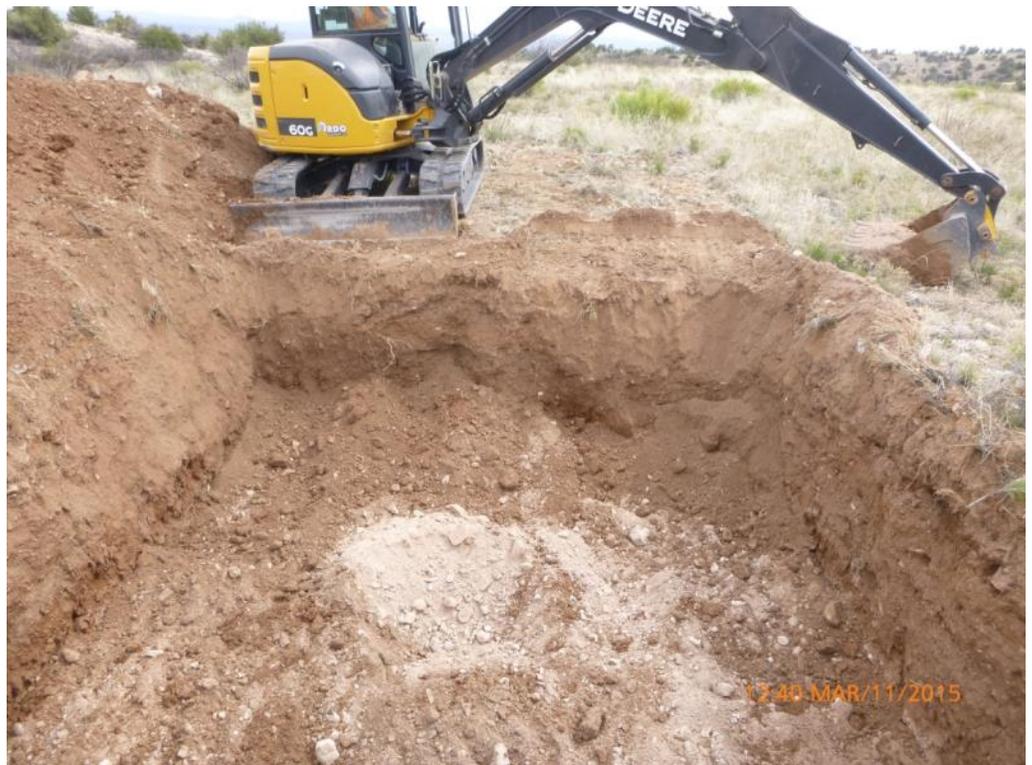
Photo No.
70

Looking east at excavated sample location MA3-ES3, Area 3. No trash/debris present.

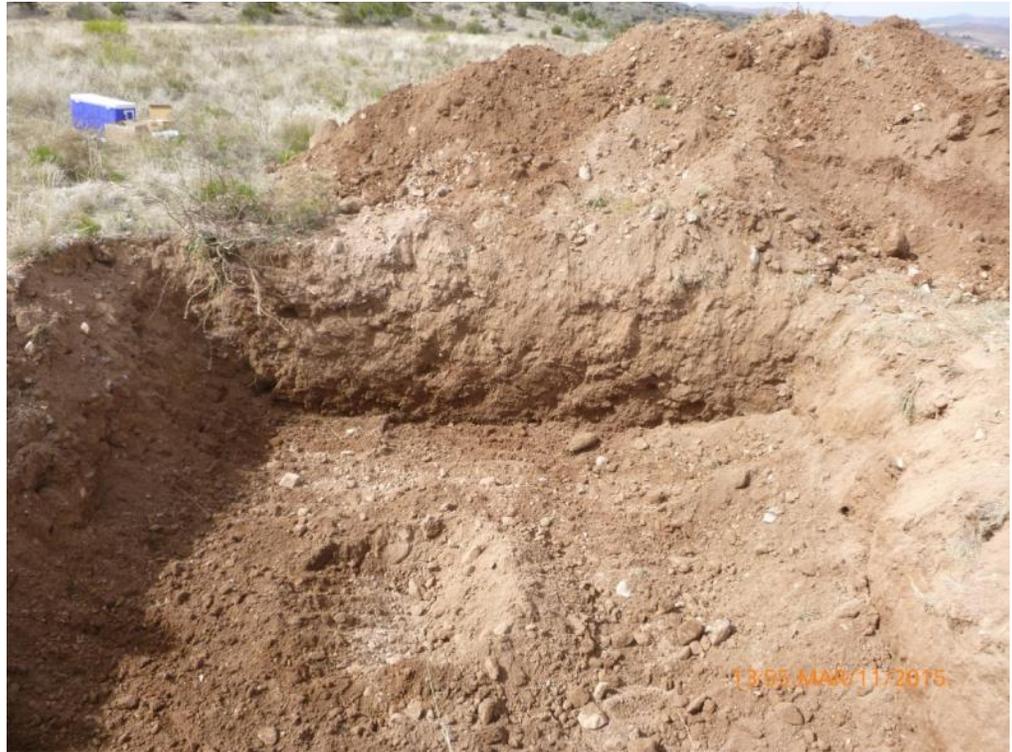
Looking north at excavated sample location MA3-ES4, Area 3. No trash/debris present.

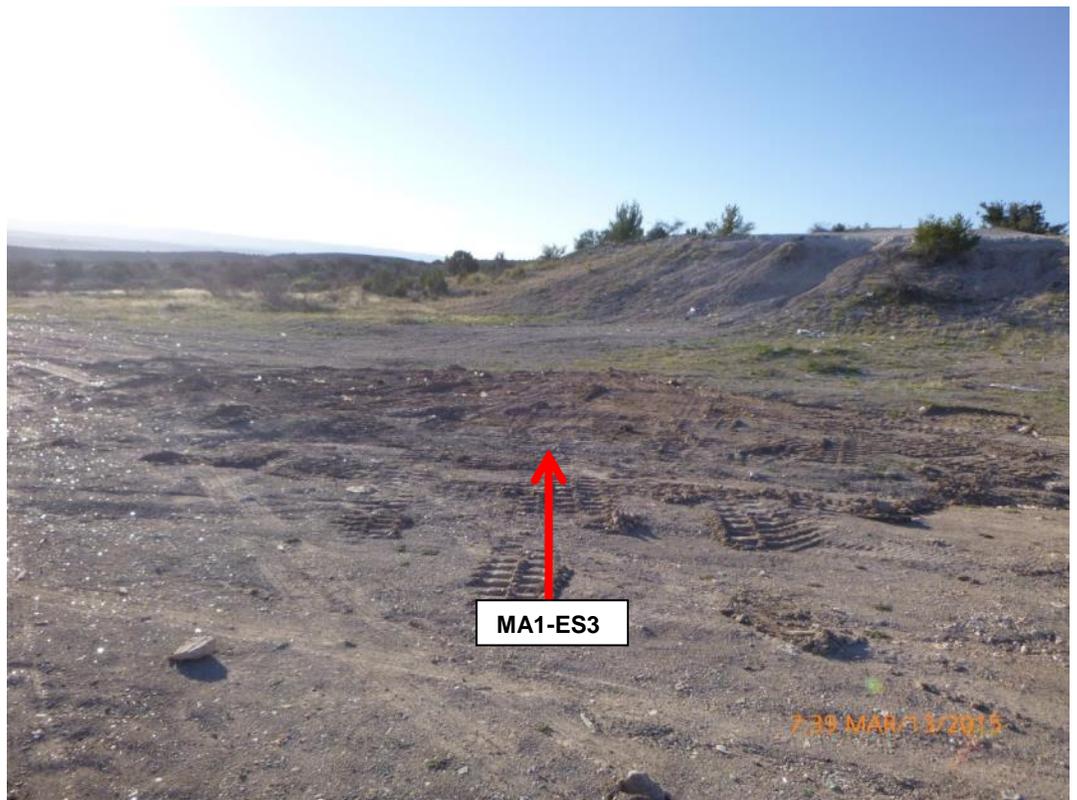
Area 1 overview, with MA1-ES3 pictured in the foreground post excavation and refill.
