LTBMU Annual Soil and Water BMP Monitoring Report for FY15

By Susan Norman, Forest Hydrologist

October 2016

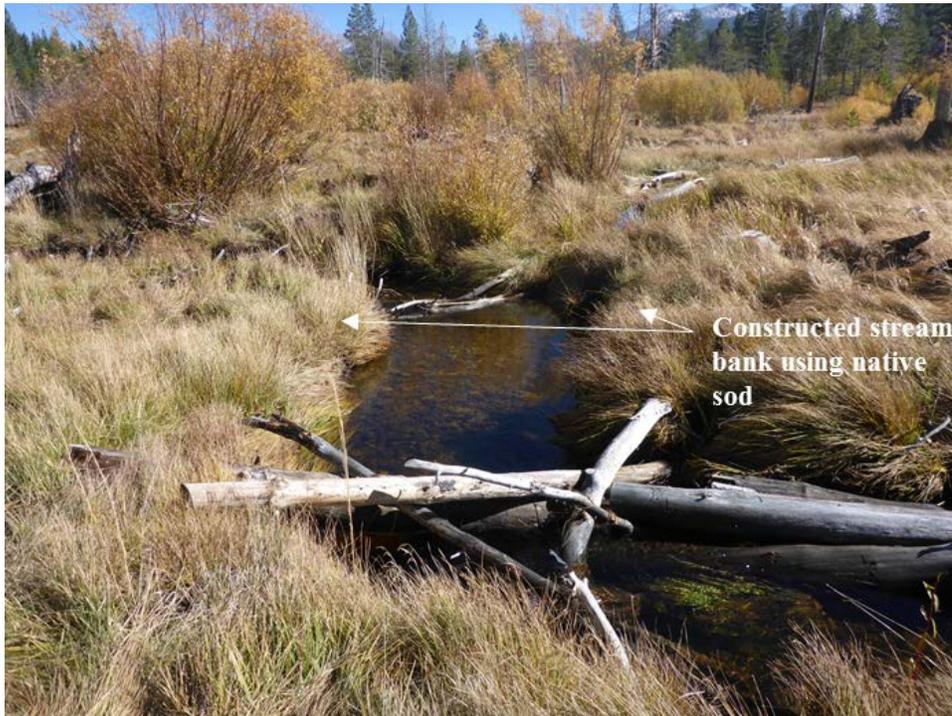
Despite these two effectiveness deficiencies the overall effectiveness of Angora Creek restoration efforts in restoring vegetation along the channel banks and meadow surface has been very successful as illustrated in the photographs below.

Photo 1. New constructed channel stream bank vegetative cover (Oct 2016).

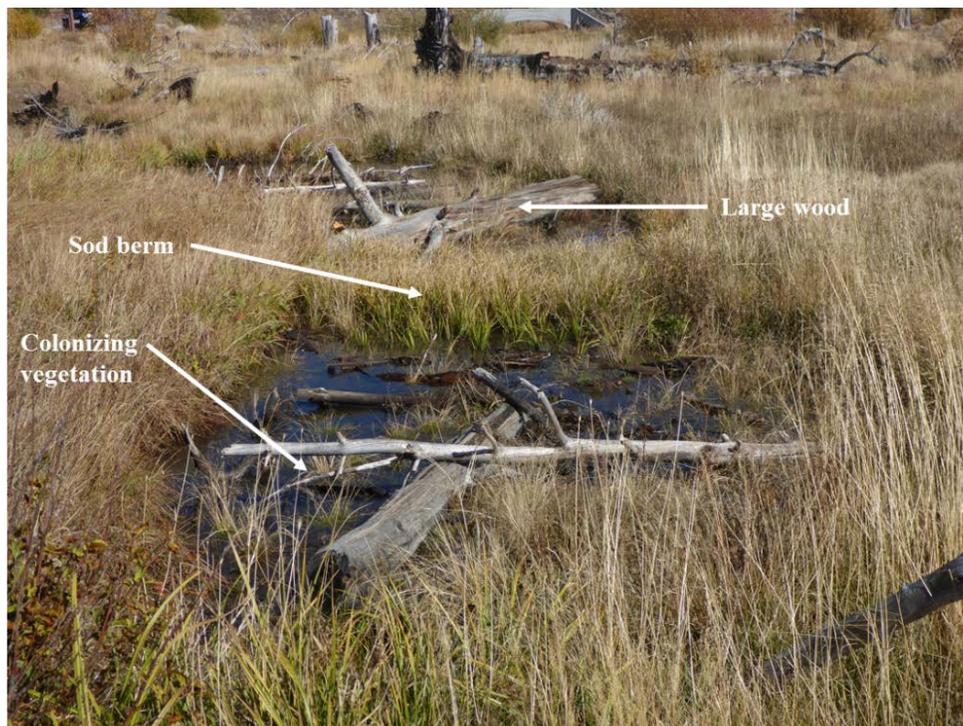
Photo 2. Decommissioned channel fill surface condition (Oct 2016).
