## **Cumulative Watershed Effects Monitoring Item 19**

**OBJECTIVE:** Determine cumulative watershed effects and to promote management consistent with water quality goals.

**REPORTING PERIOD:** 2014 and 2015

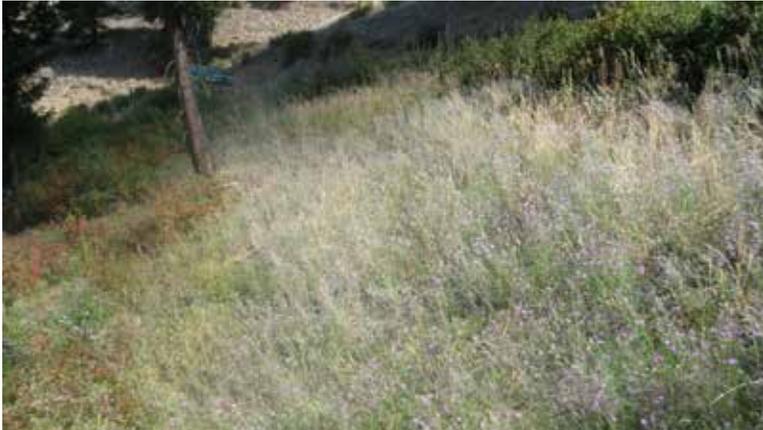
### Burned Area Recovery Implementation: Road Storage

NFSR 73313 in Mink Creek (East Fork Bitterroot River tributary) was stored in 2004 as part of the Burned Area recovery project. This road was recontoured from the entrance to the stream crossing, allowing the stream crossing to recover without intervention. The road is located in an area where knapweed is common. Early in the growing season, a variety of plants are growing on the recontoured road: snowberry, young Douglas-fir, aspen, spirea, ninebark and various unnamed flowering forbs. As knapweed matures, the natives become dwarfed by the robust growth of knapweed.

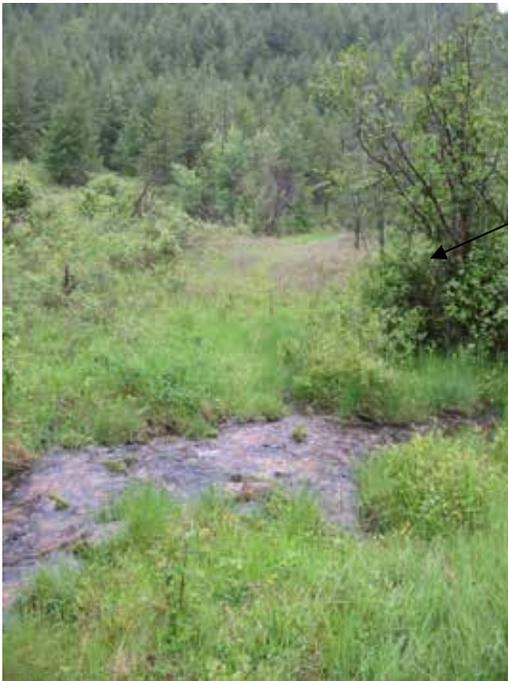
Stream Crossing in 2005      2014

The stream crossing on NFSR 73313, has changed considerably in 10 years. Stream-side shrubs are greater than six feet in height in 2014, and it is difficult to locate the ford. At the crossing (the ford) the bankful stream channel is well vegetated but is still approximately 2.5 times wider than the stream above and below the ford. This short section of stream is similar in shape and dimension to the ford prior to the road being closed but is heavily vegetated with shrubs.

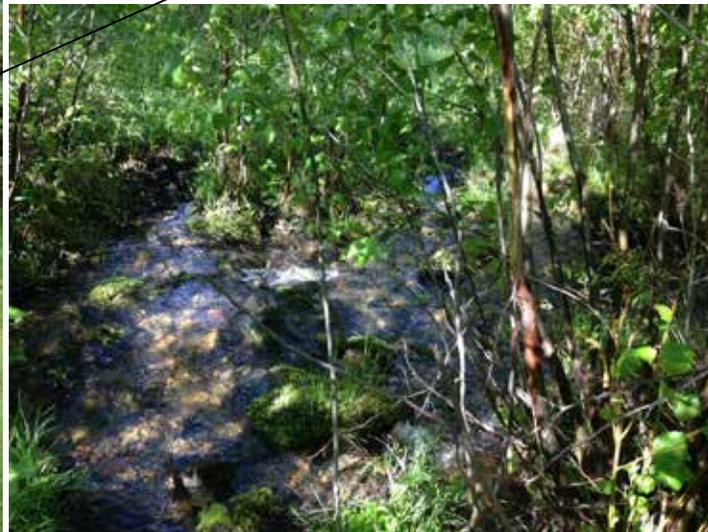
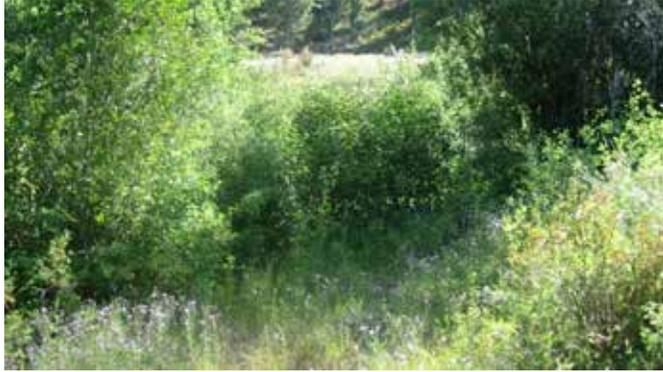
**Crossing in approximately 2012 on the left.**

**Crossing in 2015 on the right.**

This crossing was not planted, the shrubs have spread from above and below the crossing to fill the void, making it difficult to locate the old ford.

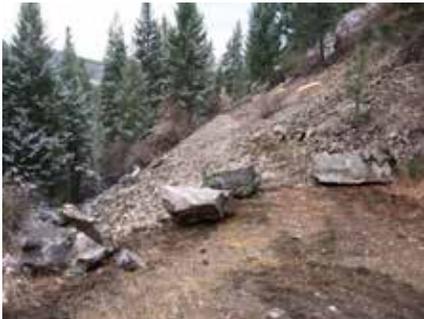
2012, Immediately Following Recontour

In the Lower West Fork project road 13838 was decommissioned in East Piquett Creek. The entrance to this road was a harsh site, where small to medium cobble sized rock made up most of the “soil”. In an effort to improve revegetation success, loose straw was mixed in with the rocky soil to provide additional organic matter. Despite high rock content, vegetation establishment was surprisingly good, notice that transplanted shrubs are green and the presence of grasses in the cobbly soil.

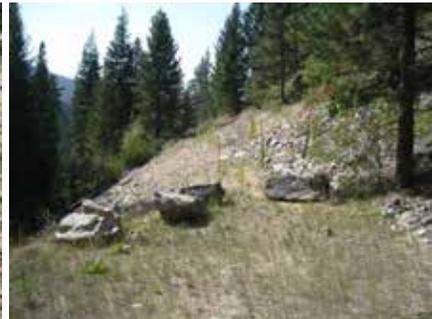
2014

On cooler aspects of 13838, where soils were deeper, revegetation was good with Idaho fescue and other tall grasses contributing to about 60% ground cover. On dry, hot sites, knapweed and cheatgrass were the most common plant. On those hot dry sites, other more desirable plants were present but were not as robust as the weeds.

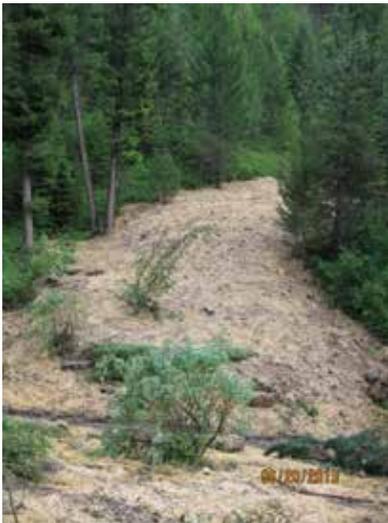
**Photo Number 1**

NFSR 13411 was the site of the largest culvert removal of the Lower West Fork project. NFSR 13411 was stored in 2013 and a large culvert on a tributary to East Piquett was removed to allow aquatic life (including fish) to reach upstream habitat. Photo Number 1, (below) shows the site in 2013 immediately following culvert removal. The following year had high runoff and this site had more downcutting and bank erosion than at most sites where culverts have been removed. It is possible the large runoff contributed to channel erosion but it could also be caused by insufficient removal of bedding material. When limited bedding material is removed, the stream can downcut through that creating over steepened streambanks that are erosive. Photos Number 2 and 3 show the site in mid-summer 2014 after the stream high water. We are not positive that the erosion was caused by excess bedding material or high flows but attention should be given to remove as much bedding material as possible and lay back the slopes of the new streambanks to match the landform above and below the crossing. The stored

road around the crossing was mulched, seeded and fertilized, but knapweed was growing well on the site while other desirable vegetation is struggling.

- **Monitoring Item 3:** Monitor culvert removals. Removal of a 36" culvert on a tributary to East Piquett Creek on NFSR 13411 was monitored by both the project fisheries biologist and hydrologist. Results indicate that insufficient removal of the bedding material and construction of a too small channel contributed to downcutting, channel widening and streambank erosion that left 2-3' high erosive banks along portions of the constructed stream channel. Another culvert was removed from a stored road on a tributary to Lavene Creek. This site also had downcut more than we expected which was likely due to incomplete removal of the bedding material. Culverts removed in Violet Creek were acceptable. There are always some adjustments stream elevation, width and depth that take place after a culvert is removed. Monitoring indicates that during culverts removals ensure that as much bedding material is

removed as possible to reduce downcutting, lay back side slopes to prevent over-steepened stream banks and limit erosion as the stream adjusts

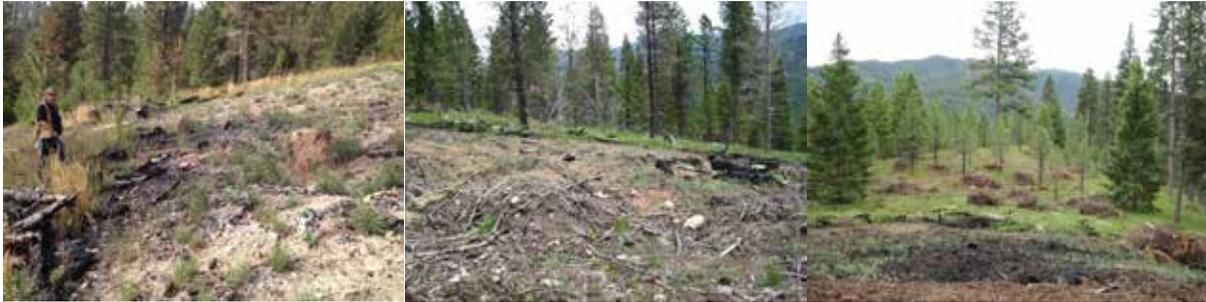
A number of burn piles along NFSR 5630A were seeded and fertilized in 2013. As seen in the photos below, slender wheat grass was growing well on these burned soils. Other burn pile sites on this road as well as along the road to the Baker Lake Trailhead were seeded and fertilized in late 2014 and 2015. Burn piles located along 12.9 miles of road in the Trapper Bunkhouse project, Lower West Fork Project and several small sales were seeded and fertilized in 2015. The photos below show vegetation recovery on burn piles seeded in 2013.

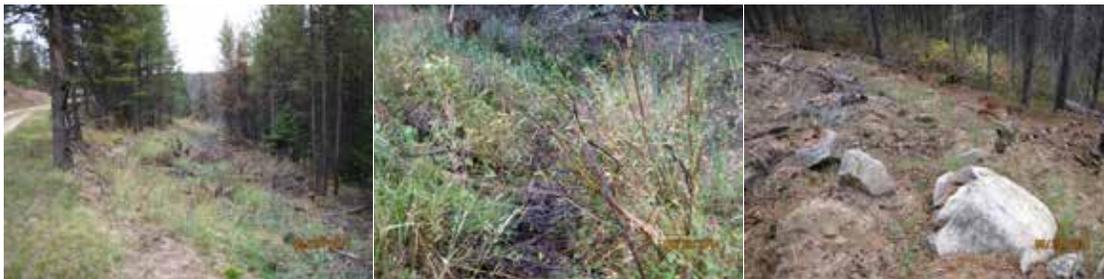
**Entrance to Road 73011**

The majority of road storage and decommission in the Martin Creek Watershed Restoration project was completed in 2013, monitoring of these roads found various levels of vegetation recovery. Undetermined roads 73011 and 73015, located in Bertie Lord Drainage, were implemented through a partnership with Trout Unlimited. The stream crossings had very good vegetation recovery with native shrubs, grasses, forbs and seeded varieties present on the disturbed soils. There was very little bare ground. Away from the stream channel, most of the recontoured soils on both roads were well vegetated with seeded grasses but there was also a component of robust knapweed growing on site.

**Stream Crossing**

**Area of Less Robust Vegetation**
