October 2017

# Still Creek Watershed Restoration Completion Report

**Mt. Hood National Forest  
Zigzag Ranger District**

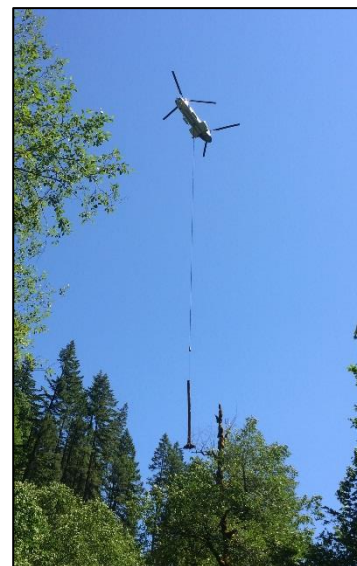
**Figure 4.** A helicopter delivers a 40' long piece of LWD to Still Creek.

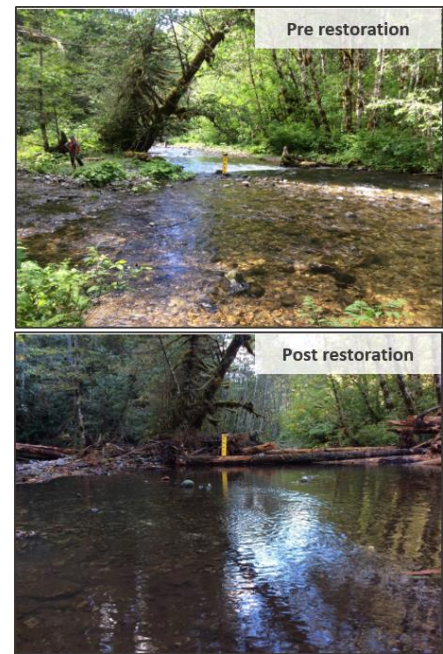
*Figure 10. A pool forms behind a log jam structure in the upper Cabins project area. The photos are facing downstream.*

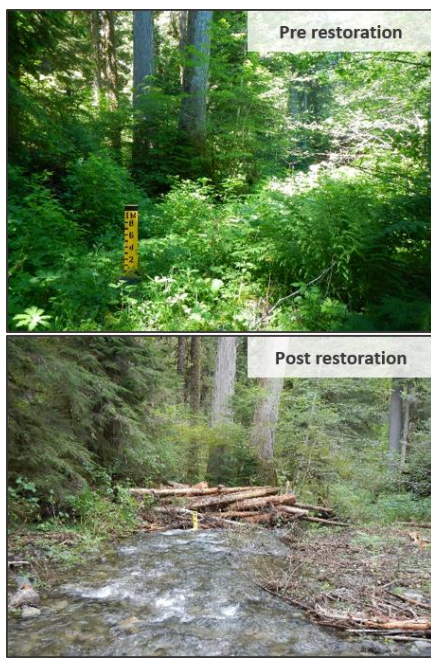
**Figure 11.** A newly excavated side channel and a placed log jam structure in the Straights project area, before and after restoration. The photos are facing downstream.

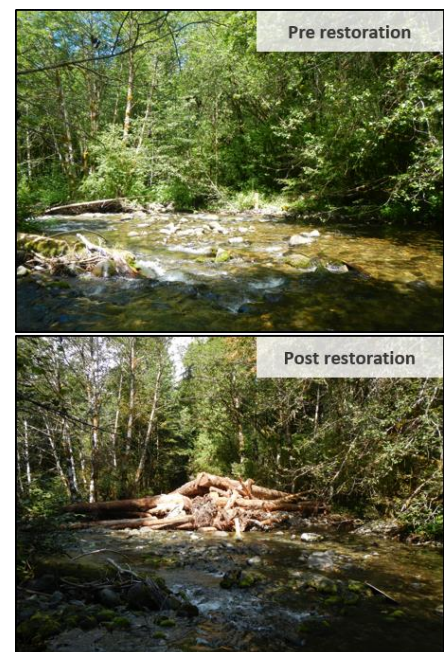
**Figure 12.** A constructed log jam forces water onto the river right floodplain in the Compression project area. Photo is facing downstream.

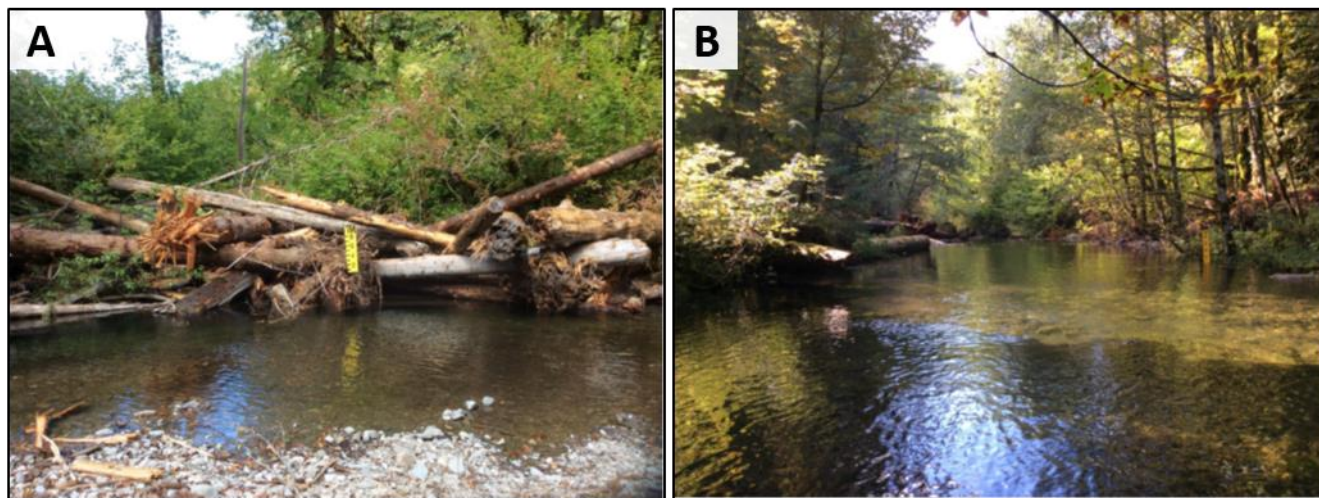
**Figure 14.** (A) A recently placed log jam on river right promotes the formation of a deep water pocket. Photo is facing across the stream, from river left towards river right. (B) A newly formed pool behind a log jam. Prior to restoration, this area had been a fast moving riffle.

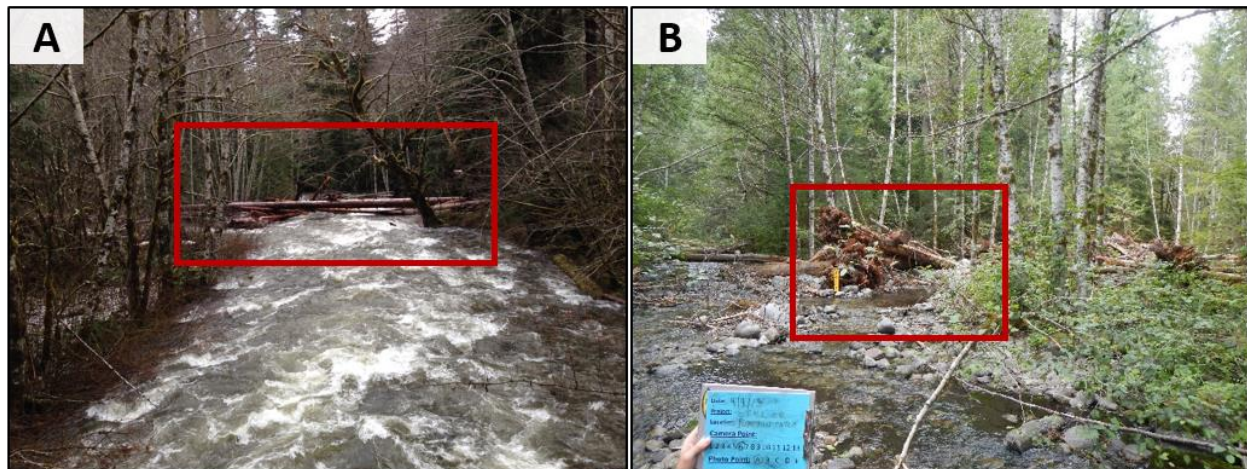
**Figure 20.** (A) A log structure slows winter high flows down the main channel, outlined in red box. Photo is facing downstream. (B) A log structure and removed riprap push water onto the floodplain, outlined in red box. Photo is facing downstream.

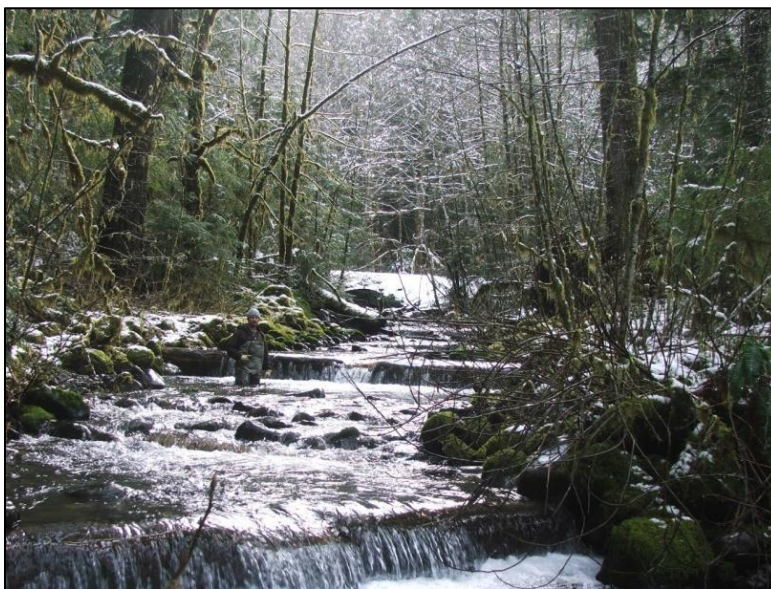
**Background** | In 2012, the weirs were altered via a spyder excavator and were replaced with riffles and roughened channel cascades that provide a more natural geomorphology and maximize upstream access for juvenile salmonids (Figure 24). Jump heights were reduced to less than 0.6 feet in height in most cases. The project opened an additional 0.65 miles of habitat to juvenile anadromous fish.

**Figure 24.** Log weirs prior to removal on Cool Creek prevented passage of anadromous salmonids to 0.65 miles of habitat.

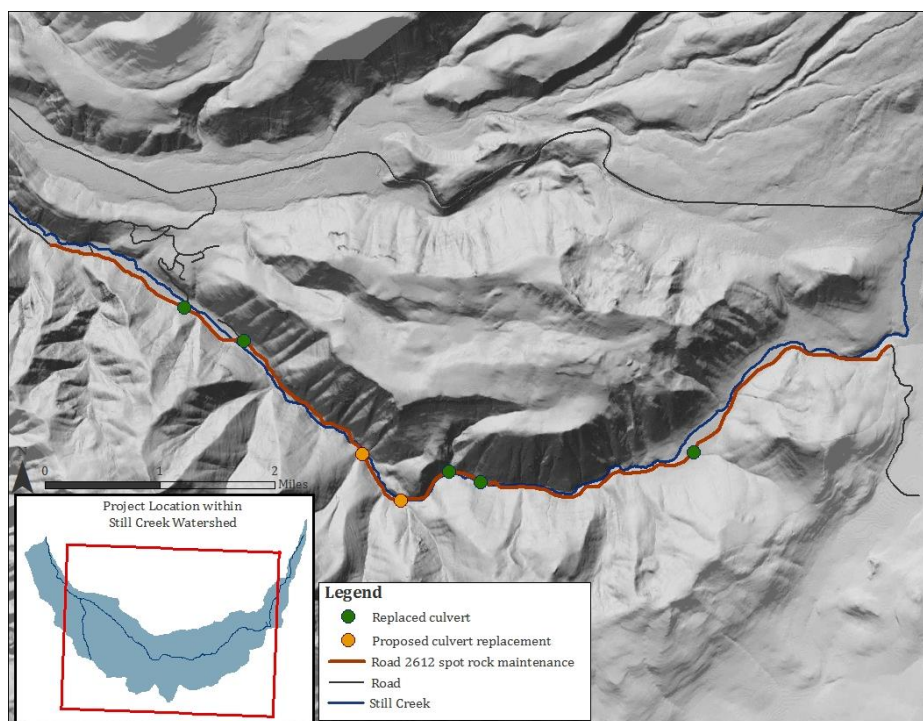
Figure 26. Map of culvert replacement sites throughout the Still Creek Watershed.

aquatic organism passage barriers. However, it was found that seven culverts were not functioning properly and were either contributing to road related sediment entering Still Creek and/or creating aquatic organism passage barriers. The original objective of this project was to replace eight culverts to improve aquatic organism passage and minimize the delivery of road sediment to the stream.

**Actions** | Following a review of culverts along Still Creek Road, it was determined that only 7 culverts were a priority for replacement. As of the writing of this report, five of the seven culverts had been upgraded along FS Road 2612, and plans are in process for the replacement of two additional culverts. Culvert locations were as follows:

**Trib D:** The original site contained two culverts; one 48 inch diameter by 39 foot long culvert, and one 24 inch diameter by 41 foot long culvert. The two were replaced with a single 18 foot wide, open-bottom arched culvert. In addition to reducing sediment transport, the replacement of the Trib D culvert re-opened approximately 2.5 miles of previously blocked tributary habitat to aquatic organism passage.

**Trib H:** The former 18 inch diameter culvert was replaced with a 36 inch diameter culvert.

**Unnamed tributary:** The former 24 inch diameter culvert was replaced with a 36 inch culvert.

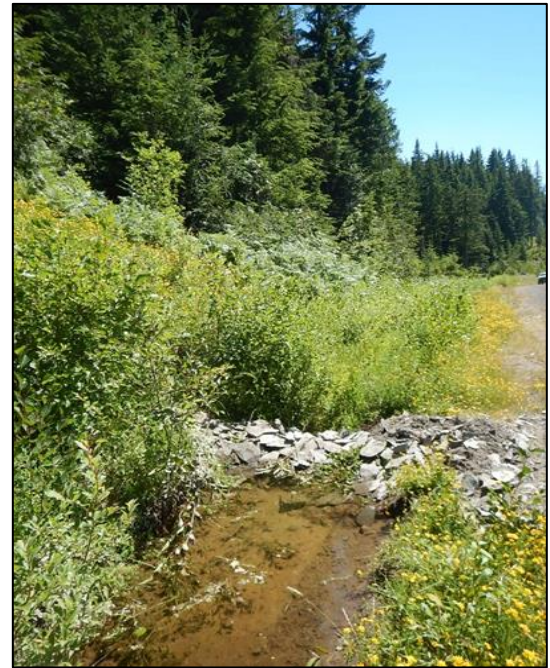
*Figure 31. A check dam constructed in 2017 traps sediment along Highway 26.*
