**BURNED-AREA REPORT**  
(Reference FSH 2509.13)

- A. Fire Name: Caples Fire
- B. Fire Number: CA-ENF-030945
- C. State: California
- D. County: El Dorado
- E. Region: 5
- F. Forest: Eldorado
- G. District: Placerville and Amador
- H. Fire Incident Job Code: P5MU8G (0503)
- I. Date Fire Started: 10/10/2019
- J. Date Fire Contained: Estimated 10/31/2019
- K. Suppression Cost: ~\$ 6,500,000 (as of 10/26/2019)

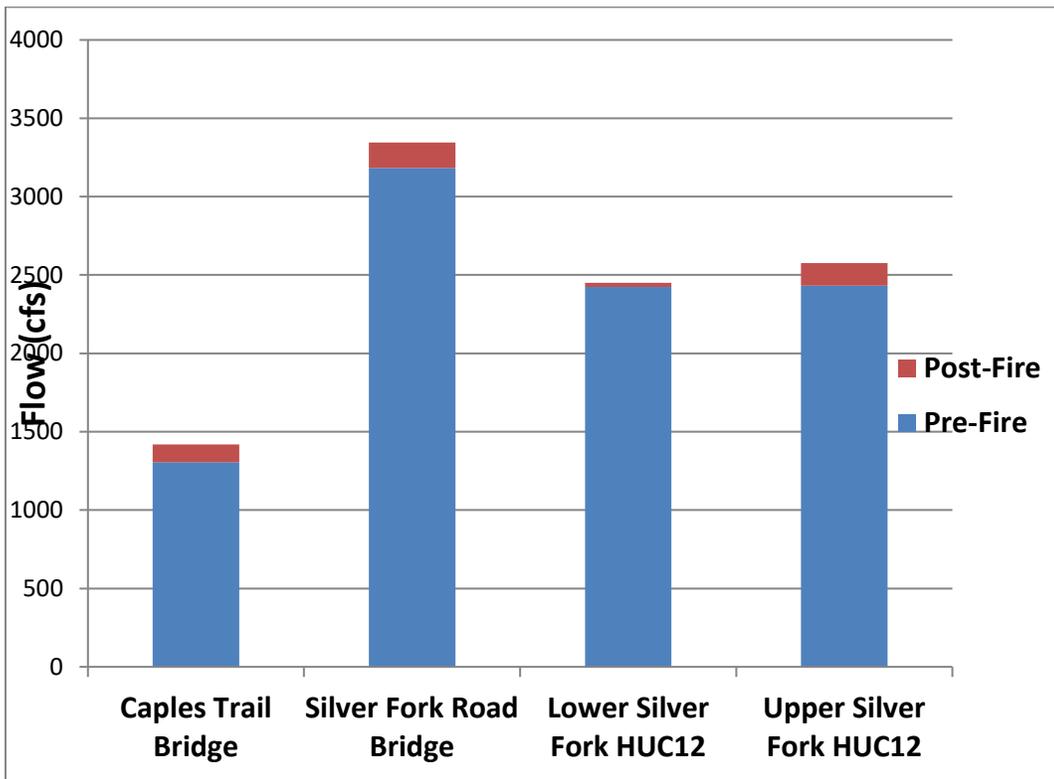
Due to minimal increases in post-fire flow, flooding is not a major concern. However, impacts to water quality in Caples Creek is likely due to increased erosion and transport of sediment and ash to the creek (Pictures 1 and 2). There is also potential for the accumulation and transport of large wood within Caples Creek (Picture 3), which could damage both the bridge on Silver Fork Road, and the trail bridge on Silver Fork Trail (note that large wood debris jams were present in Caples Creek pre-fire, and are only expected to become larger as burnt trees fall into the stream).
