**Best Management Practices  
Water Quality Evaluation Program  
Monitoring Report  
2003**

*Evaluation of Forest Service administered projects, including timber sales, roads, prescribed fire, recreation sites, grazing and mining activities*

# Klamath National Forest 2003 Best Management Practices (BMP)

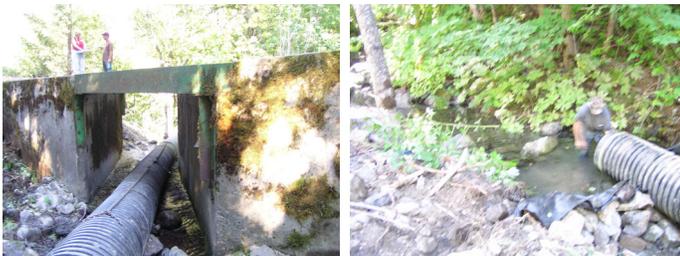
### **McNeal Creek Fish Passage Dewatering**

Review of the McNeal Creek fish passage site (10N04 road) on September 19, 2003 found that the dewatering of the site met all implementation criteria. The minor amount of turbidity noted downstream was from the construction crew positioning the inlet pipe.

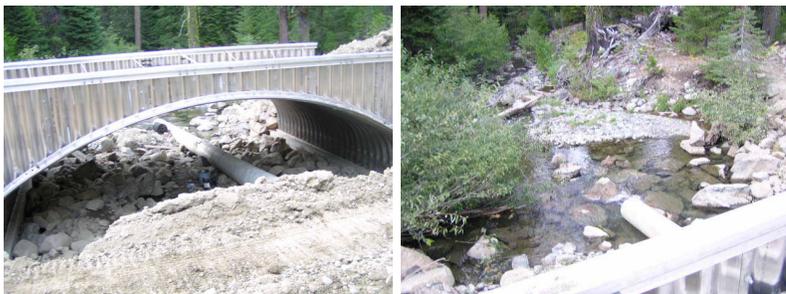
### **Upper South Fork Scott River Fish Passage Dewatering**

Review of the Upper South Fork Scott fish passage site (40N17 road) on September 19, 2003 found that the dewatering of the river was effective and the water was running clear downstream.

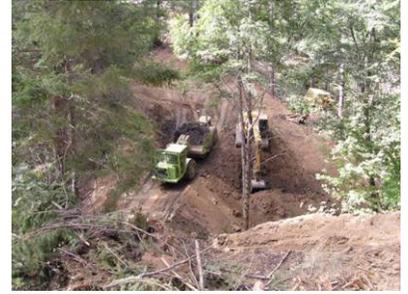
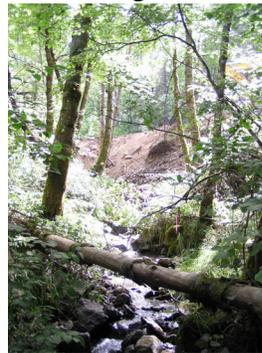
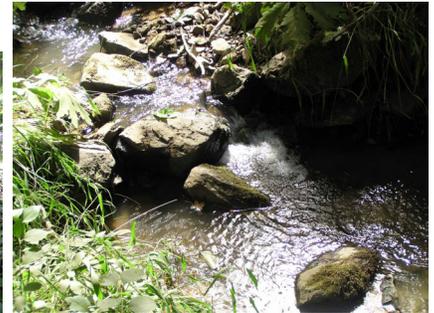
## King Solomon Mine Sediment Dam Restoration In-Stream Construction

In-stream construction was monitored on September 16, 2003. At this time, the remnant dam abutment across the Matthews Creek channel was being excavated and removed. A temporary stream crossing was constructed to access the area. The creek crossing was built with a culvert and rock fill, and about 25 feet of soil fill over the rock.

The creek water was running slightly turbid about 75 feet downstream of where the excavator was working to remove the dam. After the dam abutment was removed, the temporary crossing was also removed.

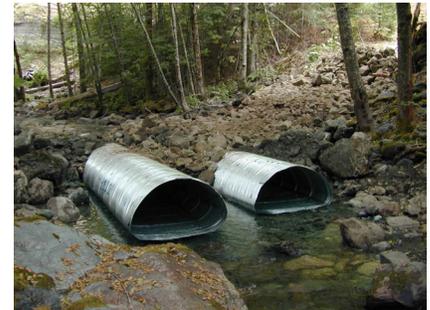
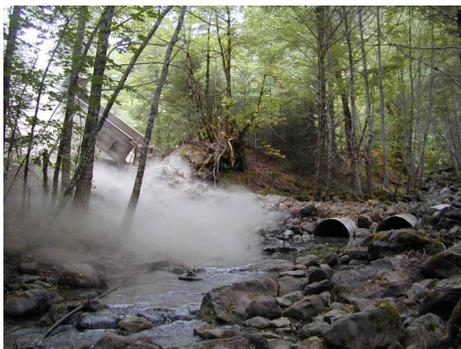
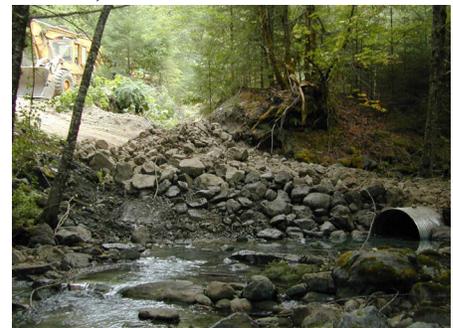
## Siskon Mine Rehabilitation Phase I, In-Stream Construction

In-stream construction was reviewed on October 3, 2003. A vented rock ford was constructed across Copper Creek to provide access to the mine area. The crossing was designed to maintain fish passage during low flows, and to allow high water to pass over the crossing without causing sedimentation during the winter storm flows. During construction, the project contract inspector noted that several large boulders had to be removed from the stream bottom to allow the twin 49" X 30" and 30 foot long corrugated metal pipes (CMPs) to fit one foot below the stream bottom.

After the pipes were placed, about 15 cubic yards of class V riprap was placed on top of the pipes. In addition, six inches of one inch minus washed gravel was placed over geotextile fabric as a travel surface. Stream

turbidity was noted during placement of the CMPs,

but it was of short duration and was not noticeable more than 300 feet downstream. This crossing will be in place for about 2 years and will be removed when clean up of the mine is completed.

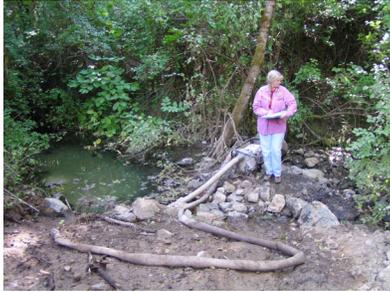
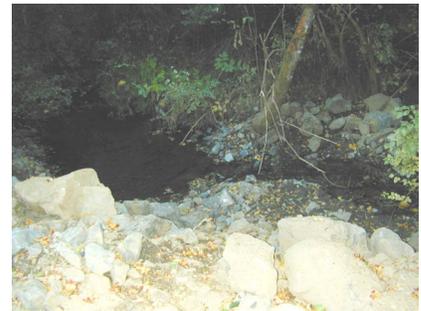
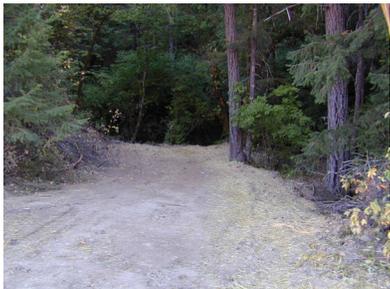
### King Solomon Mine Sediment Dam Restoration Water Source Development

The water source along the 38N17 road at M.P. 1.75 was reviewed during the project on September 19, 2003 and after project completion on October 10, 2003. The water source met most of the implementation requirements. BMPs were described in the environmental document and guidelines were established for water withdrawal, and stream bank alteration was minimized to provide the water source. The area was an old water source that had not been used for a long time. Fish were observed in the

pool, and the intake was screened appropriately. The minor problems were that sediment and rock (less than a cubic yard) was placed in the channel to construct the water source pool, instead of just rock, there was some rill erosion leading to the stream from where the hose is connected to the water truck, and the road

access was rutted due to the absence of aggregate surfacing. At the end of the project, the all of the sediment and rocks were removed from the channel, the channel bank was armored with riprap, and the disturbed areas off of the road way were mulched and seeded.

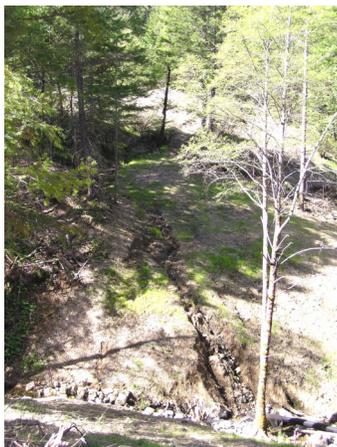
### King Solomon Mine Sediment Dam Restoration, Winter-Spring Monitoring, 2004

Project monitoring of the King Solomon project over the winter and spring of 2004 documented several small shallow debris flows on the west slope where the upper dam remnant was removed. Removal of the dam material allowed an existing spring line to surface in the restored slope. The spring line formed a gully delivering about 8 cubic yards of sediment into the stream with several more cubic yards stored in the channel. The stream down cut a couple of feet to the original base level and the creek migrated about 8 feet into the restored slope. Mitigation measures are to hand place additional riprap along the

revegetate and stabilize. The other problem noted was that road use during fall and winter by woodcutters has damaged the road, leaving large ruts. The road was outsloped using material from the dams. The road will be graded and surfaced with aggregate this summer. Additional effectiveness monitoring will occur over the whole project site in 2004.

channel and at the mouth of the gully to retard stream bank erosion while vegetation is becoming established on the slope. The dewatering pipe will also be removed. Additional grass seed, mulch, or other vegetation may also be placed on the erosion site if needed during the summer. Additional riprap was hand placed along the stream bank on the other side of the channel before the rainy season of 2004, and there were no erosion problems noted. Over the next couple of years, both restored slopes will
