Idaho Panhandle National Forest, USDA Forest Service

Mallard Peak Restoration Project

FY 2010 Project Description

Mallard Peak Lookout (10SE65) Project Description

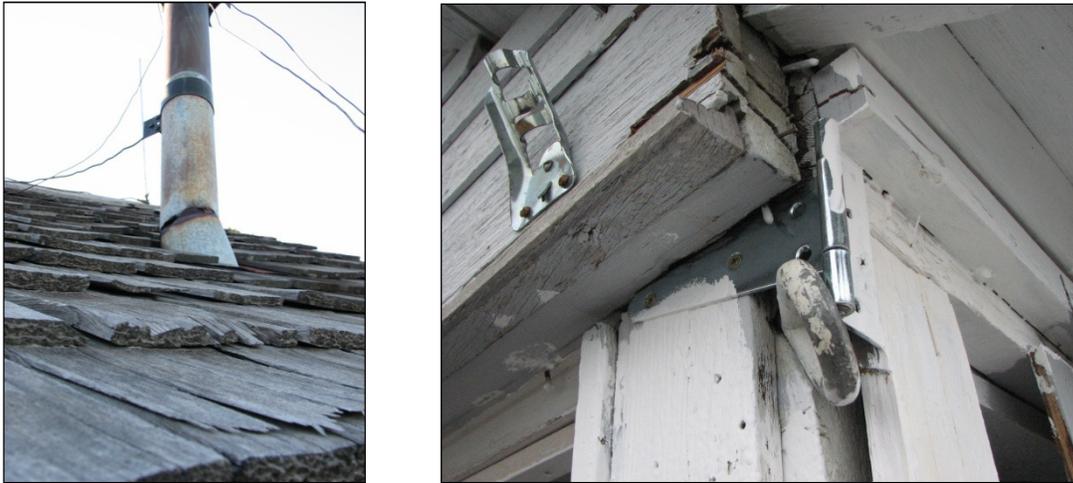
Figure 3. Chimney damage at junction of lower pipe sections prior to refitting (left) and temporary repair to SE corner with galvanized hinge. Need to replace with L-brackets under siding/molding both inside and out.

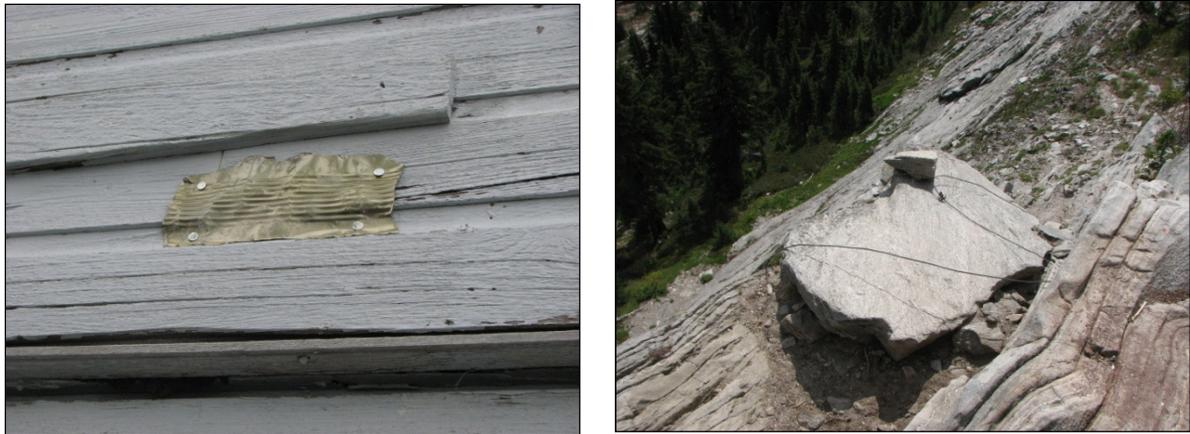
- ✓ Detached southeast guy wire (the consensus was that the large flat boulder the guy is attached to may be sliding slightly down hill causing the corner to pull away);

Figure 4. Repaired wood pecker holes with flattened tin cans; viewed prior to painting (left) and View of SE corner anchor boulder that may be slipping downhill and pulling corner out of alignment (right).

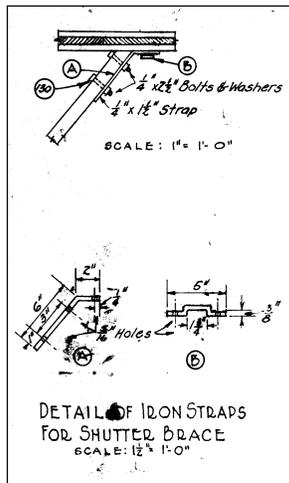
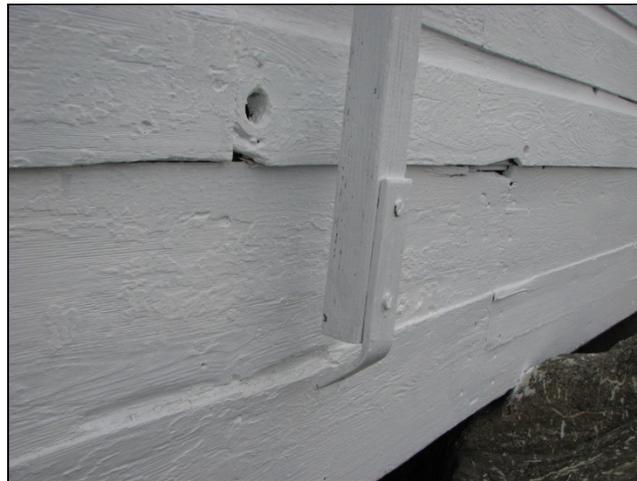
Figure 17. Detail of 1931 shutter brace hardware (left) and present alignment (right). Mount hardware on opposite side of stabilizer arm and cut top of arm at same angle as hardware. Place hook and eye on siding to keep stabilizer arm from swinging and damaging siding.

- ✓ Inspect existing shutters and repair as necessary
- ✓ Replace east side plywood shutters with new window shutters
- ✓ Install iron straps for shutter brace correctly and develop tie down so braces do not swing against siding in the wind.

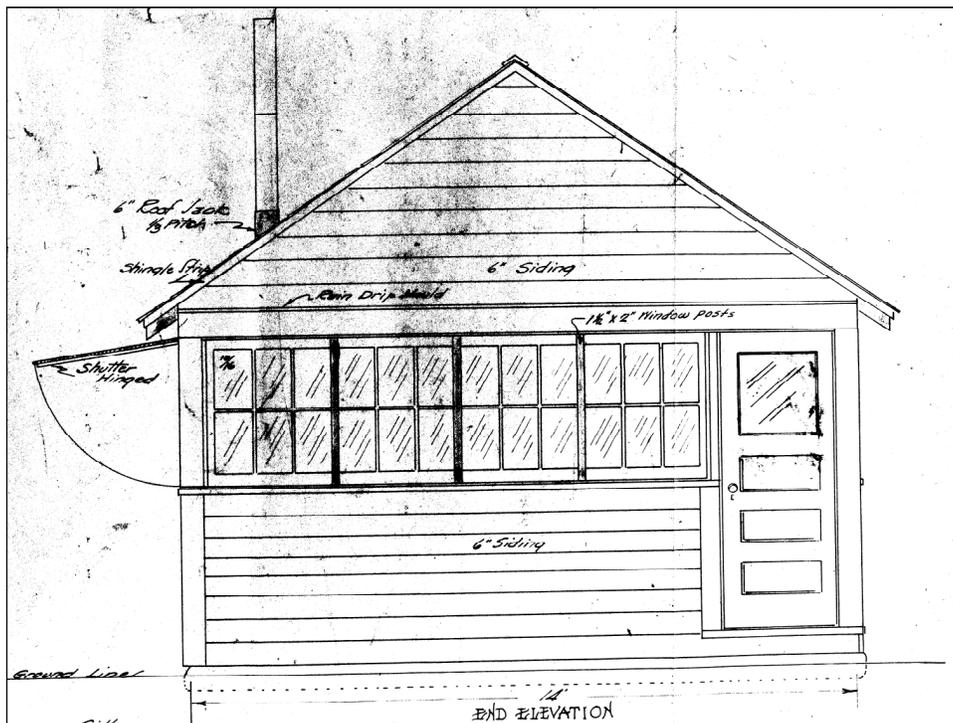
Figure 19. Note location of drip molding installation in original plans.

- ✓ Install drip molding between siding panels as per original plan drawings rather than as previously installed. Previous location interferes with appropriate placement of shutter hinges.

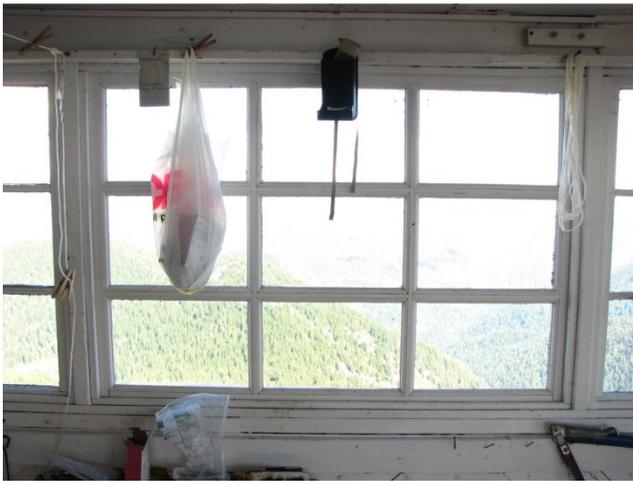
Figure 20. Present interior window detail. From sill to sill window is 3' tall.

- ✓ Install original 3-over-2 configuration windows with two of five panes on west, north and east side and two of four panes on south side so that they slide open for ventilation.
- ✓ Inspect and replace window headers with either single header or spliced header as per original plans to remove bow in north side of lookout.
- ✓ Install window posts as per plan detail.

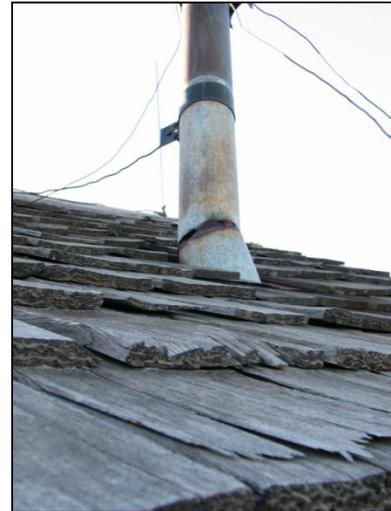
Figure 23. Repair or replace stove pipe, guy wires and roof jack to prevent leaks.

- ✓ Replace roof jack, stove pipe and guy wires.

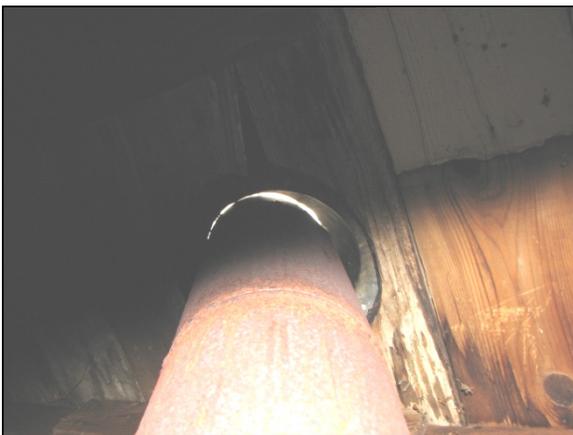
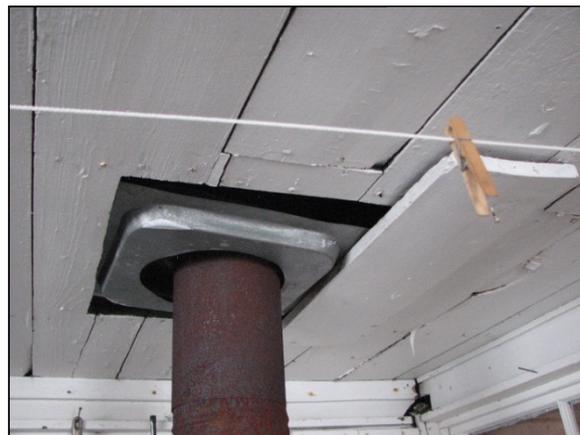
Figure 24. Interior view of stove pipe junction at roof sheathing (left). Replace missing ceiling board with 1x8" shiplap and find appropriate collar for ceiling (right).

- ✓ The existing ceiling flange no longer fits the opening. Replace ceiling boards with 8" shiplap to reduce size of hole and replace ceiling flange.

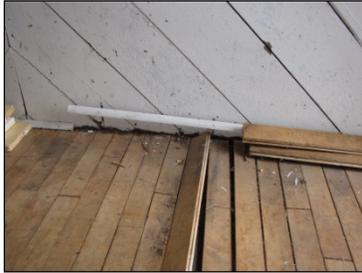
Figure 26. Floor is warped near the door so that several inches of space has been lost.

- ✓ Inspect and replace maple flooring and any subflooring as necessary. The floor will need to be removed to at least the warped section, warped wood replaced and straight wood placed back as appropriate.
- ✓ If warping continues, nail flooring or replace with 1x8" shiplap as per original design.

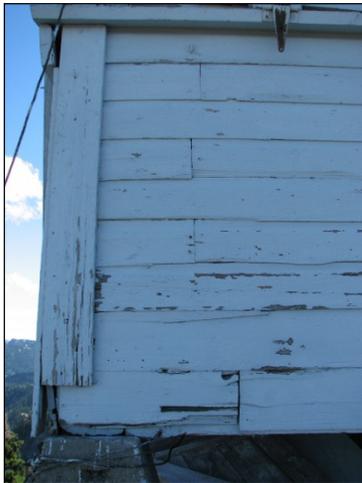
Figure 27. Trim boards weathered, cut-off and warped and lower sections of shiplap siding replaced with 1x8" shiplap.

- ✓ Lightning Protection System – inspect, tighten and replace minor elements as necessary to function as is. Replace with modern clamps if possible and reattach to ground as necessary.
- ✓ Replace exterior corner boards on south and north sides
- ✓ Replace 1x8" shiplap lower siding on north and east sides with 1x6" tongue and groove siding.
