Management by Closure to Use, BMP 11.09

Site Description

Narrative

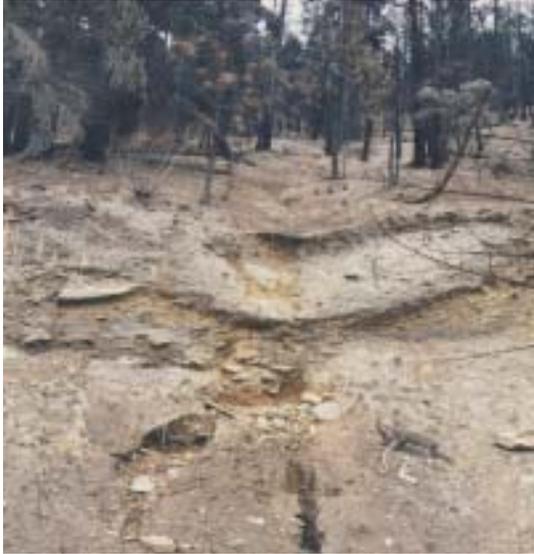
Photo 1

After the September rain event in the Johnson Creek drainage, overland flow concentration and soil erosion quickly accelerated on the historic jammer road systems located above and below Road 540 (Map 1). Runoff concentration caused gullies to form and with increased sediment became mudflows (photos 1-3). Water velocity increased and accumulated sediment as it scoured down the drainages.

The four main fills of Road 540 were removed due to the cumulative effects of rill and gully erosion (photos 1-3).

Jammer roads below upper section of Road 540, photos 1.
-

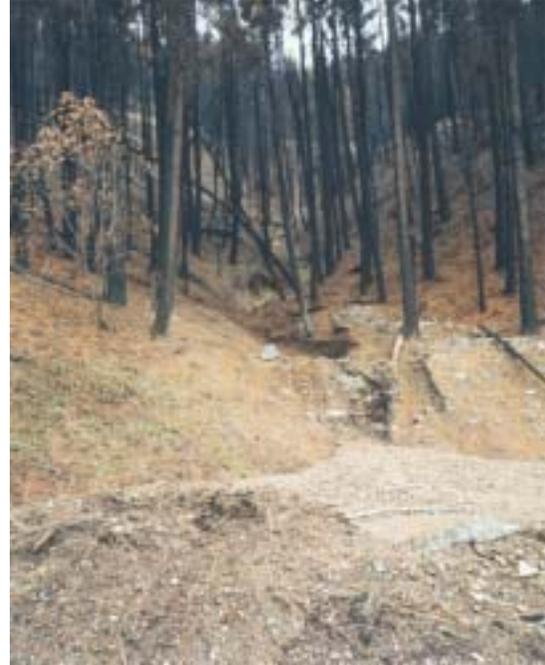
Photo 3

Roads 18741. Gully erosion and sediment deposits, photos 3.
-

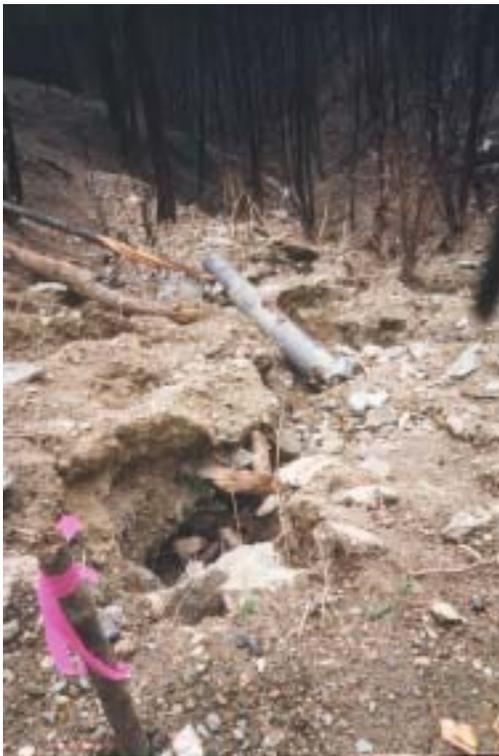
Photo 2

Four main draws where fills were pulled. Rehab, photos 4 - 7. Gully erosion, photos 2.
