Log Landing Erosion Prevention and Control, BMP 14.11

Erosion Prevention and Control Measures during Timber Sale Operations, BMP 14.12

Erosion Prevention and Control Measures during Timber Sale Harvest, BMP 14.12 Erosion Control on Skid Trails, BMP 14.15

Stream Channel Protection, BMP 14.17

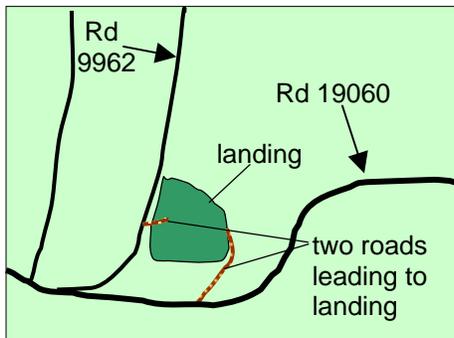
Figure 1

This site was used as a helicopter landing (photo 1). After construction, it was seeded, left over the winter, and used again the following spring. The two access roads leading from the landing were water-barred. This allowed water to drain off of the landing and the access roads and disperse before it reached roads 9962 and 19060 (figure 1).

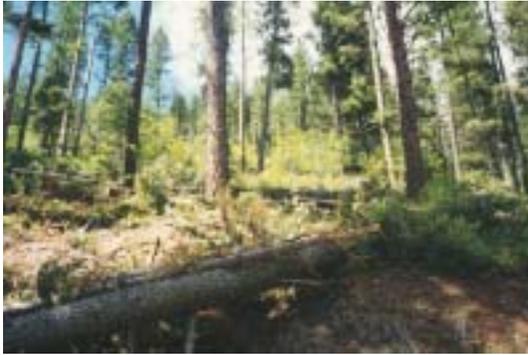
Photo 2

Vegetative buffers on all sides of the landing provided a filter for sediment and a safeguard between the landing and the road (photo 2). The landing will be scarified and seeded in the following one to two years.

Erosion prevention and control measures were effectively working. Water bars were draining successfully. There was no sign of rilling or rutting on the road or landing. Any displaced sediment was trapped and filtered by the existing buffer vegetation. Water predominately flowed to the southeast, where the vegetation buffer was wider than 100 feet.

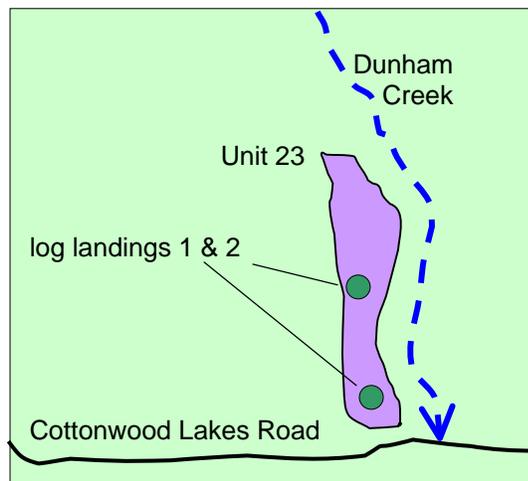
Figure 1

Minimizing access limits vehicle pressure on the soil, decreasing compaction and changes in bulk density. Haul trucks were restricted beyond the second landing (figure 1). Beyond this point, the only access was via rubber-tired skidder.

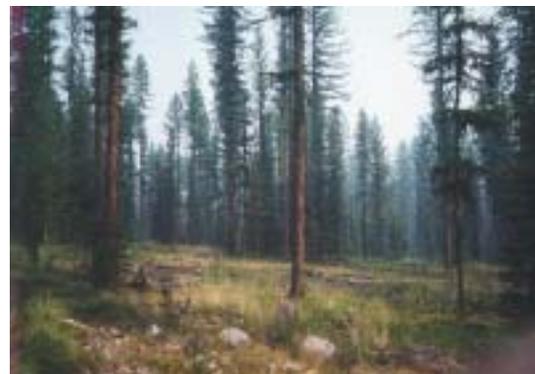
Photo 1

Two log landings were located within Unit 23. At the second landing, where two main skid trails branched off, was an open area. The open area allowed easy access and tractor mobility. In addition, only a few trees were removed for the landing (photo 1). After use, both landings and the road connecting them were scarified and seeded (photos 1, 2 & 3). Froelich and others (1985, p 1017) recommend scarifying skid trails because of the long-term erosion potential.

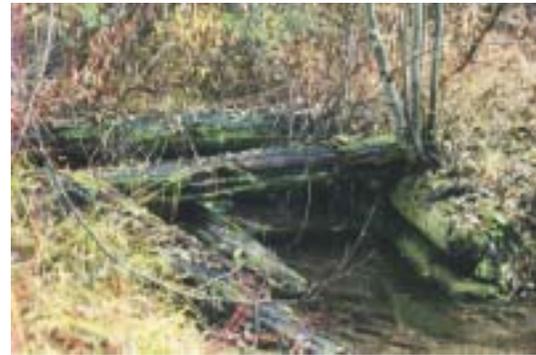
While evaluating the area after the fire for emergency rehabilitation needs, two log bridges were discovered on Camp and Soldier Creeks. Both bridges had last been used in the 1960's (photos 1, 2, 3 & 4).

Photo 1 – Camp Creek

During high run-off, the bridges constrict the active channel resulting in bank erosion and increased sediment entering the stream. To prevent further sedimentation and stream constriction it was determined that both bridges would be removed.

In order to remove the bridges a small excavator was used to pull the stringers and abutments. By removing the stringers and abutments, water could move naturally along the stream bank.

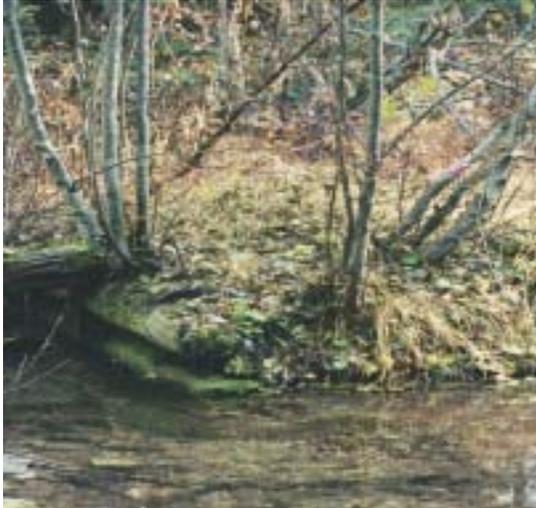
Photo 2 - Camp Creek abutment

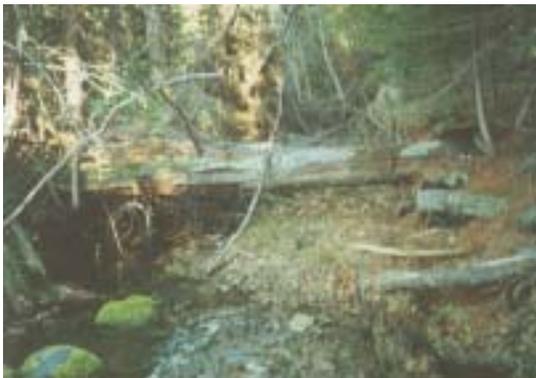
Photo 3 - Soldier Creek stringers and abutment

In Soldier Creek, only the stringers were removed from the bridge. The abutments were not considered a threat to bank stability and therefore remain in place (photos 3, 5, & 6). Impacts to date have been minimal and the riparian area is intact and functioning effectively.

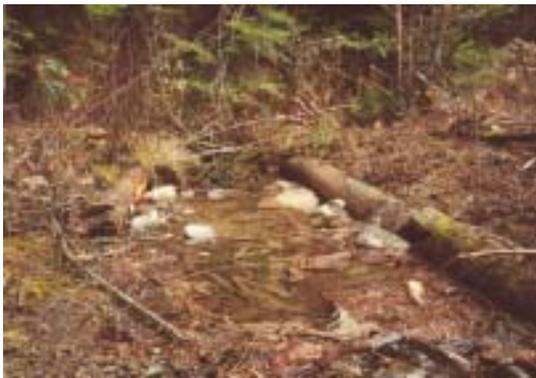
Photo 4 - Support logs along the bank of Camp Creek

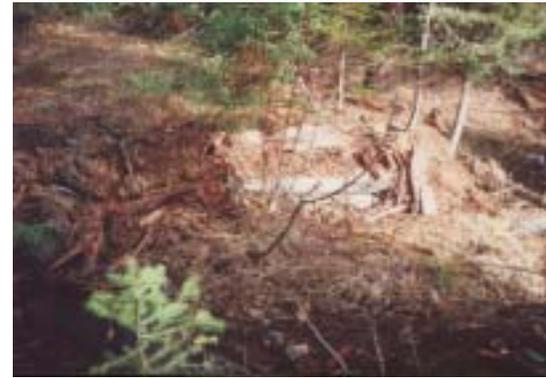
Photo 5 – Soldier Creek, stringers removed, abutment remains

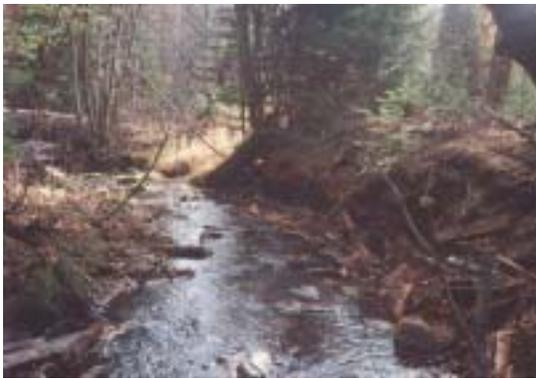
Photo 6 - Soldier Creek after bridge removed
