On-Site Large Woody Residue and Soil Litter Retention, BMP 14.24

General Guidelines for the Location and Design of Roads and Trails, BMP 15.02

Mitigating Surface Erosion and Stabilizing Slopes, BMP 15.06

Control of Permanent Road Drainage, BMP 15.07

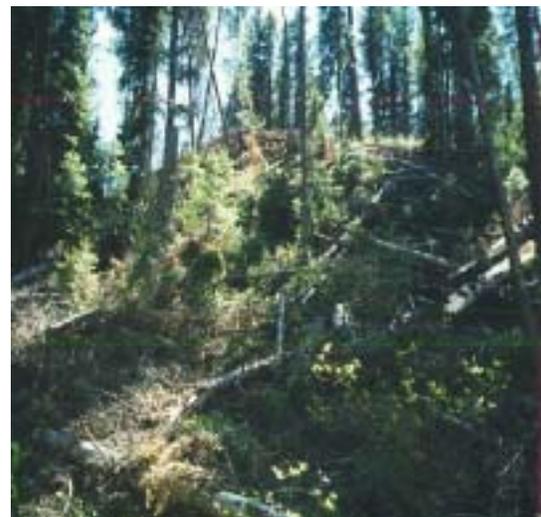
Photo 1

The majority of logs left onsite are 3 to 8 inches in diameter, with a few 12 inch diameter logs. Smaller slash was scattered between the larger logs. Surface litter is approximately 3 to $3\frac{1}{2}$ inches deep. Nearly 70 percent of the slash are log tops and smaller limbs, with the remainder logs greater than 3 inches. Signs of erosion or soil displacement are nonexistent onsite. Tree and shrub re-growth is productive (photos 1 & 2).

The amount of large woody debris retained is effective. Soil erosion and displacement have been prevented. Larger logs have created wildlife habitat that will decompose and provide enhancement to soil productivity in the future. Surface litter retained onsite is 3 to 3½ inches deep, over 75 percent of the unit.

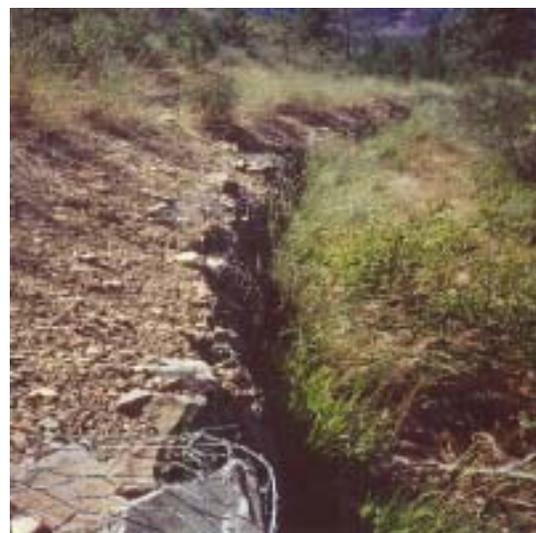
Photo 1

The gabion wall prevents the fill from sloughing. The wall is 95 feet long by 3 feet tall by 2.8 feet wide (photo 1). Roughly 90 percent of the rocks used to build the gabion have similar shapes, averaging 1 foot by 2 to 3 inches. The holes in the wire mesh are hexagonal, 3 inches by 4 inches (photo 3).

Building a gabion wall to prevent fill-slope failure has been effective. Stabilizing the slope has minimized the amount of sediment entering the stream. Since the

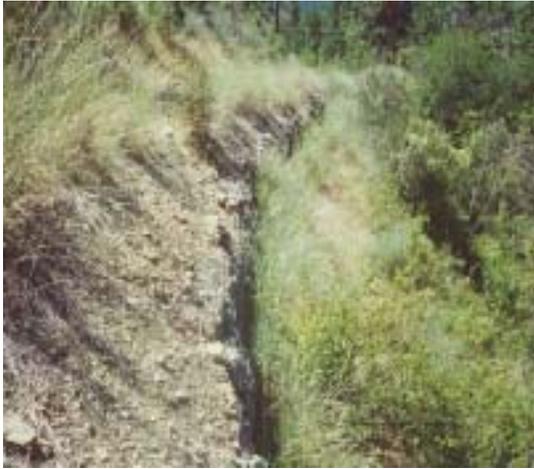
Photo 2

Grass has not established on top of the gabion, the soil in this area is fine and rooting will be difficult. However, the vegetative buffer below the gabion is substantial and will filter sediment that travels over the wall (photo 2). The gabion provides a firm foundation for the fill; potential for failure is minimal.

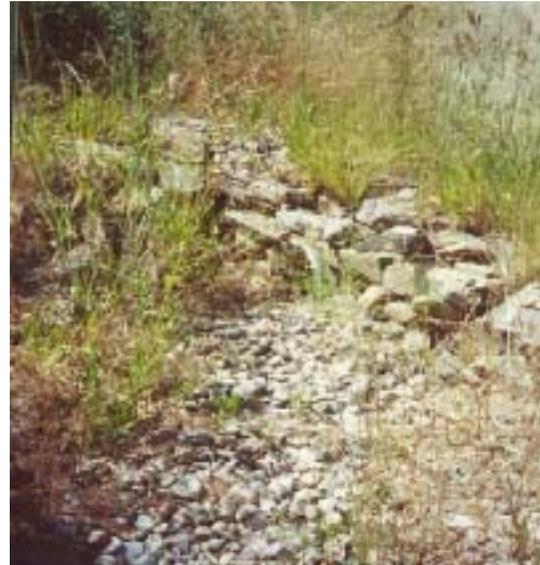
Photo 1 - Rocked ditch to inlet

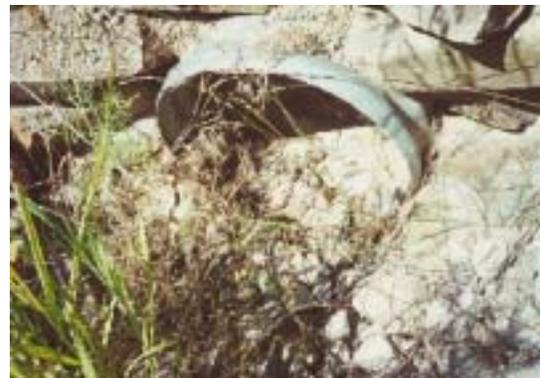
The inlet and outlet were adequately armored with rock. The rock will add stability and reduce erosion potential (photos 2 & 3).

Photo 2 - Culvert inlet has collected sediment

The relief culvert and catch basin effectively combine to minimize sediment delivery and maintain water quality. Reconstructing the relief ditch and adding the rock lining minimizes erosion by protecting the soil, slowing down the water, and collecting sediment before it enters the culvert. The catch basin prevents sediment from entering the stream. To maintain its effectiveness, the catch basin will need to be cleaned out periodically.

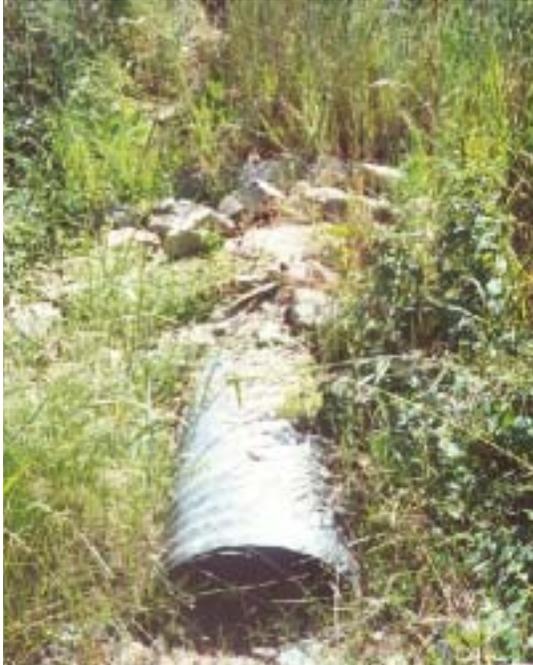
Photo 3 - Culvert outlet

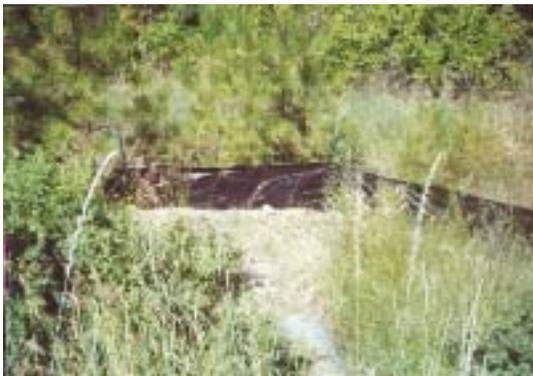
Photo 4

The silt fence is shaped in a half-circle 28 feet long x 2½ feet tall. The bottom is securely fastened and buried beneath the soil (photo 4).

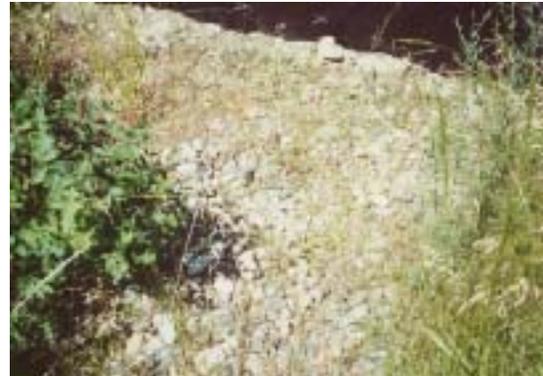
Photo 5

A substantial amount of sediment from the road moves through the culvert, with accumulations of fine soil and rock from 1½ to 2 inches thick (photo 5).

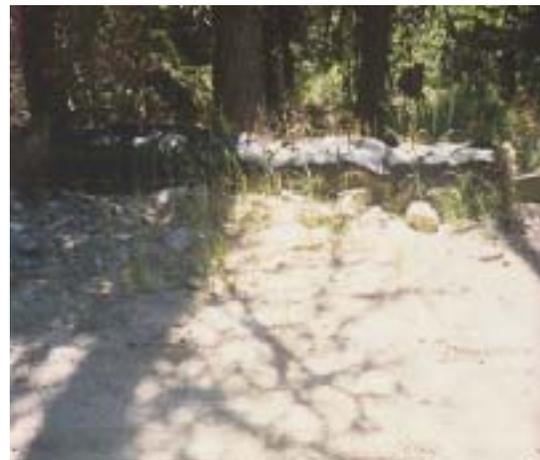
Photo 1 - Monitoring Site 1 at 3 miles

To build the silt fence, first the straw bales were placed on the side of the road. Next, the straws bales were covered with filter cloth and secured with rebar. Two pieces of rebar were hammered through each bale (photos 1 & 2) to secure them in place. Finally, a catch basin was constructed directly in front of the silt fences.

Ten months after installation, the silt fence remains intact. The straw bales to date are still 3 feet long by 2½ feet wide, forming a silt fence 12 feet long by 2 feet tall. Sediment has successfully been trapped in the catch basin (photo 1).

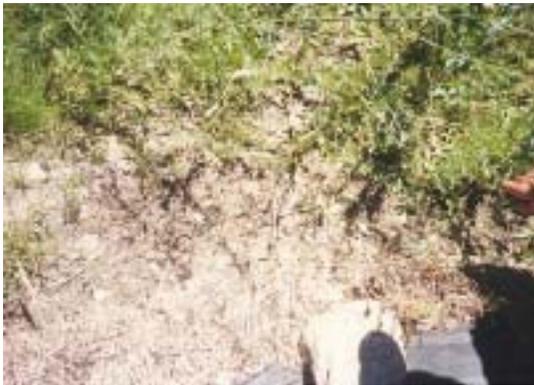
Photo 3 - Monitoring Site 1 at 3 miles

At this time, 13 feet³ of sediment have been trapped at Site 1, and 21 feet³ of sediment at Site 2. There are only trace amounts of sediment behind the silt fences (photos 3 & 4). Thick riparian buffers behind the silt fences provide additional filtration. After nearly one year without maintenance, both silt fences are in good condition.

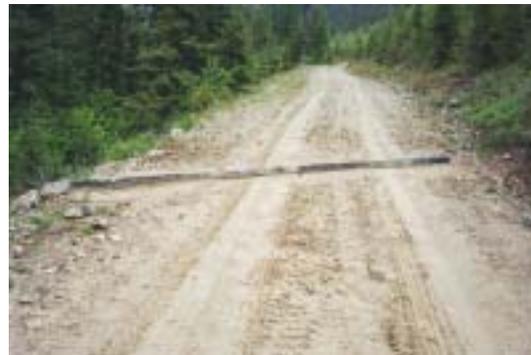
Photo 1

The water belt was installed at an angle redirecting water off the road surface and into a riparian buffer area (photo 1). The redirected water then enters the fillslope rock armor, which was placed for stability and to reduce erosion. Next the sediment is filtered through a slash filter windrow and finally is filtered into a well-established riparian vegetative buffer.

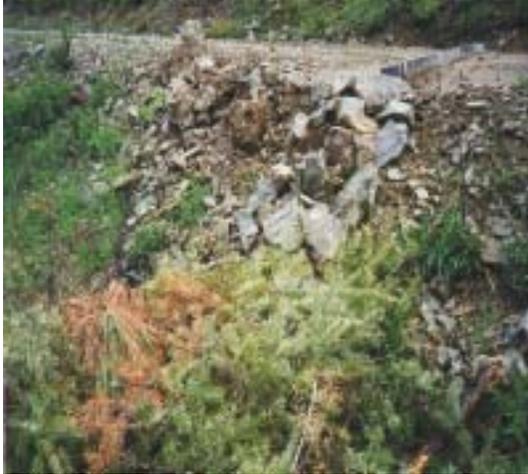
Photo 2

The 22-foot long rubber belt was installed at the proper angle to the road. The rock armoring is 2½ feet x 1½ foot, consisting of rock 3 to 8 inches thick (photo 2). The slash-filter windrow is 5 feet x 3½ feet, built of Douglas fir and ponderosa pine branches (photo 2). Water drains along the belt, over the rocks, through the windrow and into the riparian buffer. There is no sign of rilling above or below the water belt.
