Control of Road Construction Excavation and Sidecast Material, BMP 15.10

Controlling In-Channel Excavation, BMP 15.13

Diversion of Flows Around Construction Sites, BMP 15.14

Stream Crossings on Temporary Roads, BMP 15.15

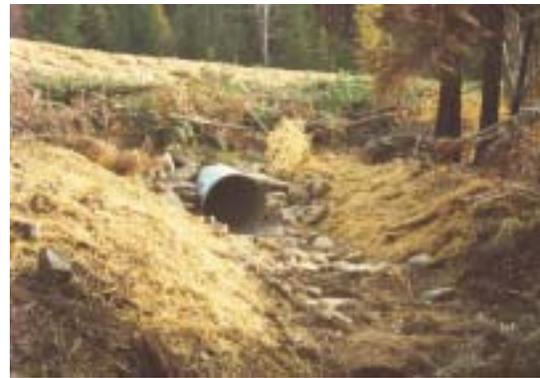
Photo 1

The fillslope between the windrow and road was seeded and mulched with weed-free straw (photo 1). The seeded area will provide an extra buffer once vegetation has established. Below the windrow is a 48-inch culvert. The inlet and outlet of the culvert are armored with rock and mulched with straw.

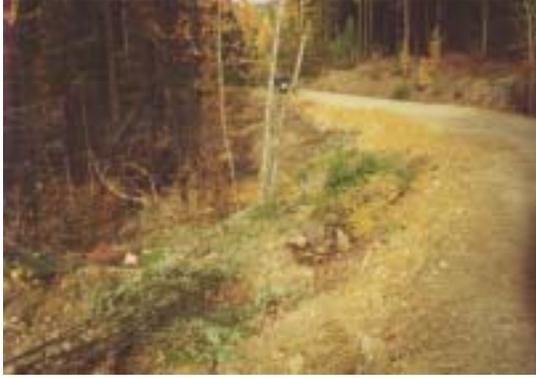
Photo 2

The windrow is 100 yards long (photo 2). The average diameter of the slash ranges from 1 to 4 inches, consisting mostly of western larch and Douglas fir branches. The 9-foot slope between the slash-filter windrow and the road surface is thoroughly seeded and mulched.

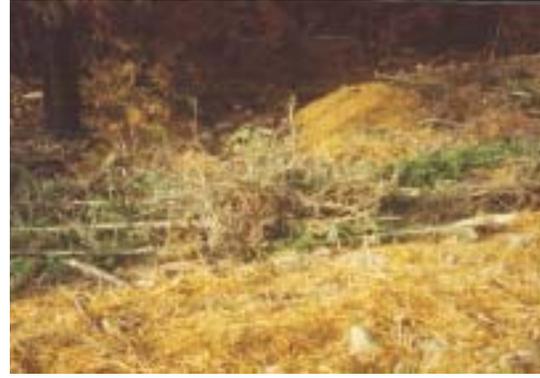
Photo 3

An adequate amount of slash was used in the construction of the windrow (photo 3). Erosion has not occurred on this site.

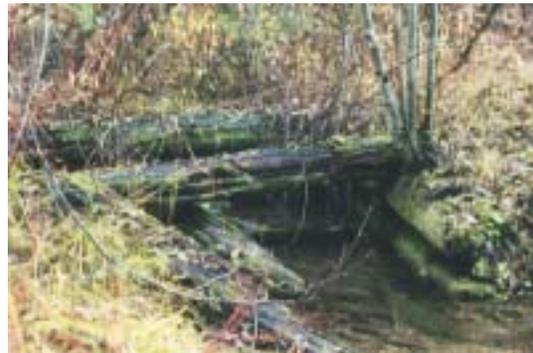
Photo 1

On Camp Creek, a small excavator was permitted next to the creek to remove an old log bridge (photo 1).

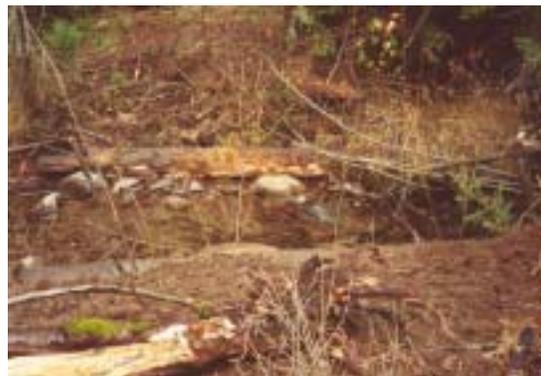
Photo 2

The excavator, used to remove the bridge abutment at Camp Creek, had a track approximately 10 feet wide. For the removal, only one abutment was eradicated. The excavator worked from one side of the stream. Disturbed areas of the stream banks and areas where the excavator tracked were seeded and mulched with straw following the removal. Willow and red-osier dogwood slips were planted along the stream banks (photo 2).

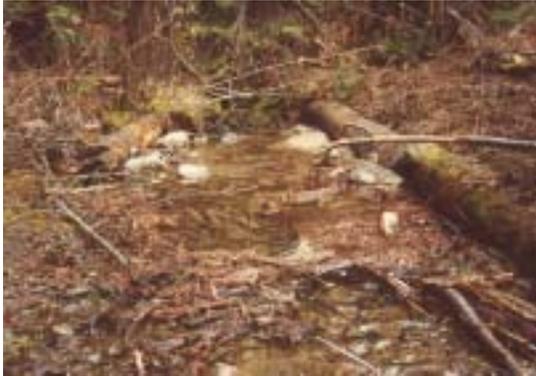
Photo 3

The streambed was not damaged during the removal. Minimal pieces bark and wood splinters remained from the abutments, and could be washed downstream during high runoff (photo 3).

Minimal sediment displacement was observed when the abutment was removed (Photo 3). The excavator was on site for less than one day, and did not cross the stream. The surface area disturbed was minimal due to the use of a smaller excavator.

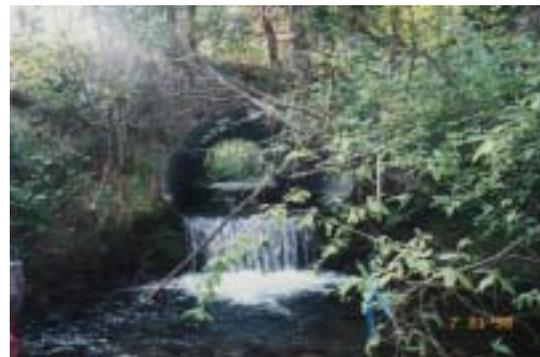
Photo 1

The monitoring site culvert was considered too small and had a 2.8-foot drop at the outlet, preventing fish from migrating

upstream. In 1979, Siegel Creek averaged 12 feet wide when bank-full. The culvert forced the stream to be necked down to 8 feet, thereby increasing water velocity passing through the culvert. By 1998, the increased velocities had scoured the streambed to a depth of 6 feet below the bottom of the culvert. In addition it widened the channel to 15 feet at the outlet (photo 1).

The culvert on Road 17384 was removed in stages. First, straw-bale sediment buffers were placed. Then brush and fill were removed from the site, and a clean-water diversion was installed. Next, the culvert was removed. Lastly, the stream channel was reshaped and stabilized.

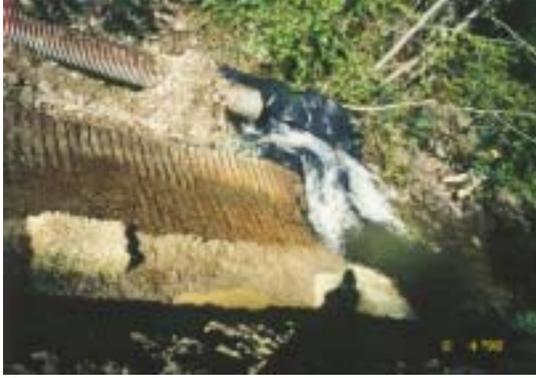
Photo 2

At low flow, the stream was diverted through a by-pass culvert to keep fill and debris from washing into the stream (photo 2). After the culvert was removed, the channel was reshaped and contoured back to the natural grade (photo 3). Step-pools were created to match upstream and downstream grades, and to provide fish habitat. Streambanks were seeded, mulched with straw, and covered with slash to protect the bare soil.

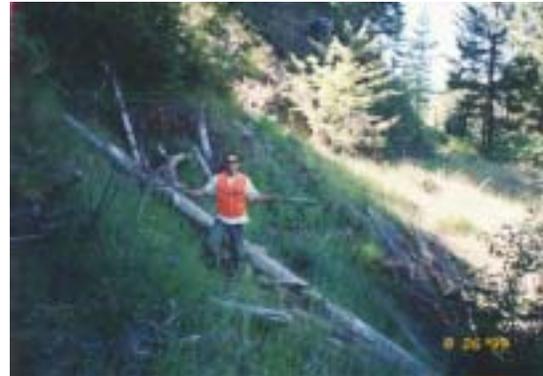
Photo 4

alternate stream route, is now covered with grass and slash, and conforms to the natural bank. Diverting the original channel greatly reduced the amount of sediment delivered to the stream. Sediment concentrations increased for a short period, but decreased to pre-removal levels in 24 hours. About 500 cubic yards of fill were excavated to remove the culvert. Water monitoring demonstrated that less than 2 cubic yards of fill were lost in removal. Areas impacted by construction were restored to natural grade, condition and alignment (photo 4).

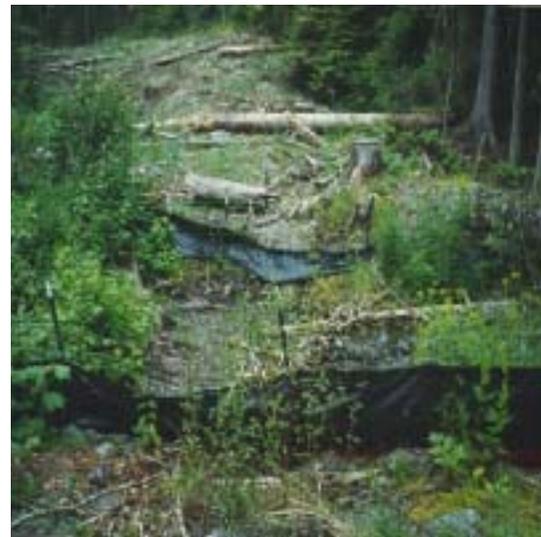
Photo 1

A temporary bridge was installed as a crossing structure at LaValle Creek for a short-term road, 19205. A silt fence constructed on each side of the stream during installation prevented disturbed soil from entering the stream (photos 1 & 2).

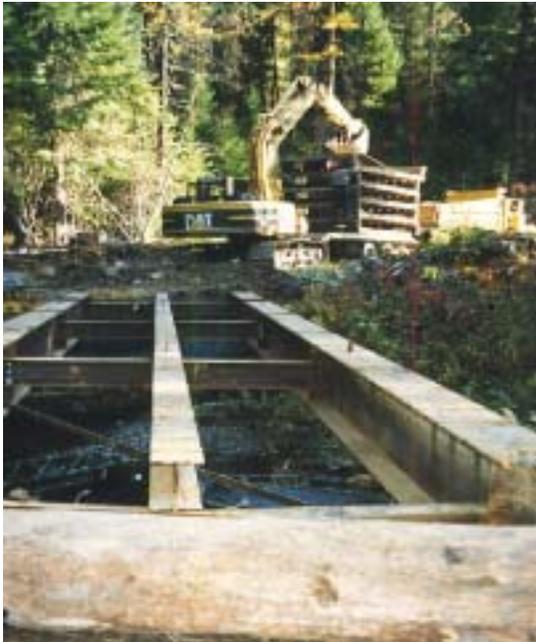
Photo 3

damaging the channel. Then, concrete abutments were poured on both sides of the stream for support. Next, the temporary bridge was set in place (photos 3). After use, the bridge was removed in the reverse order. The impacted area was then seeded and covered with slash. Finally, road approaches on both sides of the stream were re-contoured.

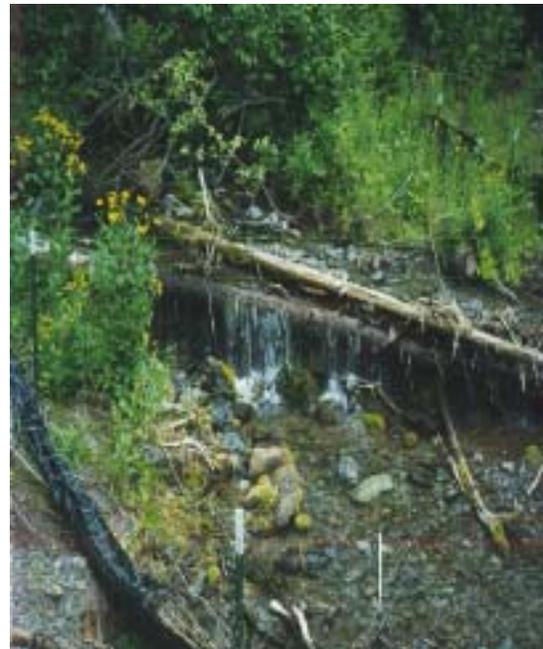
Photo 4

Sedimentation was not visible at the site. Vegetation is reestablishing. Overall, the channel was closely restored to pre-project conditions (photo 4).

Smaller debris may need to be added to the slash filter windrow. Treetops and branches could be utilized in the slash-filter windrows on both sides of the stream. Using a combination of smaller and larger slash in the windrow, compacted tightly together, would increase the effectiveness of the filter and provide additional bank protection. Planting willows or dogwood slips on the stream banks would also increase stability.

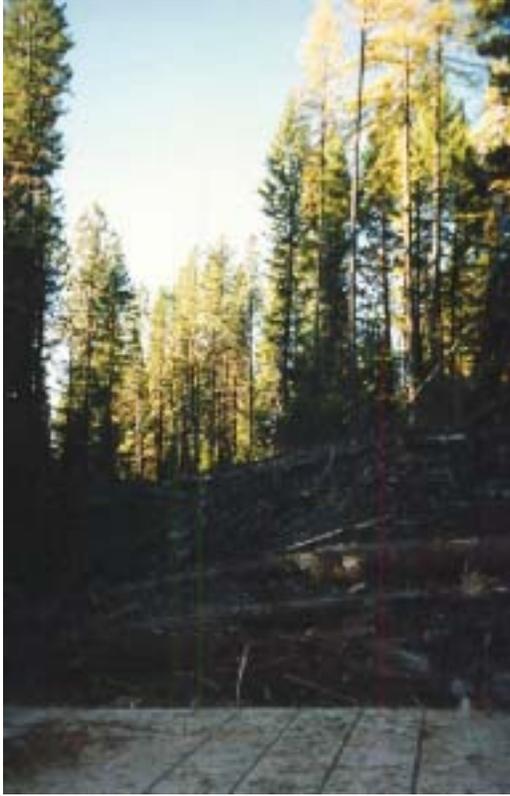
Photo 5

The temporary bridge effectively met the desired objectives. The stream was protected from damage. Keeping machinery out of the stream limited disturbances. Fish were able to pass under the bridge and the natural stream flow was not constricted. After the bridge was removed, the road was successfully obliterated, seeded and covered with slash (photo 5).
