Obliteration of Temporary Roads, BMP 15.25

Stabilization of Fire-Suppression Related Watershed Damage, BMP 18.05

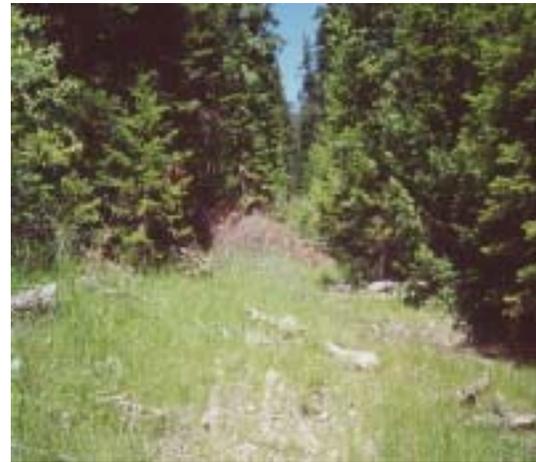
Photo 1

The monitoring area is approximately 100 feet from the stream. Grass has established, averaging 6 to 8 inches tall in most places (photos 1 & 2).

The road prism has been obliterated and a natural slope is restored. Slash of different sizes was scattered on the site: 70 percent is less than 3 inches thick, 25 percent is 2 to 4 inches, and the remaining 5 percent is 7 to 10 inches (photos 1 & 2). Erosion was not observed on site.

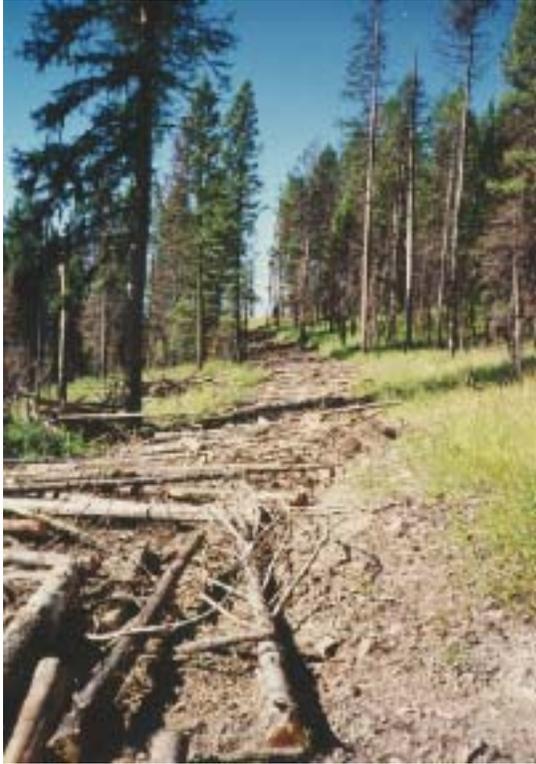
Photo 2

Approximately 65 percent of the slash scattered on the road is 6 to 10 inches thick, with the remainder being 6 inches or less. Large root wads and logs are also present on site.

fill-slopes and travelway to their natural contour. Next, the soil was seeded and fertilized. Finally, slash was scattered over the site to prevent erosion and supply nutrients to the soil (photo 2).

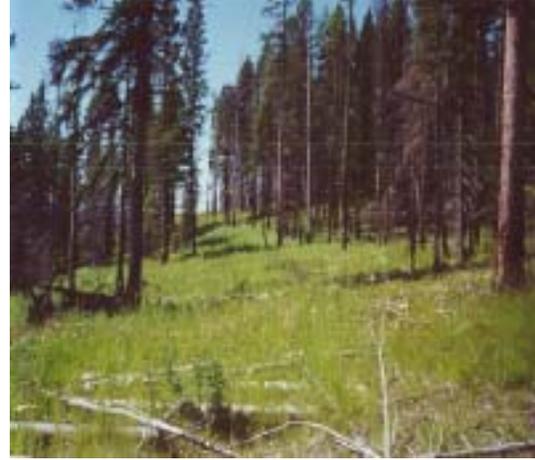
Photo 3

Re-vegetation has been successful. Grass growth ranges from 1 to 2 feet in height. The thick vegetation will serve as an effective sediment filter after obliteration (photo 3).

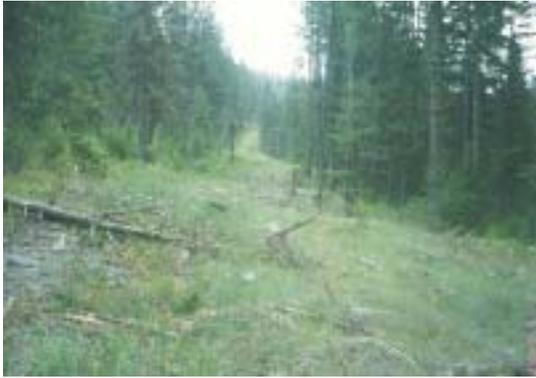
Photo 2

The site recovered rapidly. Grass is growing to a height of 2 to 12 inches (photo 2). Slash covers 40 percent of the total disturbed area, providing long-term nutrients.

Nearly 70 percent of the slash left on the site is 1 to 4 inches thick, with the remaining 30 percent 3 to 6 inches thick. Sedimentation and erosion are not apparent.

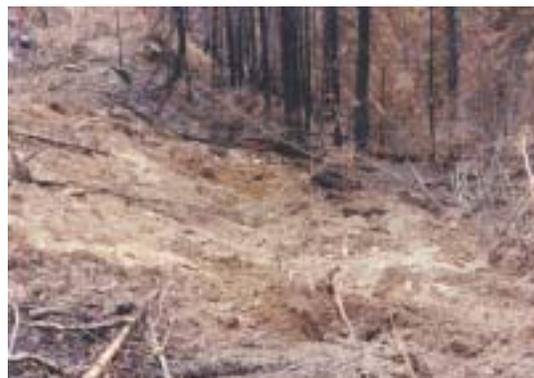
Photo 1

Fall rainstorms resulted in overland flows from the burned unprotected slopes, causing surface erosion in the upper portions of the ephemeral draw. A gully began to form at the upper end of the draw, increasing in width and depth as it continued down the drainage through each of the six-jammer road crossings.

The re-contoured crossing closely matches the natural slope of the draw. The road was ripped 8 to 12 inches deep, creating a surface which water can infiltrate. Slash diameters varied widely, with a 2-inch average. The slash will add nutrients to the soil and provide shade for vegetation. Through a combination of slash and vegetation, the jammer roads will stabilize. Because the fills have been removed from the draw, sedimentation will be minimized and the natural drainage system restored.

To eliminate mass movement of soil during runoff, the fill in the draw was removed and the natural contour of the slope was restored (photo 1). In 1995, Best and others found that on burned hill slopes, from 80 to 90 percent of the erosion is a result of road fill failures and diversions at stream crossings.

To increase the effectiveness of pulling the fill from the draw, both sides of the road leading away from the draw were ripped and seeded. Slash was left on site by the process of ripping the vegetated jammer roads. This practice allows the slope to regain its natural drainage. Eliminating the road fill also restores the natural water flow pattern through the draw.
