Bear Creek Watershed - Rapid Trail Condition Assessment

Assessment prepared by:
Amber Shanklin, RMFI Program Director

December 18, 2013

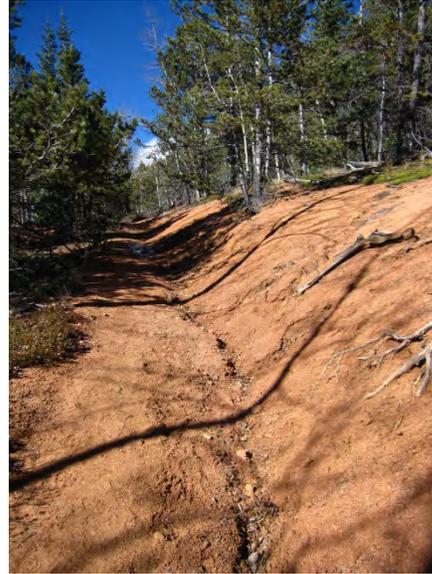
Example of Class III within Zone
A

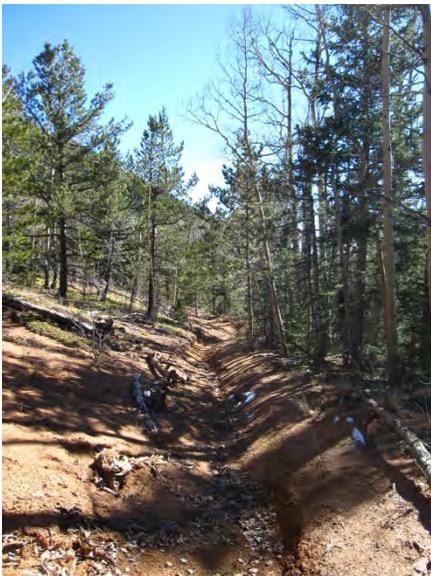
Example of Class III within Zone
A

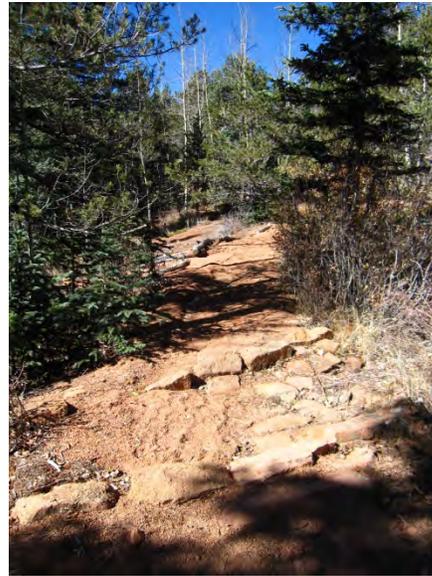
This zone lies within the Pike National Forest and currently dead ends at the Colorado Springs Utilities South Slope watershed. The length of trail included in the assessment of this zone is approximately 6,099 feet. Sixteen sections were assessed in Zone A. The average trail tread width is approximately 40 inches. One section is Class IV, 7 are Class III, 4 are Class II, and 4 are Class I. One structure failure was discovered in Zone A; an in-trail drain has filled and is no longer functional.

Structure failure within Zone A

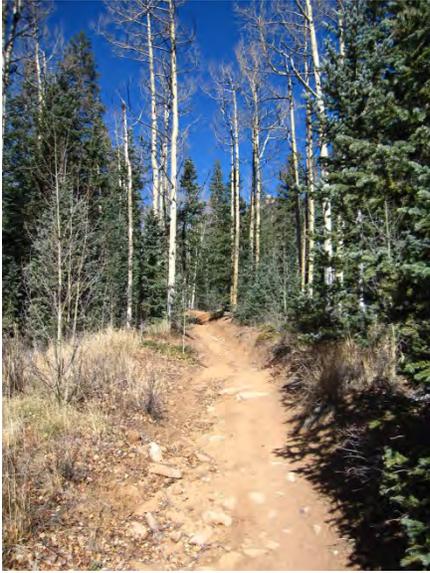
Example of Class III within Zone
B

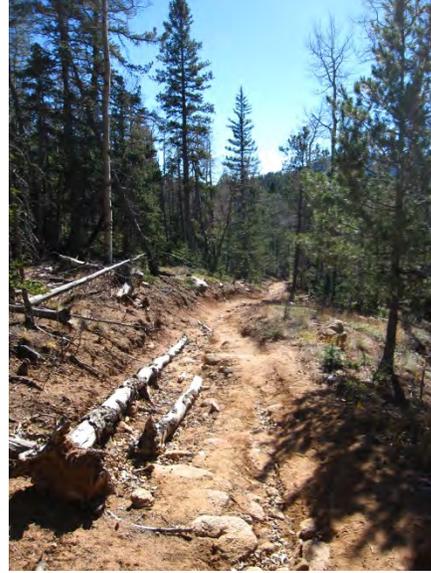
Example of Class IV within Zone
B

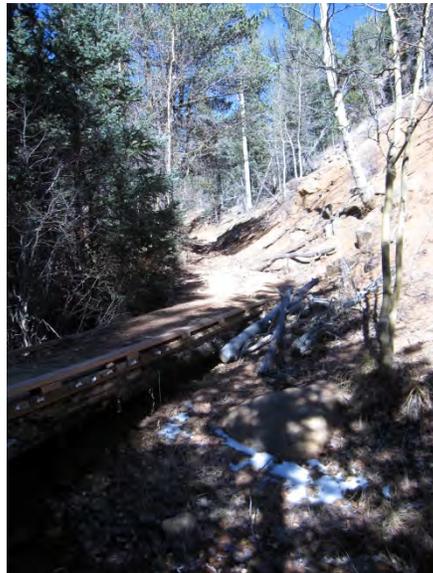
Zone B lies exclusively on Colorado Springs Utilities land. Approximately 5,907 feet of trail was assessed within this zone. Sixteen sections were assessed in Zone B. Two sections are Class IV, 3 are Class III, 11 are Class II, no Class I sections exist in this Zone. The average trail tread width is approximately 50 inches. One structure failure was discovered in Zone B, a bridge to keep users out of the stream has become inundated with sediment and continues to contribute sediment into the stream.

Structure failure within Zone B

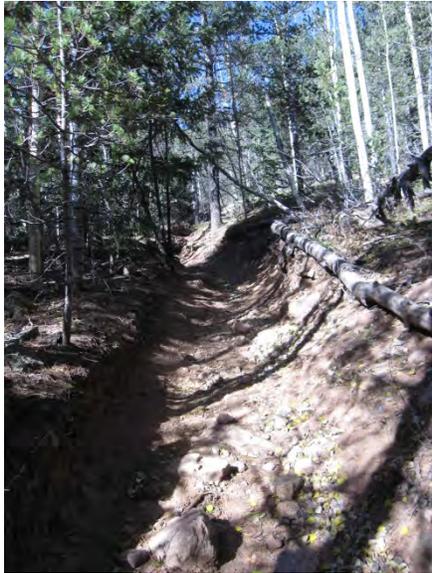
Example of Class III within Zone C

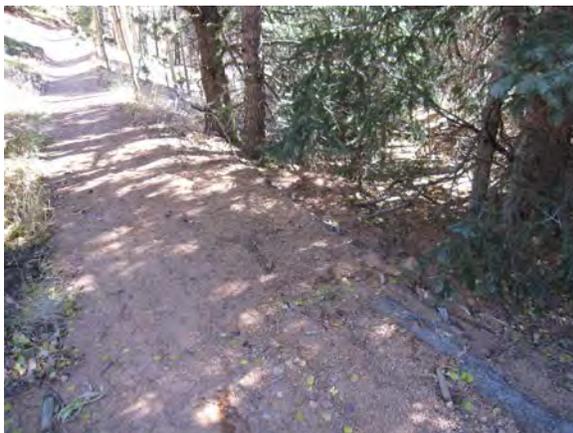
The assessment for Zone C covered approximately 8,753 feet of trail on CSU property. Trail #720A connects with #667 in this zone. Twenty-four sections were assessed in Zone C. No Class IV sections are present in this section, 12 are Class III, 11 are Class II, and 1 is Class I. The average trail tread width is approximately 47 inches. One structure failure was discovered in Zone C; an outslope retaining wall is no longer functioning properly and is causing sediment to be deposited into the stream.

Structure failure within Zone C

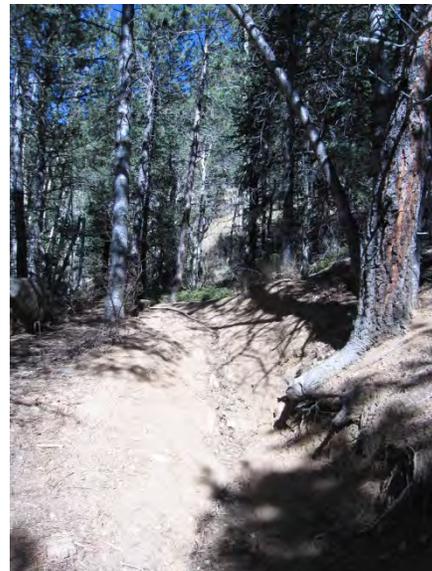
Example of root exposure within Zone C

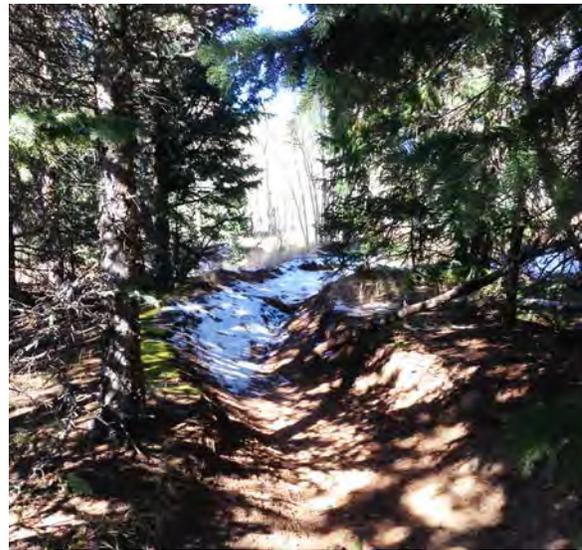
Example of Class III within Zone D

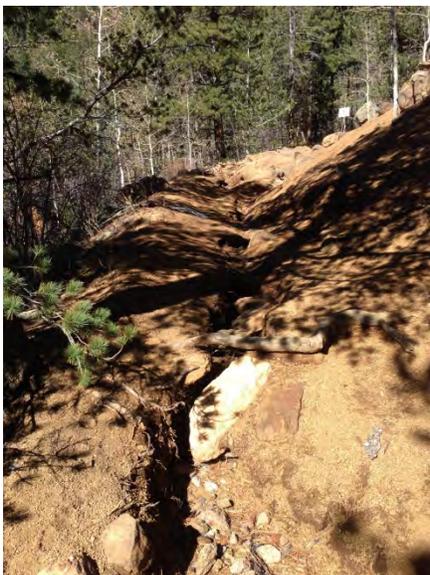
Example of Class IV within Zone D

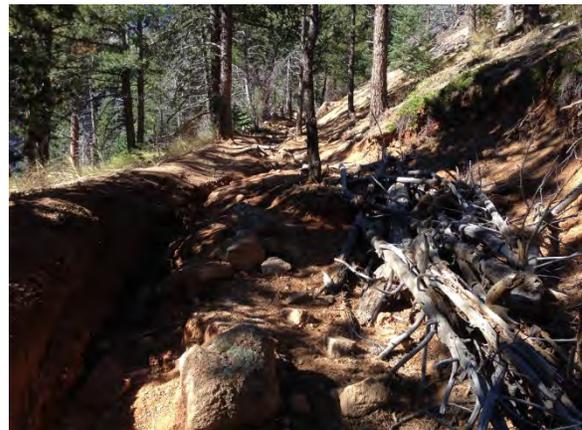
This Zone encompasses the last section of Trail #667 on CSU land. The trail along Zone D that was assessed for this document stretches approximately 5,057 feet adjacent to Bear Creek. Fourteen sections were assessed in Zone D. Three sections are Class IV, 2 are Class III, 7 are Class II, and 2 are Class I. The average trail tread width is approximately 37 inches. Four structure failures were discovered in Zone D. Within Section D-14 an extremely incised portion of trail that is approximately 10 feet wide was discovered, this was not captured within the assessment framework and was individually identified as a 'hot spot' for the purposes of this assessment.

Hot Spot within Zone D

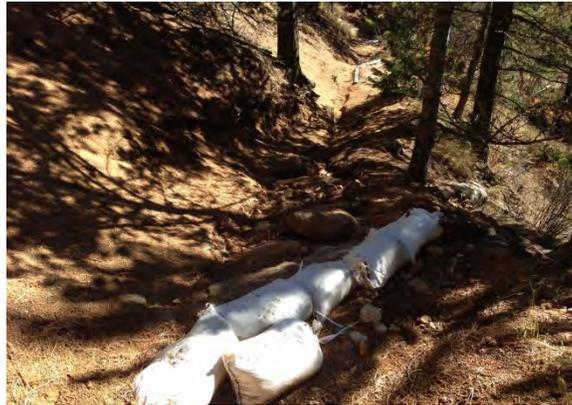
Example of Class IV within Zone E

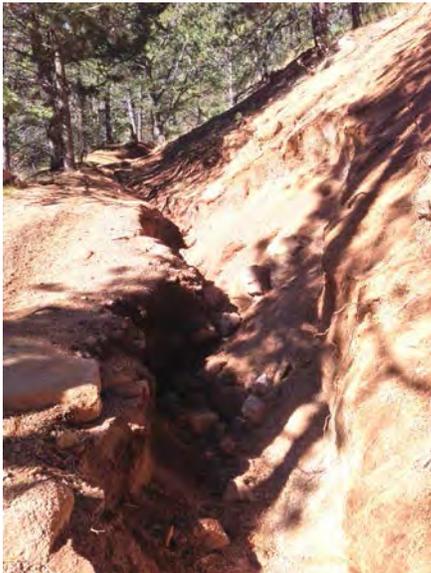
Example of Class IV within Zone
E

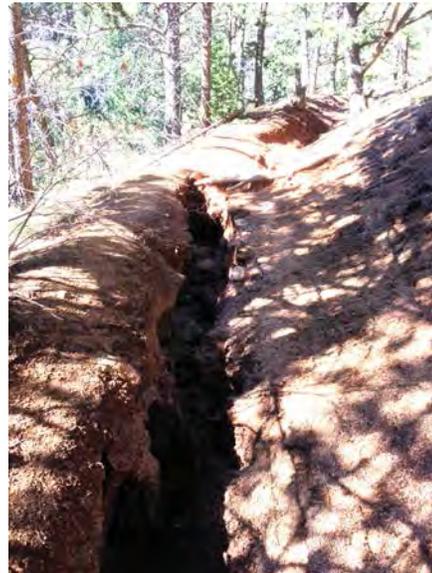
Example of Class IV within Zone
E

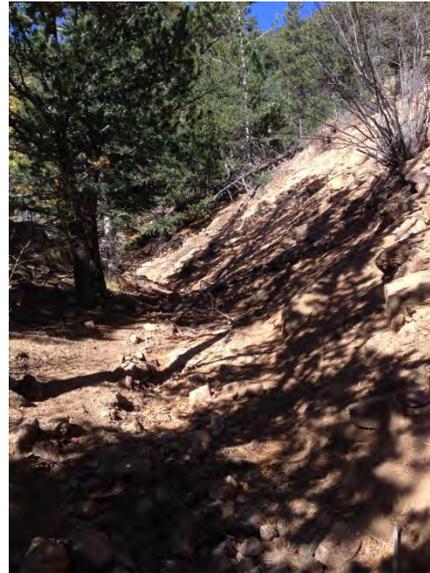
Example of Class III within Zone F

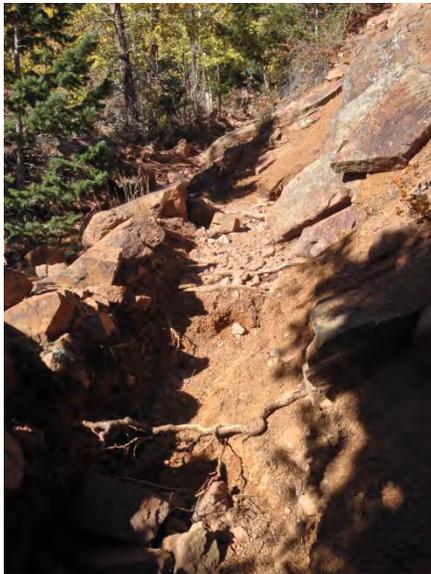
Example of Class IV within Zone F

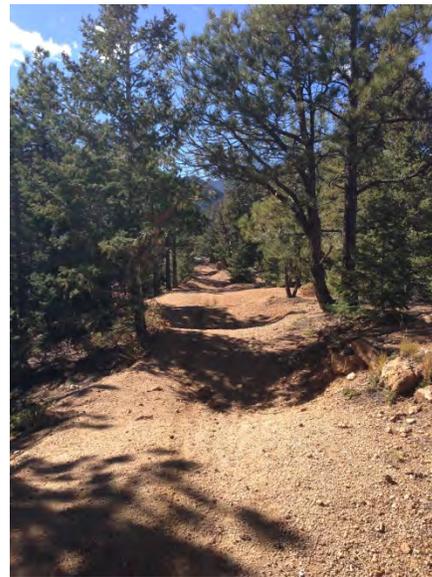
Example of Hot Spot within
Zone G

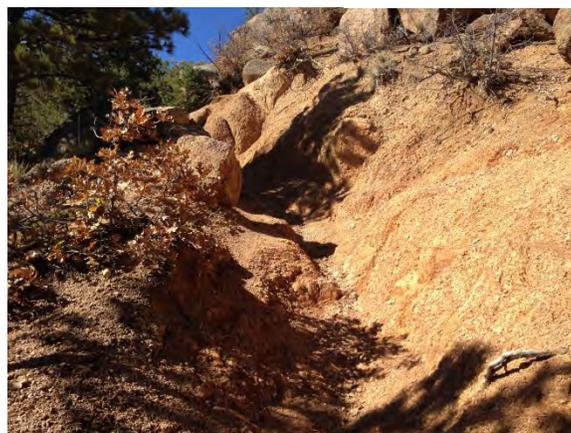
Example of Hot Spot within Zone G

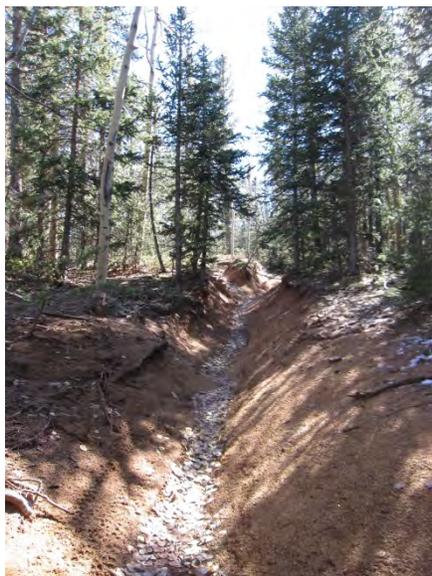
Example of Class III within Zone J

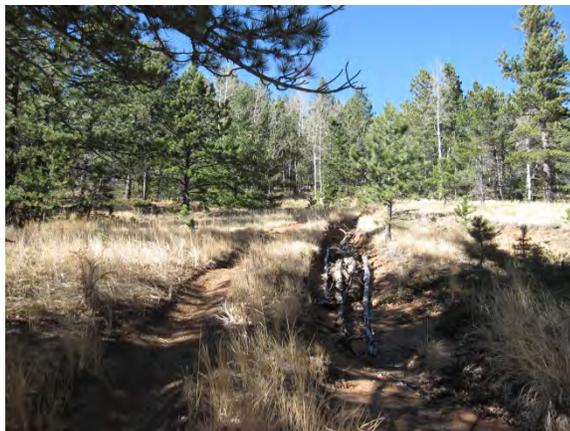
Example of Hot Spot within Zone J

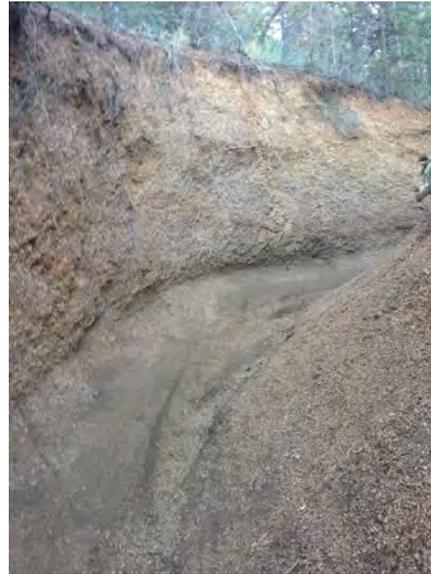
Example of Hot Spot within
Zone L
