Bear Creek Watershed – 2014 Rapid Trail Condition Assessment

Assessment prepared by:
Amber Shanklin, RMFI Program Director

July 1, 2014

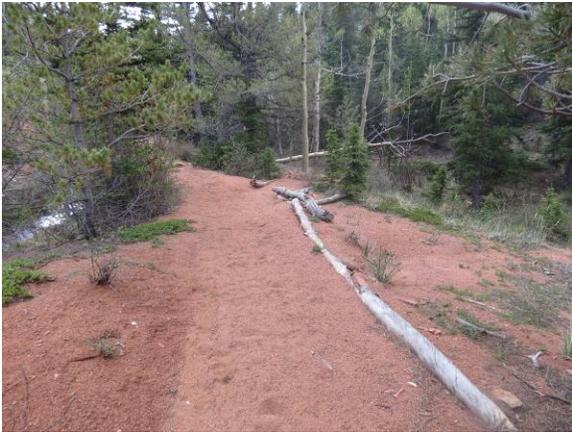
This zone lies within the Pike National Forest and currently dead ends at the Colorado Springs Utilities South Slope watershed. There are approximately 6,099 feet of trail in this zone. Of the 16 sections originally identified for the 2013 assessment, 6 were re-assessed for the purpose of this assessment. Data was collected from 12 individual locations along the trail within these 6 sections: 2 locations were classified as Class I, 8 were Class II, and 2 were Class III. There are 4 locations along the trail in Zone A where sediment is currently entering the stream or may enter the stream in the near future. Three locations along the trail are currently depositing sediment into the stream and 1 will deposit sediment soon if the sediment detention structure designed to keep sediment out of the stream is not maintained.

Sediment deposition within Zone A

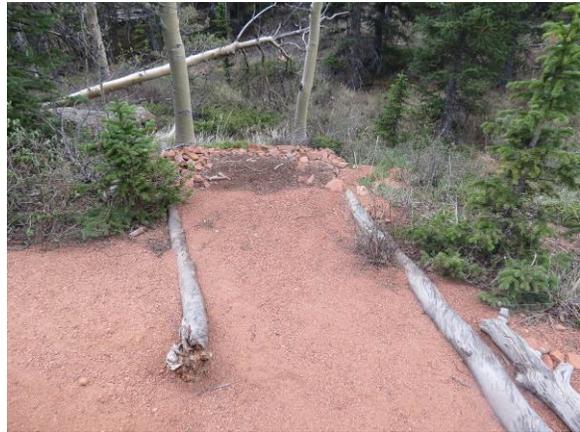
Structure in need of maintenance within Zone A

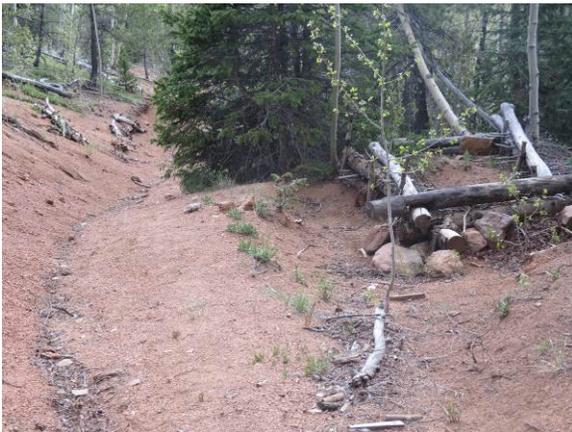
Sediment detention structures not functioning properly, water and sediment being diverted on trail

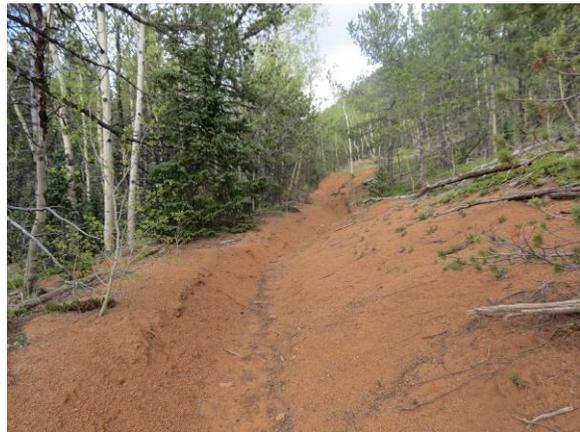
Class III section within Zone A

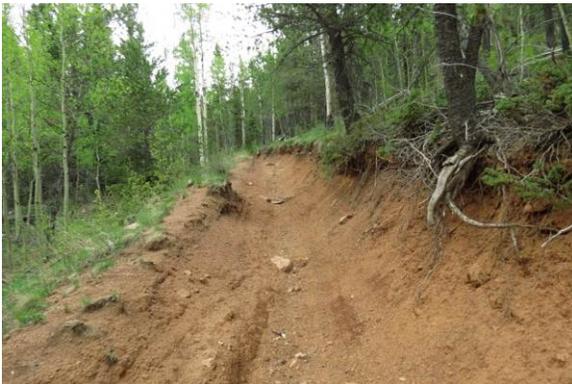
Example of Class II within Zone B

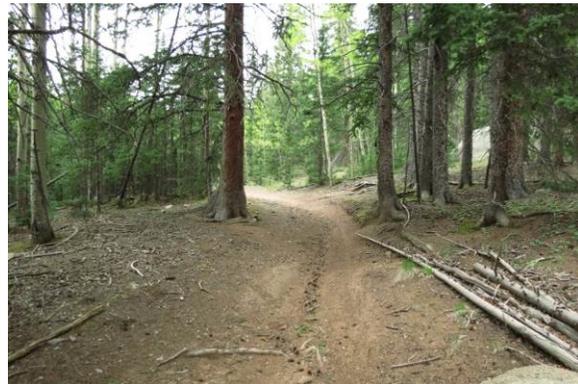
Example of Class I within Zone B

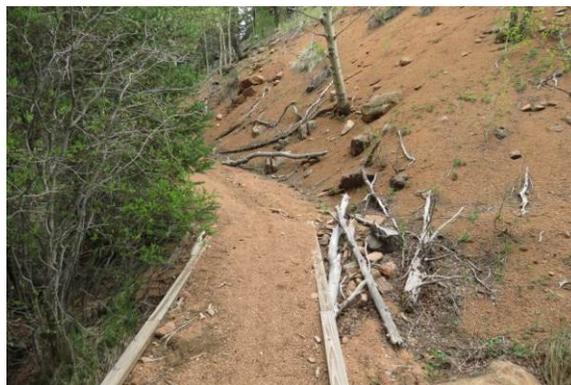
Sediment entering stream within Zone B

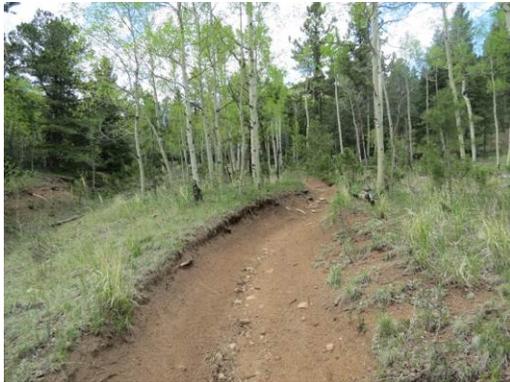
Example of Class II within Zone C

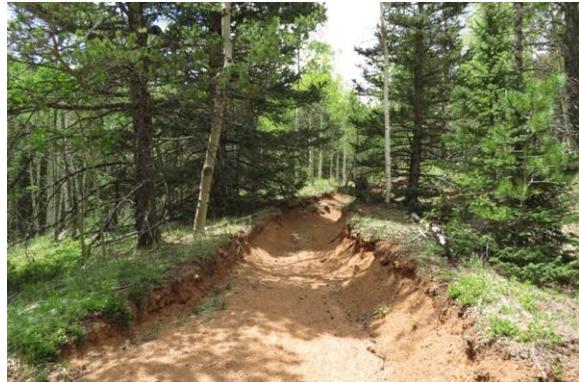
Example of Class II within Zone C

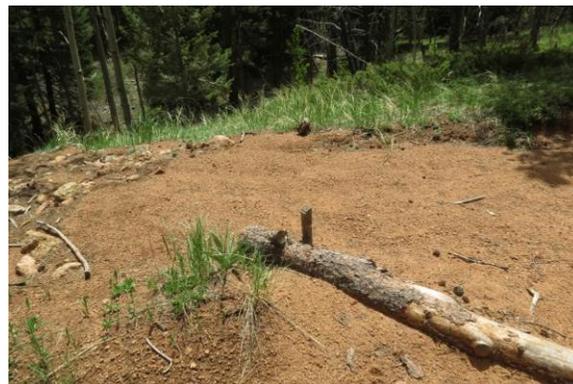
Sediment detention structure has reached capacity, needs to be maintained so sediment does not enter stream.

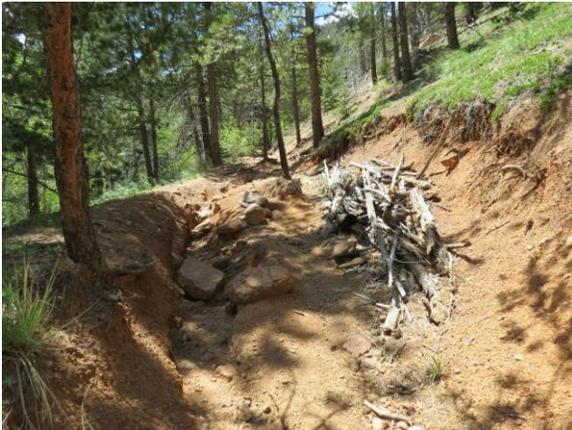
Example of Class III within Zone D

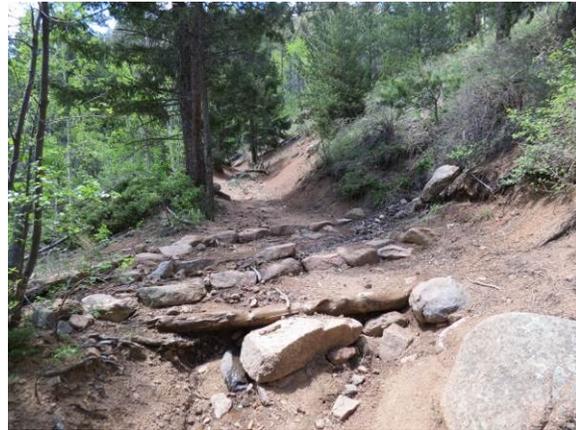
Structure that needs to be maintained within Zone D

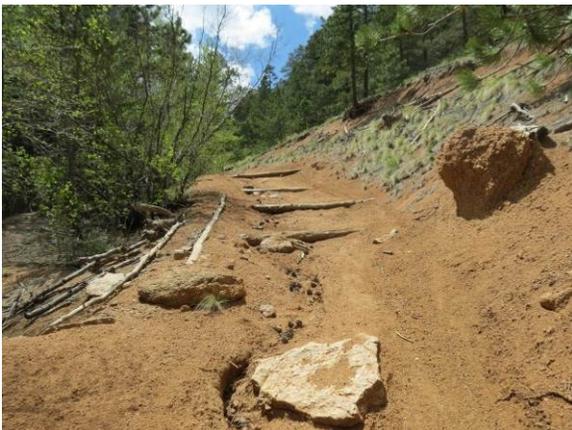
Example of Class III within Zone D

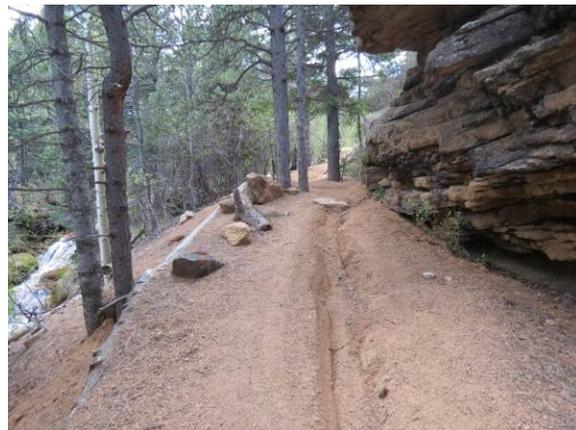
Sediment entering stream

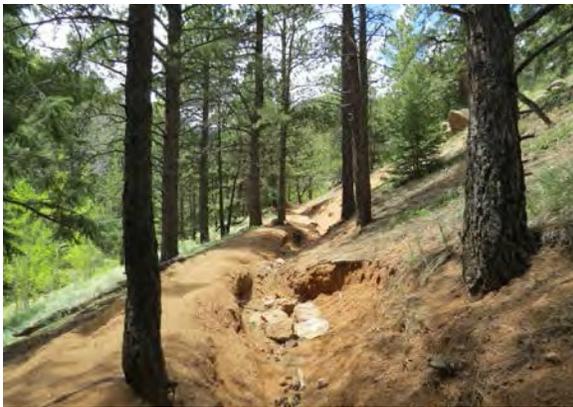
Example of Class II within Zone E

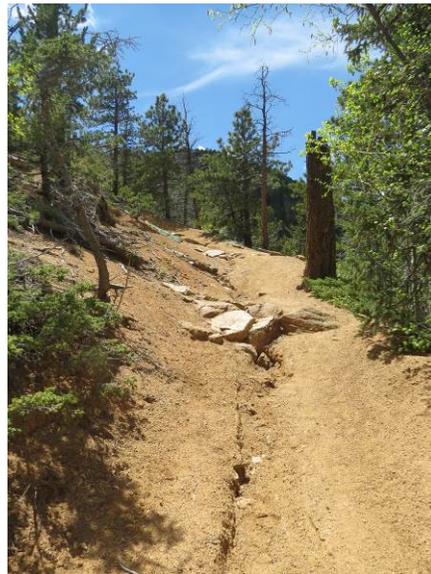
Hotspot within Zone E

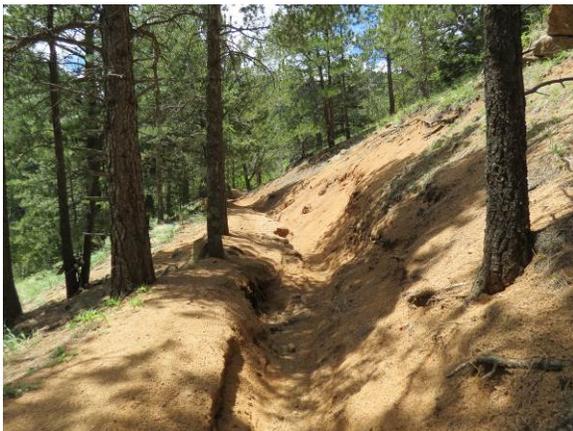
Example of Class II within Zone E

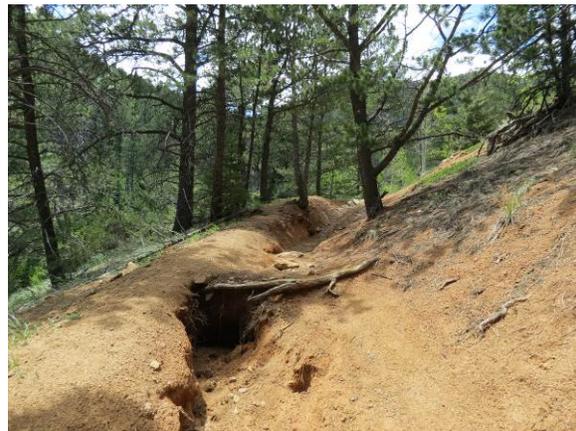
Example of Class II within Zone E

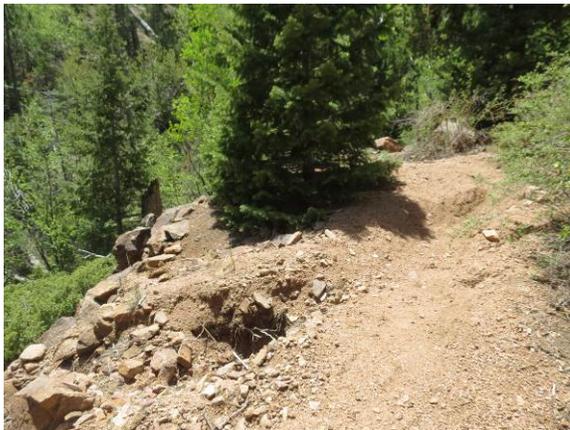
Sediment entering the stream within Zone F

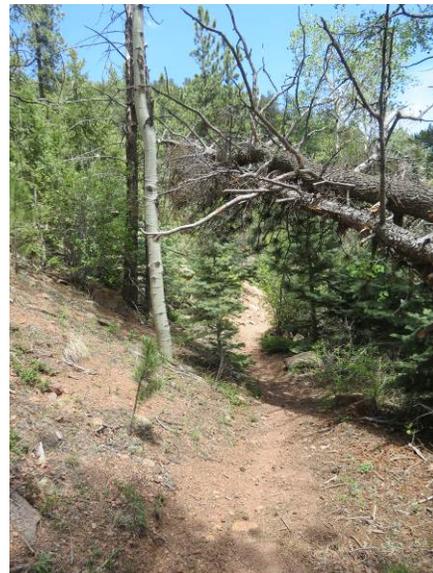
Example of Class I within Zone F

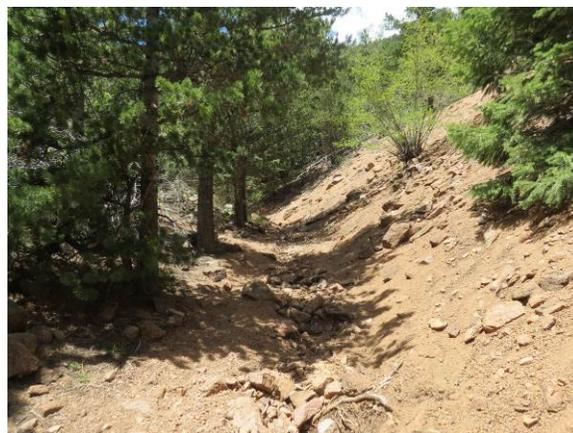
Example of Class II within Zone F

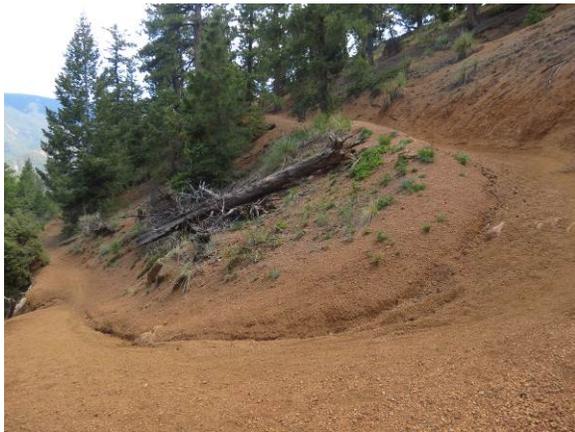
Steep switchback causing loss of vegetation and gully within Zone G

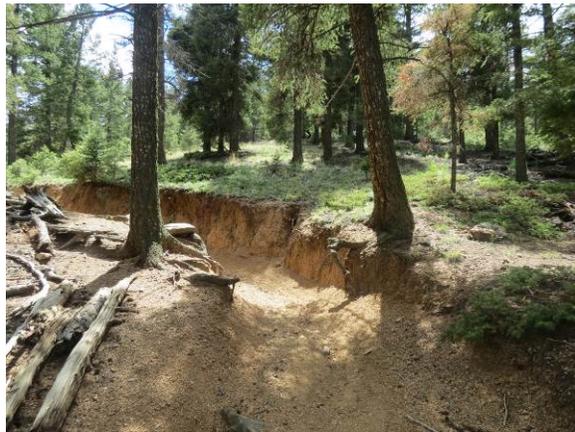
Hotspot location within Zone G

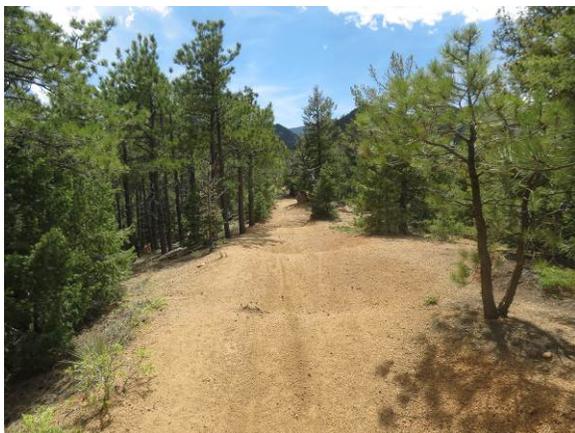
Hotspot location within Zone G

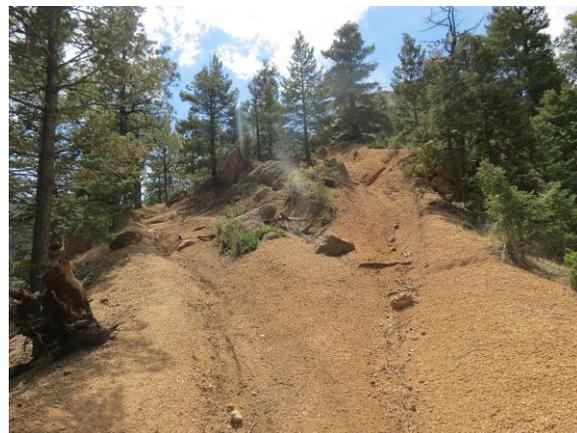
Hotspot location where trail splits within Zone G

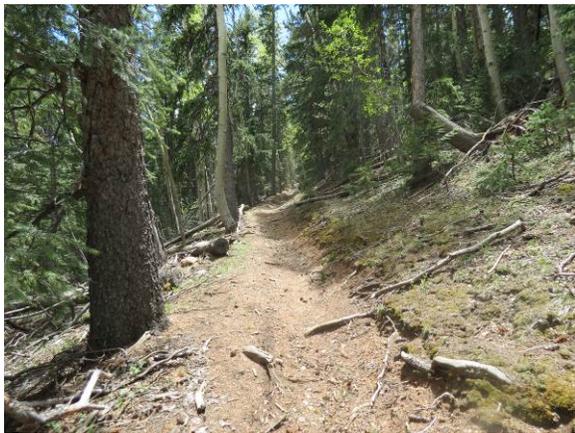
Example of Class I within Zone I

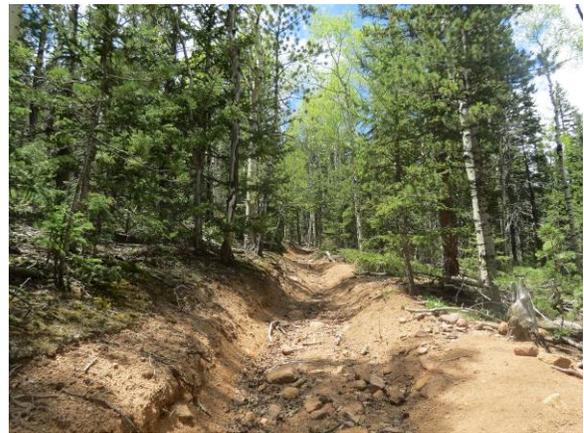
Example of Class III within Zone I

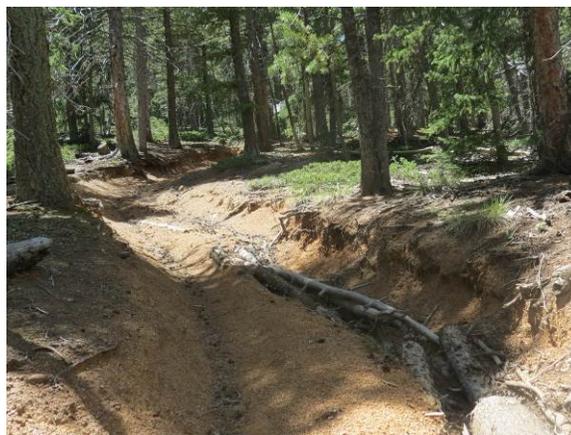
Example of Class III within Zone I

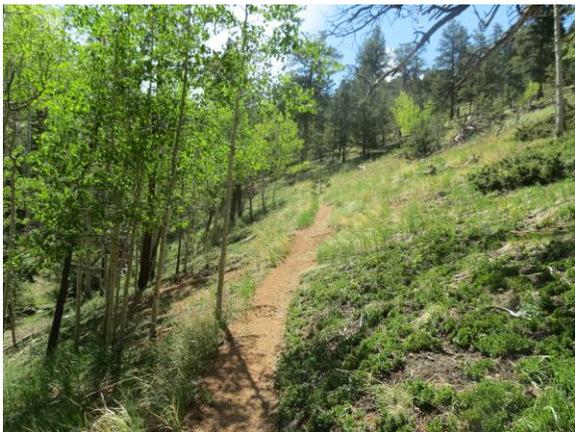
Example of Class I within Zone J

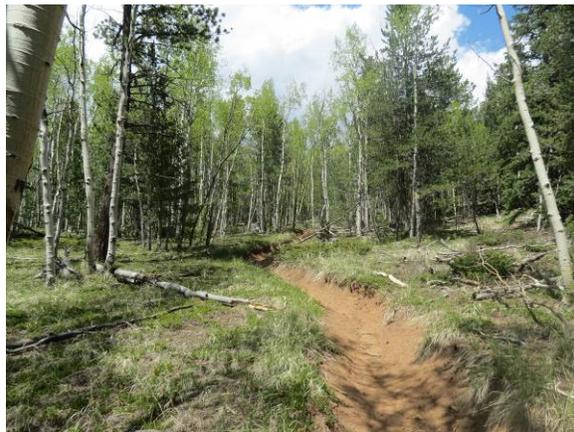
Example of Class II within Zone J

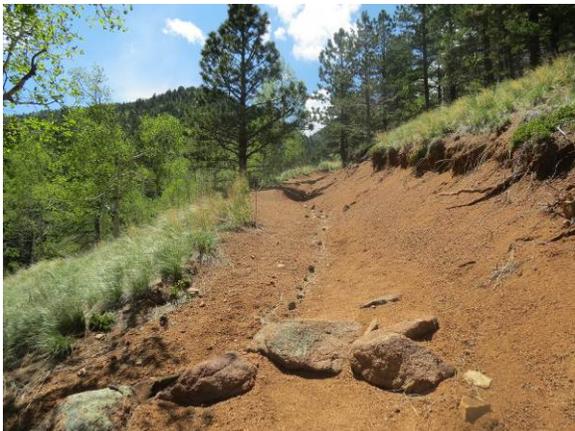
Example of Class III within Zone J

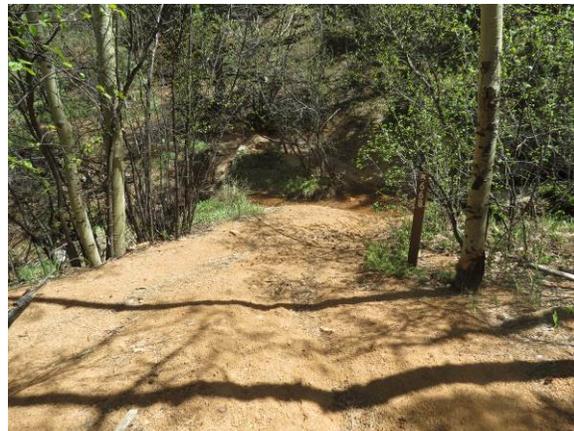
Example of sediment entering the stream within Zone J

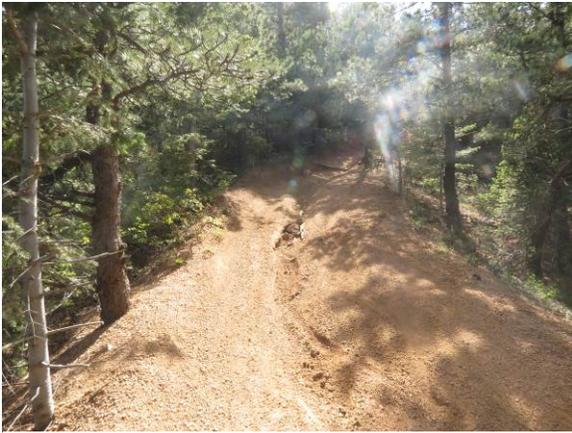
Example of Class II within Zone L

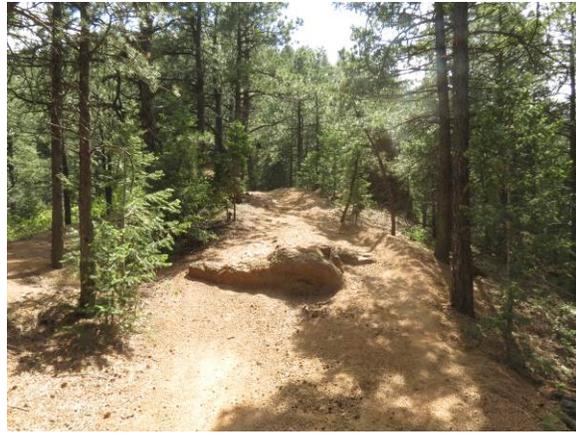
Example of Class I within Zone L
