**SUBJECT: Report of Limited Pre-Renovation Lead-Based Paint Inspection Services and Toxic Characteristics Leaching Procedure (TCLP) Sample Collection Services
2014 Interior Renovation Project
Rock Creek Work Center, Beartooth Ranger District
Red Lodge, Montana
Tetra Tech Project No. 114-551407.100**

**Limited Pre-Renovation Lead-Based Paint Inspection
and TCLP Sample Collection Services**

**Rock Creek Work Center
Beartooth Ranger District**

Red Lodge, Montana

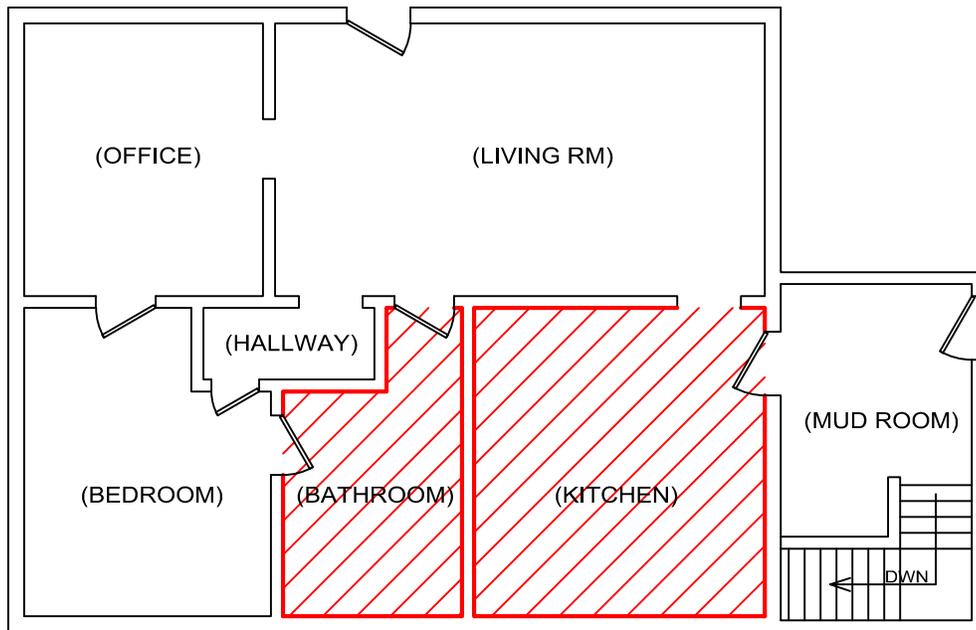
FIGURE

XRF testing conducted during this inspection indicated that LBP as defined OSHA and EPA Standards is present on select interior and exterior components. Interior components included white painted wallboard system walls and ceilings of the bathroom and kitchen, and the associated green painted trim. Exterior components included white and green painted components associated with the window units of the building. LBP as defined by the EPA is summarized in Table 1 below. Components with LBP (as defined by the EPA) are highlighted on Figure 1 provided in Attachment C. A complete listing of XRF readings collected during this inspection is provided in Appendix D.

Table 1 Summary of Lead-Based Paint Rock Creek Work Center Beartooth Ranger District Red Lodge, Montana		
Location	Building Component and General Location	Highest Lead Concentration mg/cm ²
Interior	White painted wallboard system associated with interior walls of the Bathroom and Kitchen	7.3
Interior	White painted wallboard ceiling system associated with the Bathroom and Kitchen	7.1
Interior	White and green painted trim associated with Kitchen walls	1.8
Exterior	White painted wood components associated with exterior window units	7.9
mg/cm ² = milligrams per centimeter squared.

The LBP containing materials identified in Table 1 above, associated with the limited inspection completed by Tetra Tech on February 27, 2014 are recommended to be removed prior to disturbance activities. Tetra Tech recommends that prior to any renovation activities (where the identified LBP will be disturbed), that the LBP covered materials be stabilized or removed. The proper removal of LBP will protect workers from lead exposure, ensure that non-affected portions of the buildings are not contaminated, and reduce or eliminate the lead hazard in the building. It should be noted that while painted surfaces that tested less than 1 milligram per square centimeter are not considered an LBP by EPA regulations, OSHA does not recognize a threshold limit for lead in paint. Therefore safe work practices must be utilized when any amount of detectable lead is present. Tetra Tech recommends that renovation or removal involving painted surfaces with any amount of detectable lead be conducted by personnel who have received a minimum of 8-hours of Lead in the Construction Training (commonly referred to as "Lead Awareness Training").
