April 18, 2014

Ref.: 2010-084

Technical Memorandum
April 2014 Site Inspection Report
Blue Ledge Mine
Rogue River-Siskiyou National Forest

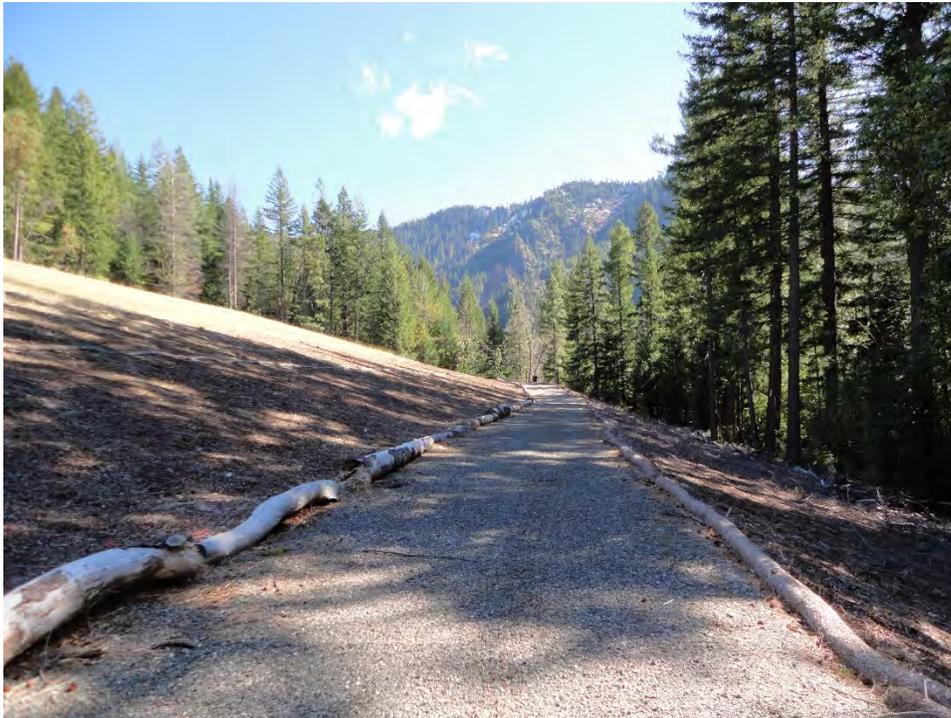
Photograph 1: View of access road, facing south. Note there is no evidence of erosion.
Blue Ledge Mine, Rogue River - Siskiyou National Forest, CA
Photographed by: Annica Nord (ERRG) Date: April 9, 2014

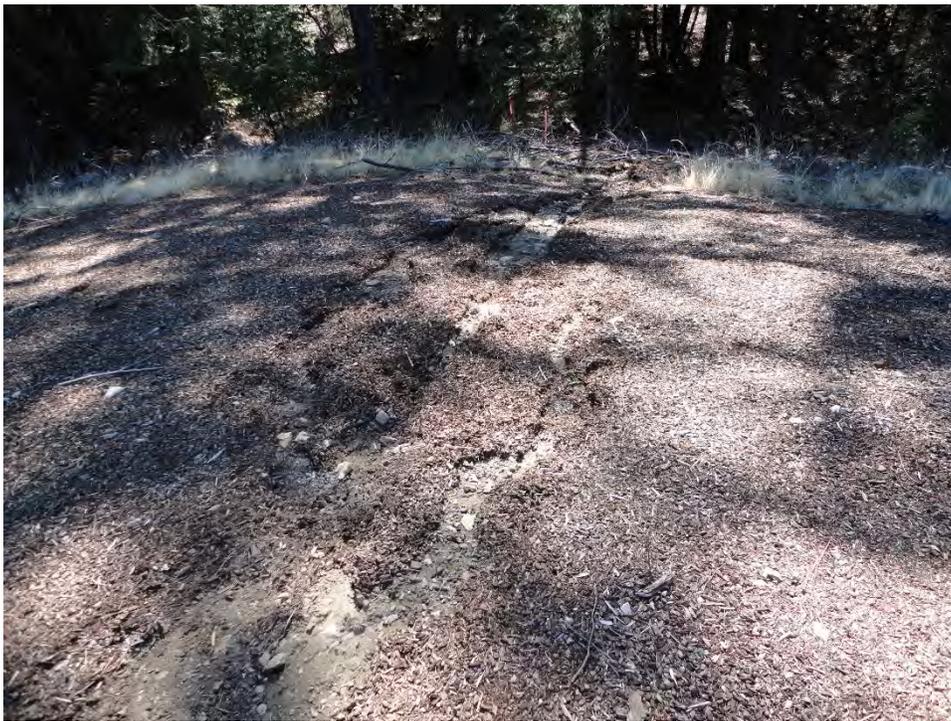
Comments: Minor erosion rills are evident near the sump. They were filled with soil. Additional straw wattles will be installed during the May inspection to divert water and prevent more erosion.

Photograph 2: Erosion rills below the sump. Rills were patched with soil.
Blue Ledge Mine, Rogue River - Siskiyou National Forest, CA
Photographed by: Annica Nord (ERRG) Date: April 9, 2014

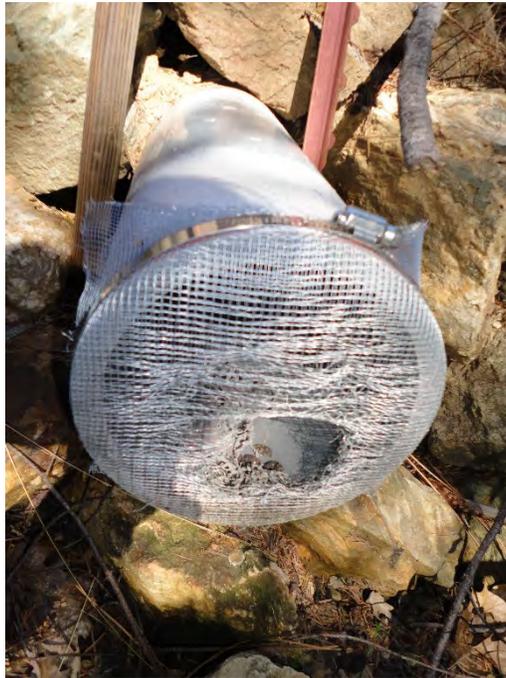
Comments: The anchor trench drain pipes are not blocked and no water is flowing from the drain. The screen was previously repaired with a second layer of screen over the pipe however, animals have scraped

Photograph 3: Anchor trench drain outlet water discharge, south end of repository.
Blue Ledge Mine, Rogue River - Siskiyou National Forest, CA
Photographed by: Annica Nord (ERRG)

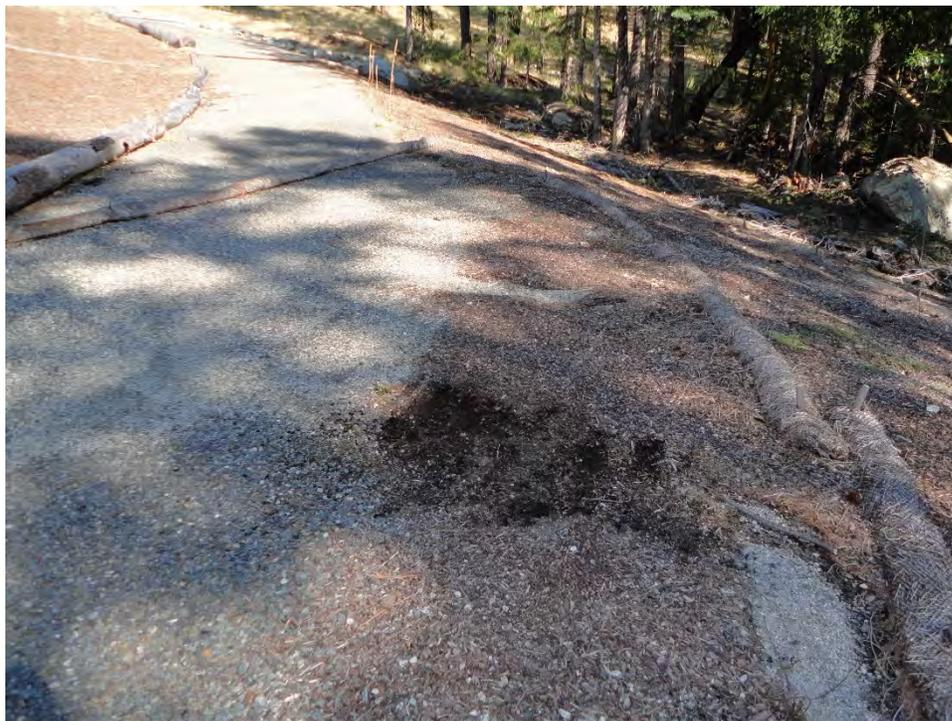
Photograph 4: Minor rilling on the south end of the repository. Rill in the foreground has been filled with soil. Second rill in the center of the photograph was later filled after the photograph was taken.

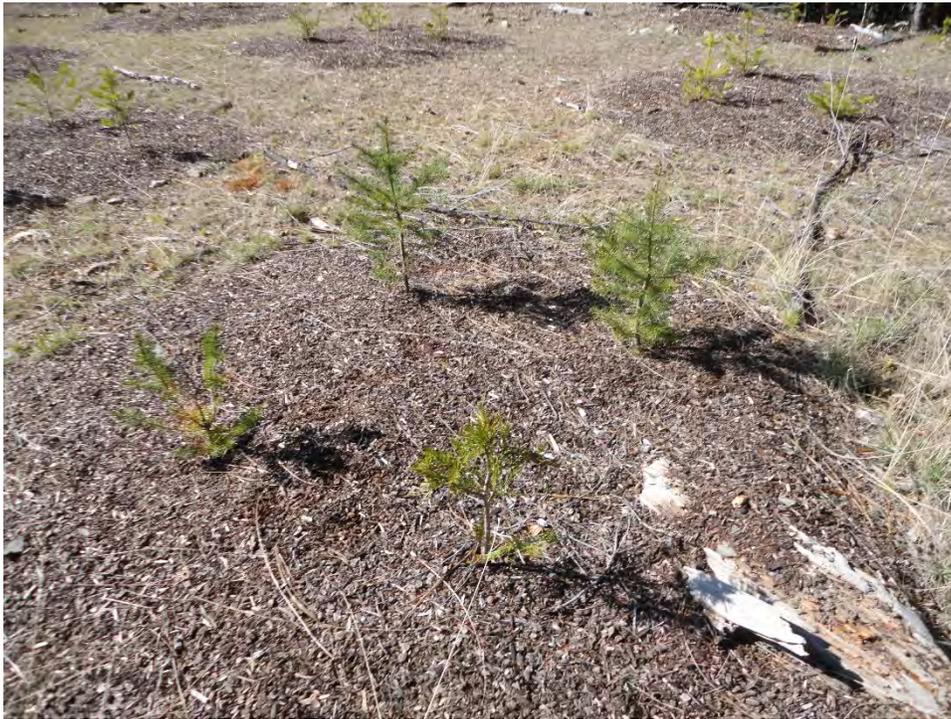
Comments: Evidence of animal browsing was observed in the incense cedars planted on the north storage area. The cedars appear similar in size to the pine and fir planted in the area.

Photograph 8: Plants at the North Storage area.
Blue Ledge Mine, Rogue River - Siskiyou National Forest, CA
Photographed by: Annica Nord (ERRG)

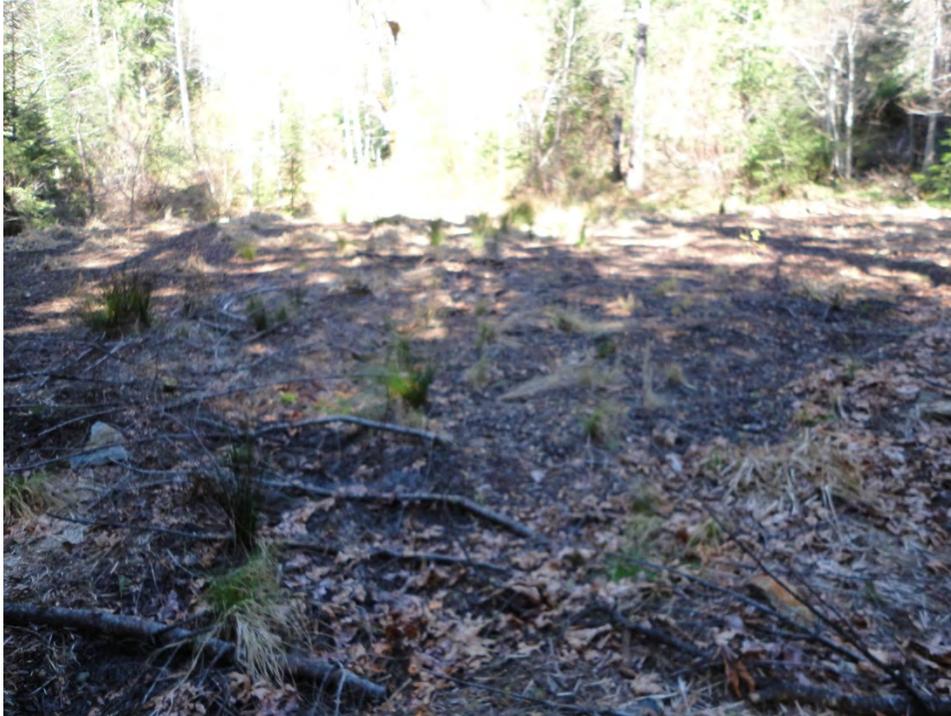
Photograph 9: South Storage area looking northeast. Plants are mostly dormant from winter.
Blue Ledge Mine, Rogue River - Siskiyou National Forest, CA
Photographed by: Annica Nord (ERRG) Date: April 9, 2014

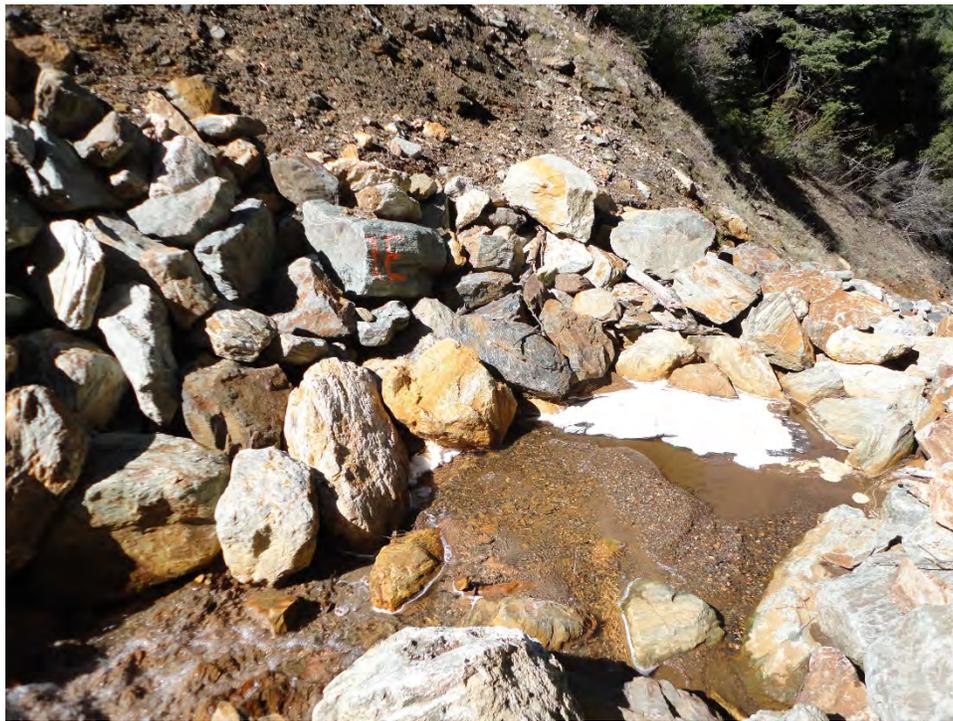
and comingling with the water coming down the main drainage and flowing through basin 1F. This is likely why the pH in basin 1E is much lower than basin 1F. There is effectively a split flow of water between the main drainage into basin 1F and the overflow of the USEPA acid seep basin that does not fully comingling until it reaches basin 1E. Basins 1E through 1A raised the pH by half a unit from 4.9 to 5.5 before entering Joe Creek. The limestone in the basins appears to be successful in raising the pH prior to entry into Joe Creek. The USEPA pilot treatment system was not visibly functioning at the time of this inspection.

Photograph 14: Sediment/pH Treatment Basin 1E. Mostly filled with sediment.
Blue Ledge Mine, Rogue River - Siskiyou National Forest, CA
Photographed by: Annica Nord (ERRG)

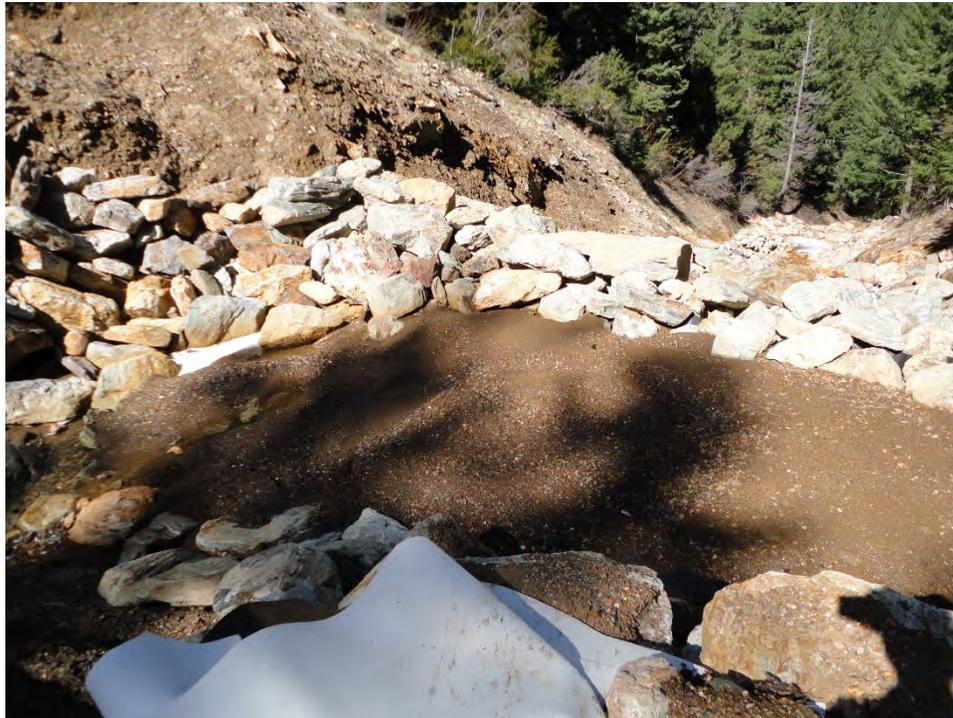
Photograph 15: Sediment/pH Treatment Basin 1F. Full of sediment.

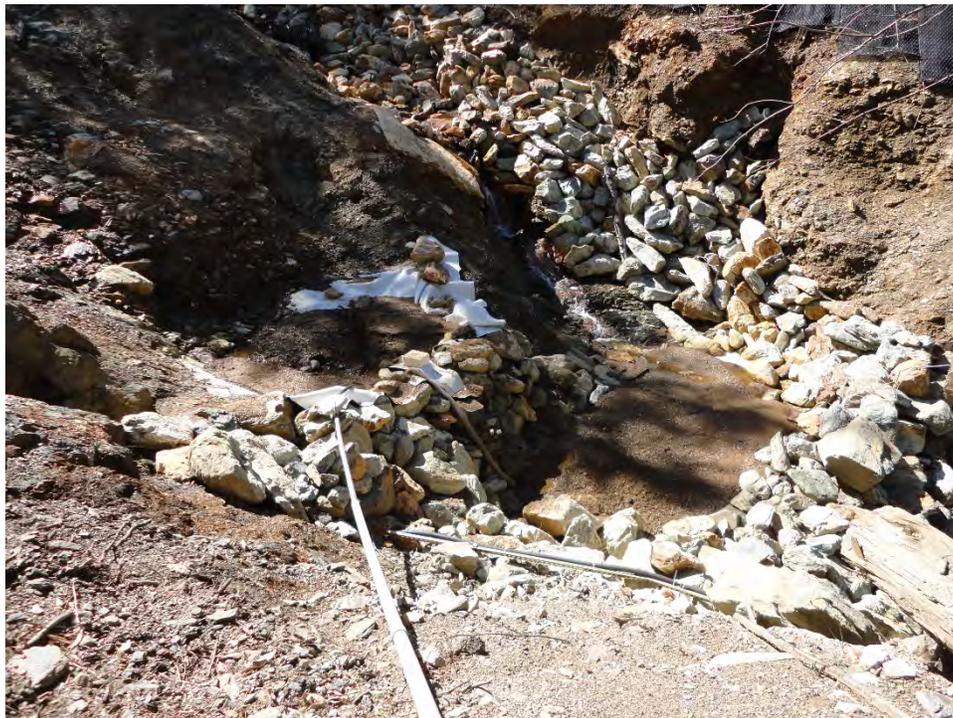
The acid seep previously entering the east side of basin 1F is being captured by the USEPA acid seep collection basin. The water seeping from adit A1N2 has been diverted by the USEPA to flow down the face of the WRP-1 bedrock to run to the acid seep collection basin. The pH in the USEPA acid seep basin was measured at 3.57, which is 0.08 lower than the October 2013 measurement. The USEPA acid seep basin overflow spillway is functioning. The 3.57 pH overflow is running through the rip rap into basin 1E

Photograph 16: EPA Acid Seep Basin and Basin 1F. Both basins are full of sediment.

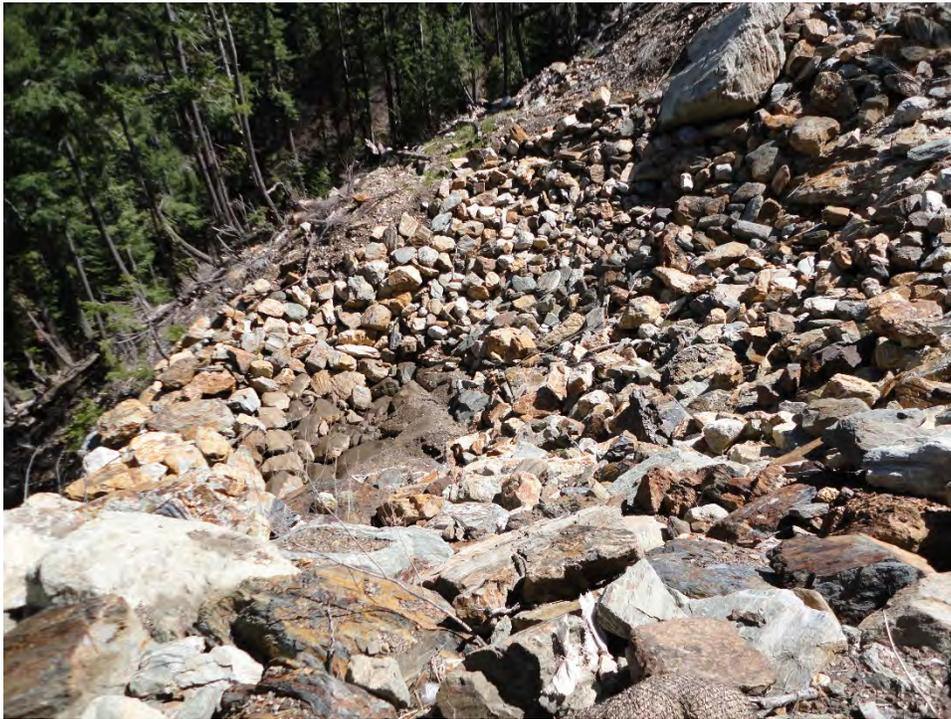
Photograph 18: Sediment/pH Treatment Basin 2B. No water is in the basin.
Blue Ledge Mine, Rogue River - Siskiyou National Forest, CA
Photographed by: Annica Nord (ERRG)
