Engineering/Remediation  
Resources Group, Inc.  
616 First Ave, Suite 300  
Seattle, WA 98104

May 13, 2014

Technical Memorandum  
May 2014 Site Inspection Report  
Blue Ledge Mine  
Rogue River-Siskiyou National Forest

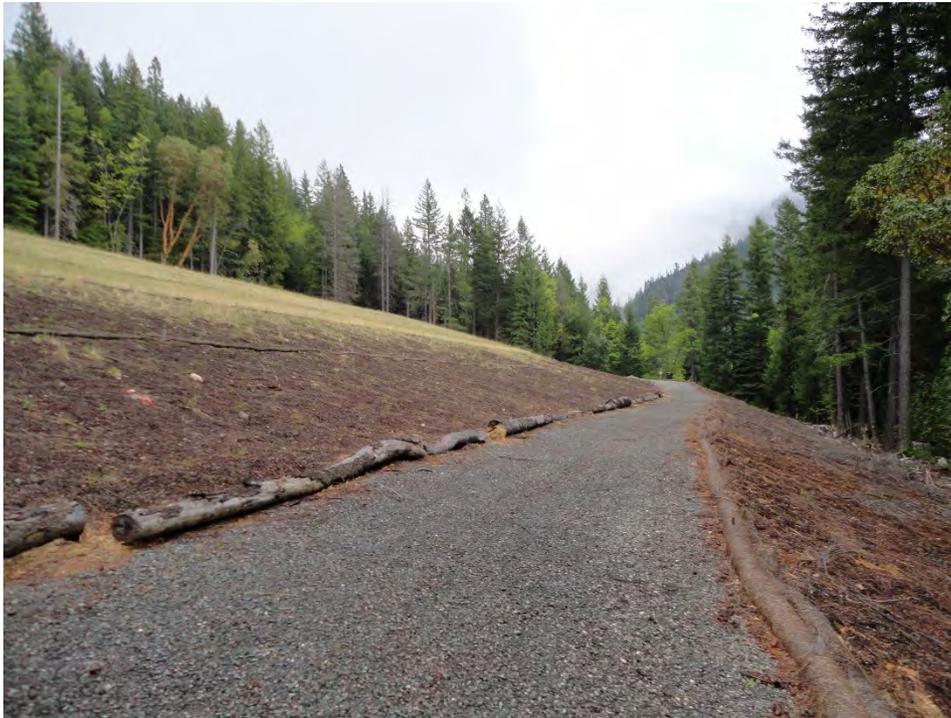
**Photograph 1: View of access road, facing south. Note there is no evidence of erosion.**  
Blue Ledge Mine, Rogue River - Siskiyou National Forest, CA  
Photographed by: Annica Nord (ERRG) Date: May 6, 2014

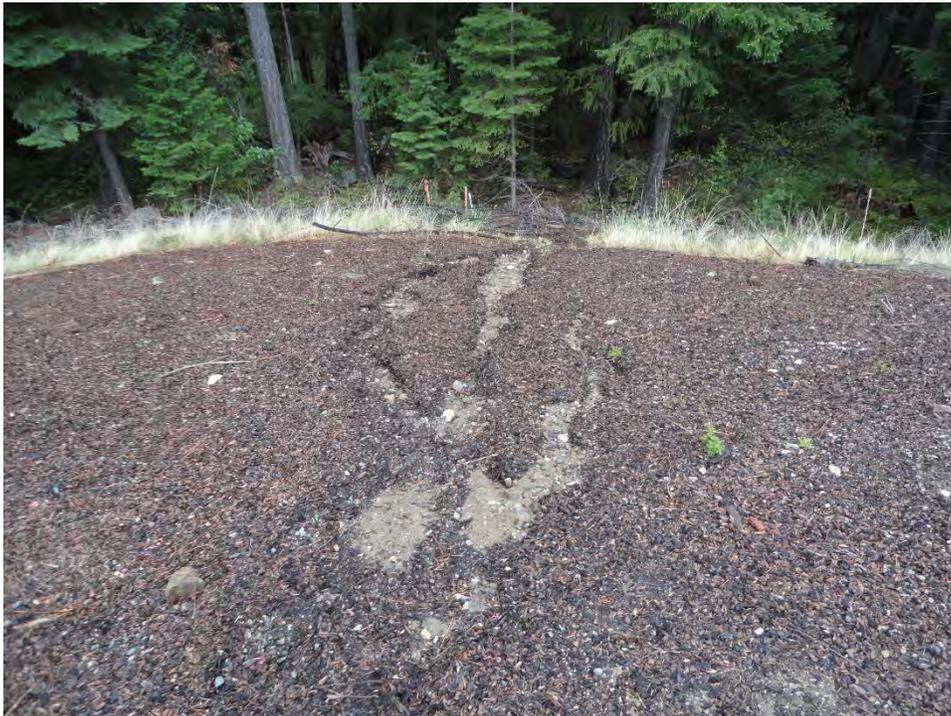
Comments: Minor erosion rills are evident downslope from the sump. They were filled with soil and bark. See photographs.

**Photograph 2: Erosion rills below the sump. Rills were later patched with soil.**  
Blue Ledge Mine, Rogue River - Siskiyou National Forest, CA  
Photographed by: Annica Nord (ERRG) Date: May 6, 2014

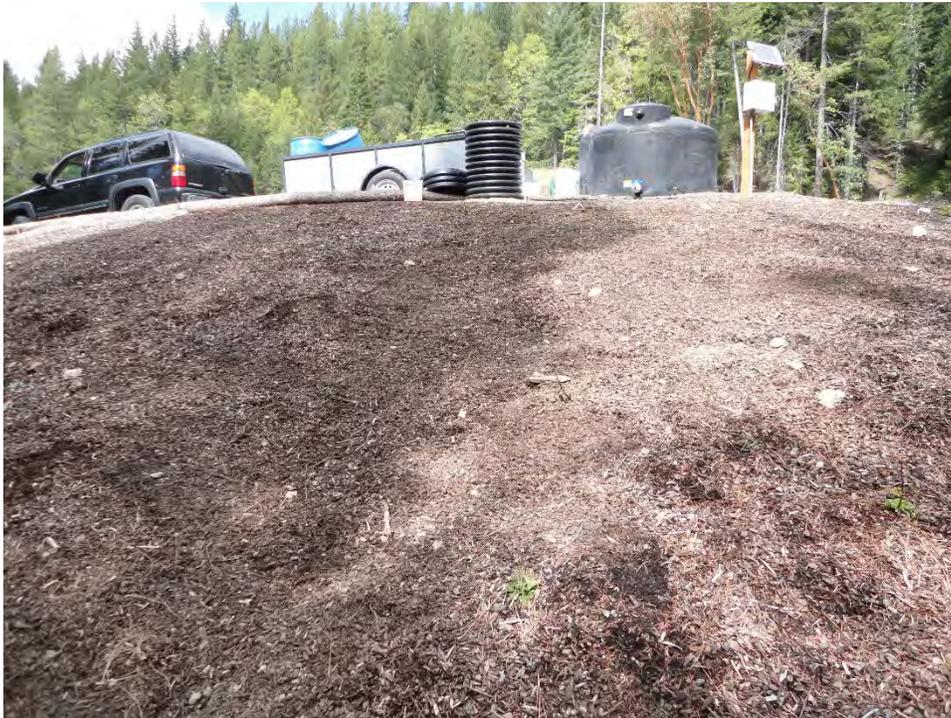
**Photograph 3: Rills were patched with soil, facing northeast.**  
Blue Ledge Mine, Rogue River - Siskiyou National Forest, CA  
Photographed by: Annica Nord (ERRG)

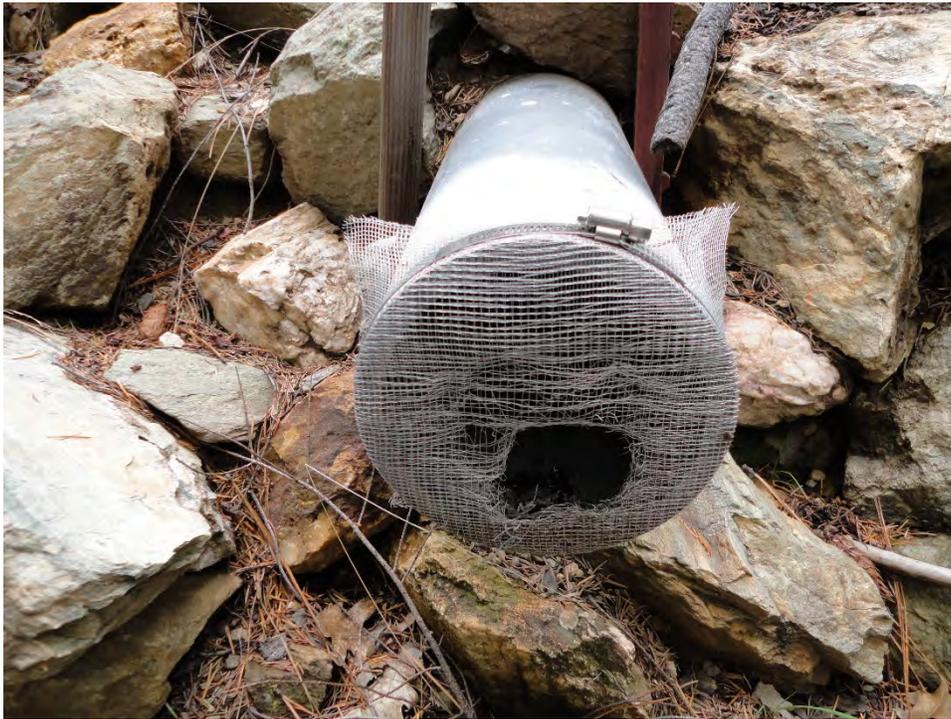
**Photograph 4: Anchor trench drain outlet water discharge, west side of repository.**  
Blue Ledge Mine, Rogue River - Siskiyou National Forest, CA  
Photographed by: Annica Nord (ERRG)

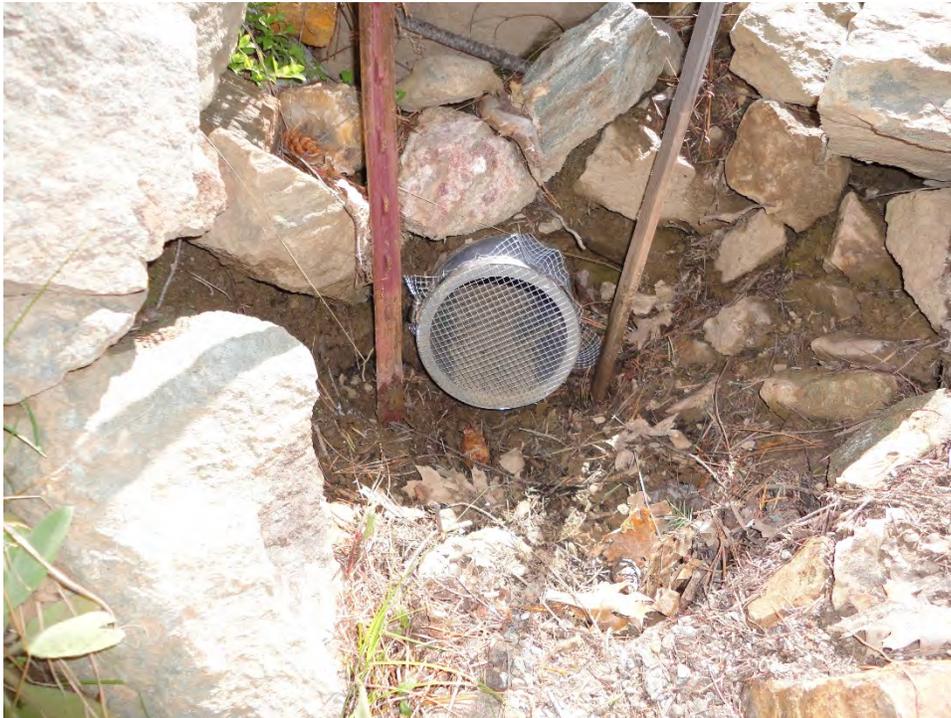
Comments: The anchor trench drain pipes are not blocked and no water is flowing from the drain. The screen was previously repaired with a second layer of screen over the pipe however, animals have scraped through the second layer. A thicker, more durable galvanized screen replaced the damaged screen on all anchor trench drains. The underdrain is not blocked and a small stream of water is flowing from the pipe. The screen is intact and not damaged.

**Photograph 5: The screens on the anchor trench drains (west side of the repository) were replaced with more robust galvanized screens.**

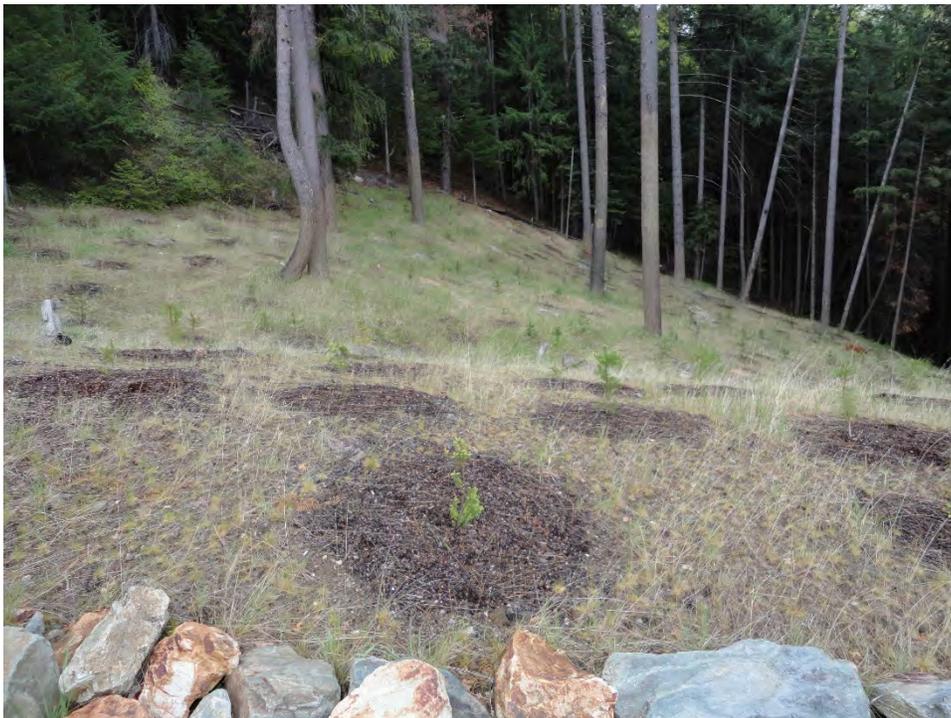
**Photograph 6: Repository Stockpile Area with hydroseed and reclamation planting.**

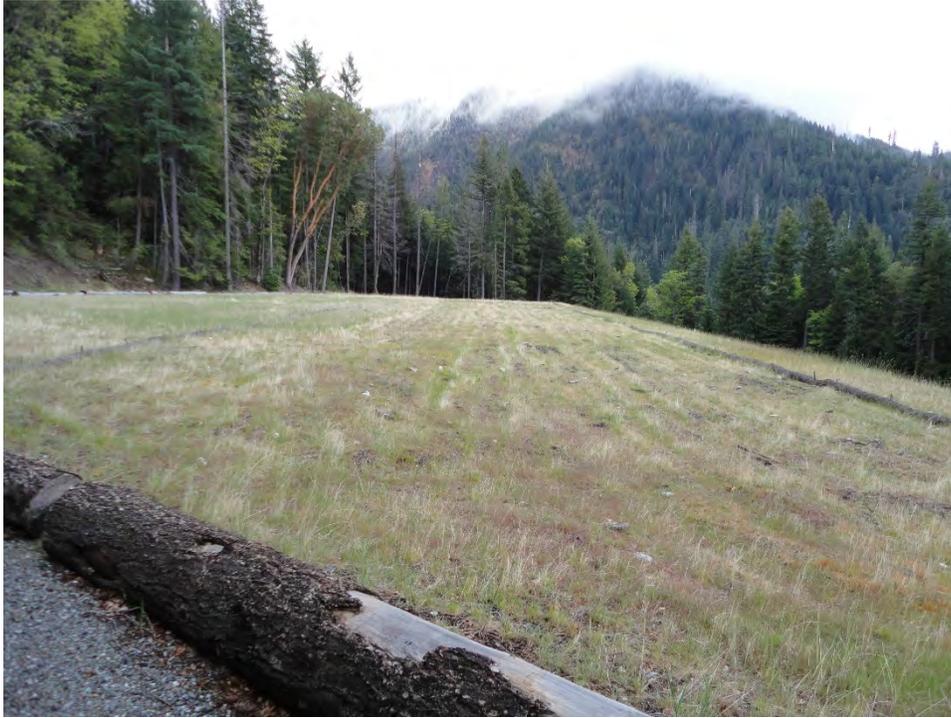
**Photograph 7: Hydroseeded top of repository looking south.**  
Blue Ledge Mine, Rogue River - Siskiyou National Forest, CA  
Photographed by: Annica Nord (ERRG)

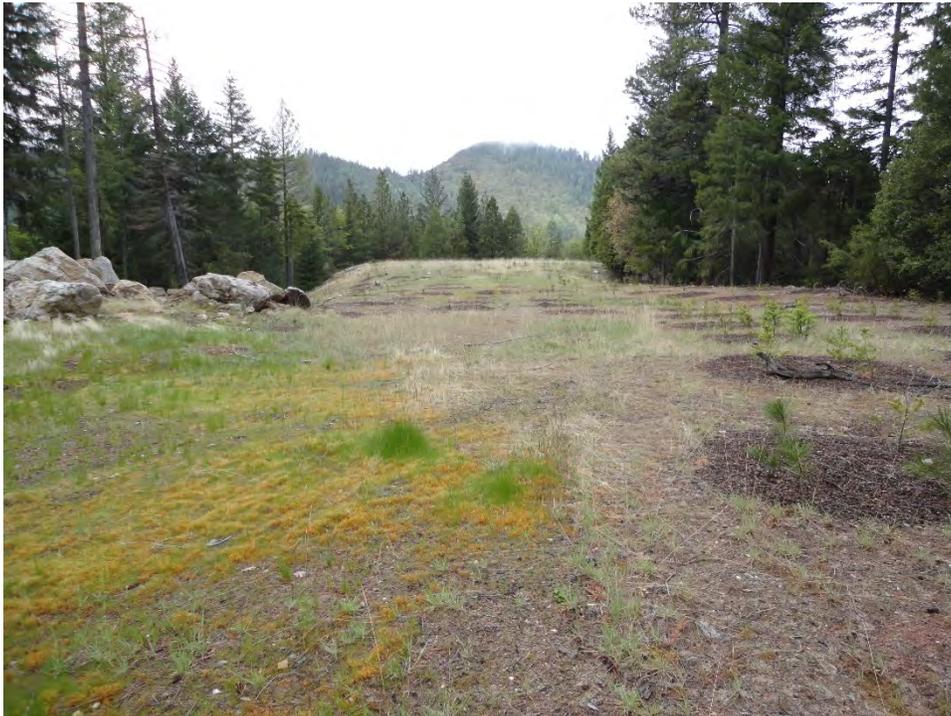
**Photograph 8: North Storage area looking west.**  
Blue Ledge Mine, Rogue River - Siskiyou National Forest, CA  
Photographed by: Annica Nord (ERRG)

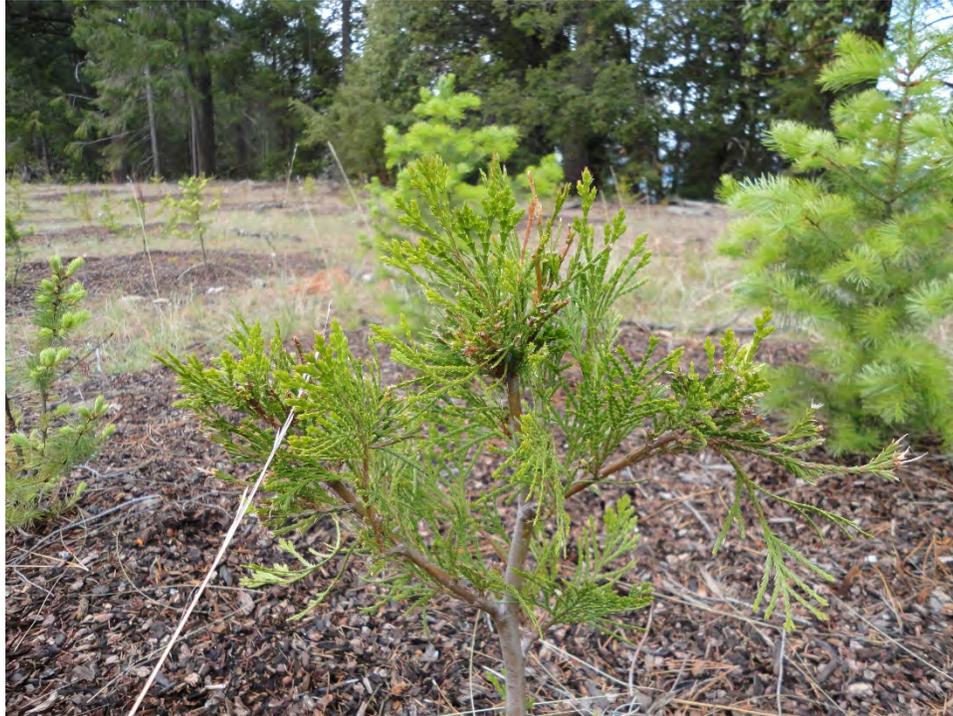
Comments: Planted trees show new spring growth.

**Photograph 9: Plants at the North Storage area.**  
Blue Ledge Mine, Rogue River - Siskiyou National Forest, CA  
Photographed by: Annica Nord (ERRG)

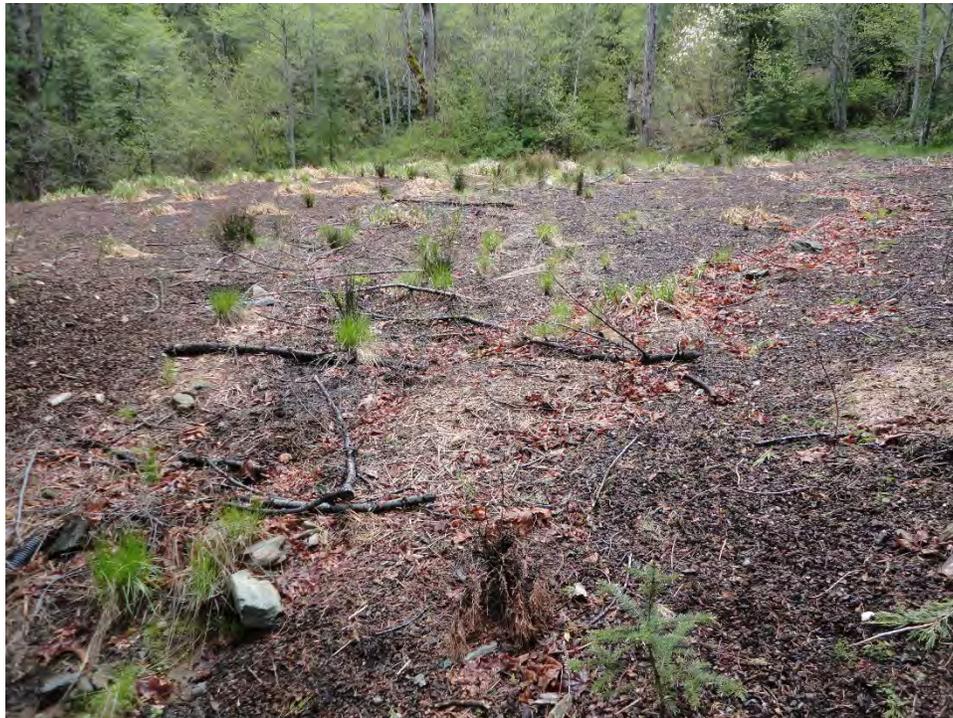
Comments: The plants show new spring growth.

**Photograph 10: South Storage area looking northeast. Plants show some spring growth.**  
Blue Ledge Mine, Rogue River - Siskiyou National Forest, CA  
Photographed by: Annica Nord (ERRG)

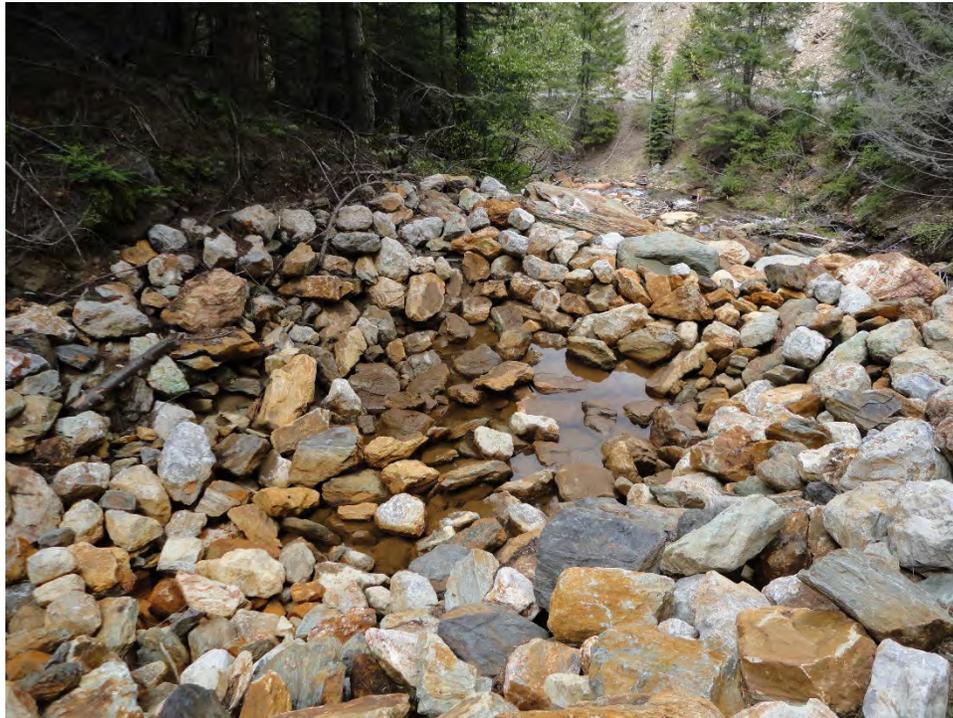
**Photograph 11: Sediment/pH Treatment Basin 1A.**  
Blue Ledge Mine, Rogue River - Siskiyou National Forest, CA  
Photographed by: Annica Nord (ERRG)

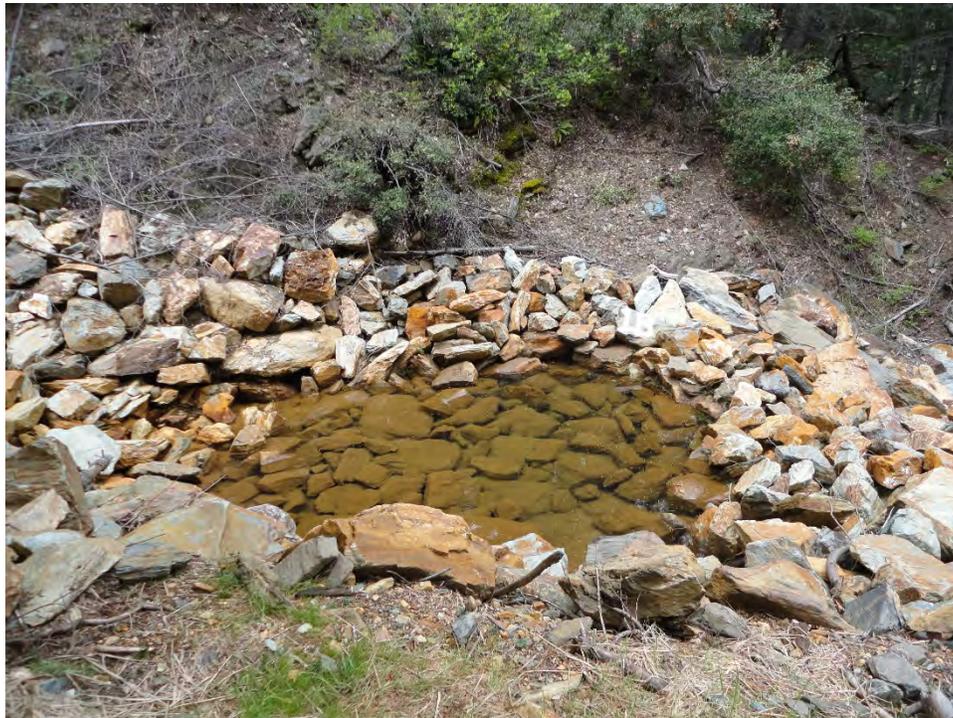
**Photograph 12: Sediment/pH Treatment Basin 1B.**  
Blue Ledge Mine, Rogue River - Siskiyou National Forest, CA  
Photographed by: Annica Nord (ERRG)

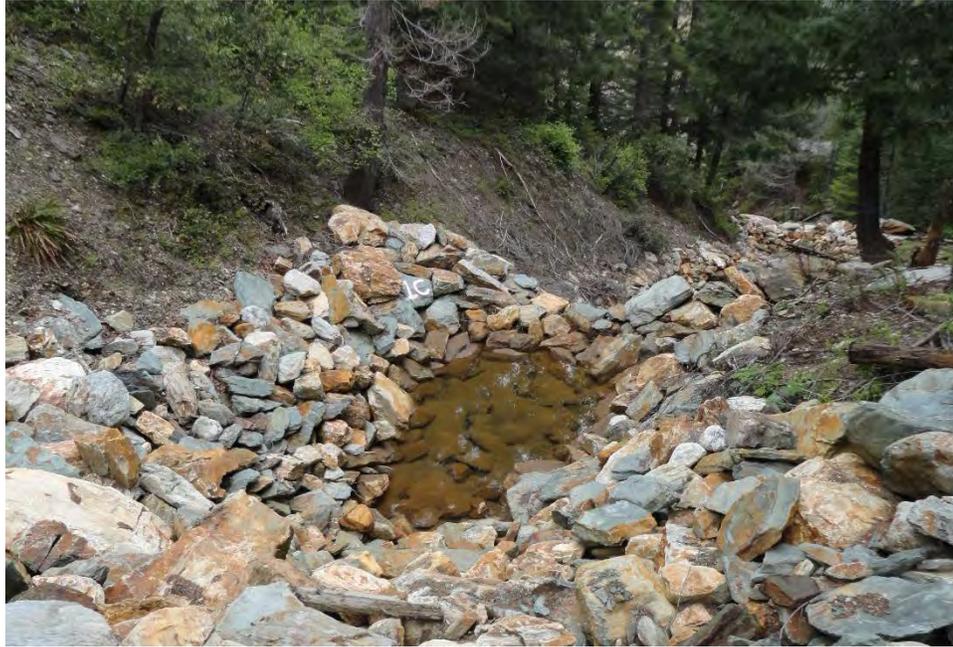
**Photograph 13: Sediment/pH Treatment Basin 1C.**  
Blue Ledge Mine, Rogue River - Siskiyou National Forest, CA  
Photographed by: Annica Nord (ERRG)

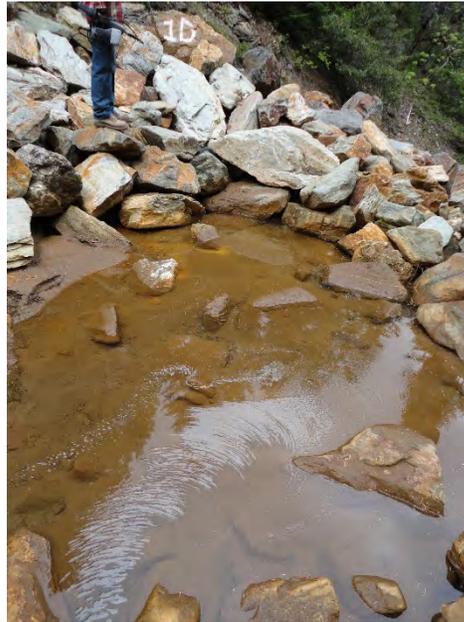
**Photograph 14: Sediment/pH Treatment Basin 1D.**  
Blue Ledge Mine, Rogue River - Siskiyou National Forest, CA  
Photographed by: Annica Nord (ERRG)

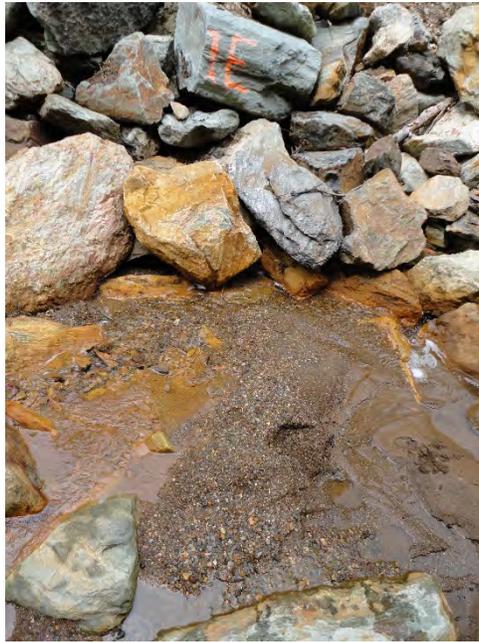
**Photograph 15: Sediment/pH Treatment Basin 1E. Full of sediment.**  
Blue Ledge Mine, Rogue River - Siskiyou National Forest, CA  
Photographed by: Annica Nord (ERRG)

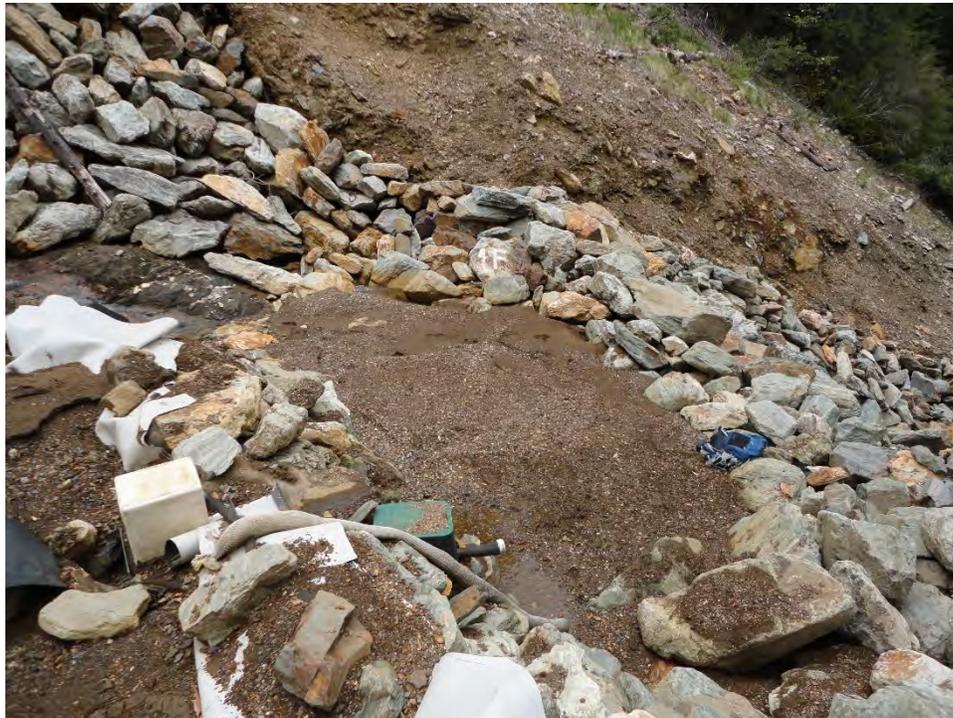
The acid seep previously entering the east side of basin 1F is being captured by the USEPA acid seep collection basin. The water seeping from adit A1N2 has been diverted by the USEPA to flow down the face of the WRP-1 bedrock to run to the acid seep collection basin. The pH in the USEPA acid seep basin was measured at 2.9, which is 0.67 lower than the April 2014 measurement. Measurements in May 2014 were collected using a YSI multi-parameter probe instead of the pH meter typically used to measure pH. This may account for differences between the April 2014 readings and the May 2014 readings. The USEPA acid seep basin overflow spillway is functioning. The 2.9 pH overflow is running through the rip rap into basin 1E and comingling with the water coming down the main drainage and flowing through basin 1F. This is likely why the pH in basin 1E is much lower than basin 1F. There is effectively a split flow of water

**Photograph 16: Sediment/pH Treatment Basin 1F. Full of sediment.**  
Blue Ledge Mine, Rogue River - Siskiyou National Forest, CA  
Photographed by: Annica Nord (ERRG)

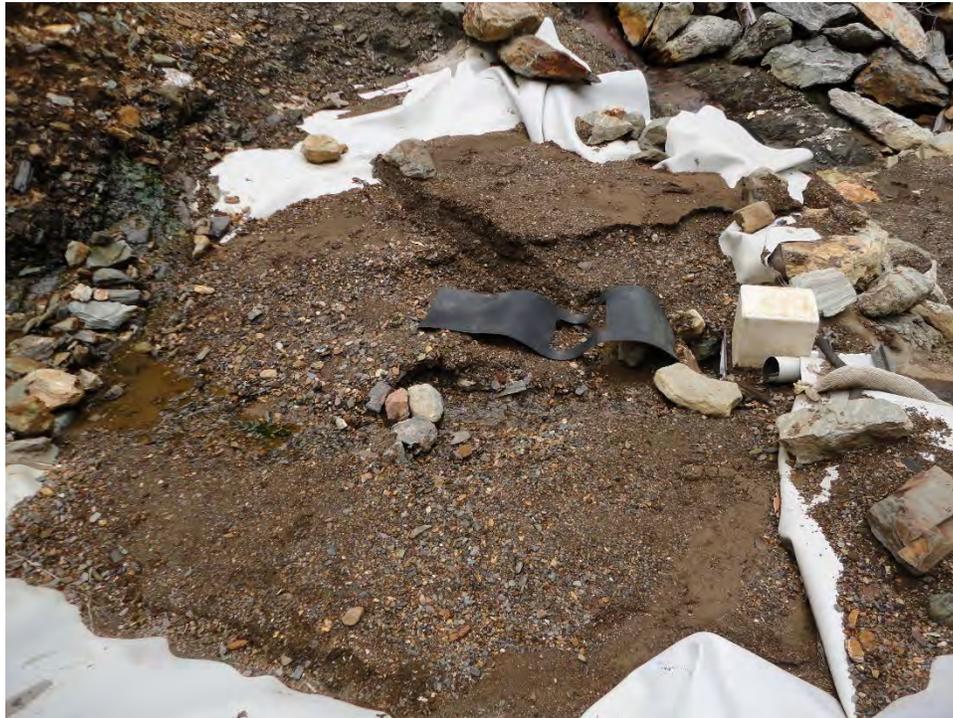
**Photograph 17: EPA Acid Seep Basin. Basin is full of sediment.**  
Blue Ledge Mine, Rogue River - Siskiyou National Forest, CA  
Photographed by: Annica Nord (ERRG)

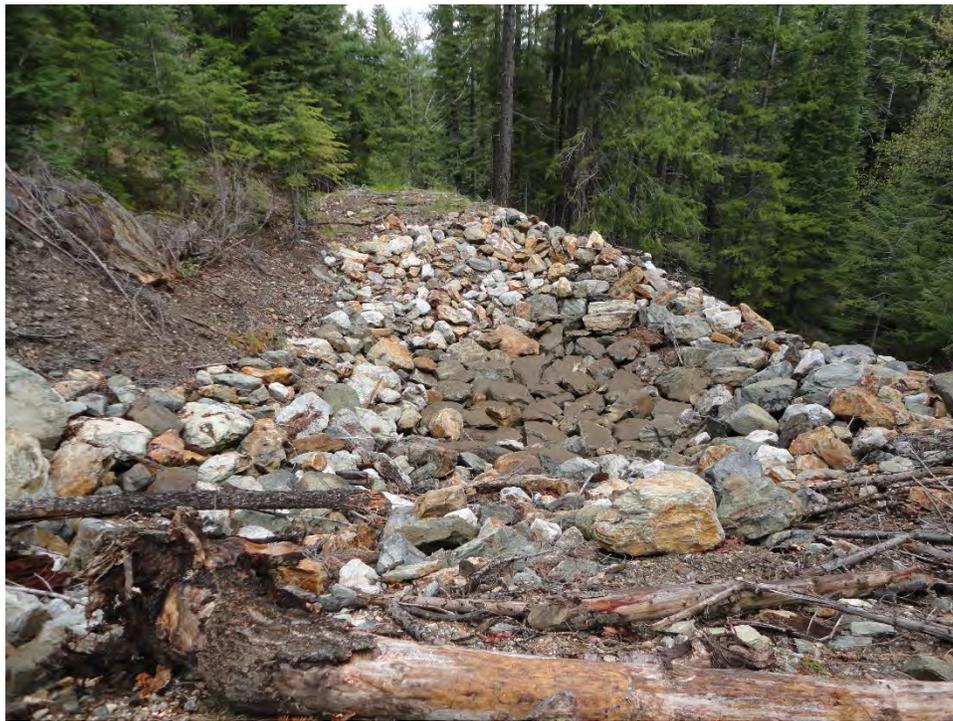
**Photograph 18: Sediment/pH Treatment Basin 2A. No water in the basin.**  
Blue Ledge Mine, Rogue River - Siskiyou National Forest, CA  
Photographed by: Annica Nord (ERRG)

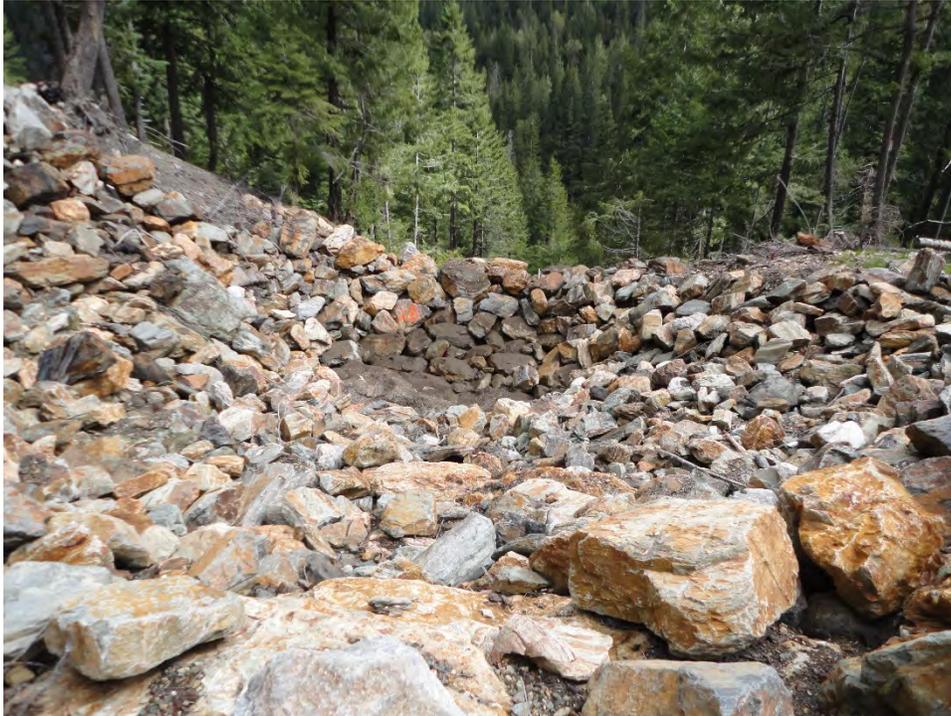
**Photograph 19: Sediment/pH Treatment Basin 2B. No water is in the basin.**  
Blue Ledge Mine, Rogue River - Siskiyou National Forest, CA  
Photographed by: Annica Nord (ERRG)

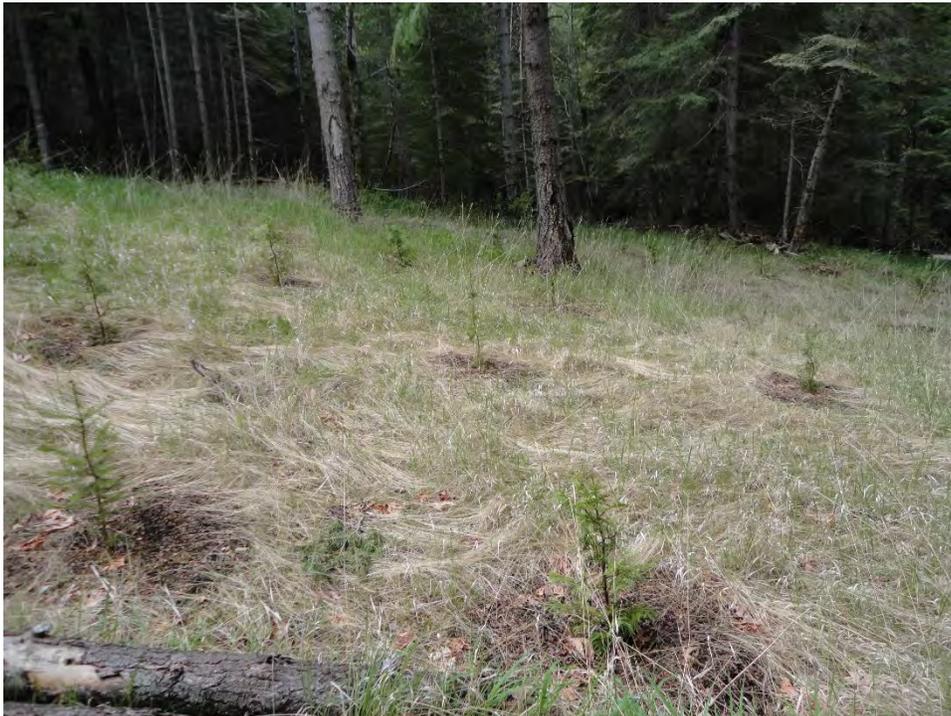
**Photograph 20: Rock Stockpile reclamation plants and grass looking west.**  
Blue Ledge Mine, Rogue River - Siskiyou National Forest, CA  
Photographed by: Annica Nord (ERRG)

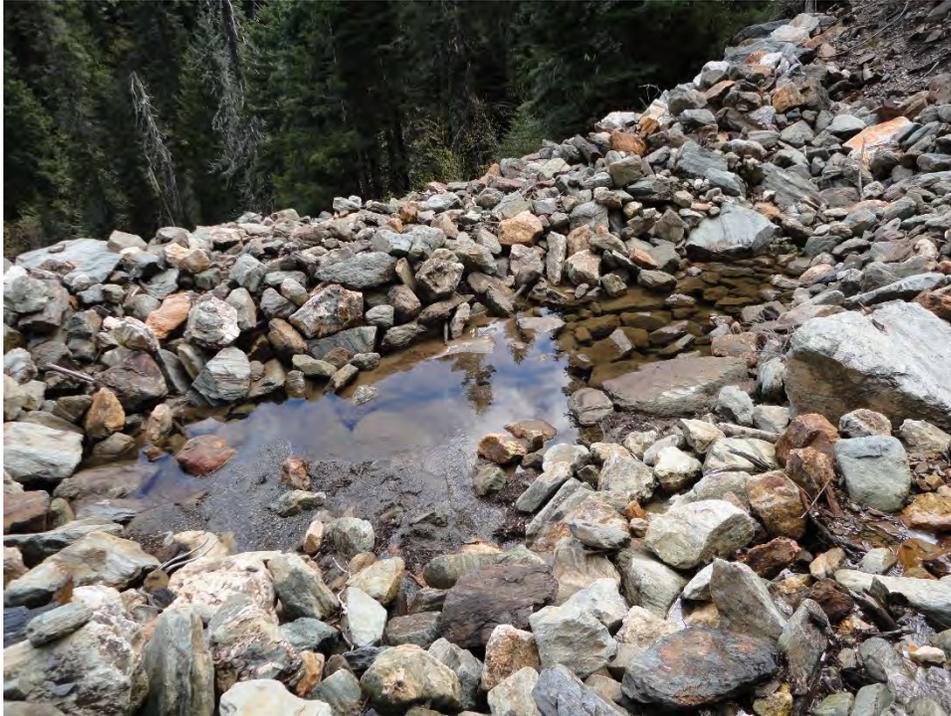
**Photograph 21: Sediment/pH Treatment Basin 3.**  
Blue Ledge Mine, Rogue River - Siskiyou National Forest, CA  
Photographed by: Annica Nord (ERRG)

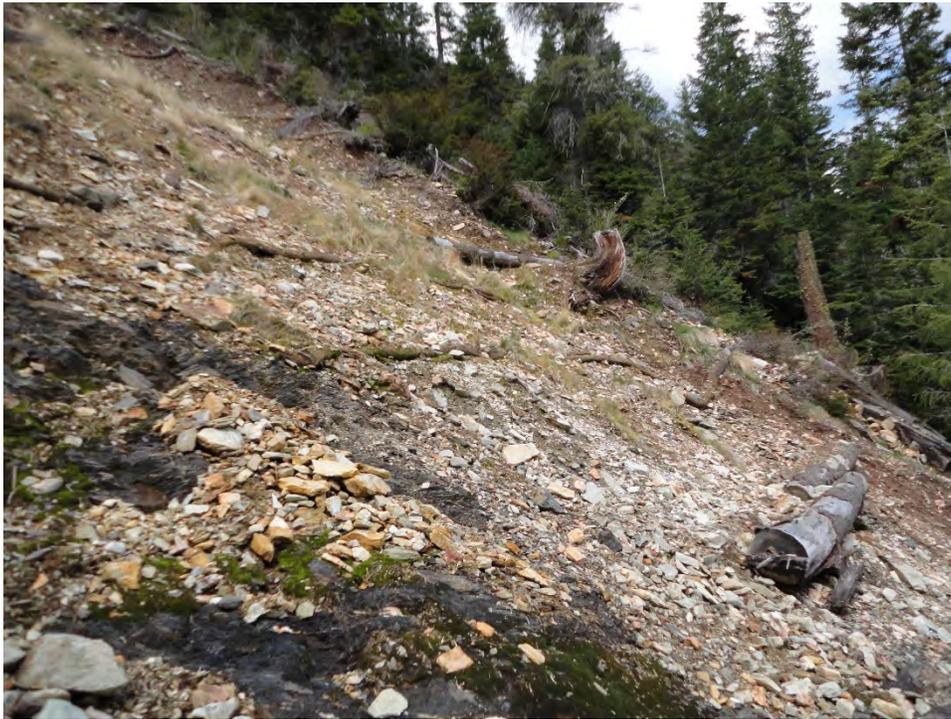
**Photograph 22: WRP-3 reclamation plants and grass.**  
Blue Ledge Mine, Rogue River - Siskiyou National Forest, CA  
Photographed by: Annica Nord (ERRG)
