July 14, 2014

Ref.: 2010-084

Technical Memorandum
July 2014 Site Inspection Report
Blue Ledge Mine
Rogue River-Siskiyou National Forest

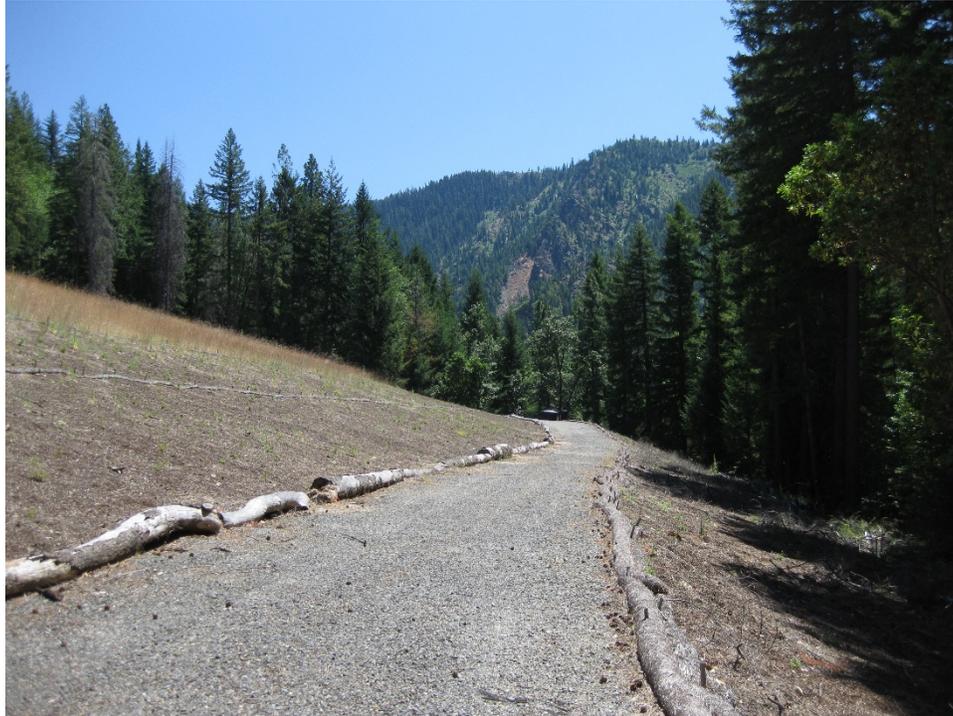
Photograph 1: View of access road, facing south. Note there is no evidence of erosion.
Blue Ledge Mine, Rogue River - Siskiyou National Forest, CA
Photographed by: Annica Nord (ERRG)

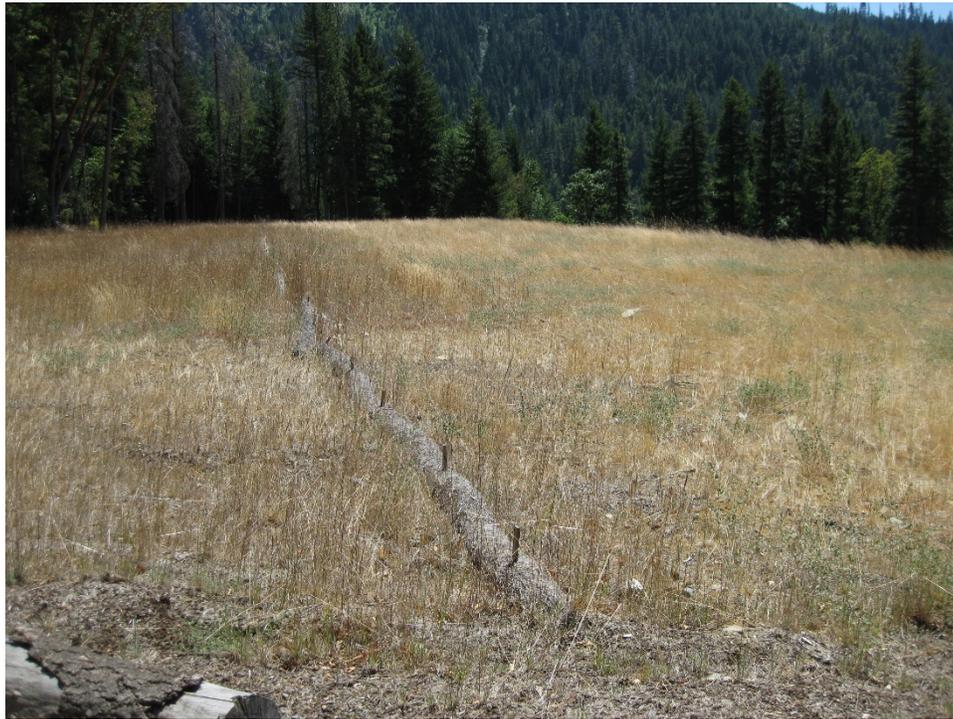
Photograph 2: Top of repository, facing south.
Blue Ledge Mine, Rogue River - Siskiyou National Forest, CA
Photographed by: Annica Nord (ERRG)

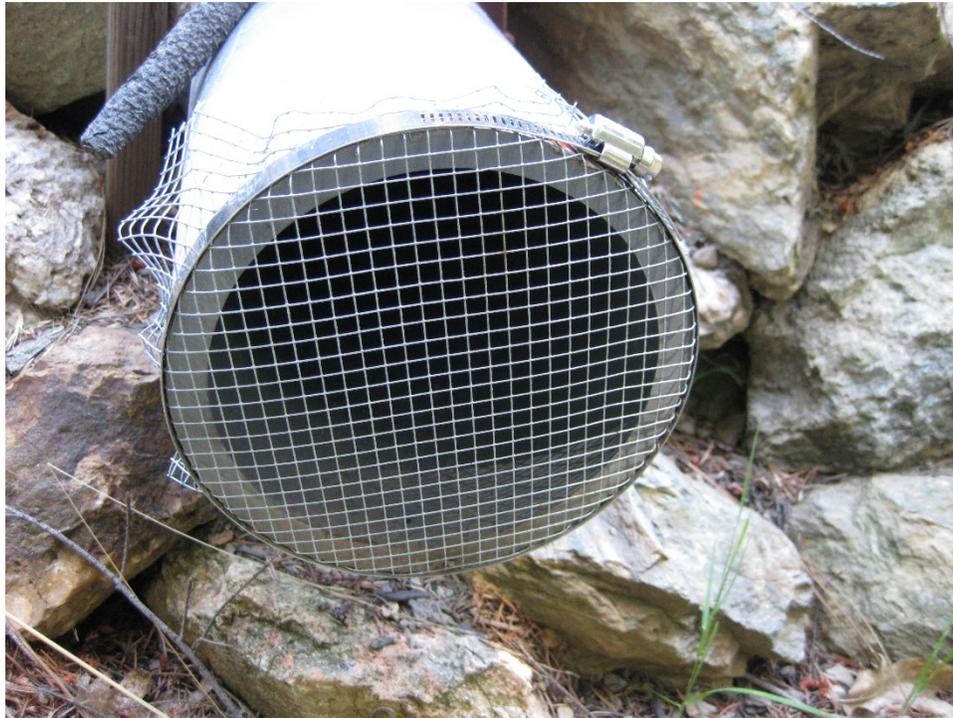
Comments: The anchor trench drain pipes are not blocked, screens are intact, and no water is flowing from the drain. A thicker, more durable galvanized screen replaced the damaged screen on all anchor trench drains in May 2014. The underdrain is not blocked, screen is intact, and no water is flowing from the pipe.

Photograph 3: Anchor trench drain outlet water discharge, west side of repository.
Blue Ledge Mine, Rogue River - Siskiyou National Forest, CA
Photographed by: Annica Nord (ERRG)

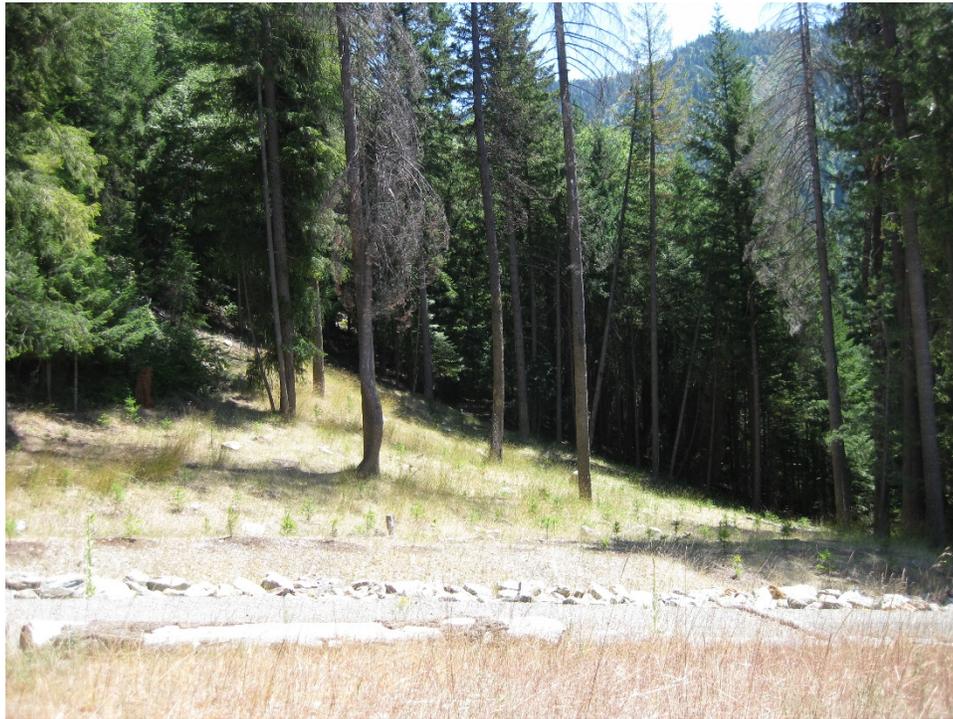
Photograph 4: Repository Stockpile Area with hydroseed and reclamation planting.
Blue Ledge Mine, Rogue River - Siskiyou National Forest, CA
Photographed by: Annica Nord (ERRG)

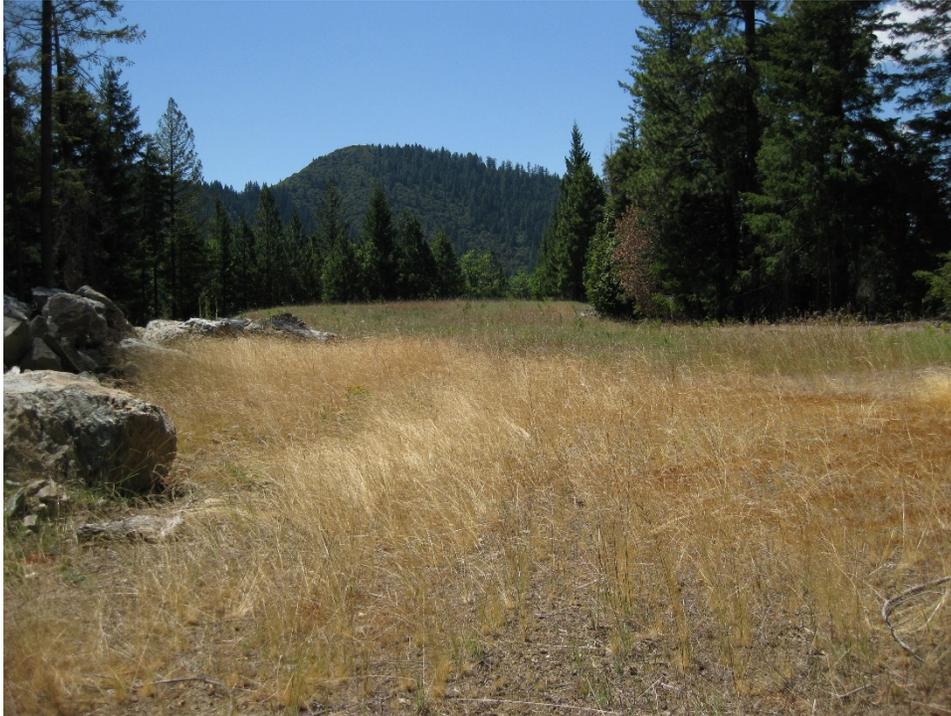
Photograph 5: North Storage area looking west.
Blue Ledge Mine, Rogue River - Siskiyou National Forest, CA
Photographed by: Annica Nord (ERRG)

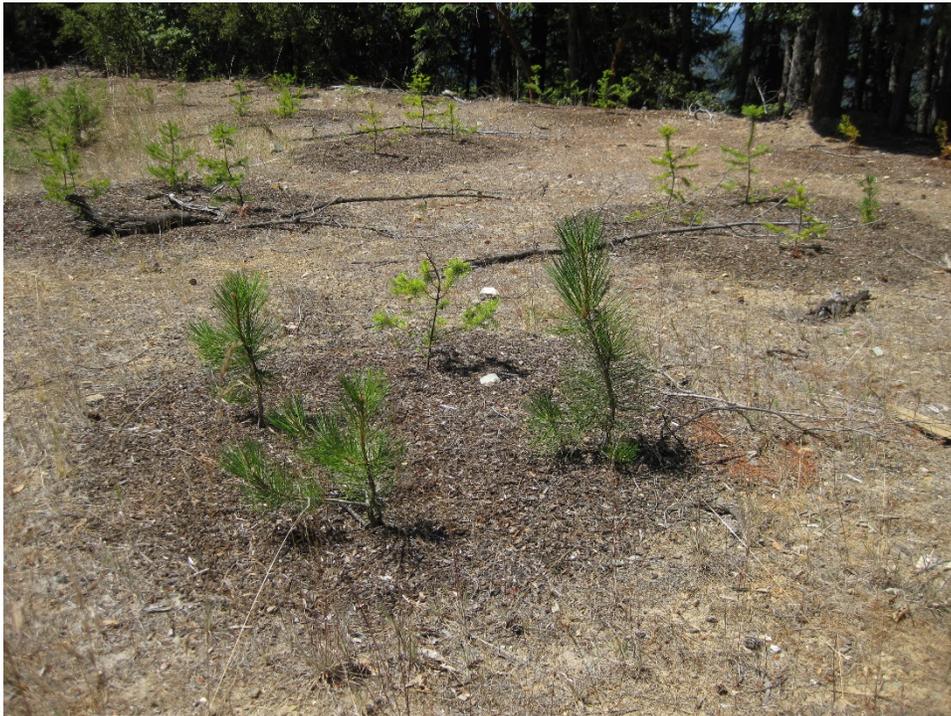
Comments: Plants appear to be growing and are larger than last summer.

Photograph 6: Plants at the North Storage area.
Blue Ledge Mine, Rogue River - Siskiyou National Forest, CA
Photographed by: Annica Nord (ERRG)

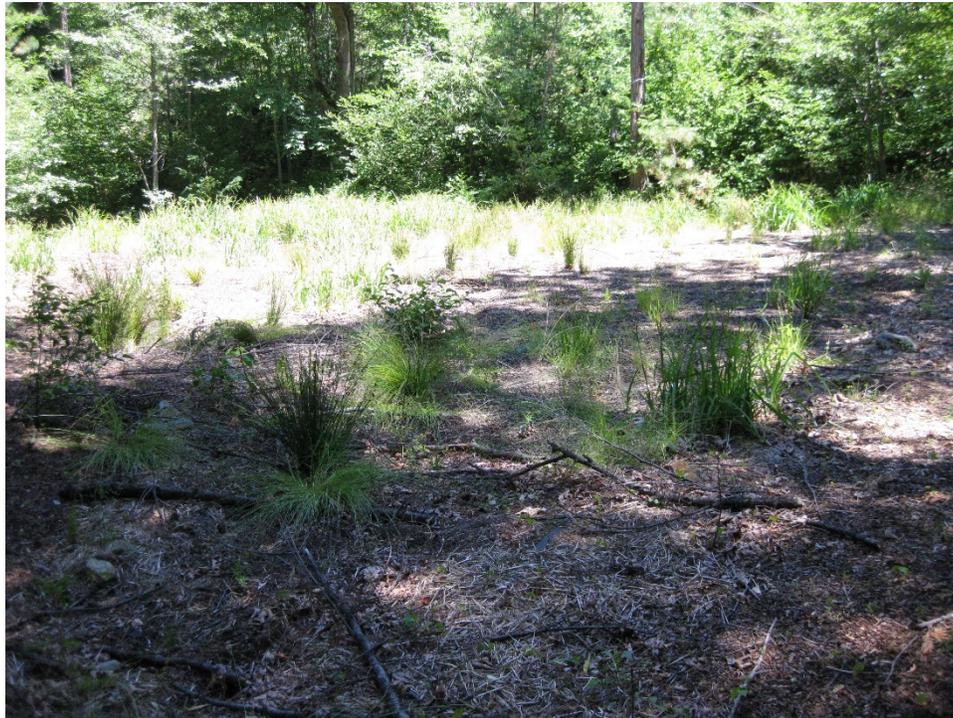
Comments: The uphill silt fence is no longer needed and was previously removed. The lower silt fence is intact.

Photograph 7: South Storage area looking northeast.
Blue Ledge Mine, Rogue River - Siskiyou National Forest, CA
Photographed by: Annica Nord (ERRG)

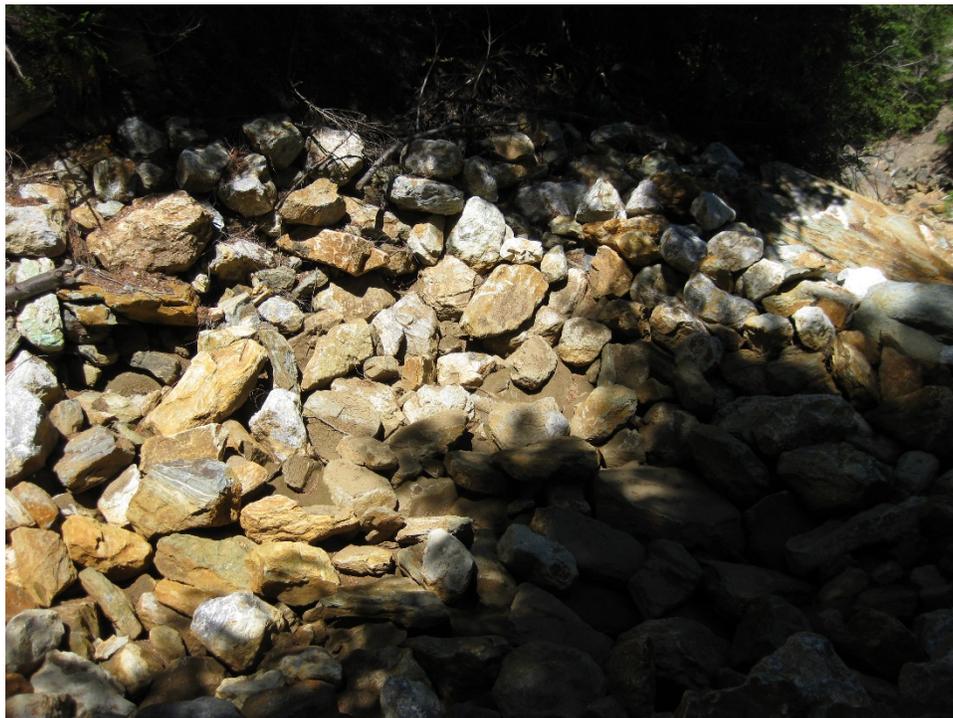
pH in basin 1A: not measured-no water was observed in the basin

Photograph 8: Sediment/pH Treatment Basin 1A.
Blue Ledge Mine, Rogue River - Siskiyou National Forest, CA
Photographed by: Annica Nord (ERRG)

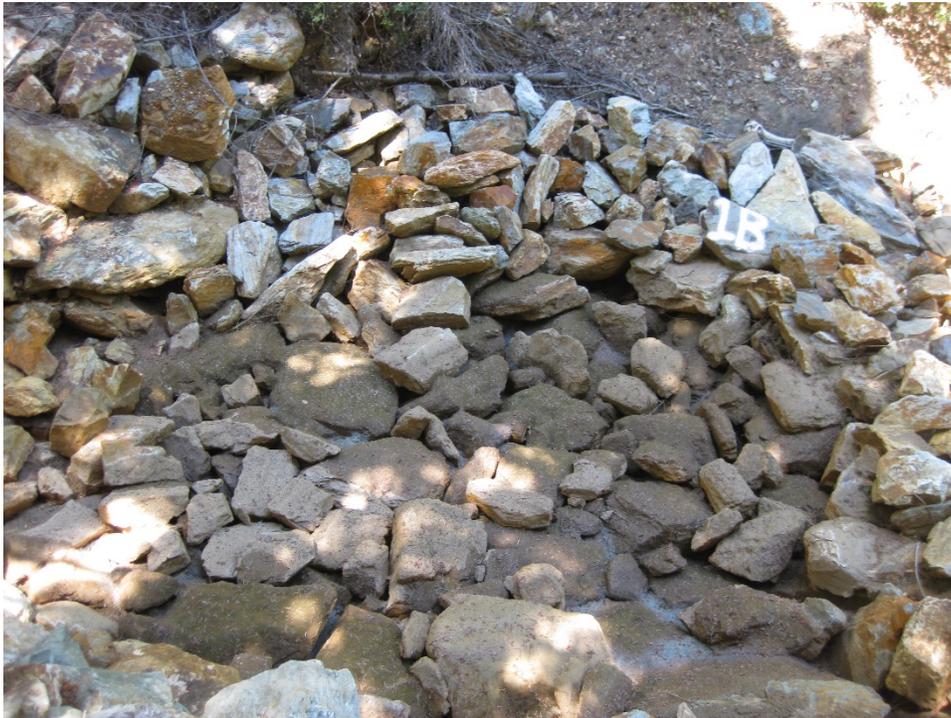
pH in basin 1B: not measured - no water was observed in the basin

Photograph 9: Sediment/pH Treatment Basin 1B.
Blue Ledge Mine, Rogue River - Siskiyou National Forest, CA
Photographed by: Annica Nord (ERRG)

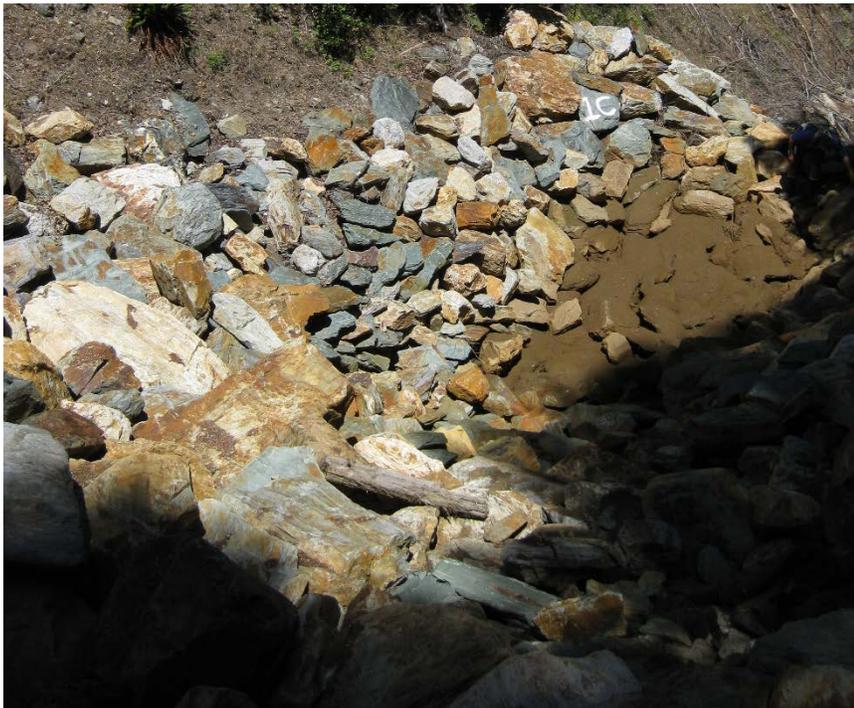
pH in basin 1C: not measured - no water was observed in the basin

Photograph 10: Sediment/pH Treatment Basin 1C.
Blue Ledge Mine, Rogue River - Siskiyou National Forest, CA
Photographed by: Annica Nord (ERRG)

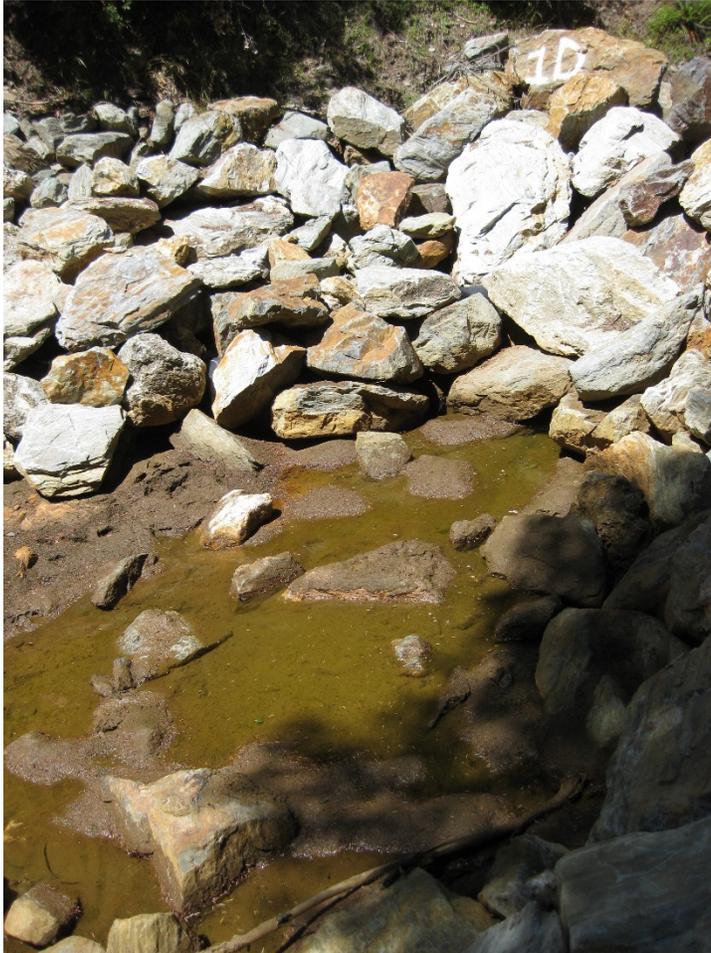
Photograph 11: Sediment/pH Treatment Basin 1D.
Blue Ledge Mine, Rogue River - Siskiyou National Forest, CA
Photographed by: Annica Nord (ERRG)

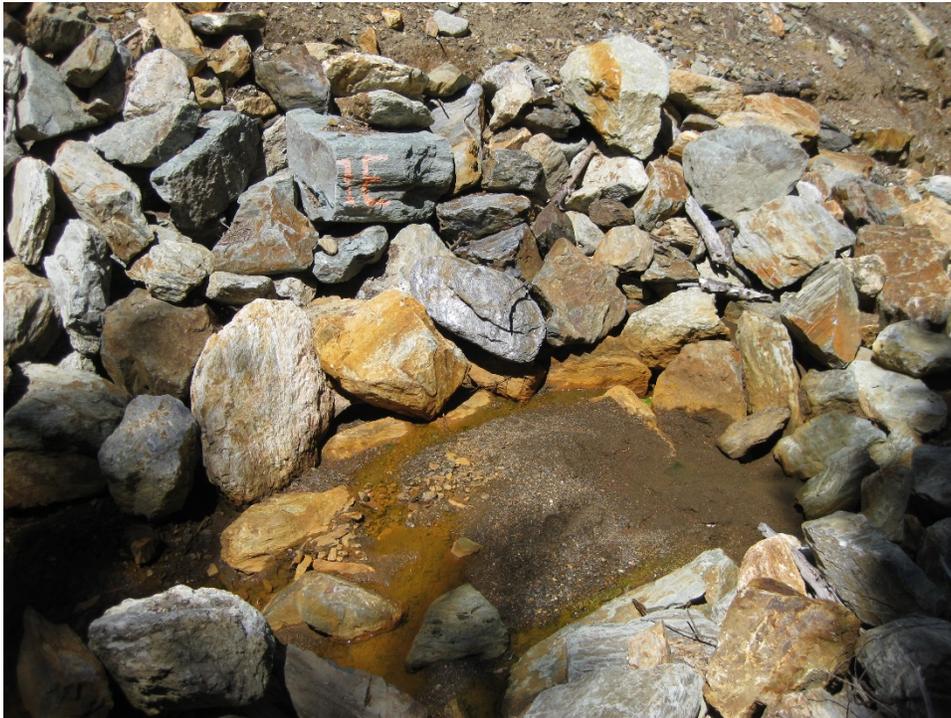
Photograph 12: Sediment/pH Treatment Basin 1E. Full of sediment.
Blue Ledge Mine, Rogue River - Siskiyou National Forest, CA
Photographed by: Annica Nord (ERRG)

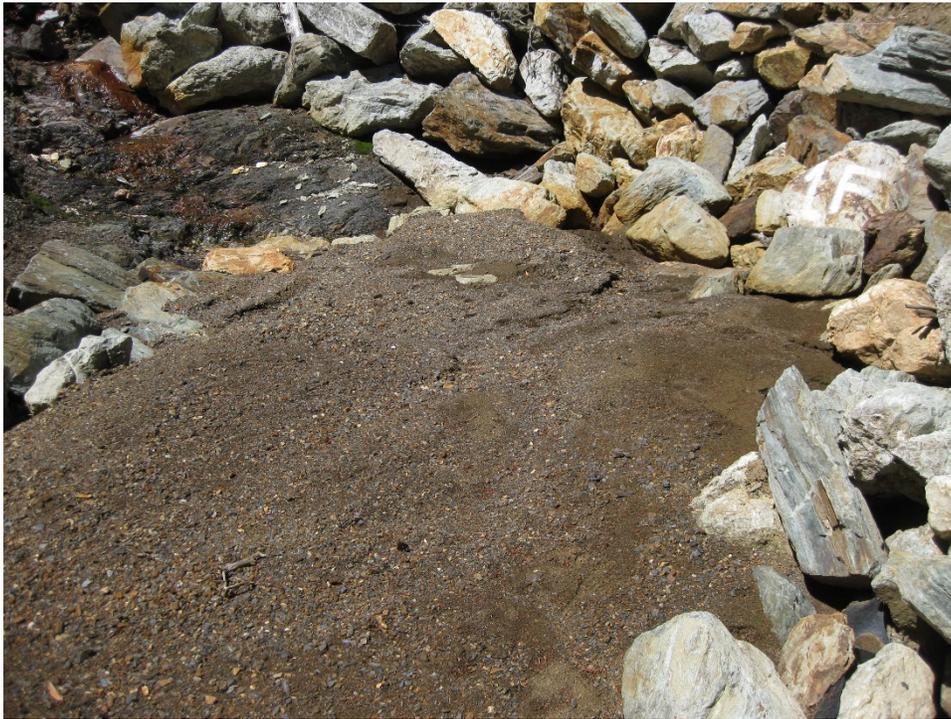
pH in basin 1F: no water was observed in the basin

Photograph 13: Sediment/pH Treatment Basin 1F. Full of sediment.
Blue Ledge Mine, Rogue River - Siskiyou National Forest, CA
Photographed by: Annica Nord (ERRG)

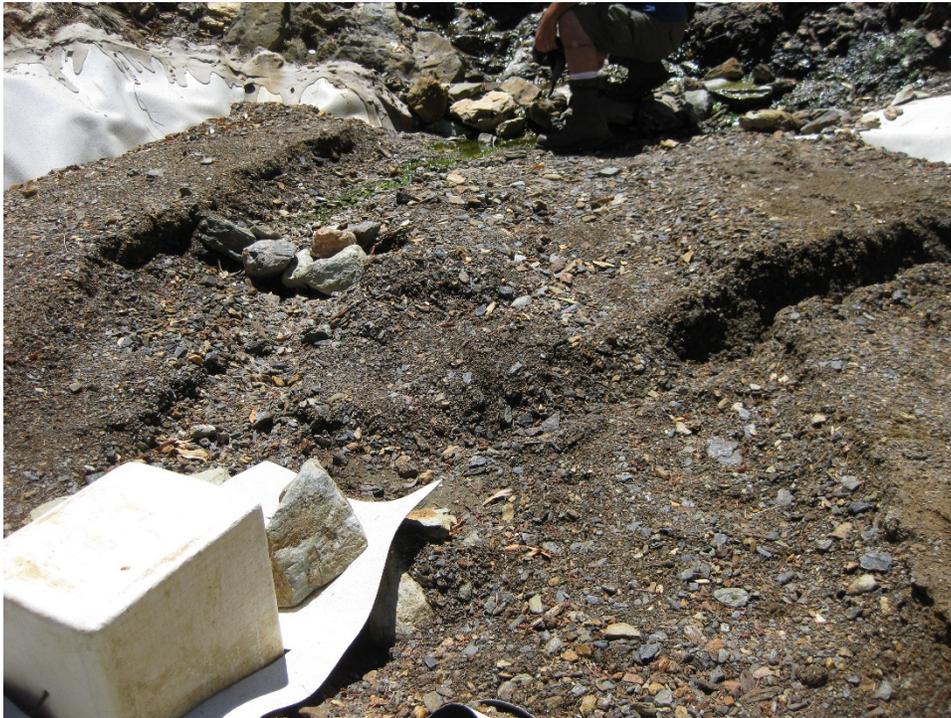
The acid seep previously entering the east side of basin 1F is being captured by the USEPA acid seep collection basin. The water seeping from adit A1N2 has been diverted by the USEPA to flow down the face of the WRP-1 bedrock to run to the acid seep collection basin. The pH in the USEPA acid seep basin was measured at 3.6, which is the same as measured in June 2014. The USEPA acid seep basin overflow spillway is functioning. The 3.6 pH overflow is running through the rip rap into basin 1E and comingling with the water coming down the main drainage and flowing through basin 1F. This is likely why the pH in basin 1E is lower than basin 1F. There is effectively a split flow of water between the main drainage into basin 1F and the overflow of the USEPA acid seep basin that does not fully comingle until it reaches basin 1E. Basins 1E through 1D raised the pH by 0.2 units from 4.8 to 5.0. No water was observed in basins 1A, 1B, and 1C. Joe Creek pH at the base of WRP-1 was measured to be 6.8. The limestone in the basins

Photograph 14: EPA Acid Seep Basin. Basin is full of sediment.
Blue Ledge Mine, Rogue River - Siskiyou National Forest, CA
Photographed by: Annica Nord (ERRG)

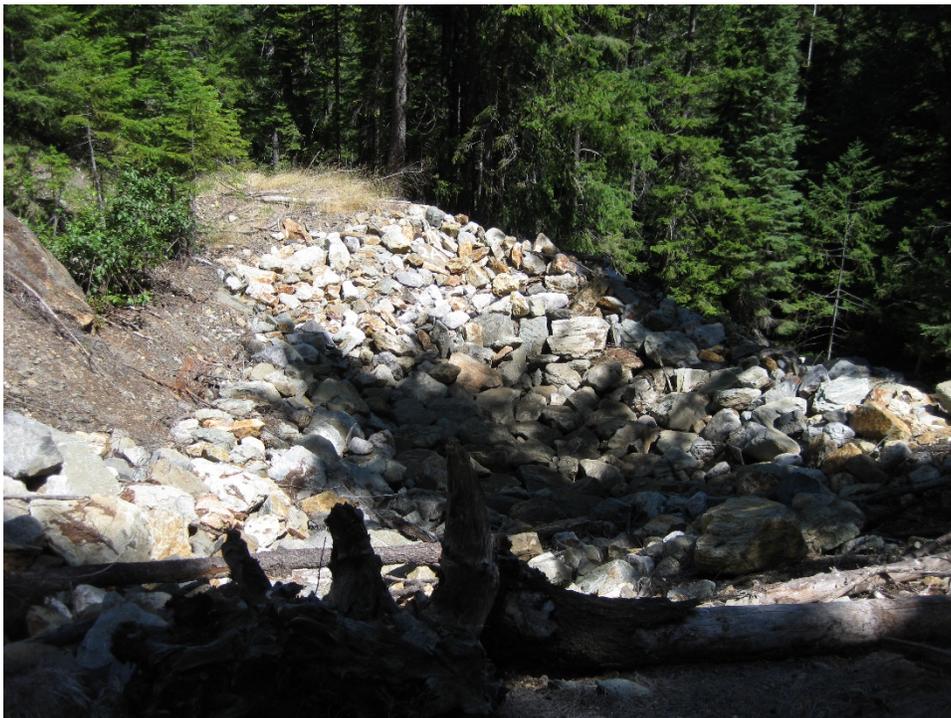
Photograph 15: Sediment/pH Treatment Basin 2A. No water in the basin.
Blue Ledge Mine, Rogue River - Siskiyou National Forest, CA
Photographed by: Annica Nord (ERRG)

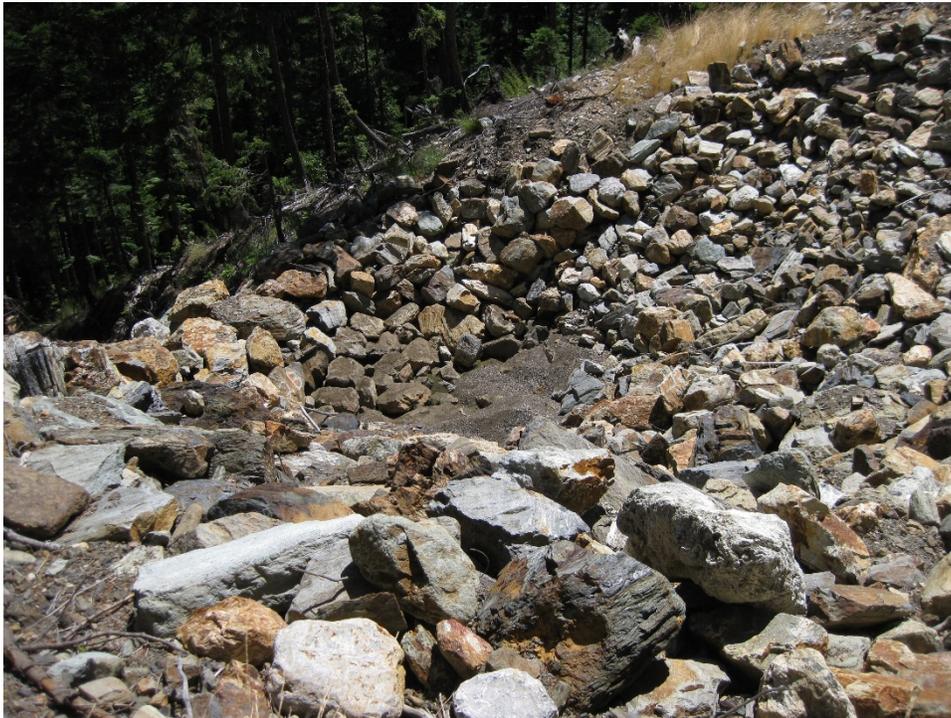
Photograph 16: Sediment/pH Treatment Basin 2B. No water is in the basin.
Blue Ledge Mine, Rogue River - Siskiyou National Forest, CA
Photographed by: Annica Nord (ERRG)

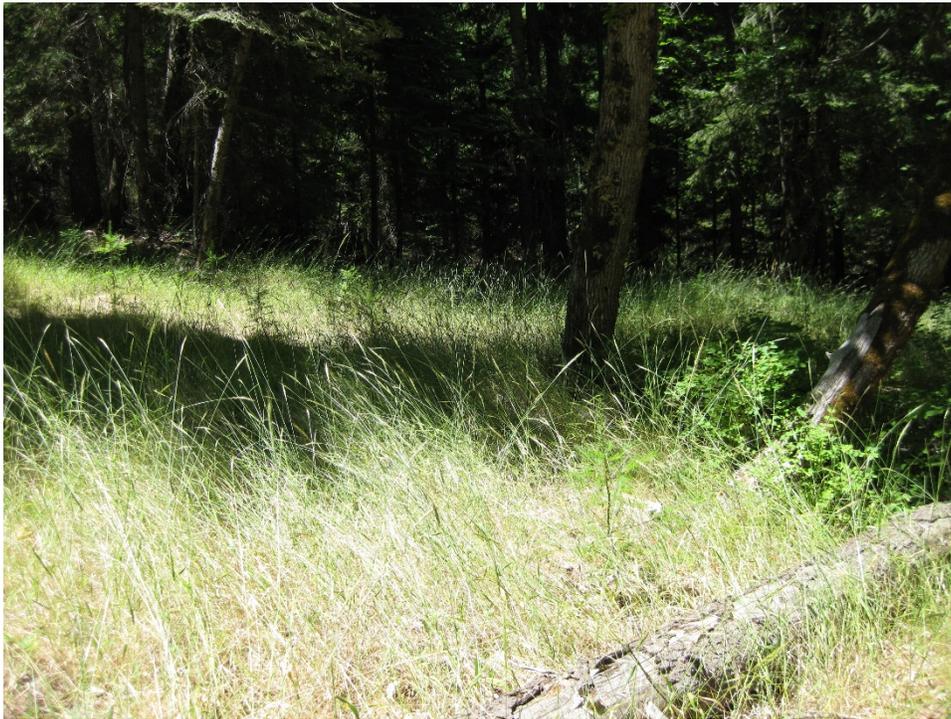
Comments: Plants appear healthy. Trees are larger than summer 2013 appear to be growing.

Comments: The grass is growing tall (at least 3 feet) and is established.

Photograph 17: Rock Stockpile reclamation plants and grass looking west.
Blue Ledge Mine, Rogue River - Siskiyou National Forest, CA
Photographed by: Annica Nord (ERRG)

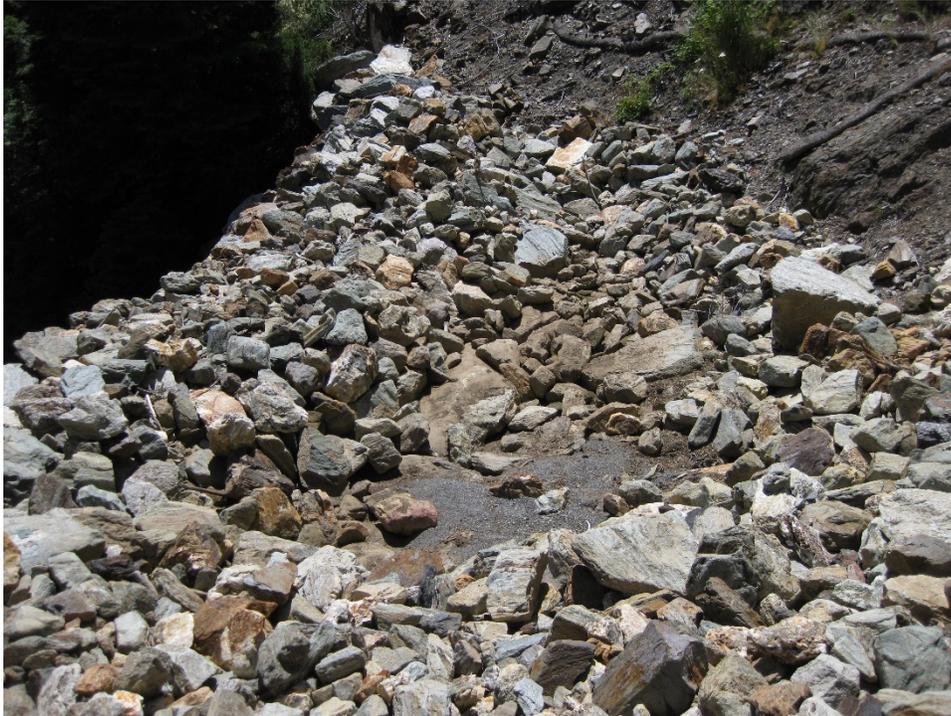
pH in basin 3: not measured- no water was observed in the basin

Photograph 18: Sediment/pH Treatment Basin 3. No water in the basin.
Blue Ledge Mine, Rogue River - Siskiyou National Forest, CA
Photographed by: Annica Nord (ERRG)

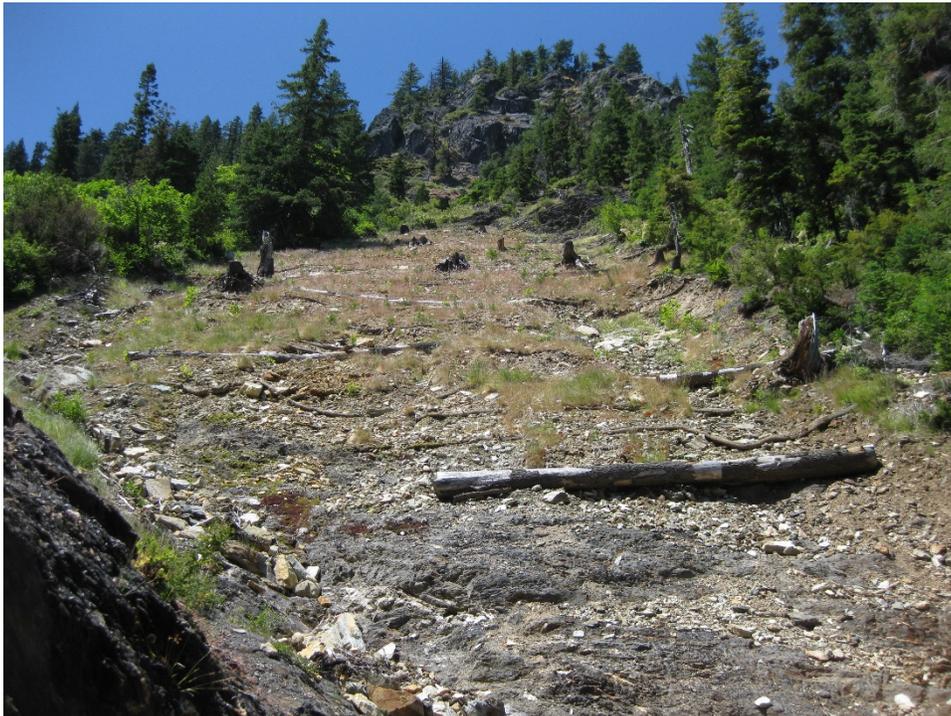
Photograph 19: WRP-3 reclamation plants and grass.
Blue Ledge Mine, Rogue River - Siskiyou National Forest, CA
Photographed by: Annica Nord (ERRG)
