August 29, 2014

Ref.: 2010-084

Technical Memorandum  
August 2014 Site Inspection Report  
Blue Ledge Mine  
Rogue River-Siskiyou National Forest

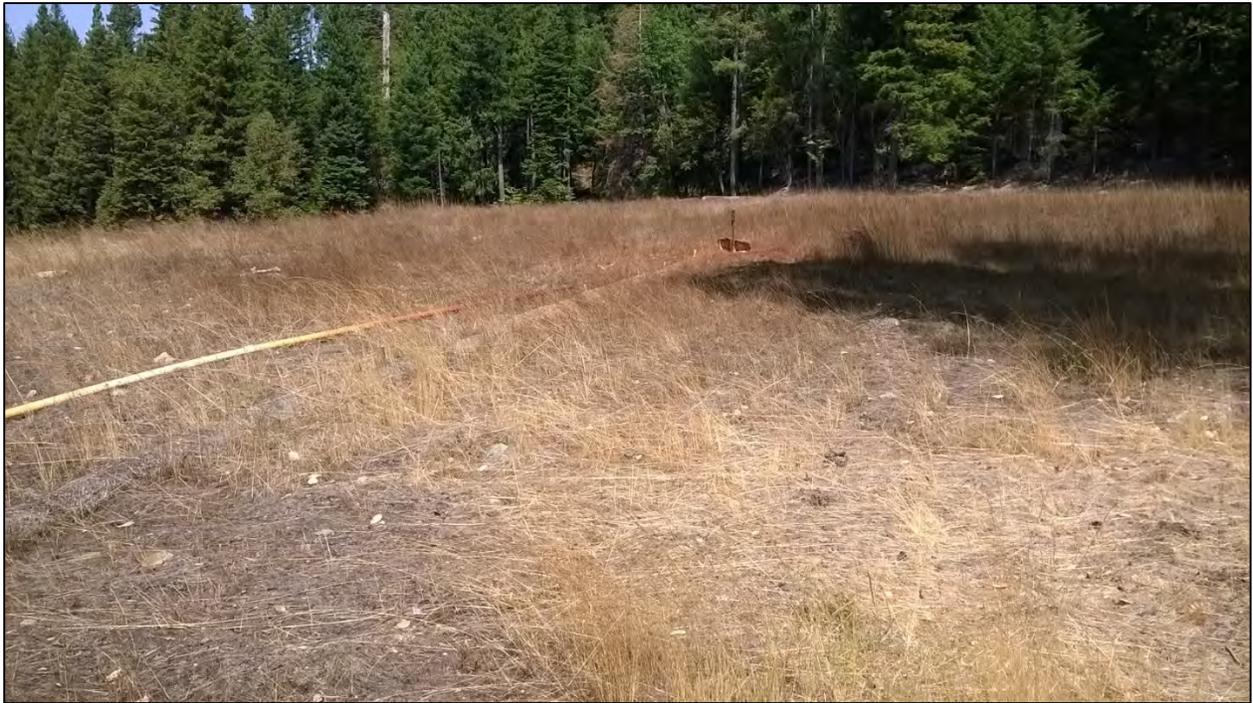
Comments: Straw wattles, Flexterra, and bark are functioning properly.

Comments: The grass appears to be well established but is brown as a result of the warm, dry summer days.

**Photograph 1: Top of repository, facing north.**  
Blue Ledge Mine, Rogue River - Siskiyou National Forest, CA  
Photographed by: Jeremy Podvin (ERRG)

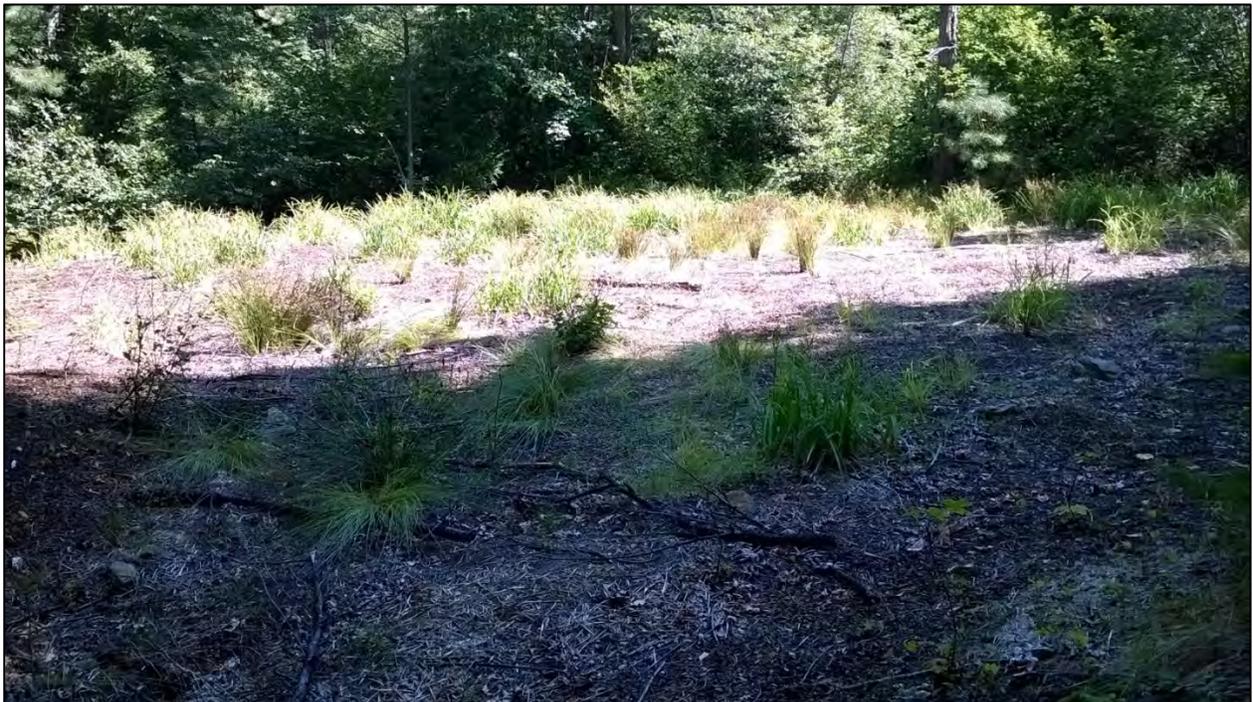
Comments: The uphill silt fence is no longer needed and was previously removed. The lower silt fence is intact.

**Photograph 2: South Storage area looking northeast.**  
Blue Ledge Mine, Rogue River - Siskiyou National Forest, CA  
Photographed by: Jeremy Podvin (ERRG)

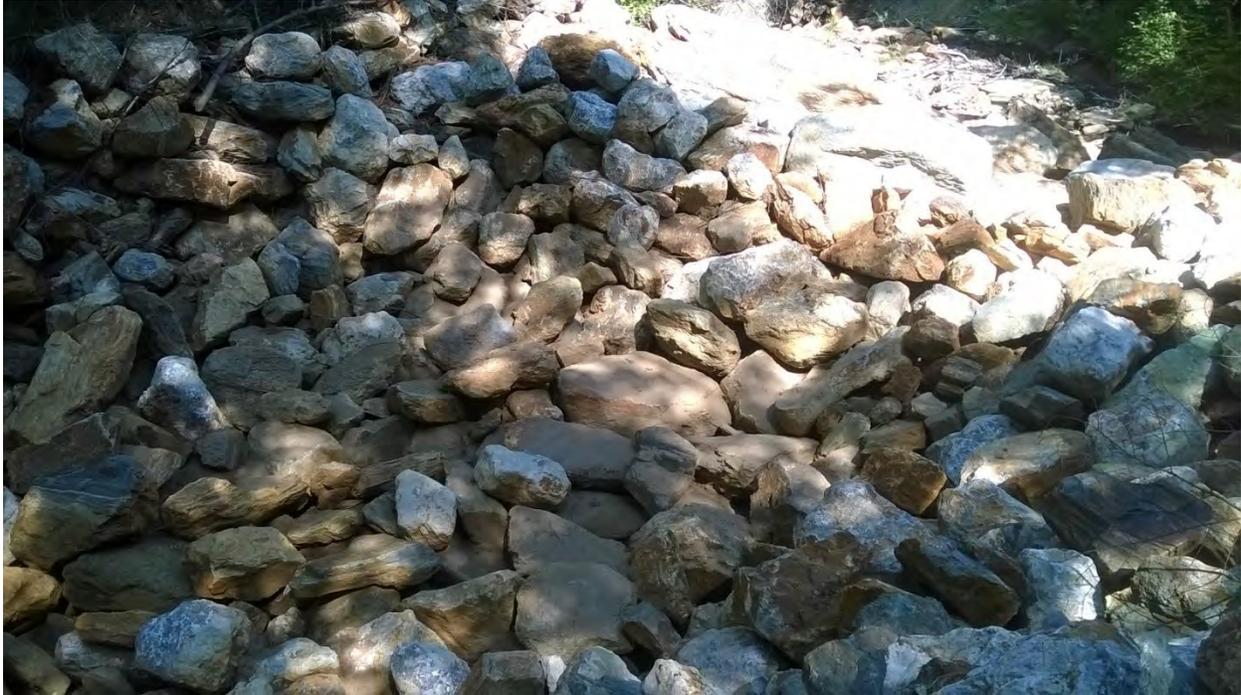
Accumulated sediment: 15%

pH in basin 1A: not measured-no water was observed in the basin

**Photograph 3: Sediment/pH Treatment Basin 1A.**  
Blue Ledge Mine, Rogue River - Siskiyou National Forest, CA  
Photographed by: Jeremy Podvin (ERRG)

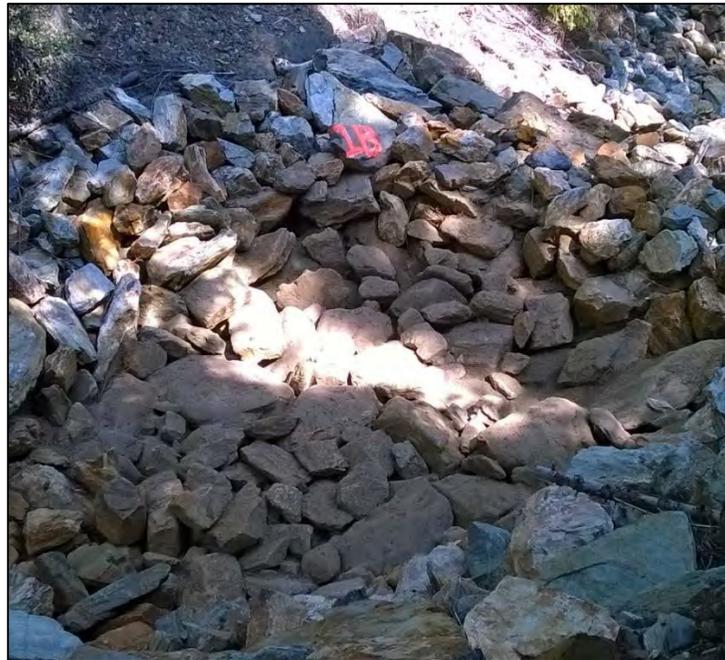
pH in basin 1B: not measured - no water was observed in the basin

**Photograph 4: Sediment/pH Treatment Basin 1B.**  
Blue Ledge Mine, Rogue River - Siskiyou National Forest, CA  
Photographed by: Jeremy Podvin (ERRG)

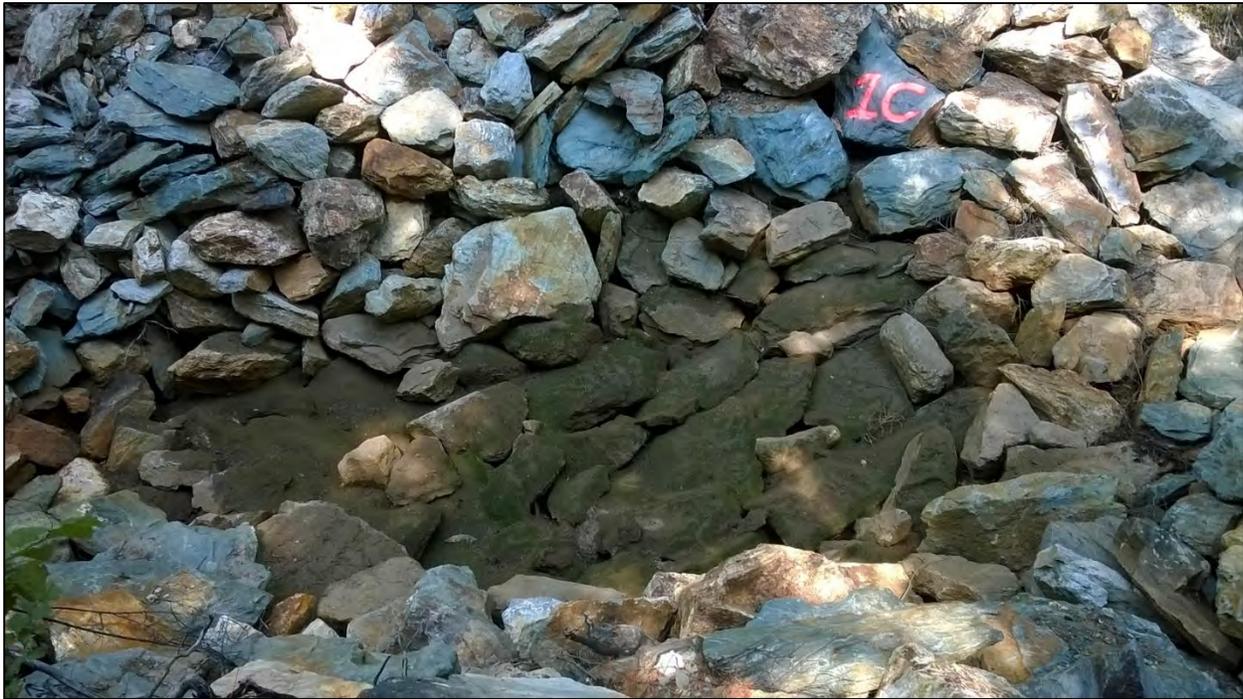
pH in basin 1C: not measured - no water was observed in the basin

**Photograph 5: Sediment/pH Treatment Basin 1C.**  
Blue Ledge Mine, Rogue River - Siskiyou National Forest, CA  
Photographed by: Jeremy Podvin (ERRG)

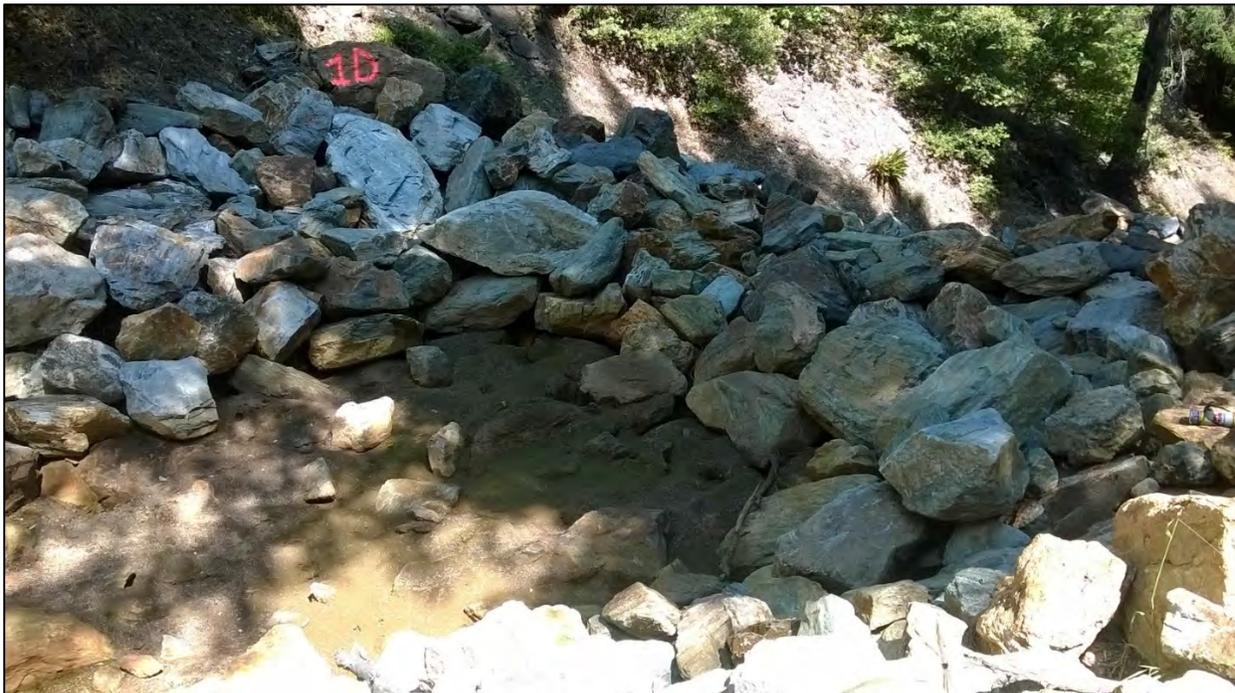
**Photograph 6: Sediment/pH Treatment Basin 1D.**  
Blue Ledge Mine, Rogue River - Siskiyou National Forest, CA  
Photographed by: Jeremy Podvin (ERRG)

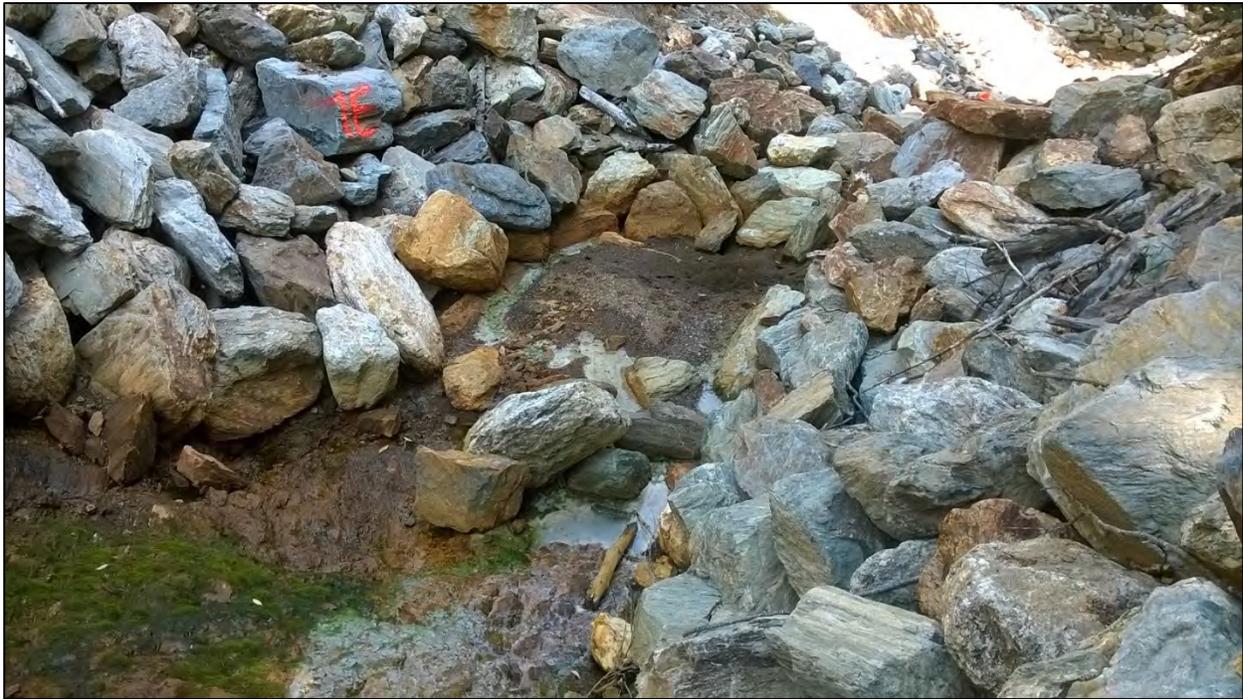
**Photograph 7: Sediment/pH Treatment Basin 1E.**  
Blue Ledge Mine, Rogue River - Siskiyou National Forest, CA  
Photographed by: Jeremy Podvin (ERRG)

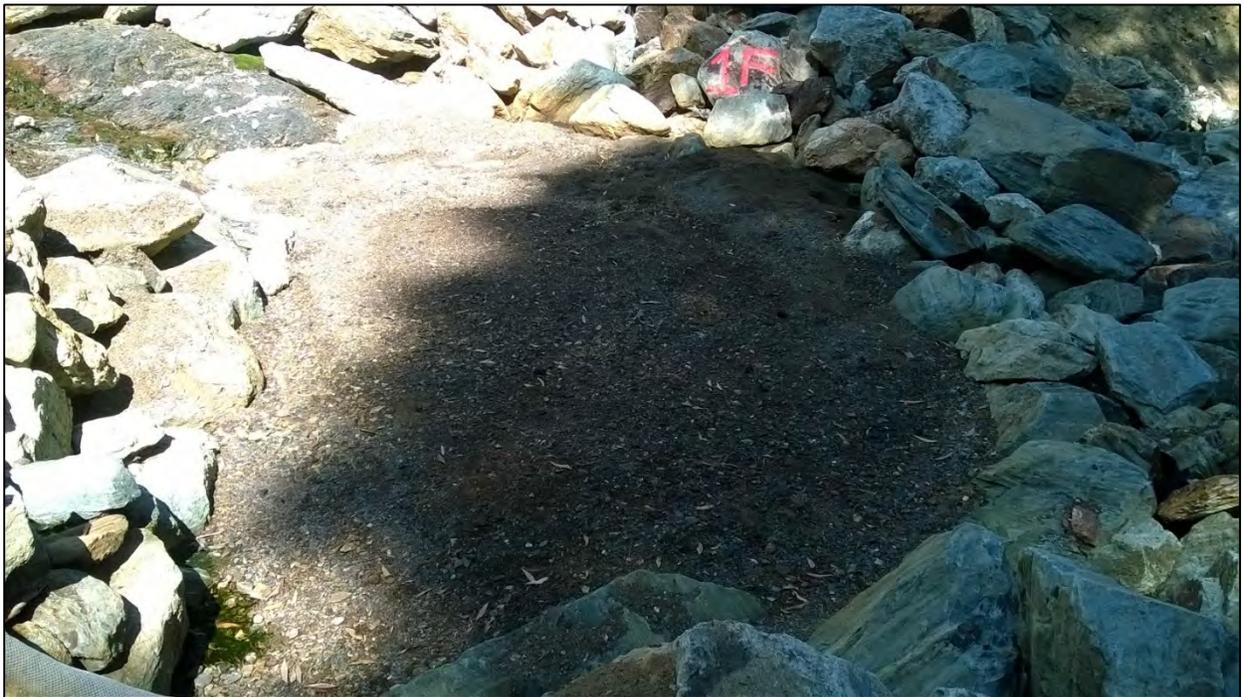
The acid seep previously entering the east side of basin 1F is being captured by the USEPA acid seep collection basin. The water seeping from adit A1N2 has been diverted by the USEPA to flow down the face of the WRP-1 bedrock to run to the acid seep collection basin. The pH in the USEPA acid seep basin was measured at 3.7, which is 0.1 higher than measured in July 2014. The USEPA acid seep basin overflow spillway is functioning. The 3.7 pH overflow is running through the rip rap into basin 1E and comingling with the water coming down the main drainage and flowing through basin 1F. This is likely why the pH in basin 1E is lower than above basin 1F. There is effectively a split flow of water between the main drainage into basin 1F and the overflow of the USEPA acid seep basin that does not fully comeingle until it reaches basin 1E. Basins 1E through 1D raised the pH by 0.3 units from 4.8 to 5.1 which is similar to July 2014. No water was observed in basins 1A, 1B, and 1C. Joe Creek pH at the base of WRP-1 was measured to be

**Photograph 8: Sediment/pH Treatment Basin 1F. Full of sediment.**  
Blue Ledge Mine, Rogue River - Siskiyou National Forest, CA  
Photographed by: Jeremy Podvin (ERRG)

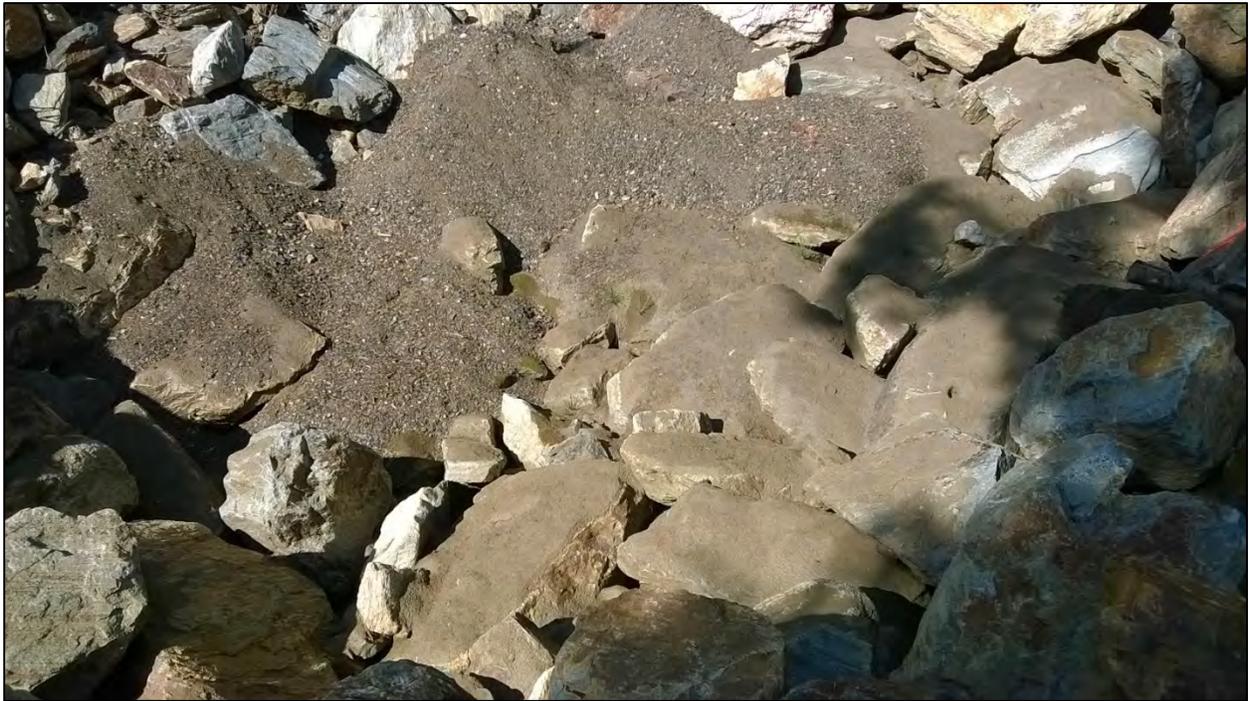
**Photograph 9: Sediment/pH Treatment Basin 2A. No water in the basin.**

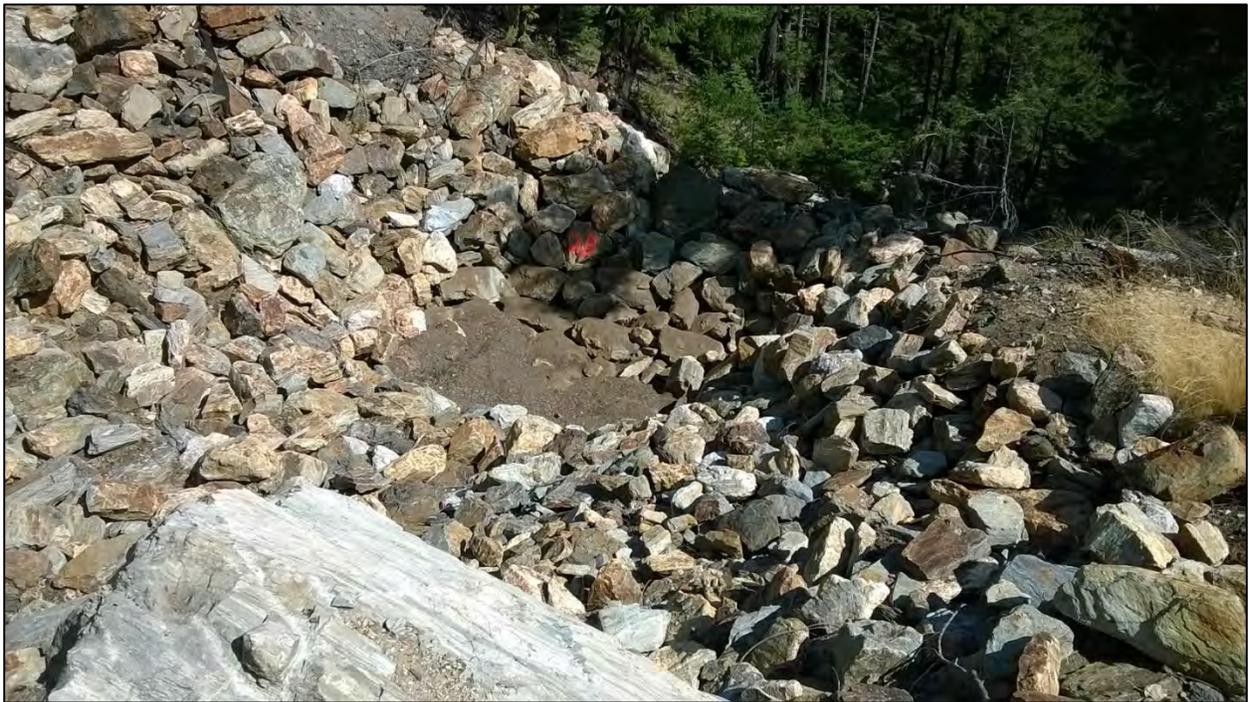
**Photograph 10: Sediment/pH Treatment Basin 2B. No water is in the basin.**

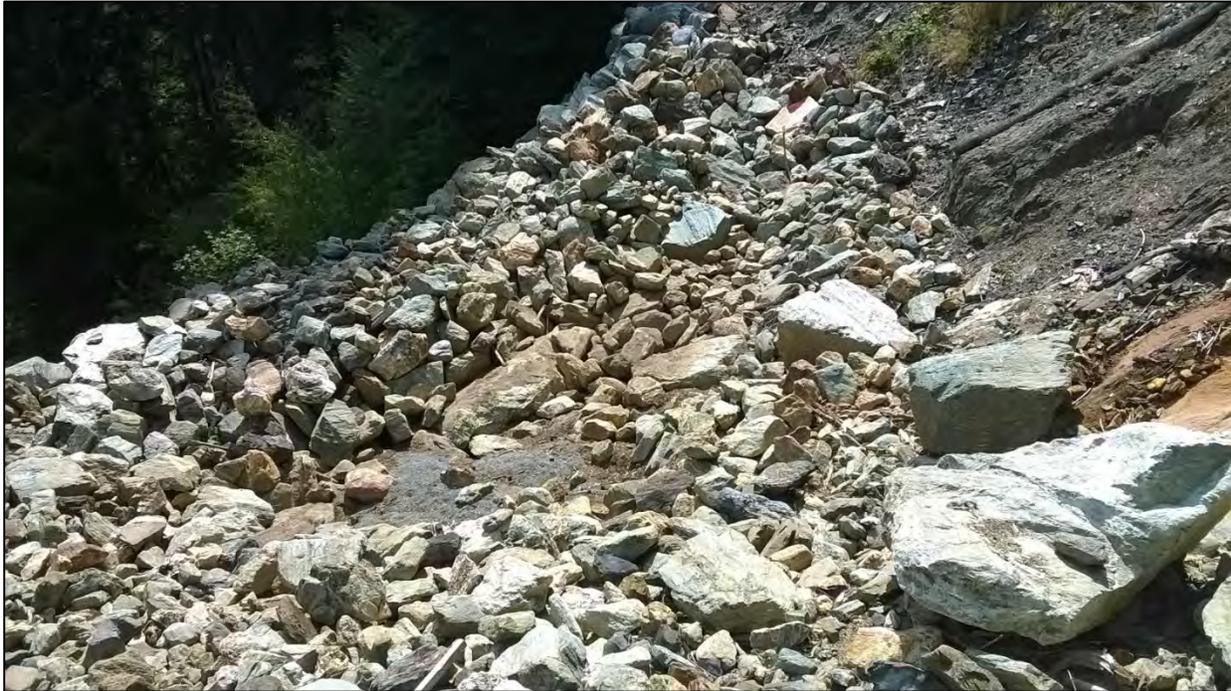
pH in basin 3: not measured- no water was observed in the basin

**Photograph 11: Sediment/pH Treatment Basin 3. No water in the basin.**

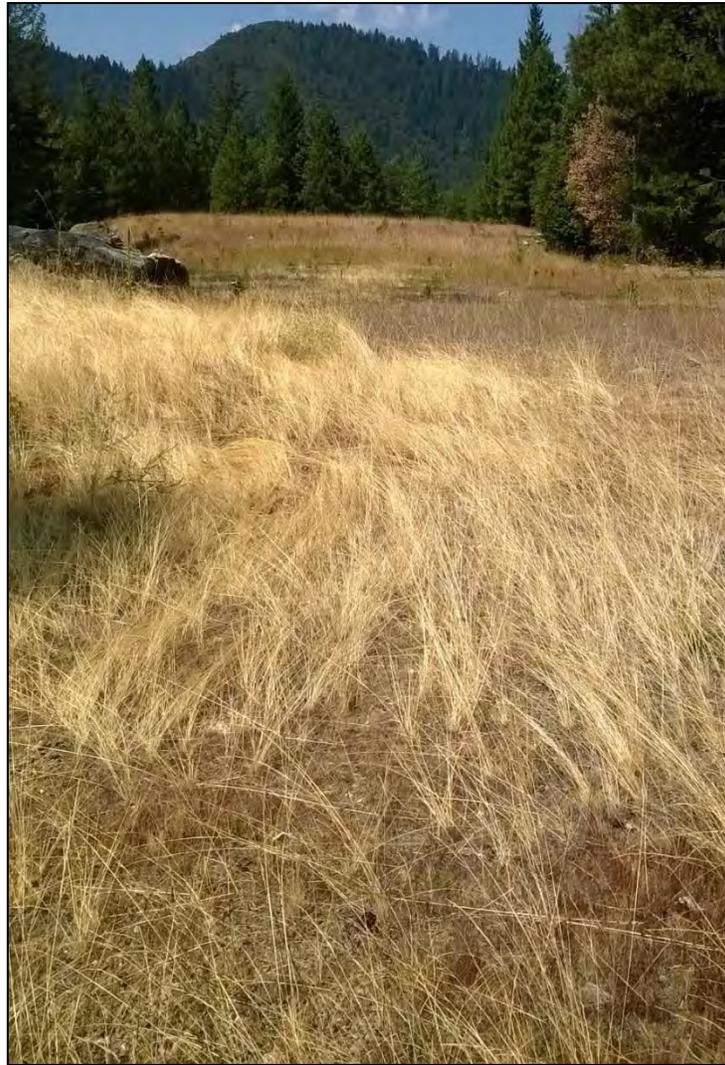
Comments: Grass appears to be established but is brown as a result of the warm, dry season.

Comments: Plants appear to be growing and are larger than last summer.

**Photograph 12: North Storage Area, facing west.**  
Blue Ledge Mine, Rogue River - Siskiyou National Forest, CA  
Photographed by: Jeremy Podvin (ERRG)

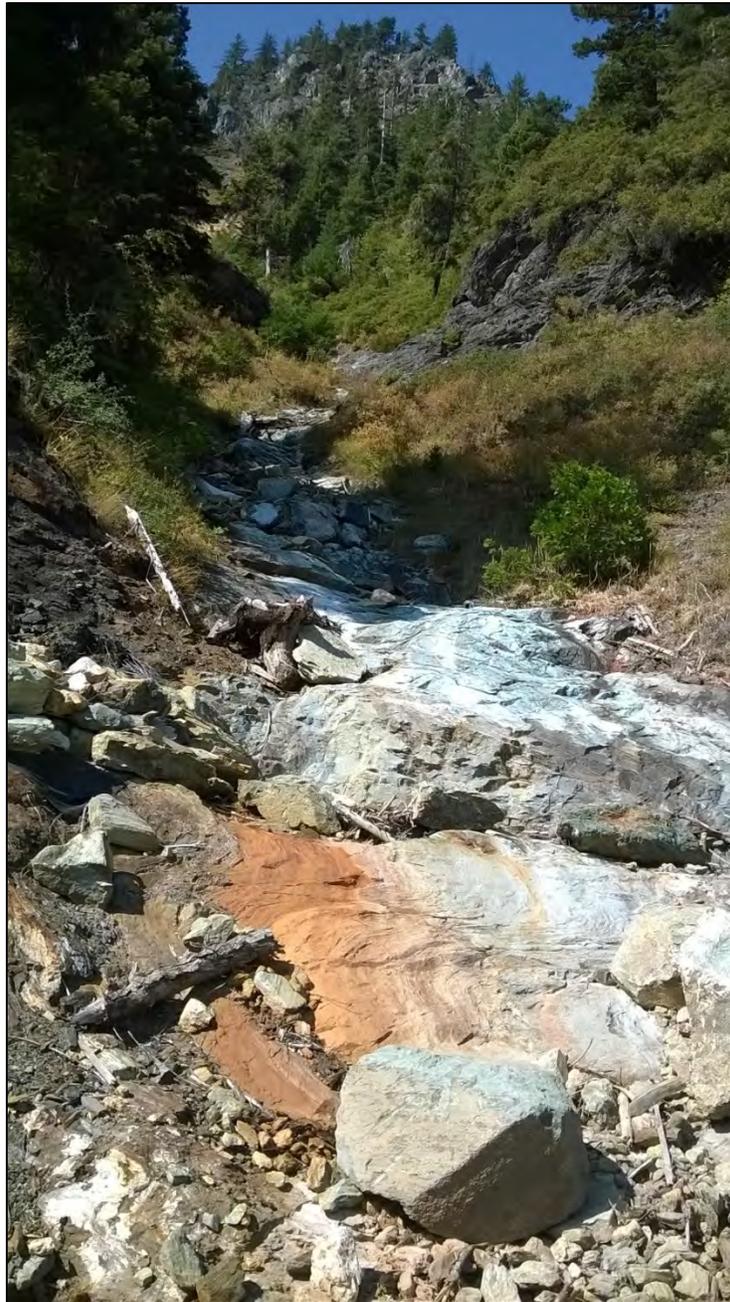
**Photograph 13: WRP-3 reclamation area.**  
Blue Ledge Mine, Rogue River - Siskiyou National Forest, CA  
Photographed by: Jeremy Podvin (ERRG)

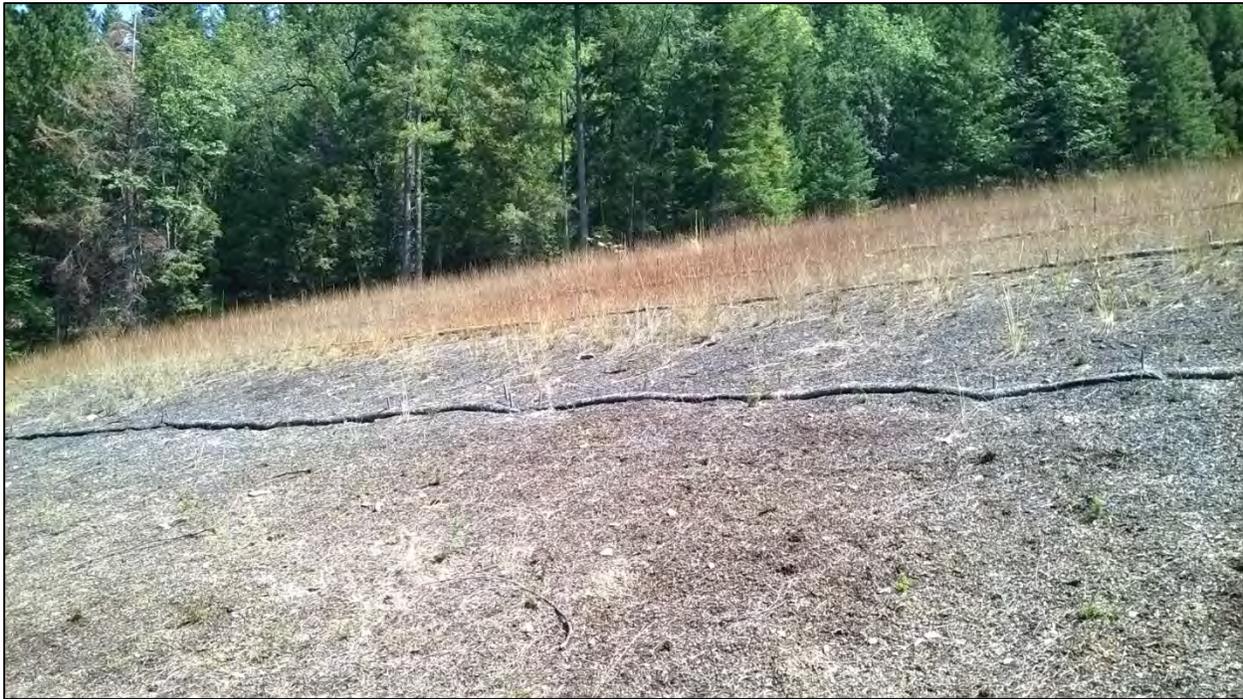
Comments: Plants appear healthy. The plants are small as a result of heavy browsing by deer but remain alive.

Comments: The grass appears to be well established. The majority of repository replacement plants (planted in October 2012) have survived, but have been heavily browsed by deer. Repository shrubs appear stunted due to the heavy browsing.

**Photograph 14: View of repository, facing north-northeast.**  
Blue Ledge Mine, Rogue River - Siskiyou National Forest, CA  
Photographed by: Jeremy Podvin (ERRG)

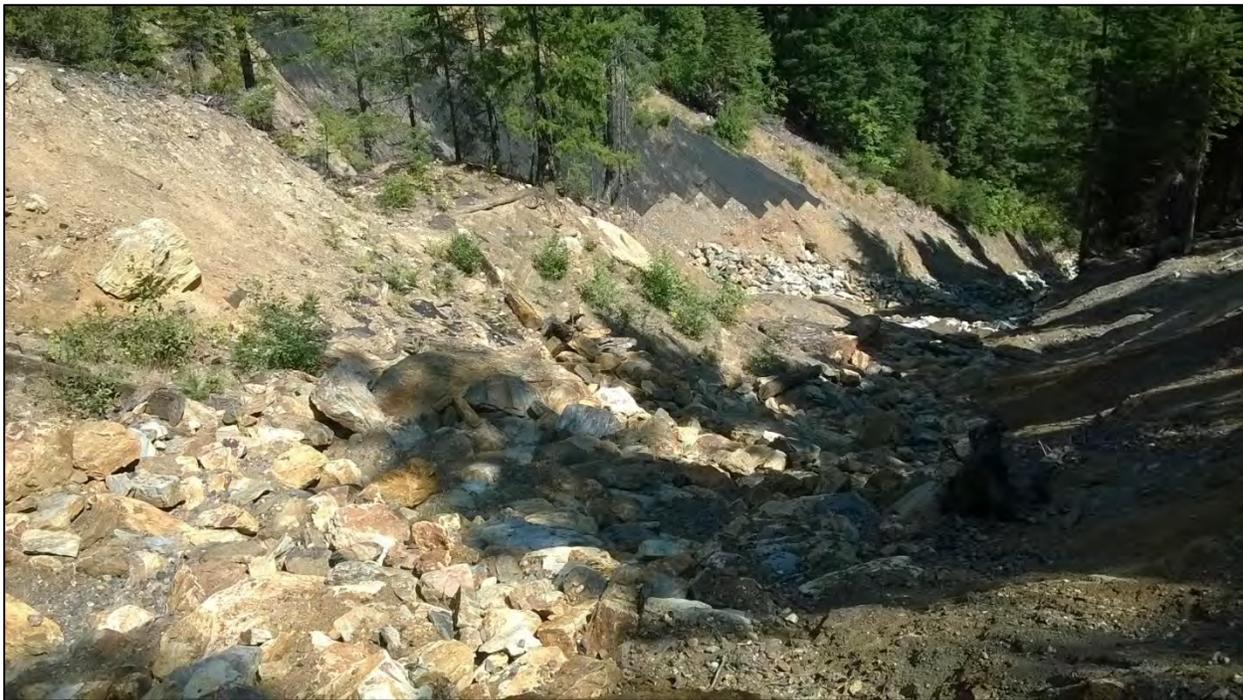
Comments: The upper tier of the reclamation area is devoid of plants, likely due to seepage of acidic mine drainage from the adjacent bedrock. This area is approximately 20 feet by 30 feet and no plants have survived.

**Photograph 15: View of WRP 1, facing northeast.**  
Blue Ledge Mine, Rogue River - Siskiyou National Forest, CA  
Photographed by: Jeremy Podvin (ERRG)

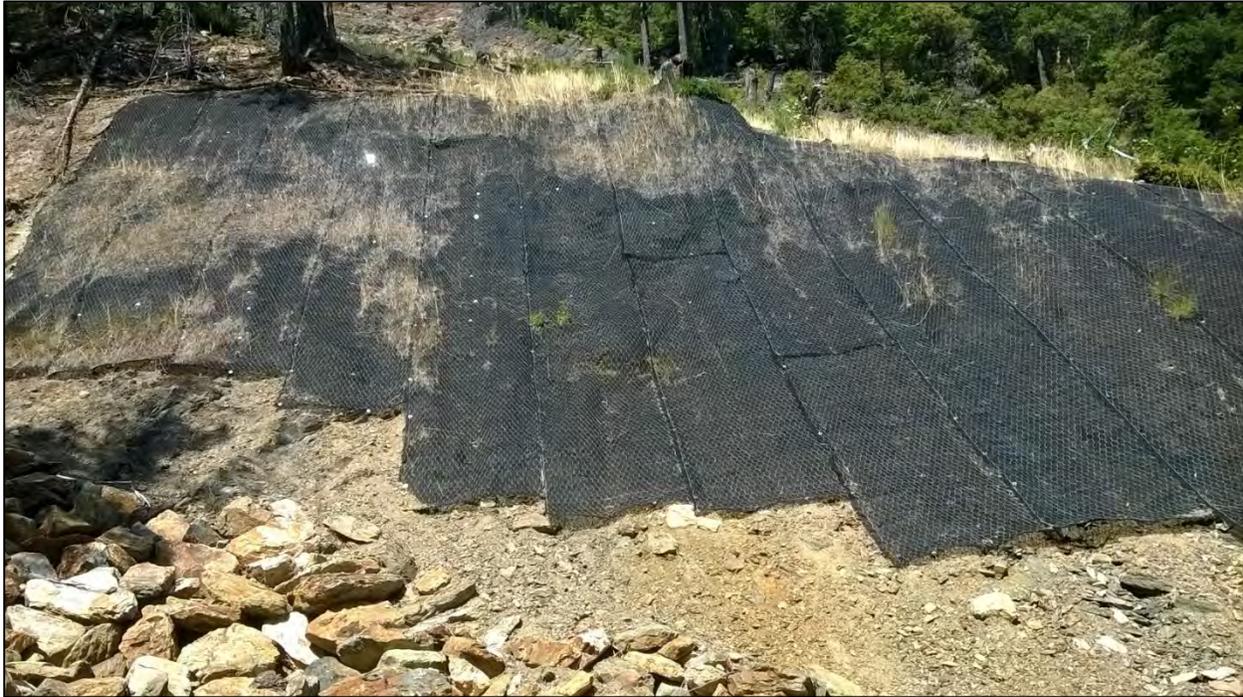
**Photograph 16: View of WRP-4, facing north.**  
Blue Ledge Mine, Rogue River - Siskiyou National Forest, CA  
Photographed by: Jeremy Podvin (ERRG)
