October 6, 2014

Ref.: 2010-084

Technical Memorandum
September 2014 Site Inspection Report
Blue Ledge Mine
Rogue River-Siskiyou National Forest

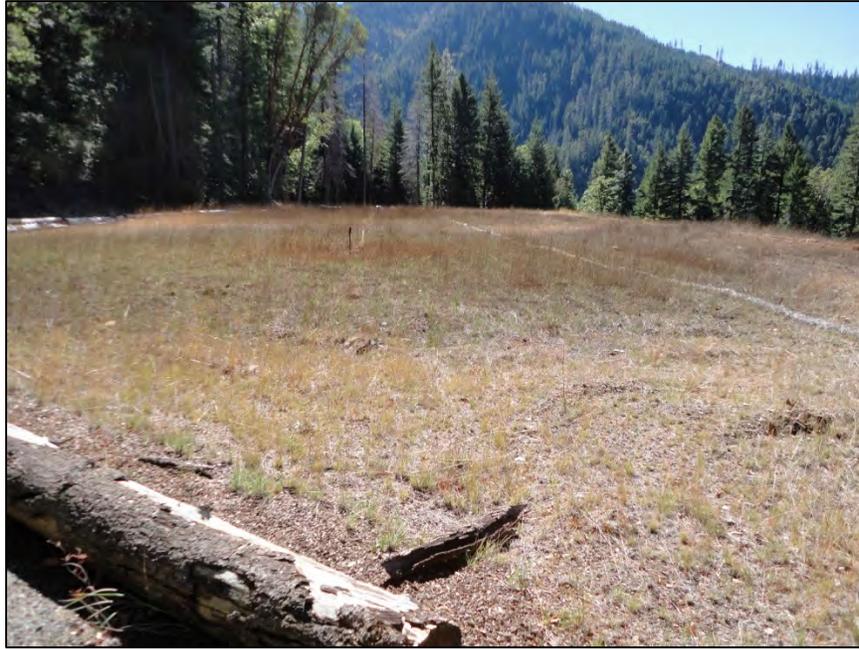
Photograph 1: Top of repository, facing south.
Blue Ledge Mine, Rogue River - Siskiyou National Forest, CA
Photographed by: Annica Nord (ERRG)

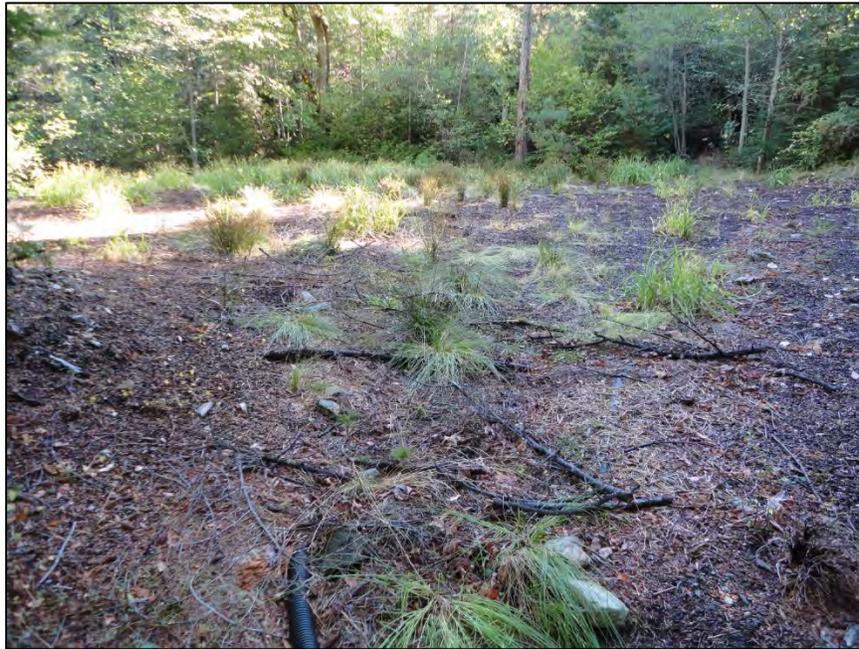
Comments: The uphill silt fence is no longer needed and was previously removed. The lower silt fence is intact.

Photograph 2: South Storage area looking northeast.
Blue Ledge Mine, Rogue River - Siskiyou National Forest, CA
Photographed by: Annica Nord (ERRG)

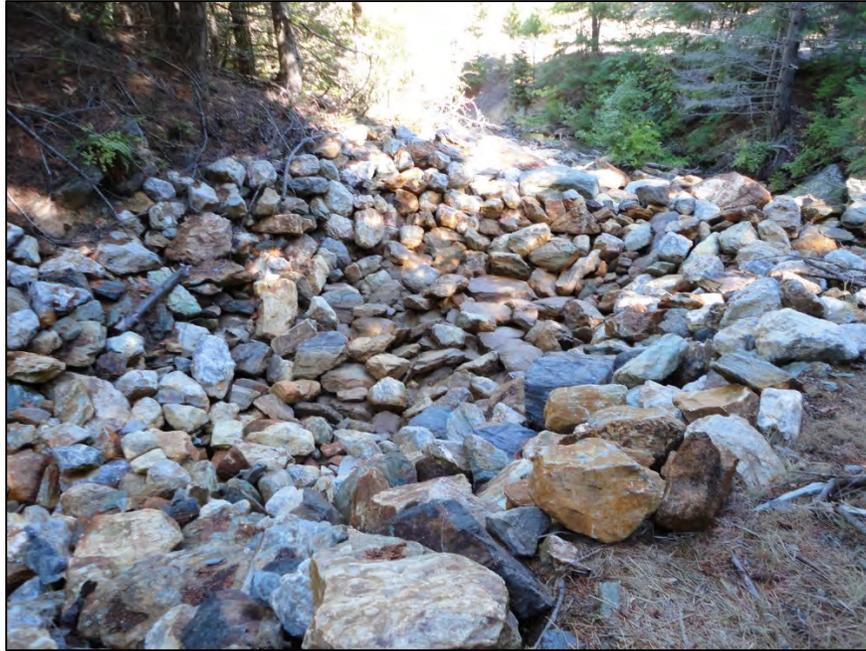
Accumulated sediment: 0%

pH in basin 1A: not measured-no water was observed in the basin

pH below basin 1A: 7.7 (in Joe Creek)

Photograph 3: Sediment/pH Treatment Basin 1A.
Blue Ledge Mine, Rogue River - Siskiyou National Forest, CA
Photographed by: Annica Nord (ERRG)

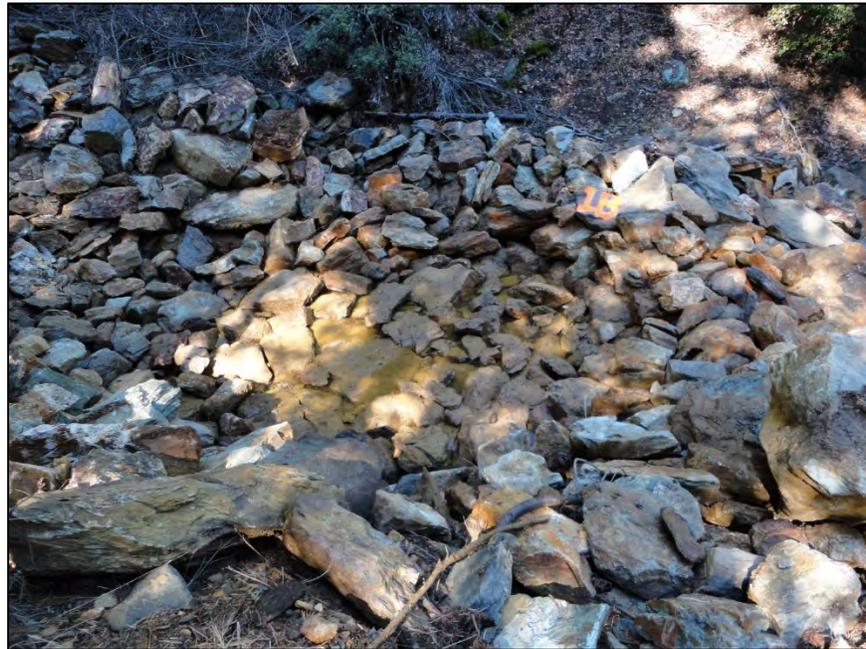
Accumulated sediment: sediment was removed during summer maintenance activities

pH in basin 1B: not measured - water in the basin was pumped out prior to sediment removal during summer maintenance activities

Photograph 4: Sediment/pH Treatment Basin 1B.
Blue Ledge Mine, Rogue River - Siskiyou National Forest, CA
Photographed by: Annica Nord (ERRG)

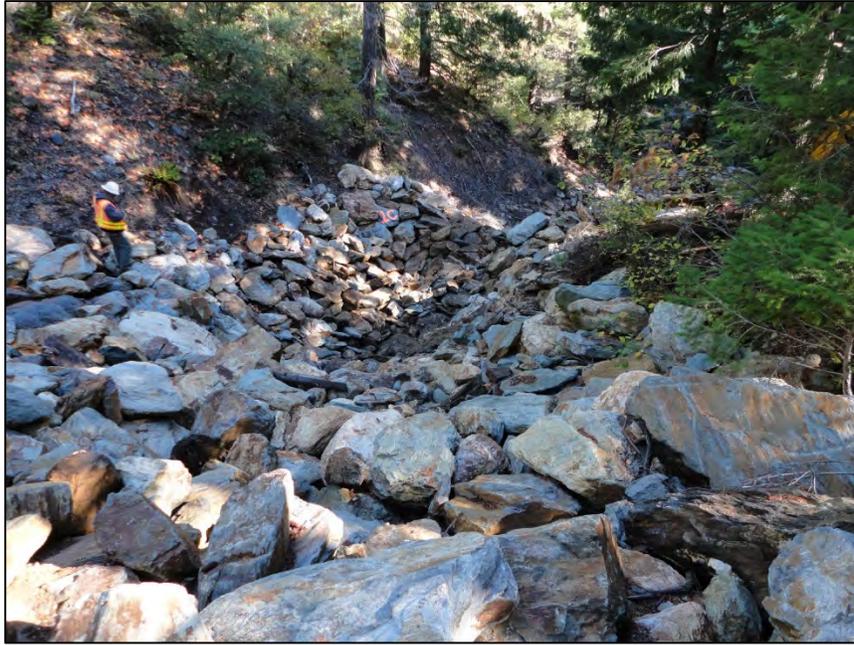
Photograph 5: Sediment/pH Treatment Basin 1C.
Blue Ledge Mine, Rogue River - Siskiyou National Forest, CA
Photographed by: Annica Nord (ERRG)

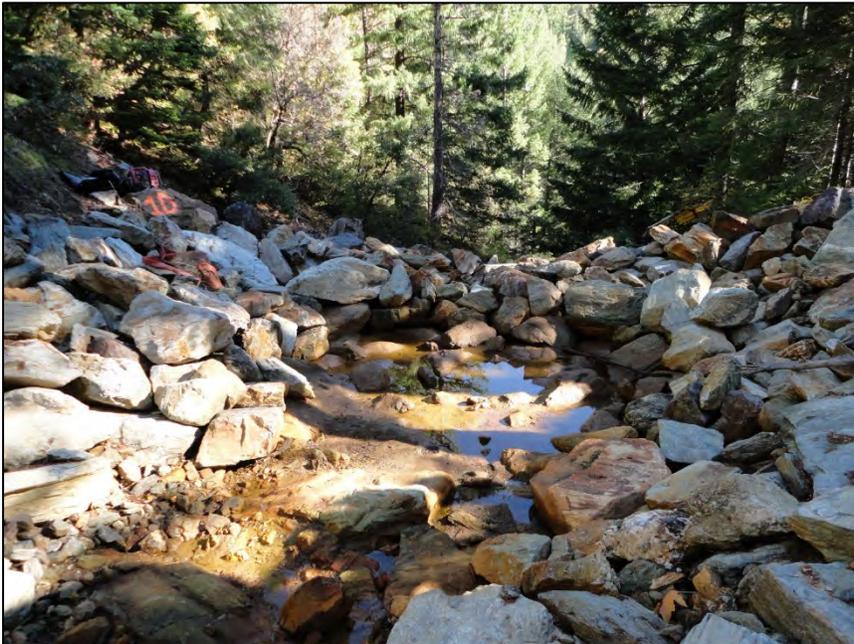
Photograph 6: Sediment/pH Treatment Basin 1D.
Blue Ledge Mine, Rogue River - Siskiyou National Forest, CA
Photographed by: Annica Nord (ERRG)

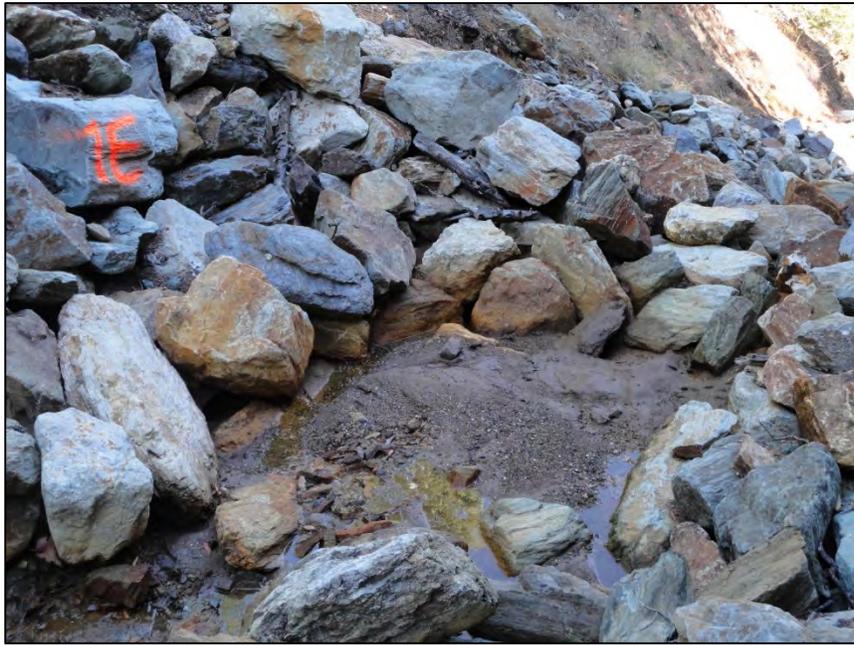
Photograph 7: Sediment/pH Treatment Basin 1E.
Blue Ledge Mine, Rogue River - Siskiyou National Forest, CA
Photographed by: Annica Nord (ERRG)

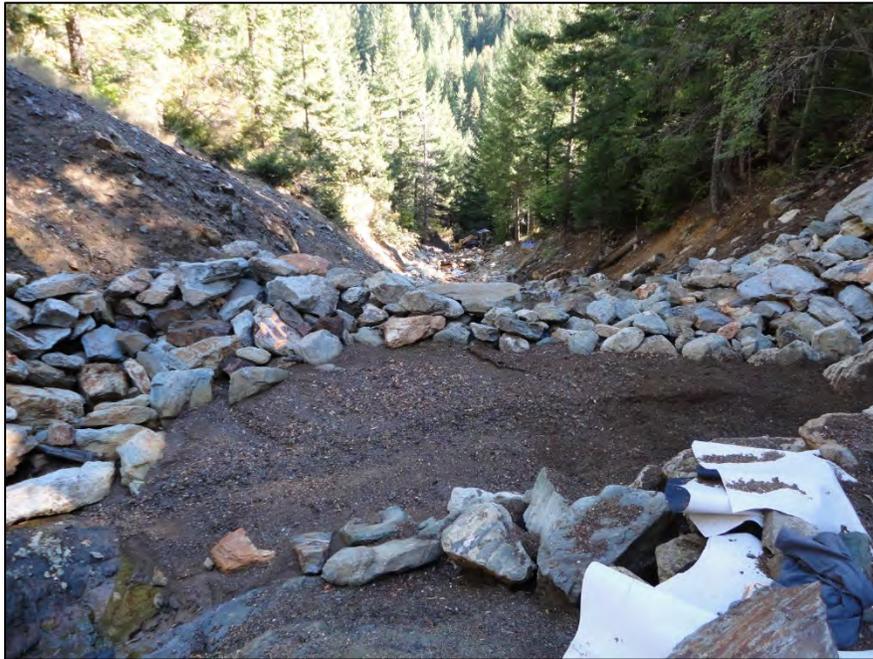
The acid seep previously entering the east side of basin 1F is being captured by the USEPA acid seep collection basin. The water seeping from adit A1N2 has been diverted by the USEPA to flow down the face of the WRP-1 bedrock to run to the acid seep collection basin. The pH in the USEPA acid seep basin was measured at 3.8, which is 0.1 higher than measured in August 2014. The USEPA acid seep basin overflow spillway is functioning. The 3.8 pH overflow is running through the rip rap into basin 1E and comingling with the water coming down the main drainage and flowing through basin 1F. This is likely why the pH in basin 1E is lower than above basin 1F. There is effectively a split flow of water between the main drainage into basin 1F and the overflow of the USEPA acid seep basin that does not fully comeingle until it reaches basin 1E. Basins 1E through 1D raised the pH by 0.1 units from 4.4 to 4.5 which is similar to August 2014. Joe Creek pH at the base of WRP-1 was measured to be 7.7, which is 0.8 higher than the measurement collected in August 2014. However, the pH in Joe Creek was measured

Photograph 8: Sediment/pH Treatment Basin 1F. Full of sediment.
Blue Ledge Mine, Rogue River - Siskiyou National Forest, CA
Photographed by: Annica Nord (ERRG)

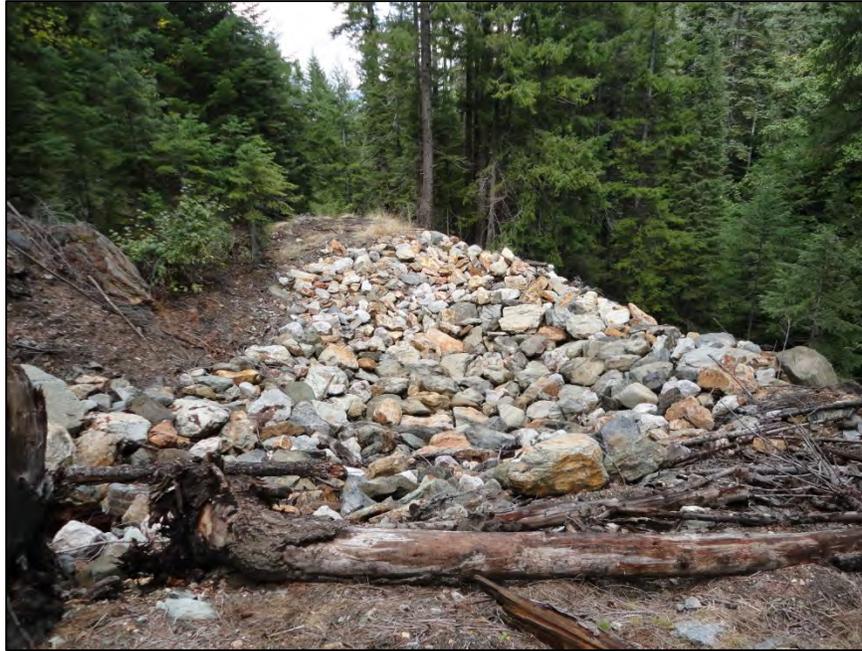
Photograph 9: Sediment/pH Treatment Basin 2A. No water in the basin.

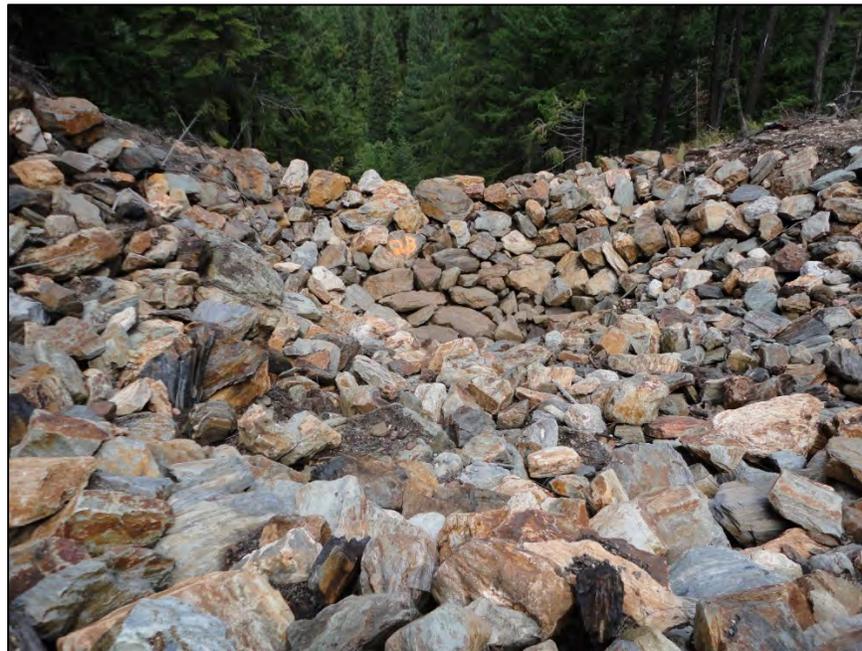
Photograph 10: Sediment/pH Treatment Basin 2B. No water is in the basin.

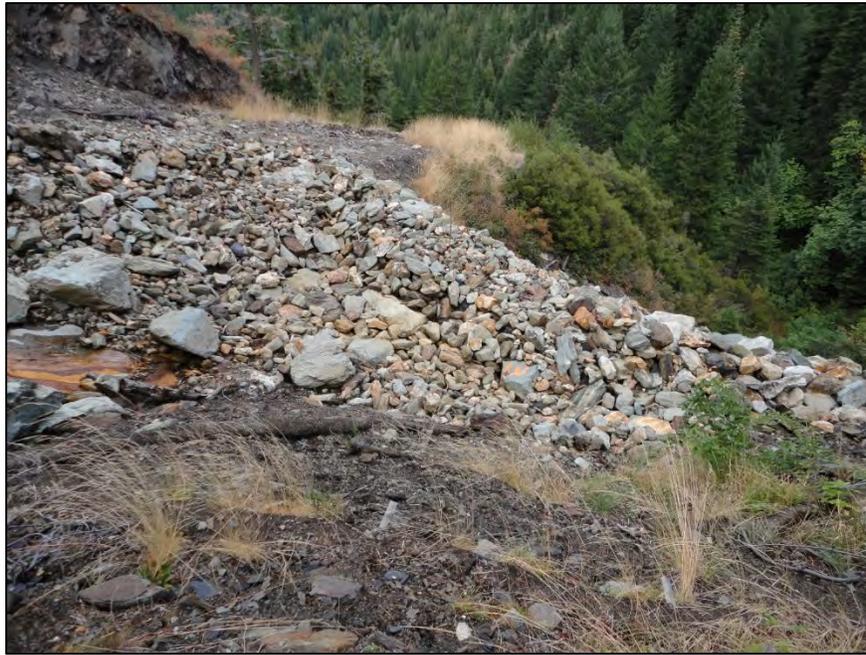
pH in basin 3: not measured- no water was observed in the basin

Water depth: no water was observed in the basin

Photograph 11: Sediment/pH Treatment Basin 3. No water in the basin.

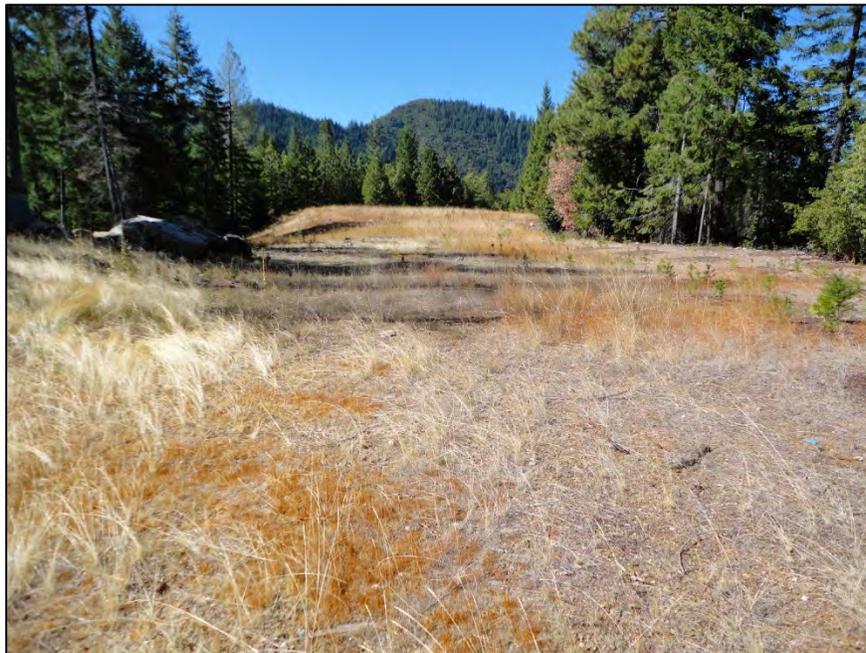
Comments: Plants appear to be growing and are larger than last summer.

Comments: This area has sufficient live plants. Plants look healthy.

Photograph 12: North Storage Area, facing west.

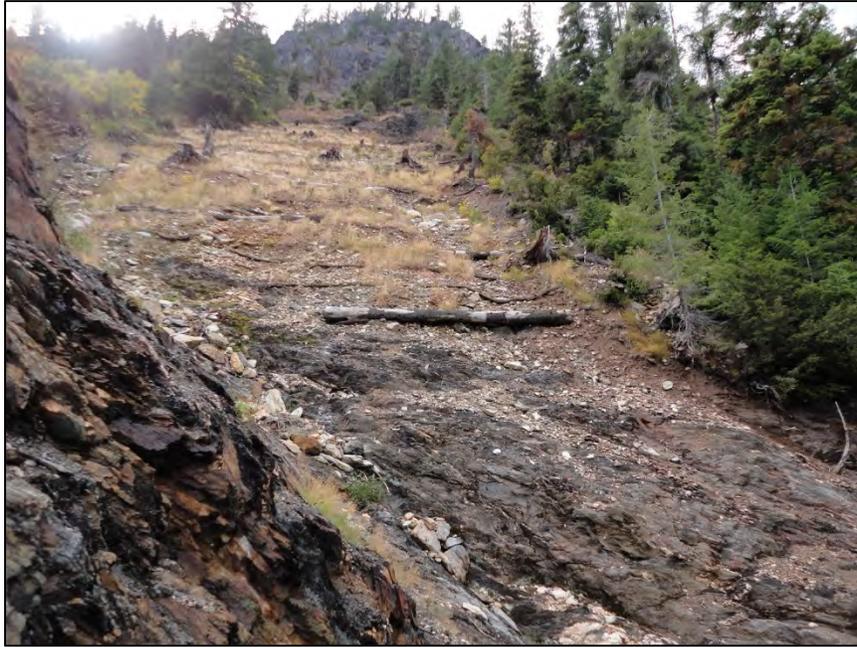
Photograph 13: WRP-3 reclamation area.
Blue Ledge Mine, Rogue River - Siskiyou National Forest, CA
Photographed by: Annica Nord (ERRG)

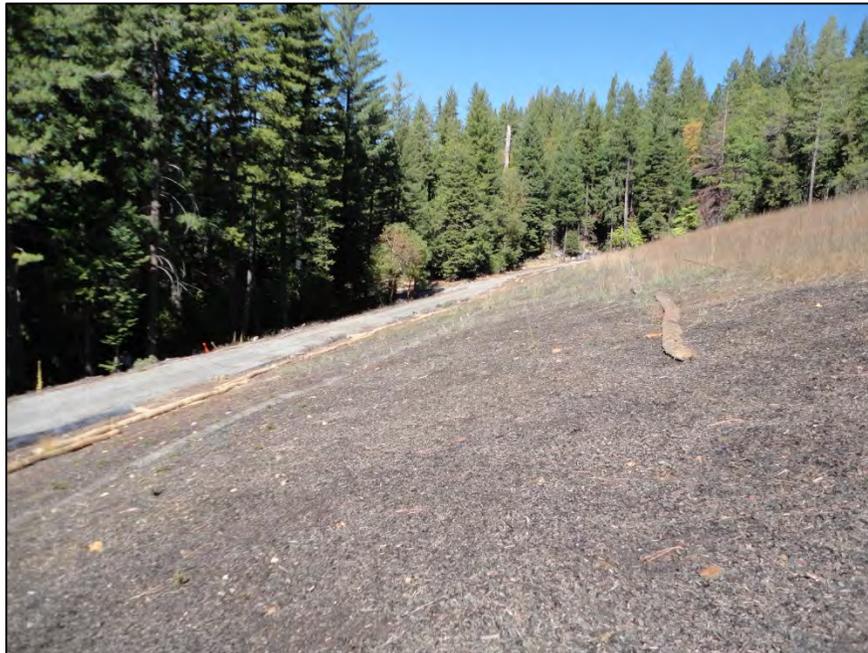
Photograph 14: View of repository, facing north.
Blue Ledge Mine, Rogue River - Siskiyou National Forest, CA
Photographed by: Annica Nord (ERRG)

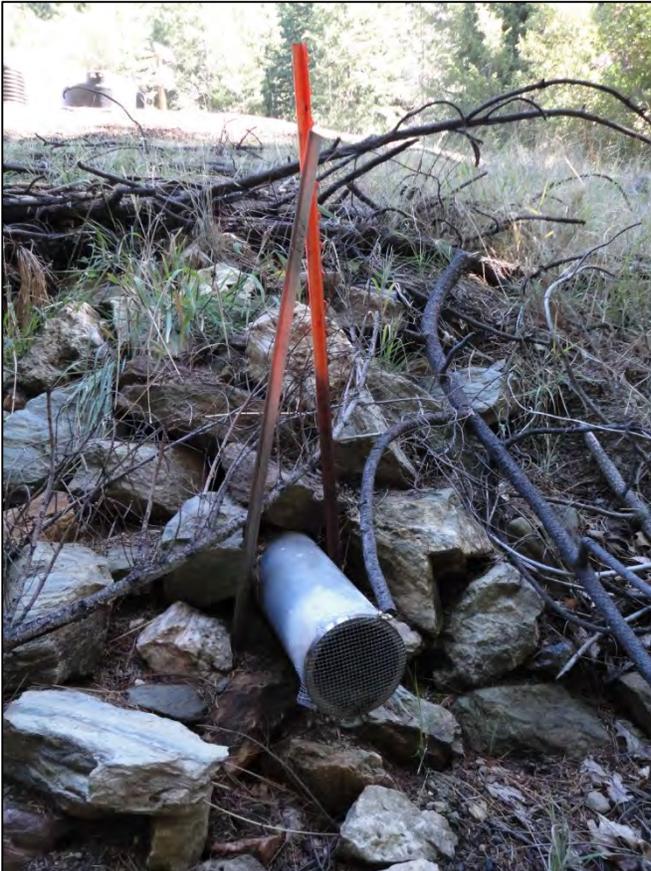
Comments: The anchor trench drain pipes are not blocked, screens are intact, and no water is flowing from the drain. A thicker, more durable galvanized screen replaced the damaged screen on all anchor trench drains in May 2014. The underdrain is not blocked, screen is intact, and no water is flowing from the pipe.

Photograph 15: View of anchor trench drain.
Blue Ledge Mine, Rogue River - Siskiyou National Forest, CA
Photographed by: Annica Nord (ERRG) Date: October 1, 2014

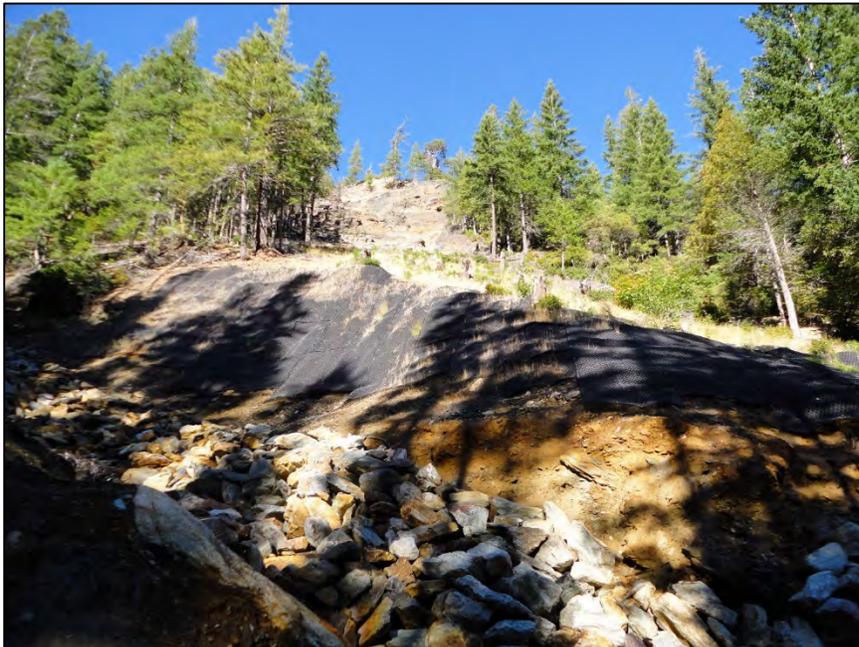
Photograph 16: View of WRP-4, facing north.
Blue Ledge Mine, Rogue River - Siskiyou National Forest, CA
Photographed by: Annica Nord (ERRG)
