## **APPENDIX M: Supplemental Hydrology Report**

### **Objectives**

### **Observation and Findings from On-The-Ground Surveys**

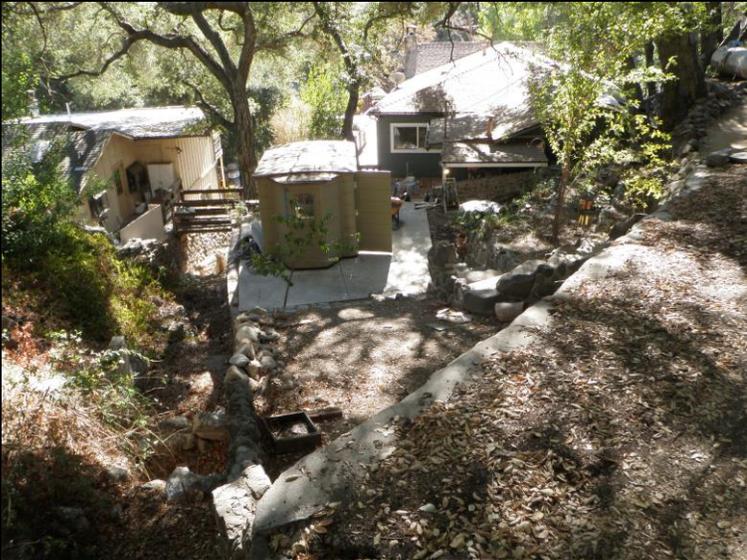
Values at Risk	Findings	Determination /Comments
	<p>The streamcrossing is linked to risks for these homes/residents as failure of the crossing may result in water flowing into the backyard and potentially home of at least two residents. It is also possible for water to be diverted down the road surface into two additional homes. Only one home at this site has erosion control measures in place.</p> <p>Modeling of the stream crossing predicts a flow of 38-52 CFS up to 110 CFS with bulking. It is estimated to pass a 2 year RI peak flow with bulking would require at least a 46-52 inch culvert. The culvert at this location is 36 inches in diameter. See culvert discussion in Roads.</p> <p><b>Potential for injury and property damage due to increased water flows, erosion, and mass wasting from burn areas.</b></p> <p><i>Photo looking downslope. Channel is ditched through neighborhood.</i></p>

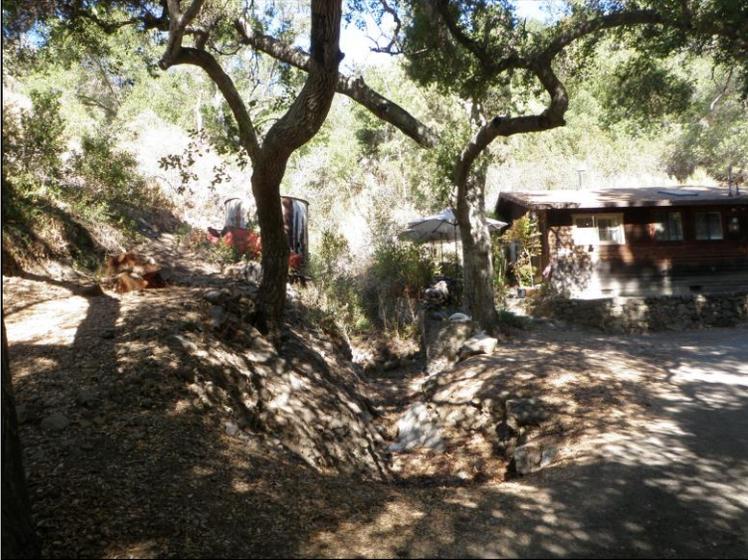
Values at Risk	Findings	Determination /Comments
	<p><i>Photo looking upslope of crossing. Stream has a small segment of unburned vegetation between burn perimeter and homes.</i></p>

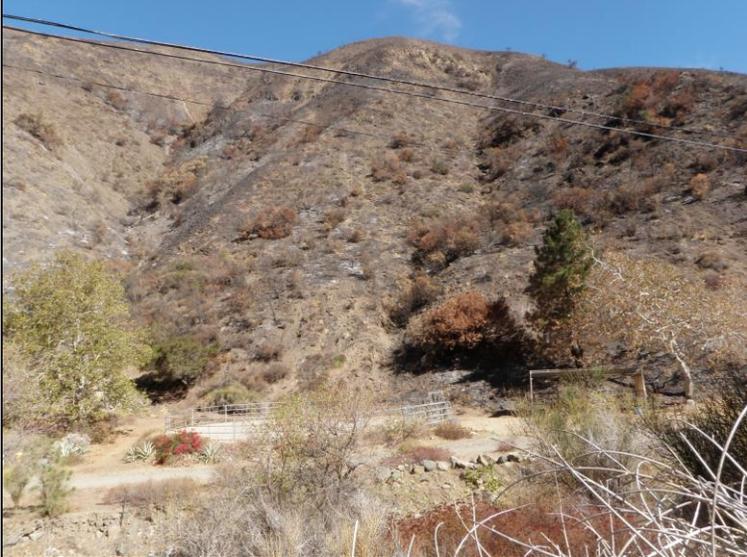
<p>Location 2 Residents of Silverado Cyn near outlet of tributary (horse corral and shed) [GPS location 33.746569, -117.590877]</p>	<p>Smaller tributaries (not designated with a specific name or modeled) are estimated to experience increases in flow and sedimentation as well. Several small tributaries have narrow steep chutes (and may be associated with past mass wasting events). One specific home has two nearby chutes that are aligned with a horse corral and storage shed. The home is out of direct alignment with the chute but may still be affected. Deposits near the base of the chutes/slope suggest past slope failures. Ingress and egress to the house could be blocked as runoff crosses their access road.</p> <p>Although no modeling was completed specifically for this site, the results from the modeled sites can be extrapolated. Flows are expected to be at least 4 times higher than usually experienced in a 2 year storm and sedimentation has the potential to increase 29 times.</p> <p><b>Potential for injury and property damage due to increased water flows, erosion, and mass wasting from burn areas.</b></p>	<p><b>Very High to High risk.</b></p> <p><b>Emergency exists</b></p>

Values at Risk	Findings	Determination /Comments
	<p><i>Photo of horse corral and shed with chutes above.</i></p>

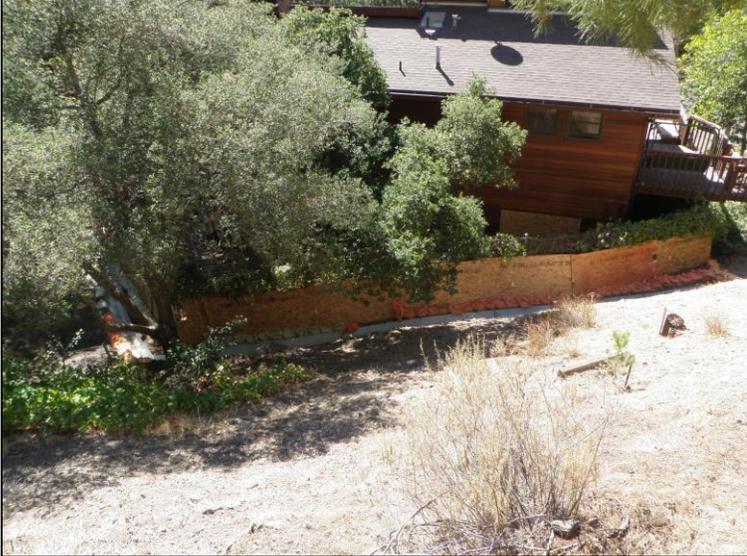
<p>Location 3 Residents of Silverado Cyn, downslope of burned area [GPS location 33.746675, -117.593647]</p>	<p>A house that has already installed some erosion control measures may still be at risk for larger sediment delivery. However, during smaller events the erosion control measures should help to protect their house.</p> <p><b>Potential for injury and property damage due to increased water flows, erosion, and mass wasting from burn areas.</b></p> <p><i>Photo of home with erosion control mitigations that will help protect home from some damage.</i></p>

<p><b>Very High to High Risk.</b></p> <p><b>Emergency exists</b></p>

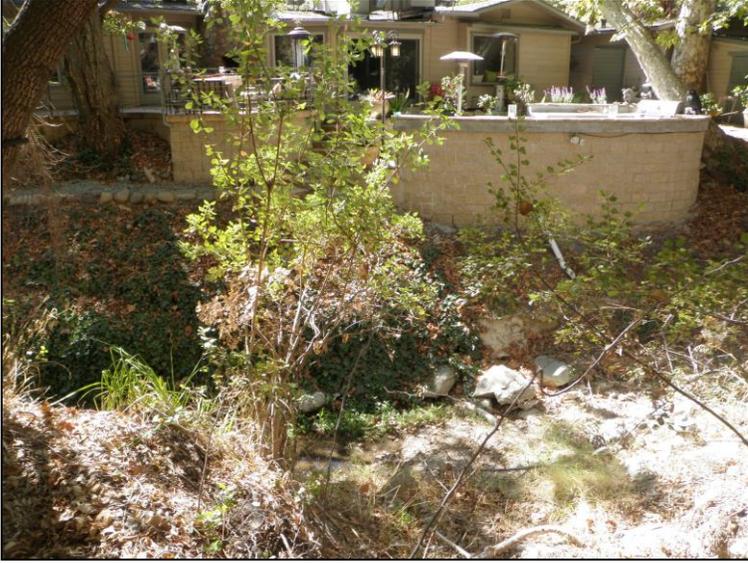
Values at Risk	Findings	Determination /Comments
Location 4 Residents of Silverado Cyn, small slope failure above house [GPS location 33.746940, -117.594266]	<p>A house with a very long driveway and located up on a ridge is not at risk from post-fire flooding in the greater tributary channel; however, there is a small burned catchment directly above their house that has historically failed. Increased runoff and sediment from this catchment is likely. Sandbags were observed on the property, however, they were not in place.</p> <p><b>Potential for injury and property damage due to increased water flows, erosion, and debris flows from burn areas.</b></p>	<p><b>Very High to High Risk. Emergency exists.</b></p>
Location 5 Residents of Silverado Cyn, House across from tributary outlet [GPS location 33.746107, -117.595500]	<p>Subwatershed D has the outlet in direct alignment with a house across Silverado Creek. Flooding from the tributary in a 2 year storm should not affect the house; however if enough volume is delivered to the channel in a larger event (mass wasting/debris flow), the house could be affected. (Debris flows may cause a risk, see geo report.) There is a wall the borders the channel, which should provide some protection.</p> <p><b>Some potential for injury and property damage due to increased water flows, erosion, and debris flows from burn areas.</b></p> <p><i>Looking at home from outlet of tributary.</i></p>

<p><b>Intermediate Risk. Emergency exists.</b></p>

Location 4 Residents of Silverado Cyn, small slope failure above house	Contact NRCS/County to determine erosion control needs. Placement of sandbags to direct flows away from structures. Maintenance of erosion control structures after each storm. Evacuation plan.	<b>Very High to High Risk.</b>  <b>Emergency exists</b>
Location 5 Residents of Silverado Cyn, House across from tributary outlet.	Evacuation plan.	<b>Intermediate Risk.</b>  <b>Emergency exists</b>
Residents of	Contact NRCS/County to determine if additional erosion	<b>Very High Risk.</b>

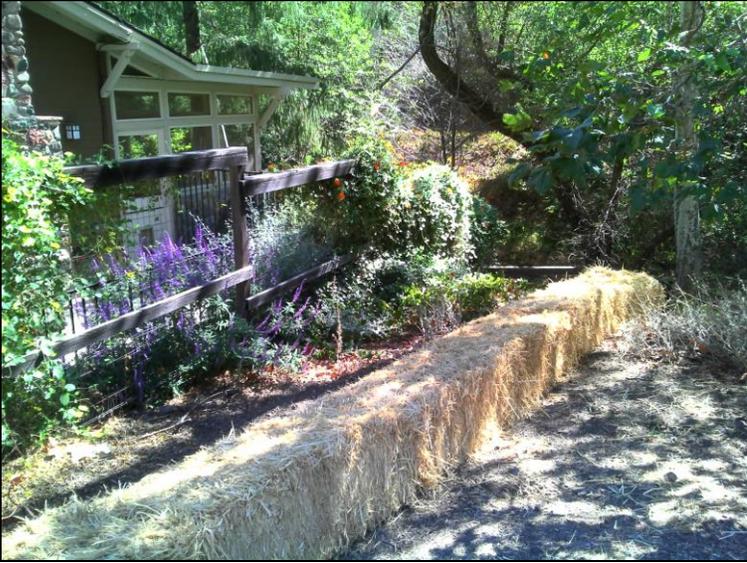
Location 6 Residents of Silverado Cyn, two homes near tributary outlet, [GPS location	<p>Two houses are at risk at the outlet of a small tributary (past subwatershed D) and may be built on an old debris flow deposit. The drainage is burned in the headwaters and has a buffer of unburned. The outlet of the subwatershed drains to a culvert (18"). The culvert is very long (extends the length of the yard), curves and is partially buried at the inlet. If the</p>	<p><b>Very High risk. Emergency exists.</b></p>

Values at Risk	Findings	Determination /Comments
<p>33.746625, -117.597158 And 33.746484, -117.597563]</p>	<p>culvert plugs, drainage may just run across the flat surface of the yard (two lines of bales have been lined out on either side of the yard.) Adjacent house may be at risk if flow diverts to that side, despite straw bale.</p> <p>Although no modeling was completed specifically for this site, the results from the modeled sites can be extrapolated. Flows are expected to be at least 4 times higher than usually experienced in a 2 year storm and sedimentation has the potential to increase 29 times.</p> <p><b>Potential for injury and property damage due to increased water flows, erosion, and debris flows from burn areas.</b></p> <p><i>Photo of home adjacent to culvert. At risk if culvert and bale fail. Could reinforce with sand bags.</i></p>

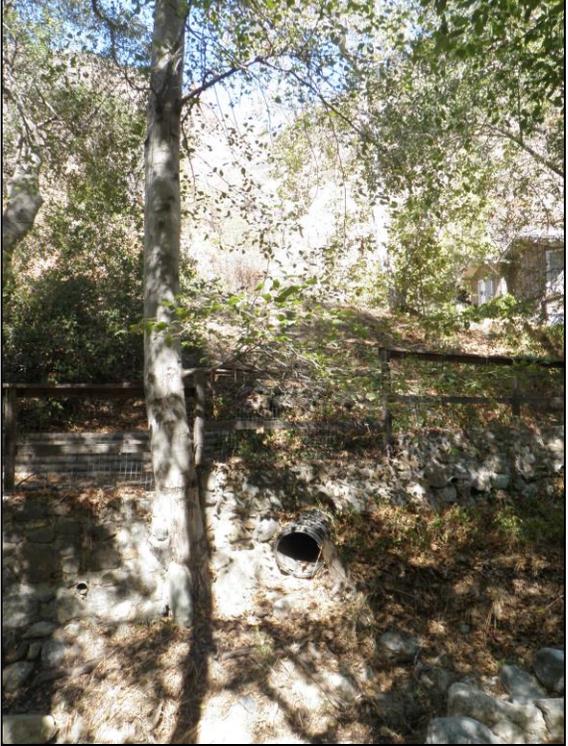
Values at Risk	Findings	Determination /Comments
	<p><i>Photo of outlet of undersized culvert.</i></p>

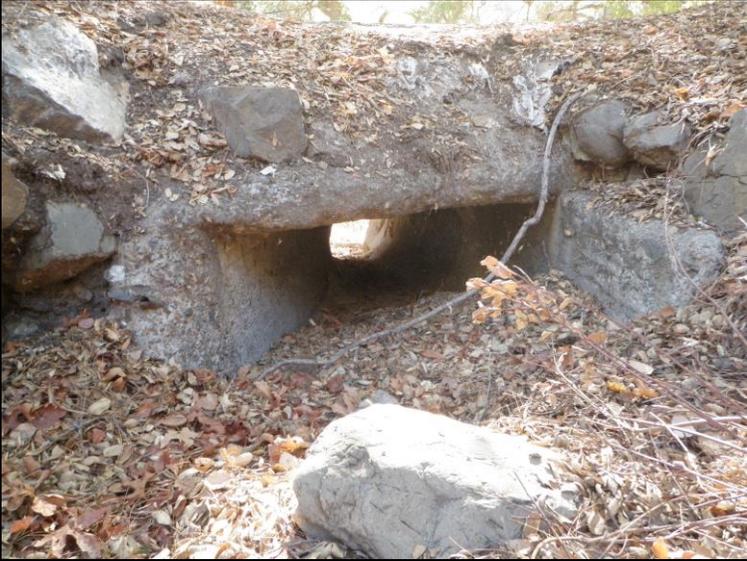
<b>Roads</b>		
<p>Mountain View Trail road, Silverado Cyn</p>	<p>The main stream crossing with drainage from Subwatershed C may be at risk of failing due to increased flows, debris, and sediment. The culvert is a 36" culvert with concrete wingwalls. Existing sediment, debris, and wood are partially decreasing culvert capacity. Sedimentation is expected to increase substantially (Table 5) and estimated bulking of flows will very likely result in crossing and potentially road failure. There is a small buffer of unburned vegetation between the burn perimeter and the culvert inlet; however, it is unlikely this small buffer will sufficiently trap sediment and floatable debris before it reaches the culvert inlet. The road provides the only ingress/egress for four to five house. See discussion on Location 1 Residents at outlet of Subwatershed C.</p> <p><b>Potential for damage to road and adjacent houses and loss of ingress/egress due to increased water flows and erosion from burn areas.</b></p>	<p><b>Very High Risk.</b></p> <p><b>Emergency exists</b></p>

Values at Risk	Findings	Determination /Comments
	<p><i>Photo of culvert inlet.</i></p>

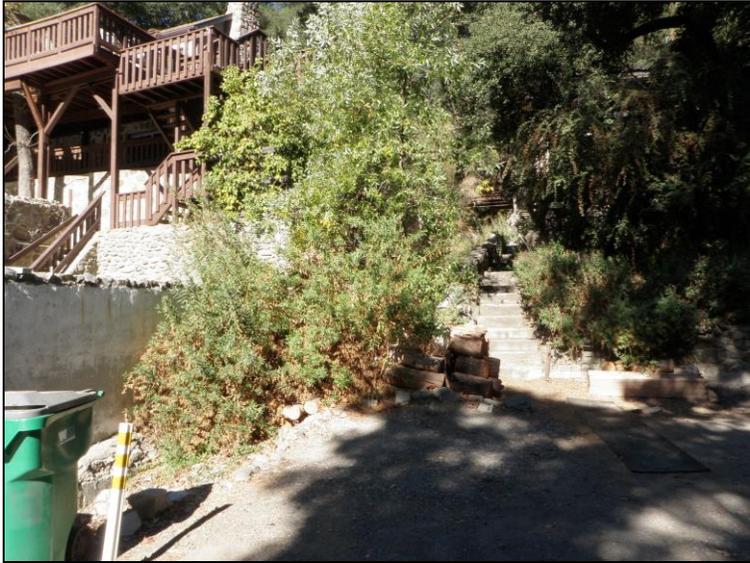
Values at Risk	Findings	Determination /Comments
	<p data-bbox="477 268 1036 300"><i>Photo of overgrown ditch between two houses.</i></p>

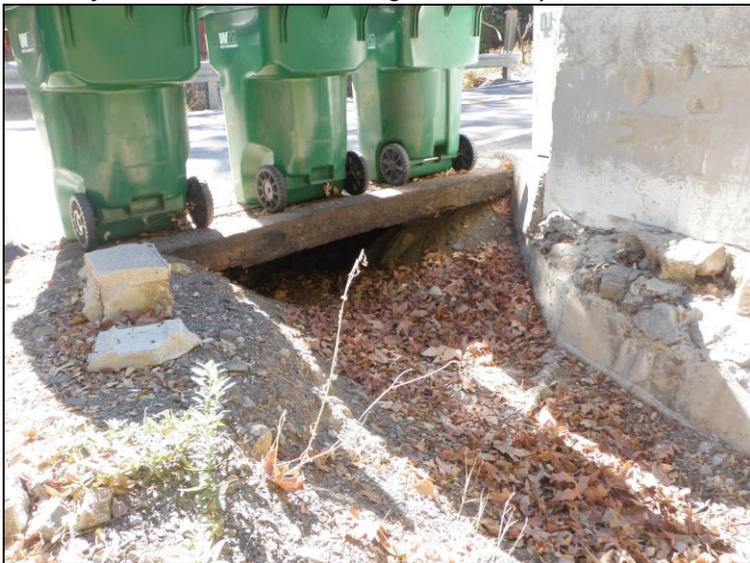
<p>County Road, Silverado Cyn</p>	<p>The crossings with drainage from Subwatershed C may be at risk of failing due to increased flows, debris, and sediment. Existing sediment, debris, and wood are decreasing existing drainage capacity. The inlet is partially buried and sediment has accumulated within the box culvert. The channel is confined to a ditch as it flows through the neighborhood but the ditch becomes shallower and flattens out as it approaches the crossing with the County Road (increasing the likelihood of flooding). There is also a substantial amount of vegetation within the ditch. Sedimentation is expected to increase substantially (Table 5) and estimated bulking of flows will very likely result in crossing and potentially road failure. (Rough estimates of ditch capacity compared to estimated increases in flow indicate this crossing is very likely to flood.)The road provides the main ingress/egress for the northern most part of the neighborhood.</p> <p><b>Potential for damage to road and loss of ingress/egress due to increased water flows and erosion from burn areas.</b></p>	<p><b>Very High Risk.</b></p> <p><b>Emergency exists</b></p>

<p data-bbox="477 898 1097 930"><i>Photo of culvert inlet and crossing with County road.</i></p>

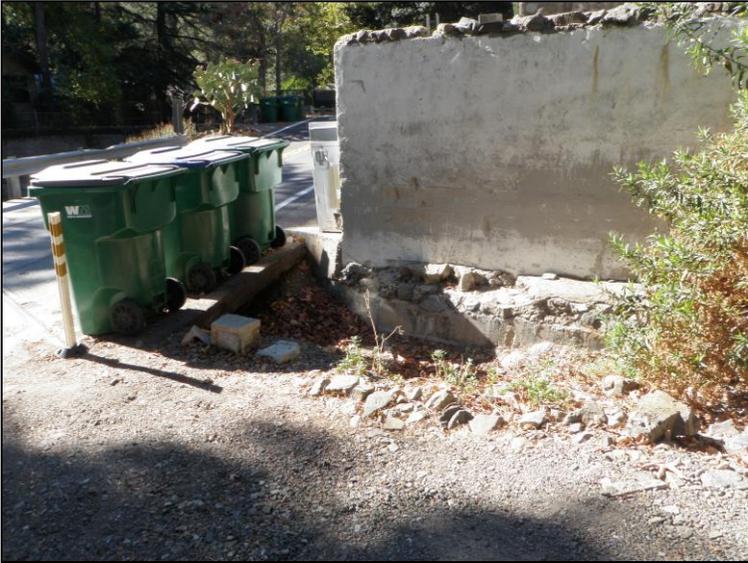
Values at Risk	Findings	Determination /Comments
	<p data-bbox="479 268 1052 300"><i>Photo of potential flooding area, if culvert plugs.</i></p>

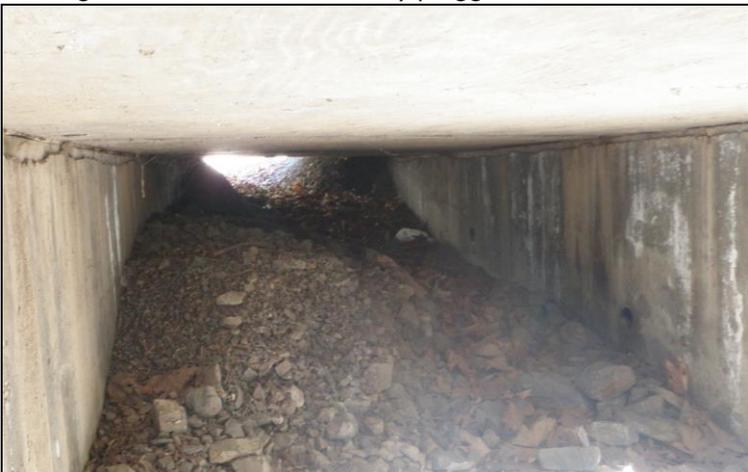
<p data-bbox="479 898 1000 930"><i>Looking into culvert outlet. Partially plugged.</i></p>

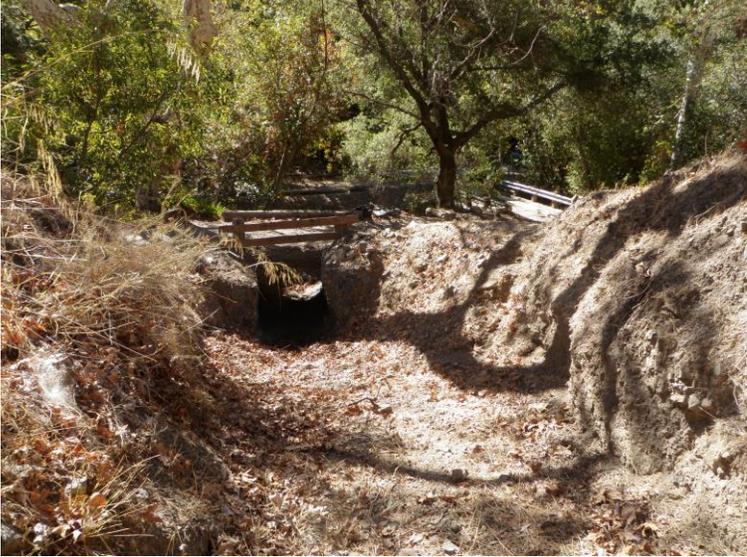
<p data-bbox="235 1444 402 1514">Private road, Silverado Cyn</p>	<p data-bbox="479 1444 1219 1759">The main stream crossing with drainage from tributary subwatershed (adjacent to Subwatershed D) has a large capacity culvert with gabion rock wingwalls and is less likely to fail during a 2 year storm from flooding and sedimentation (See geology report on debris flow risk). The channel leading to the culvert is a long narrow chute with large earthen berms on either side (may be an old debris flow). The culvert is currently clear of debris and vegetation. If the crossing does fail, one house will lose access to and from house.</p> <p data-bbox="479 1801 1187 1864"><b>Some potential for damage to road due to increased flows and erosion from burn areas.</b></p>	<p data-bbox="1252 1444 1451 1507"><b>Intermediate to Low Risk.</b></p> <p data-bbox="1252 1549 1393 1612"><b>Emergency exists</b></p>

Values at Risk	Findings	Determination /Comments
	<p><i>Road crossing that may be able to handle increased flows.</i></p>

Private road, Silverado Cyn	Contact residents about need for maintenance between storms to prevent failure. Evacuation plan for residents.	<b>Intermediate to Low Risk.</b>  <b>Emergency exists</b>
Ranch access road, Silverado Cyn	Contact NRCS/County to determine erosion control needs. Potentially add k-rails and/or sandbags to channel edge to prevent flooding onto main road. Post-storm patrol and maintenance. Evacuation plan for residents.	<b>High to Intermediate Risk.</b>  <b>Emergency exists</b>

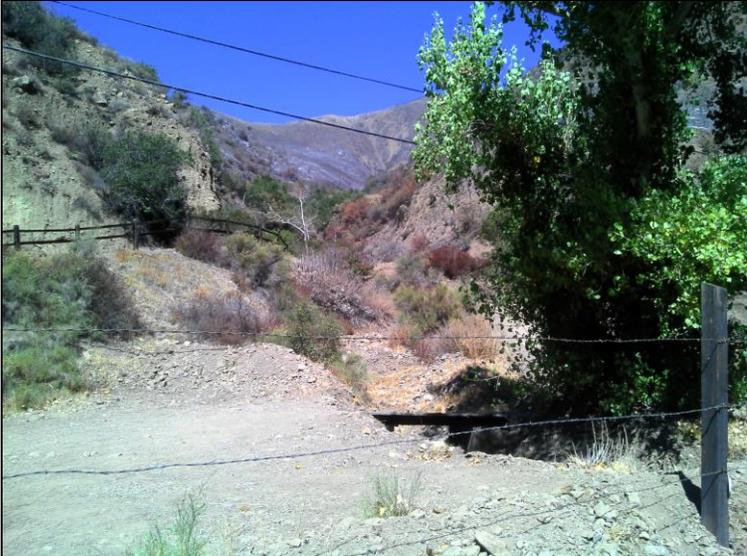
<p>Ranch access road, Silverado Cyn, 33.746497, -117.600477</p>	<p>The access road to the home upslope is adjacent to the outlet of a tributary in the burn area. The outlet is channelized and if it floods, flow will be diverted down to the access road. May flow across access road, blocking ingress/egress.</p> <p><b>Potential for damage to access road due to increased flows and erosion from burn areas.</b></p> <p><i>Photo from County Road looking up the channel and ditch.</i></p>

<p><b>High to Intermediate Risk.</b> <b>Emergency exists.</b></p>
