2014 BEST MANAGEMENT PRACTICES EVALUATION PROGRAM

ANNUAL REPORT

USDA FOREST SERVICE
LAKE TAHOE BASIN MANAGEMENT UNIT
ECOSYSTEM CONSERVATION DEPARTMENT

Sue Norman, Supervisory Hydrologist
January 2015

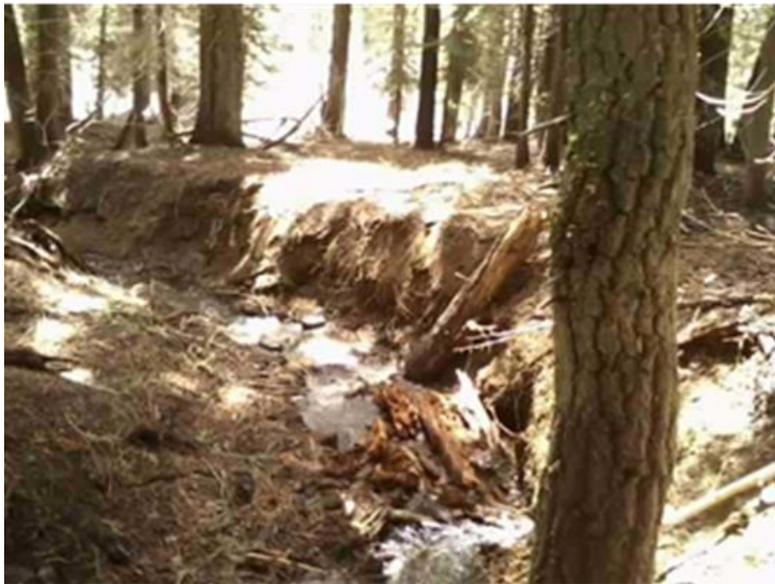
- Road 16N48 - Administrative Use Road, Maintenance – (I/NE)

This road located in the Ward Creek Watershed, and was last maintained as part of work conducted under the Quail Hazardous Fuels Reduction Project in 2007. Although the channel crossing structure itself is stable (48" culvert), the channel for 50' immediately upstream and 200' downstream of the crossing is incised. The culvert crossing is constructed in a manner that constricts channel morphology to the dimensions of the culvert, with no inset floodplain. The banks above and below the culvert are steep, bare, and contain no vegetation or rock cover. Currently in the low flow condition observed (May 9, 2014), channel banks are not actively eroding, but the channel condition is very vulnerable to future large flow events.

The photo below illustrates the condition of the channel banks approximately 100 feet downstream of the channel crossing. The bank on the right is approximately 4 to 5 feet in height. The stream channel morphology changes both upstream and downstream of this incised 250' section of channel, into a stable morphology that is not incised, and is characterized by stable rock and vegetated bank cover. The

gradient of the incised reach is much less than the stable reaches located both above and below the incised reach, which is likely why the road and crossing were located in this area.

After the follow-up visit, it was determined the primary cause of the erosion downstream of the culvert was

due to a wood jam probably formed during the 1997 flood, causing diversion of flows into the stream bank and resulting channel erosion. The dense conifer canopy is inhibiting the presence of riparian shrub vegetation, which would allow the channel to self-stabilize. This site will continue to be monitored to determine if further natural collapse of trees into the channel result in providing stabilizing structure to the channel. If future monitoring determines that the channel is continuing to degrade, a pro-active approach of selective tree thinning and placement of downed wood into the channel with riparian vegetation plantings may be warranted. These recommendations will be captured in the Watershed Improvement Tracking (WIT) database for future implementation. Ward Creek is within one of the priority watersheds identified for improving watershed condition on the LTBMU.

A restoration hydrologist and road engineer visited this site later in the summer to determine whether the current design of this channel crossing could contribute to the channel incision observed, and to provide an adaptive management recommendation.

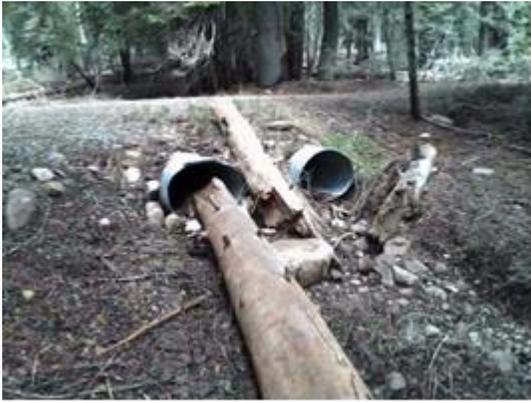
While traveling to this location to conduct the BMPEP evaluation two more issues were observed on this road that should be addressed. First, in approximately 100 feet from the start of the road (coming from the Ward Canyon end), the road comes to an intersection. The system road 16N48 heads to the right, but a visible road also extends to the left running parallel to the adjacent homes. From researching maps used for the Quail Hazardous Fuels Reduction Project, it is apparent that the road to the left is a relic forwarder trail that is still compacted and visible. From the map, the unauthorized road

extends for approximately .65 miles and crosses a perennial stream channel. This legacy forwarder trail/unauthorized road should also be revisited by a restoration hydrologist and road engineer, to determine appropriate restoration actions to capture in the WIT database.

And finally the photo above illustrates a downed tree plugging the downstream end of a culvert crossing for an ephemeral drainage located on road 16N48 on the way to the BMPEP evaluation. This situation will need to be addressed as part on ongoing road maintenance, or during future restoration actions that are planned on the road.
