December 1, 2014

Ref.: 2010-084

Technical Memorandum
November 2014 Site Inspection Report
Blue Ledge Mine
Rogue River-Siskiyou National Forest

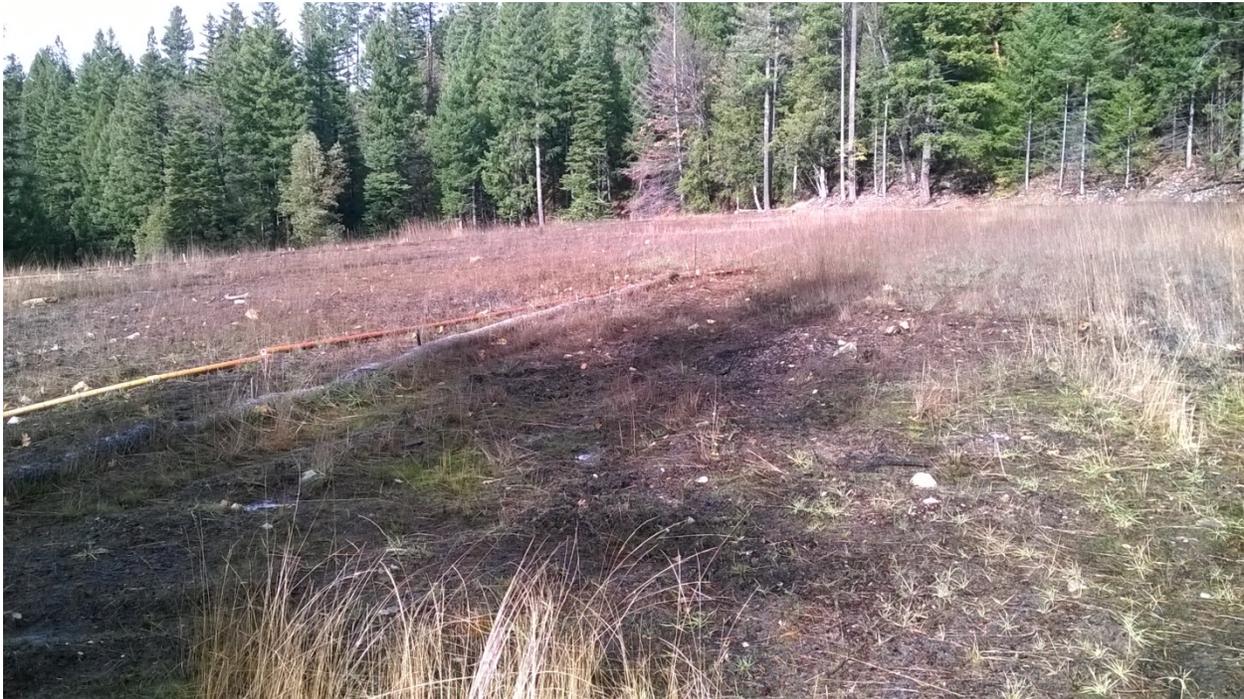
The surface of the repository had no new erosion. The majority of repository grasses are continuing to show new regrowth after application of leachate for evaporation and being dormant for the summer. The grass in a roughly 20 foot diameter area around the former leachate evaporation sprinkler heads as located by rebar stakes in the photos shows little to no grass regrowth at this point. The depth to water in the repository sump was measured at 268.5 inches below the rim, which is 3.5 inches higher than the measurement from the October 2014 Site Inspection. The total depth to the bottom of the sump is 326 inches. Therefore there is 57.5 inches of water in the sump. The sump is 60 inches total depth. The pH of the water in the sump was measured at 6.0. This is the same as the pH measurement recorded during the October 2014 Inspection.

Photograph 1: Top of repository, facing north.
Blue Ledge Mine, Rogue River - Siskiyou National Forest, CA
Photographed by: Jeremy Podvin (ERRG)

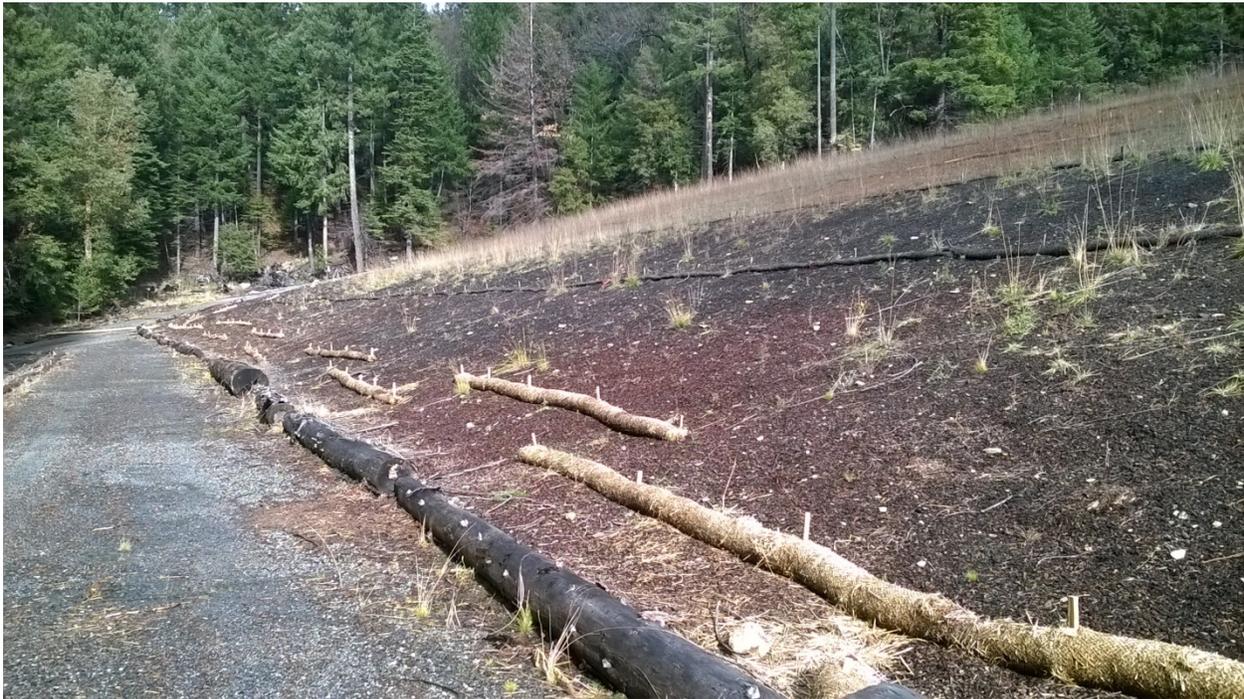
Comments: Straw wattles and bark are functioning properly.

Photograph 2: Repository slope facing north.
Blue Ledge Mine, Rogue River - Siskiyou National Forest, CA
Photographed by: Jeremy Podvin (ERRG)

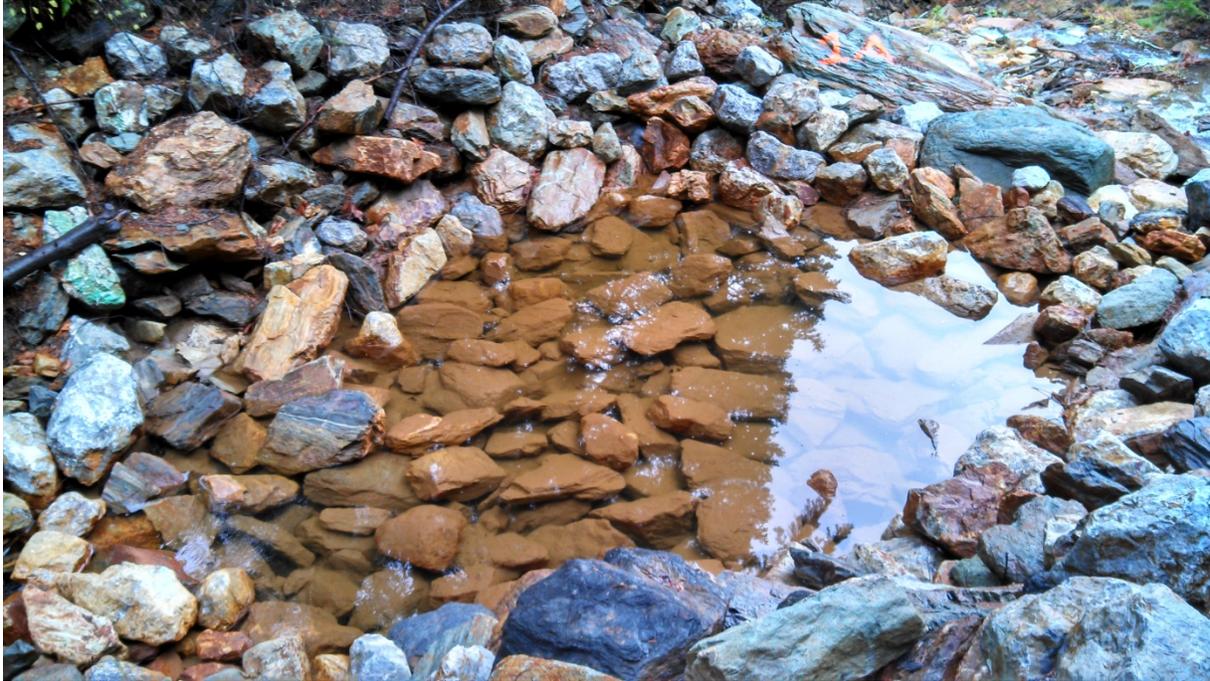
Sediment Treatment Basin 1A (closest to Joe Creek):

Accumulated sediment: <1%

Fouled limestone: not observed

pH in basin 1A: 4.6

pH below basin 1A: 7.7 in Joe Creek

Water depth: overflowing the spillway due to rain event

Photograph 3: Sediment/pH Treatment Basin 1A.
Blue Ledge Mine, Rogue River - Siskiyou National Forest, CA
Photographed by: Jeremy Podvin (ERRG)

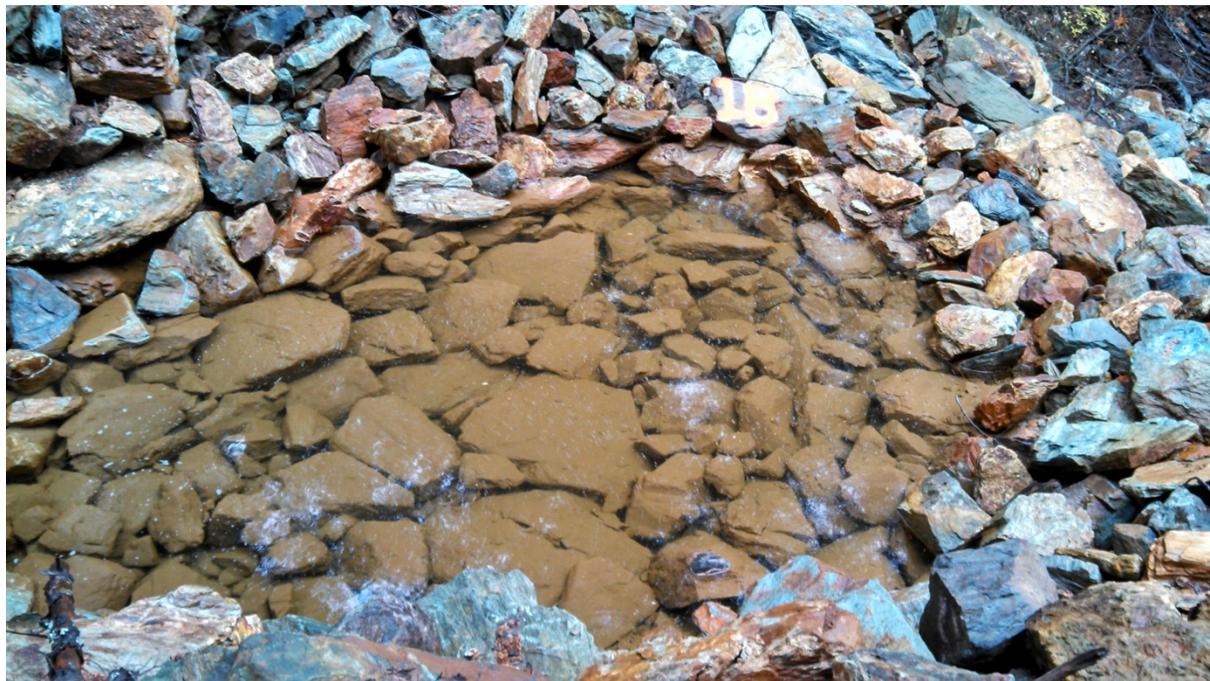
Sediment Treatment Basin 1B:

Accumulated sediment: <1%

Fouled limestone: not observed

pH in basin 1B: 4.2

Water depth: overflowing the spillway

Photograph 4: Sediment/pH Treatment Basin 1B.
Blue Ledge Mine, Rogue River - Siskiyou National Forest, CA
Photographed by: Jeremy Podvin (ERRG)

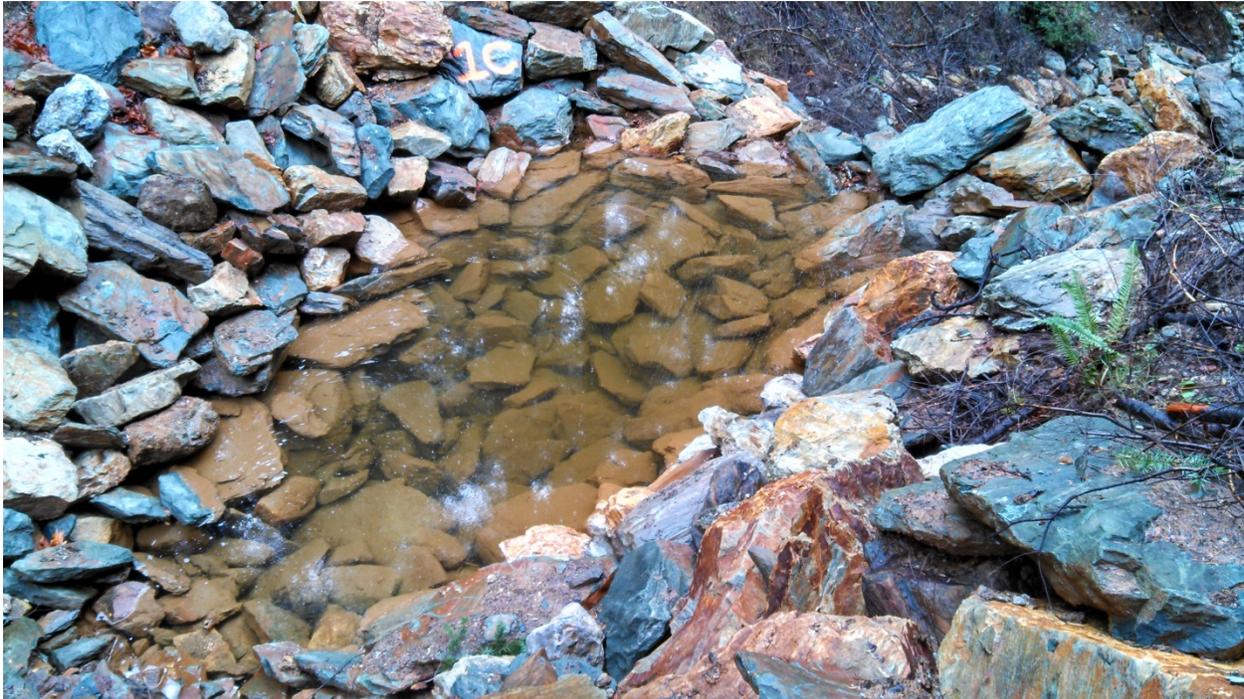
Sediment Treatment Basin 1C:

Accumulated sediment: <1%

Fouled limestone: not observed

pH in basin 1C: 4.0

Water depth: overflowing the spillway

Photograph 5: Sediment/pH Treatment Basin 1C.
Blue Ledge Mine, Rogue River - Siskiyou National Forest, CA
Photographed by: Jeremy Podvin (ERRG)

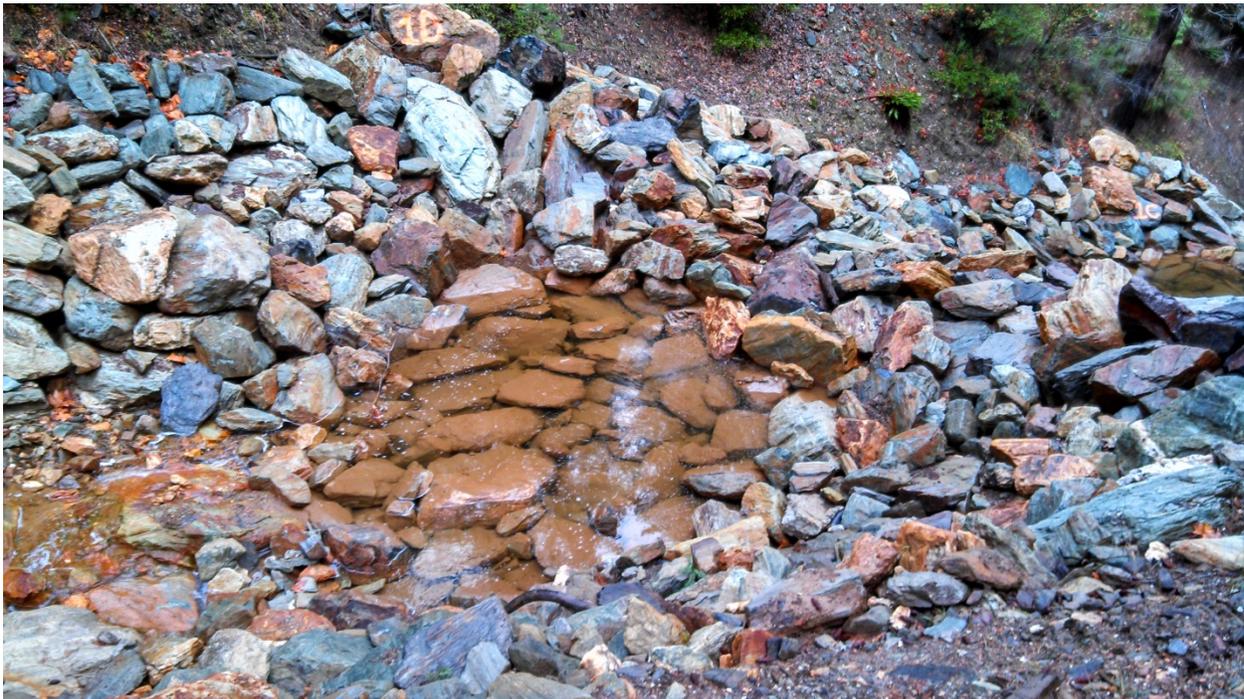
Sediment Treatment Basin 1D:

Accumulated sediment: <1%

Fouled limestone: not observed

pH in basin 1D: 4.0

Water depth: overflowing the spillway

Photograph 6: Sediment/pH Treatment Basin 1D.
Blue Ledge Mine, Rogue River - Siskiyou National Forest, CA
Photographed by: Jeremy Podvin (ERRG)

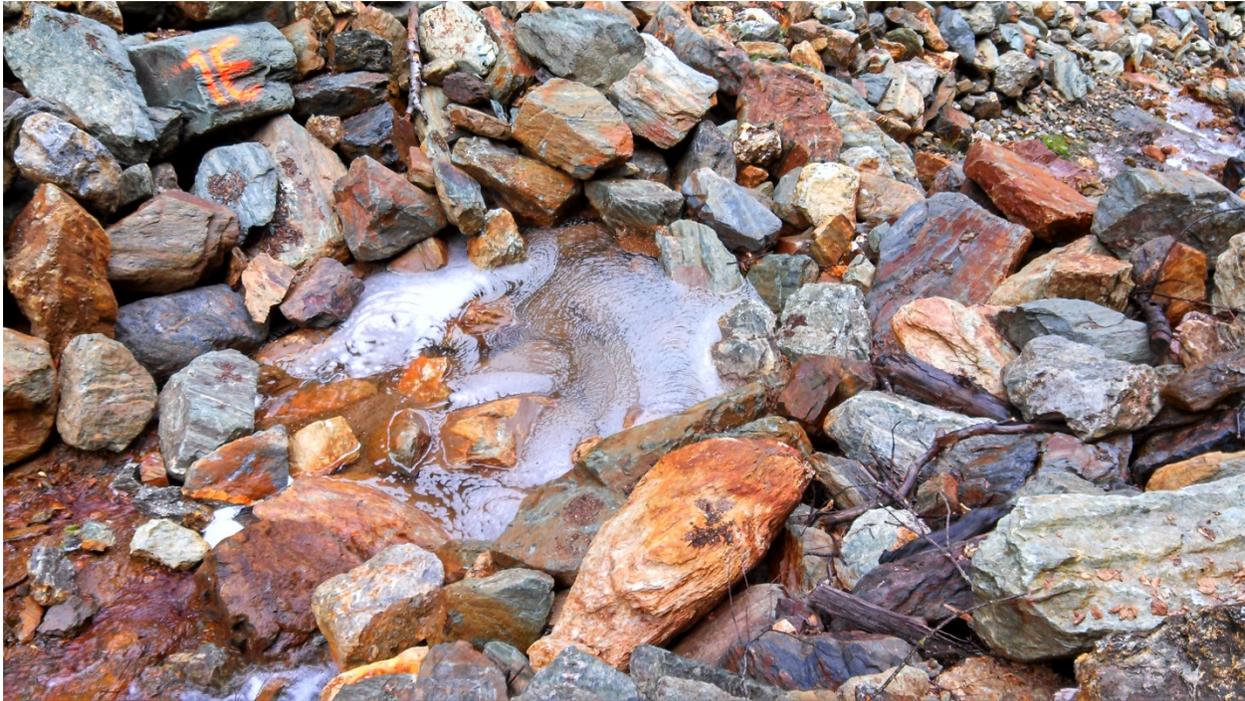
Sediment Treatment Basin 1E:

Accumulated sediment: <1%

Fouled limestone: not observed

pH in basin 1E: 3.9

Water depth: overflowing the spillway

Photograph 7: Sediment/pH Treatment Basin 1E.
Blue Ledge Mine, Rogue River - Siskiyou National Forest, CA
Photographed by: Jeremy Podvin (ERRG)

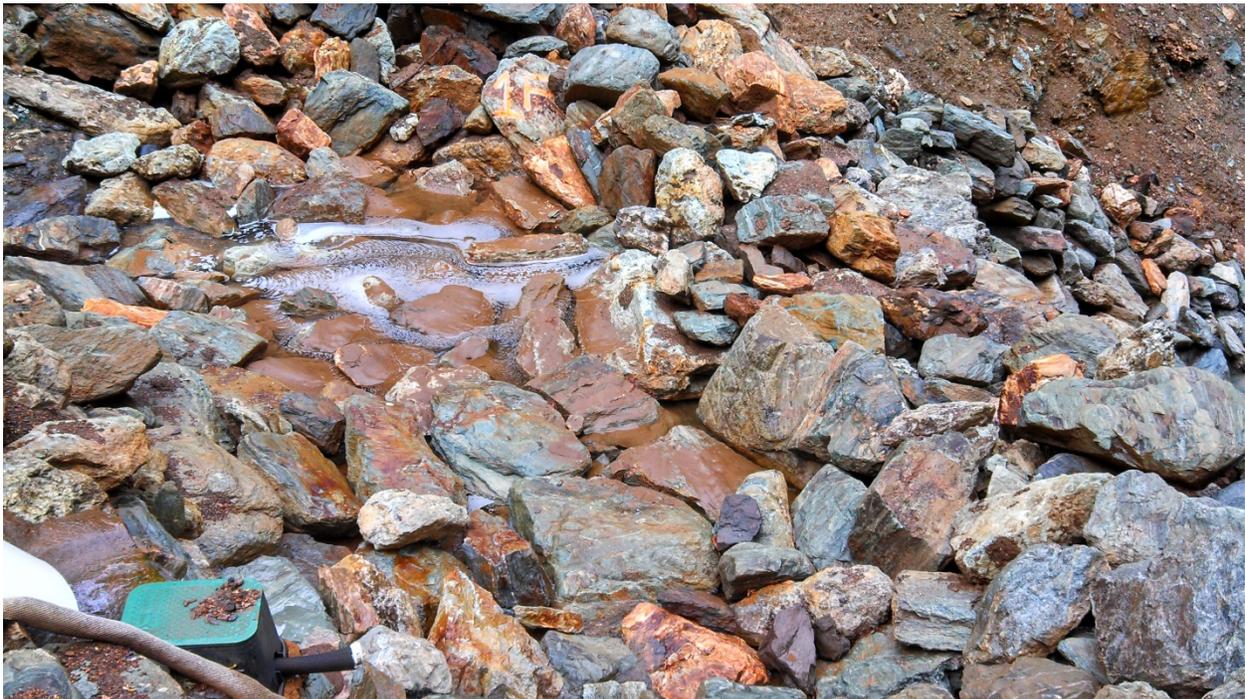
The acid seep previously entering the east side of basin 1F is being captured by the USEPA acid seep collection basin. The pH in the USEPA acid seep basin was not measured. The USEPA acid seep basin overflow spillway is functioning. The USEPA pilot treatment system is disassembled at the time of this inspection.

Sediment Treatment Basin 1F:

Accumulated sediment: <5%

Fouled limestone: not observed

pH in basin 1F: 3.9

pH above basin 1F: 4.7

Water depth: overflowing the spillway

Photograph 8: Sediment/pH Treatment Basin 1F.
Blue Ledge Mine, Rogue River - Siskiyou National Forest, CA
Photographed by: Jeremy Podvin (ERRG)

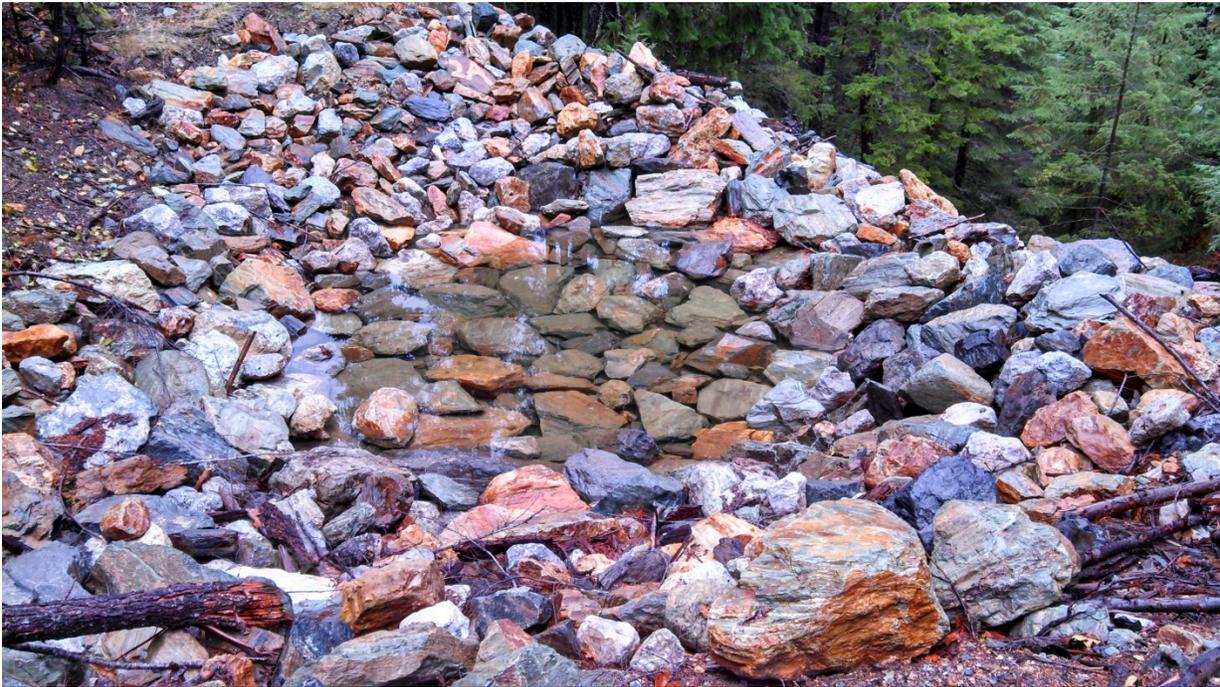
Sediment Treatment Basin 2A:

Accumulated sediment: <1%

Fouled limestone: not observed

pH in basin 2A: 7.4

Photograph 9: Sediment/pH Treatment Basin 2A.
Blue Ledge Mine, Rogue River - Siskiyou National Forest, CA
Photographed by: Jeremy Podvin (ERRG)

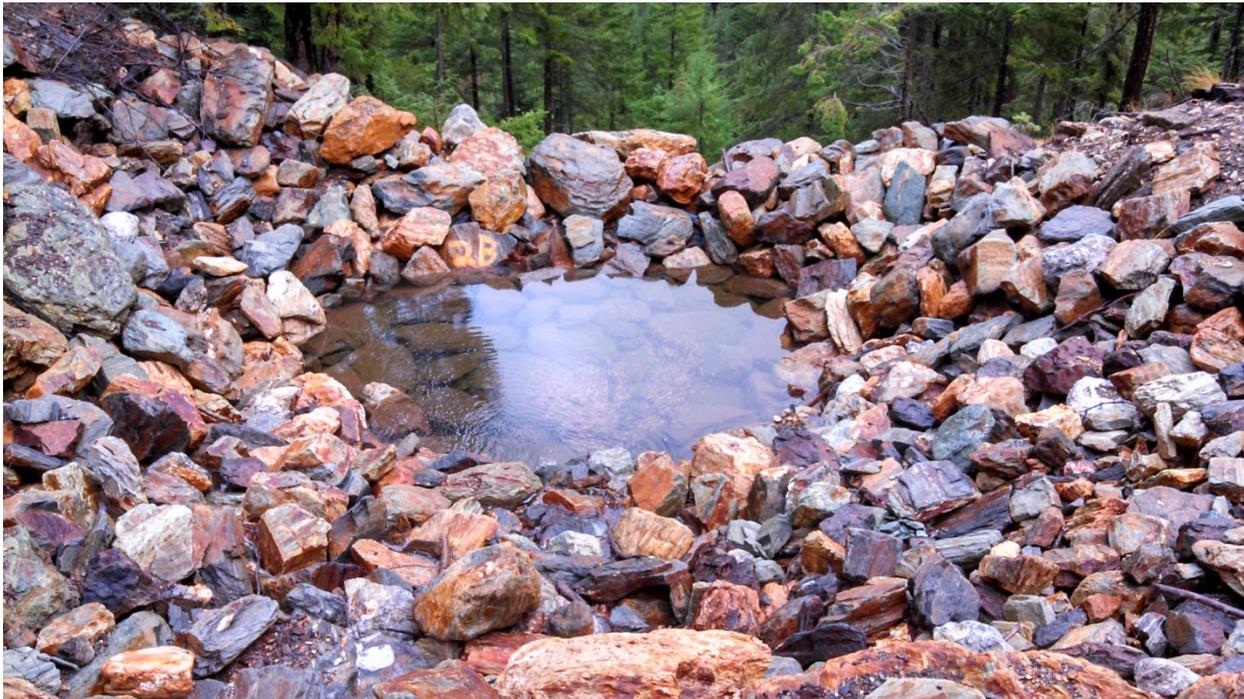
Photograph 10: Sediment/pH Treatment Basin 2B.
Blue Ledge Mine, Rogue River - Siskiyou National Forest, CA
Photographed by: Jeremy Podvin (ERRG)

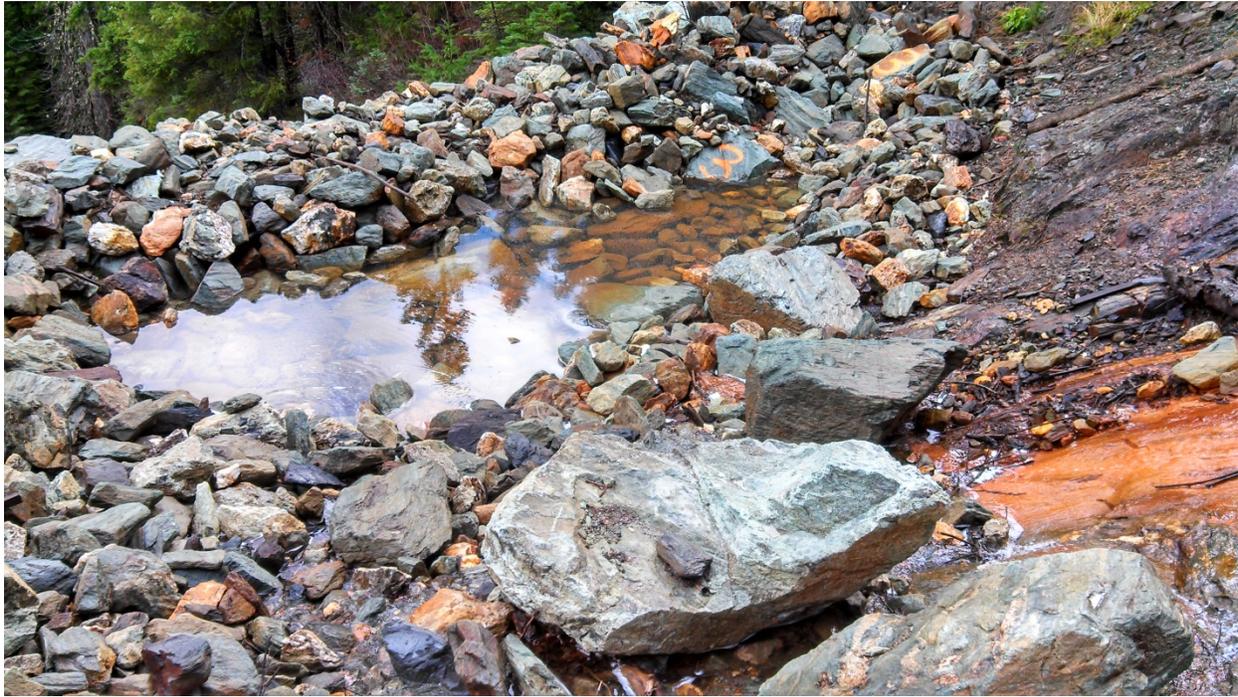
Photograph 11: Sediment/pH Treatment Basin 3.
Blue Ledge Mine, Rogue River - Siskiyou National Forest, CA
Photographed by: Annica Nord (ERRG)

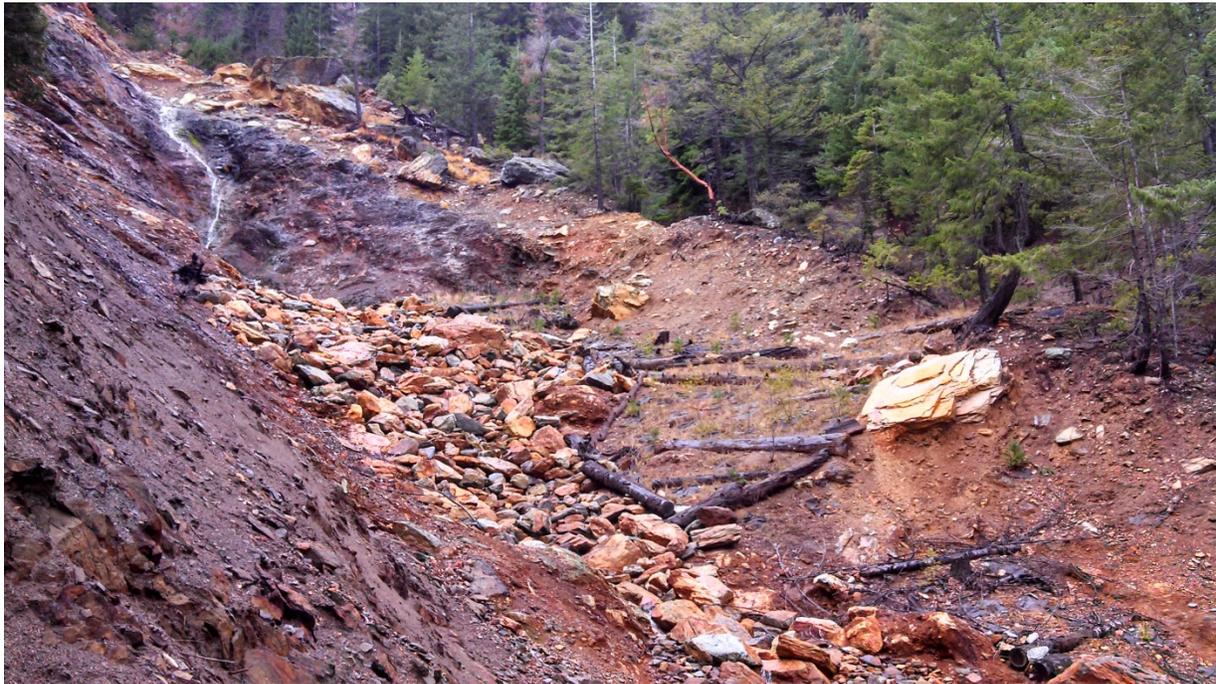
Comments: Straw wattles are in good condition and in place.

Comments: The riparian plants (alders) in this area are growing well.

Comments: The upper tier of the reclamation area is devoid of plants, likely due to seepage of acidic mine drainage from the adjacent bedrock. This area is approximately 20 feet by 30 feet and no plants have survived. The remaining alders are growing very well.

Photograph 12: WRP-1 Reclamation Area.
Blue Ledge Mine, Rogue River - Siskiyou National Forest, CA
Photographed by: Jeremy Podvin (ERRG)

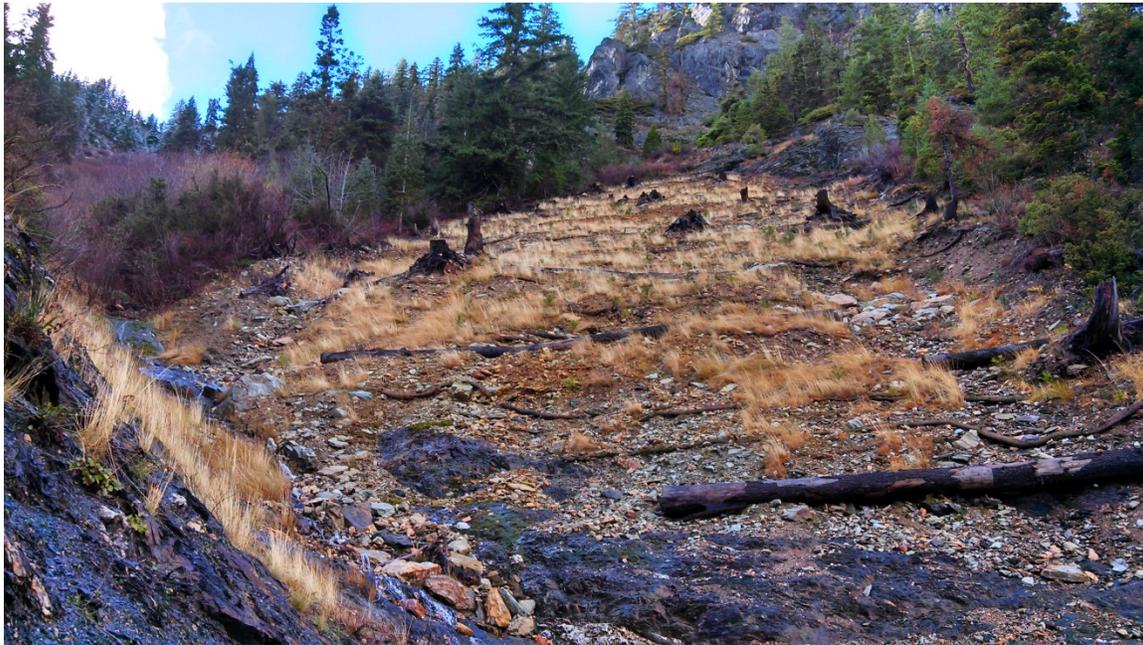
Photograph 13: WRP-3 reclamation area.
Blue Ledge Mine, Rogue River - Siskiyou National Forest, CA
Photographed by: Jeremy Podvin (ERRG)

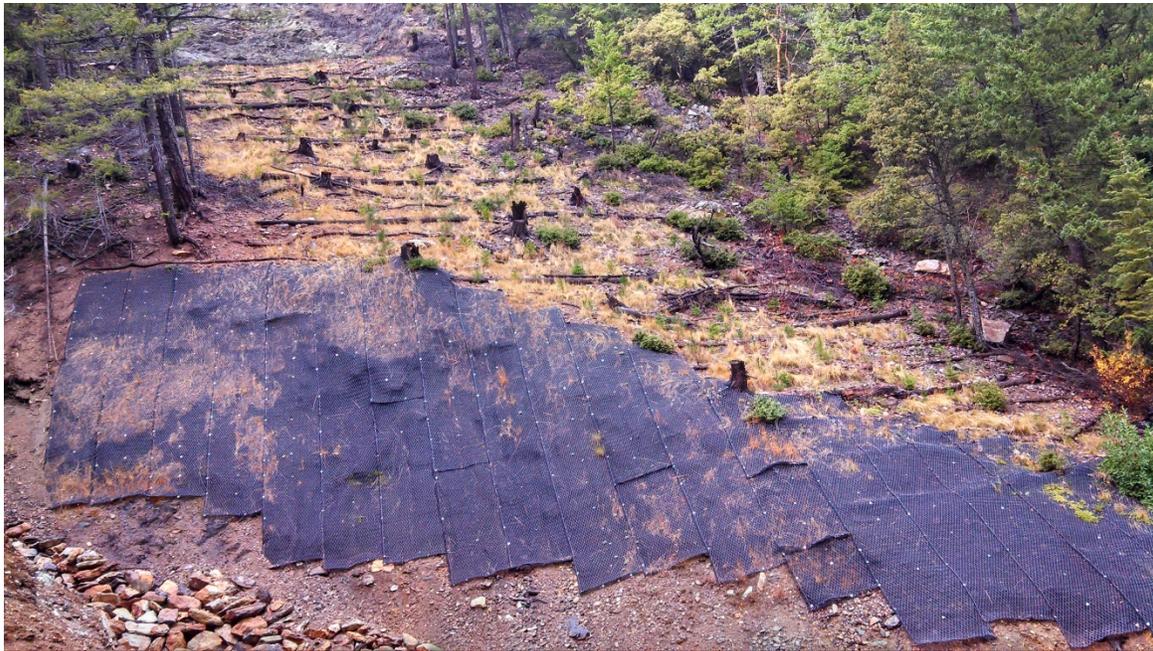
Photograph 14: WRP-4 Reclamation Area.
Blue Ledge Mine, Rogue River - Siskiyou National Forest, CA
Photographed by: Jeremy Podvin (ERRG)

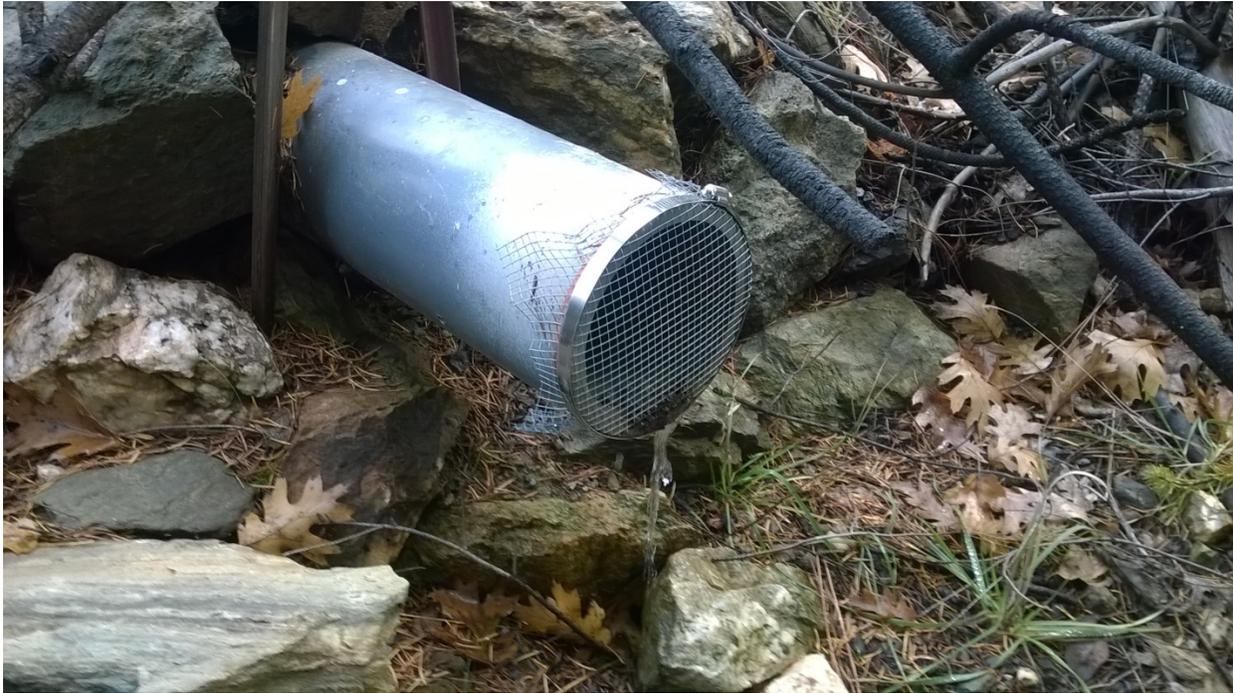
Comments: The anchor trench drain pipe screens are intact. Water is flowing from the south cap drain. No water is flowing from the other cap drains. The underdrain is not blocked, screen is intact, and no water is flowing from the pipe.

Photograph 15: View of southernmost repository cap drain discharging water after rain event.

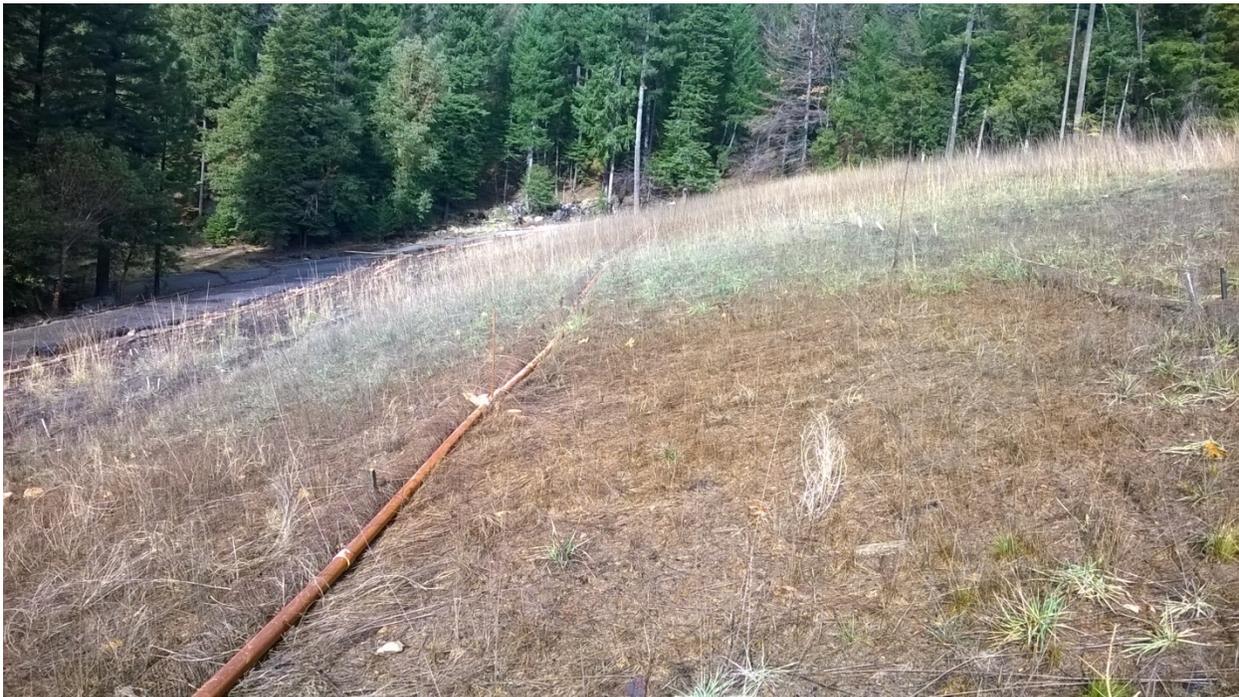
Comments: The grass is beginning to turn green in most areas. There is rust colored staining on the soil near some of the leachate evaporation sprinkler heads. The grass is not green near the sprinkler heads.

Photograph 16: View of grass at leachate evaporation sprinkler head area on repository.
