LIME COMPLEX BURNED AREA REPORT
(Reference FSH 2509.13)

A. Fire Name: Lime Complex

B. Fire Number: CA-SHF-001041

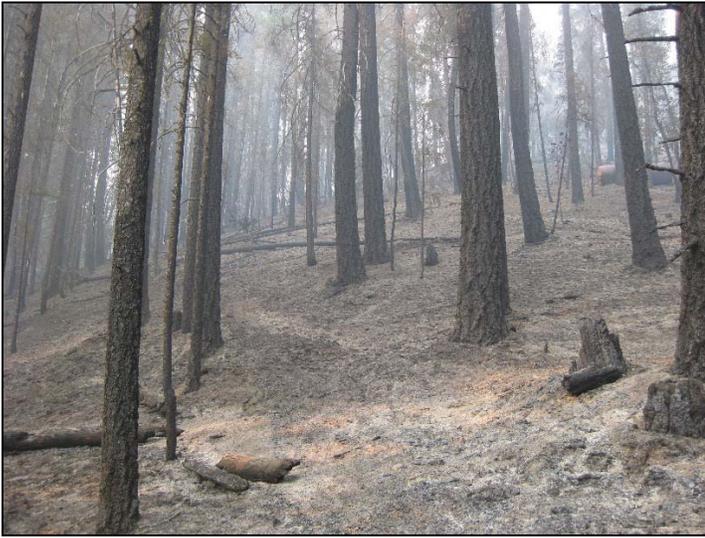
Telephone Fire under-burn

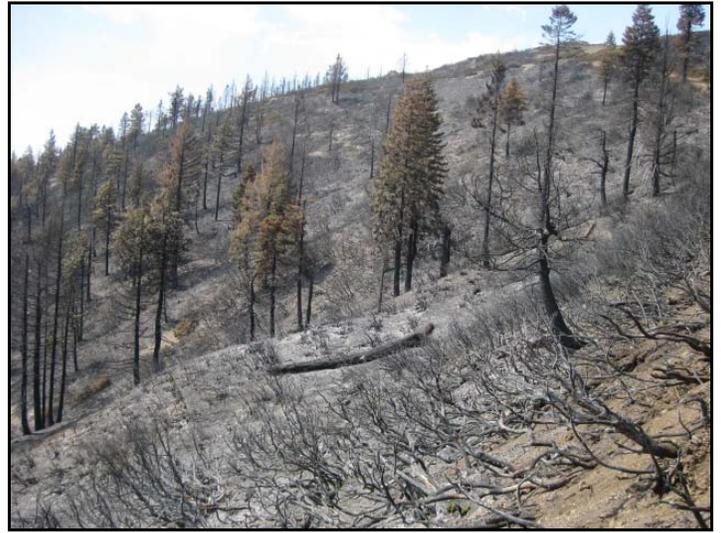
Miners Fire ridgeline

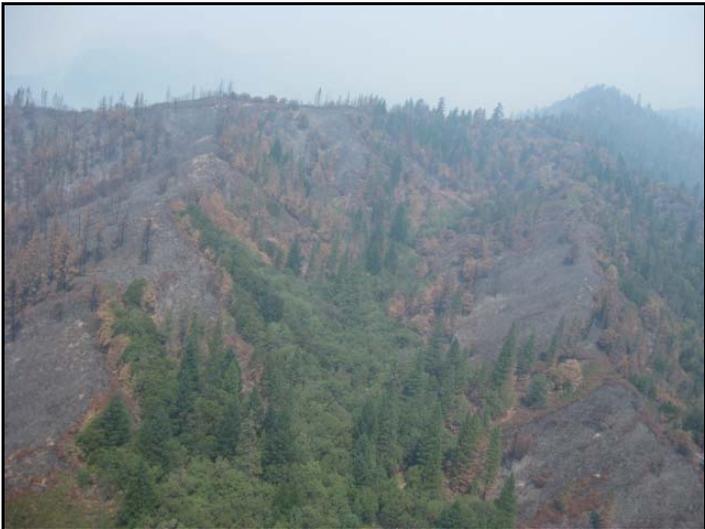
Miners Fire mixed brush

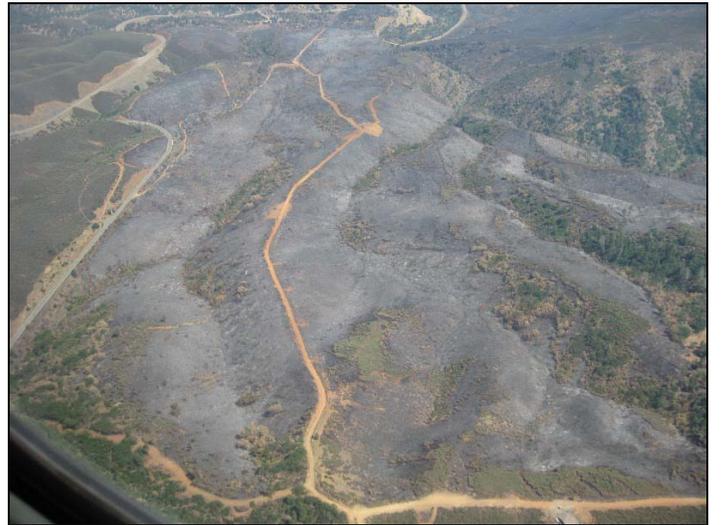
Noble Fire brush fields
