**SHU-LIGHTNING COMPLEX BURNED-AREA REPORT**  
(Reference FSH 2509.13)

- A. Fire Name: SHU Lightning Complex                      B. Fire Number: CASHU004727  
 C. State: CA    D. County: Tehama, Trinity, Shasta  
 E. Region: 5    F. Forest: Shasta-Trinity National Forest  
 G. Districts: NRA and SFMU                                      H. Fire Incident Job Code: P5D29H  
 I. Date Fire Started: 6/21/08                                      J. Date Fire Contained: 7/20/08  
 K. Suppression Cost: 35 million  
 L. Fire Suppression Damages Repaired with Suppression Funds  
     1. Fireline waterbarred (miles):  
     2. Fireline seeded (miles):  
     3. Other (identify):

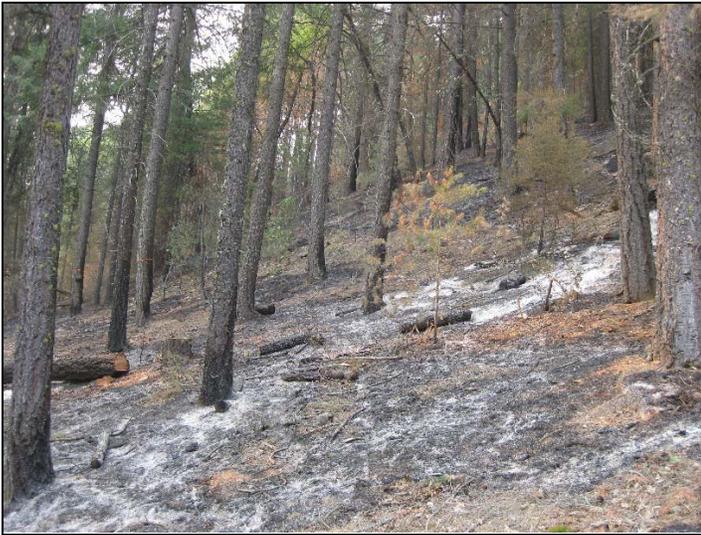
Noble Fire

General trends are forested areas that were north or east facing slopes were nice underburns. Forested areas that were south or west facing slopes burned hotter and had tree mortality of 20-40% with ridges burning hot (see pics below).

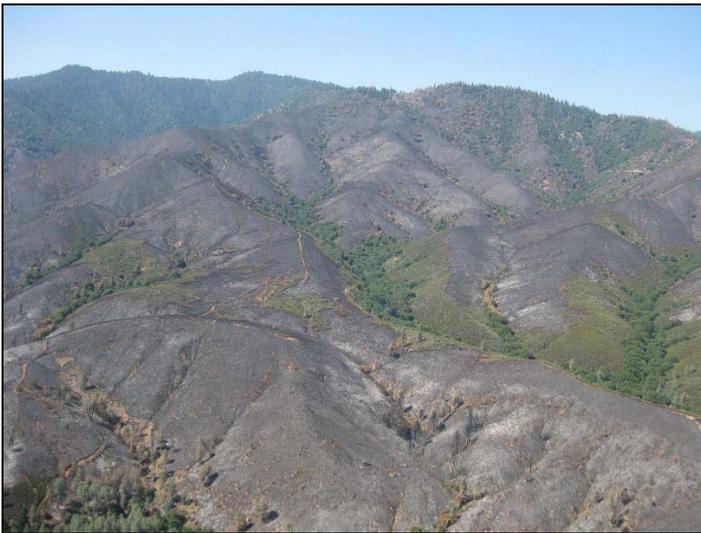
Deerlick Fire

Chaparral areas that were north or east facing slopes had moderate soil burn severity were patchy. Chaparral areas that were south and west facing, burned moderately high to high soil burn severity removing almost all vegetation (see pics below).

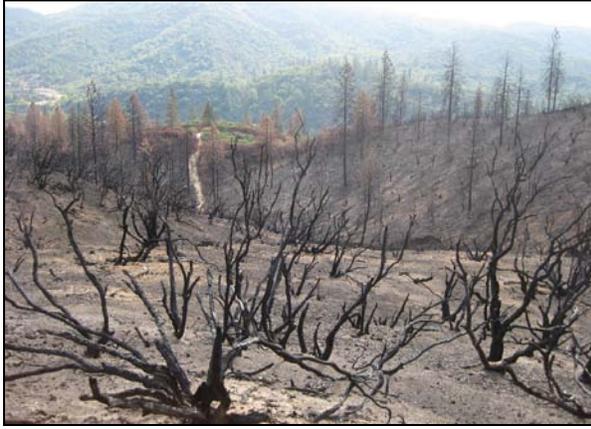
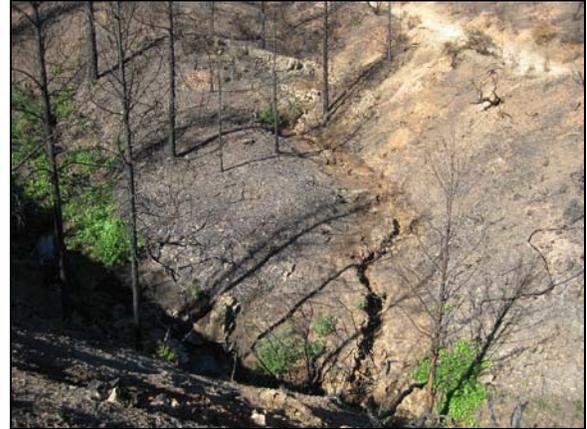
The Shasta Lake OHV staging area - currently provide motorized visitors a place to start and end their trips, parking vehicles and unloading. Trails will need repair work consisting of control fencing, mulching and closures. [With 95 miles of trails impacted by the Motion Fire within the Chappie–Shasta OHV Park, the Shasta Dam OHV staging area is a key artery for recreation for the entire park. This area was severely burned over and lacks sufficient cover to impede erosion and overland flow. Key staging area trails \(OHV03, OHV17, OHV19, and OHV76\) have severely denuded landscapes that lack vegetative cover and live trees to control water to preserving current trails and recent SWECO treatment improvements. Lack of water control will release excessive water on to OHV trails and will cause excessive erosion of trails. This was confirmed after 3.0 inches of rainfall in a 24-hour period on October 4<sup>th</sup>, 2008 where excessive erosion was observed. Hillslopes had sheet erosion which ran onto trails causing riling and gulling. If winter precipitation is prolonged and soaks these shallow sandy soils, runoff rates will be excessive and main hub trails will be severely damaged \(see pics below\).](#)
