# **BAER**

## **Burned Area Emergency Response Engineering Report**

Justin Nettleton - USDA Forest Service.  
Civil Engineer, Shasta-Trinity National Forest

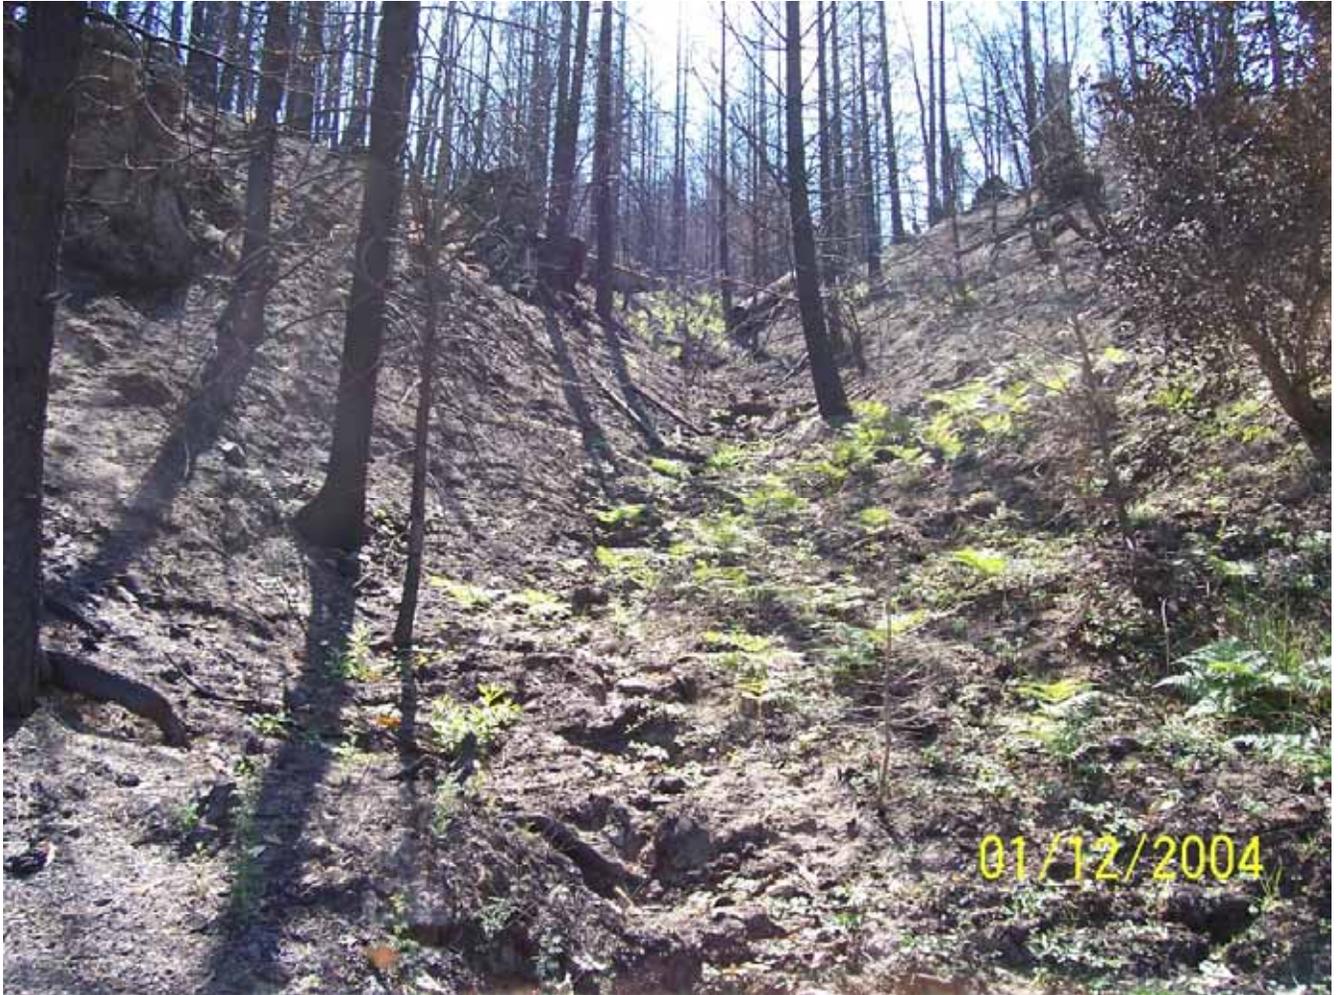
- Concern of pipes plugging or overtopping and washing away fill (Figures 1 & 2).
- Erosion at pipe and dip outlets with no energy dissipaters (Figure 3).
- Stump holes in road bed and fill slopes (Figure 4 & 5).
- Open cat lines and decommissioned roads that could suffer erosion and pose a safety concern if not closed.
- Degradation of road surface drainage profile causing runoff to flow down the road.
- Lower water demand from burned vegetation and increased flows will likely increase seepage onto road surface at existing spring when water table is recharged (Figure 6).
- Berms and/or through cuts that channel water on road surface with inadequate drainage relief and erosion protection.

Figure 1. Drainage channel above road crossing

- Construct rocked critical dip to accommodate overtopping and protect the road fills-5 (\$13,500)
- Rock dissipater for outlets of shot gunned culverts- 3 (\$2,400)
- Repair stump holes-6 (\$1,800)
- Construct rocked rolling dip at spring location. (\$1,200)
- Construct rolling dip above and/or below bermed sections-3. (\$1,500)
- Note: Mobilization cost estimated at ~ \$12,000.

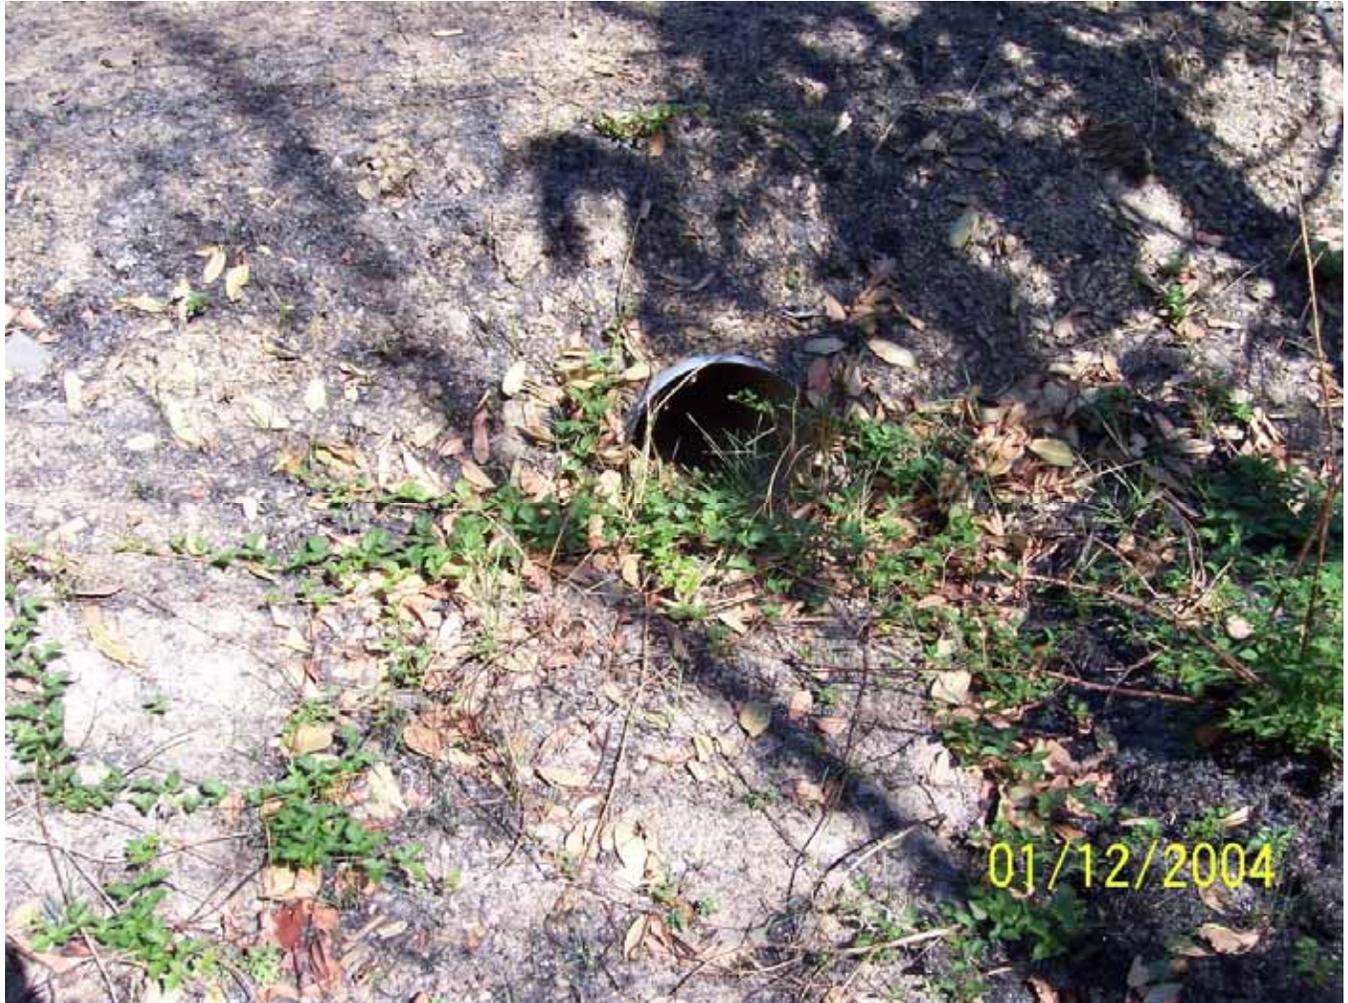
Figure 2. Culvert inlet.

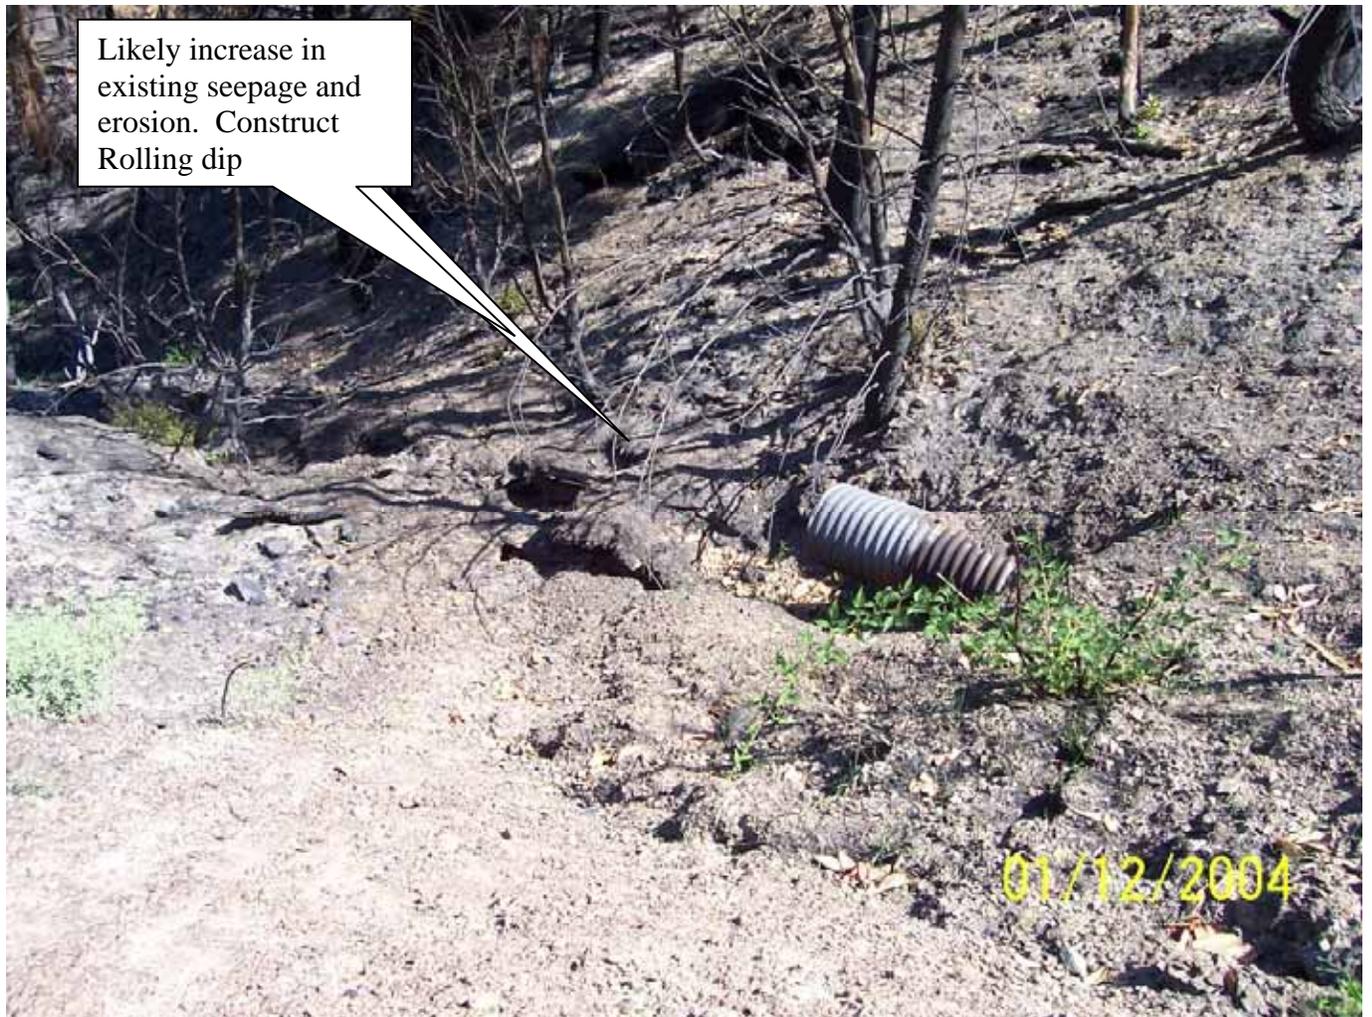
Figure 3. Erosion at shot gunned outlet of culvert.

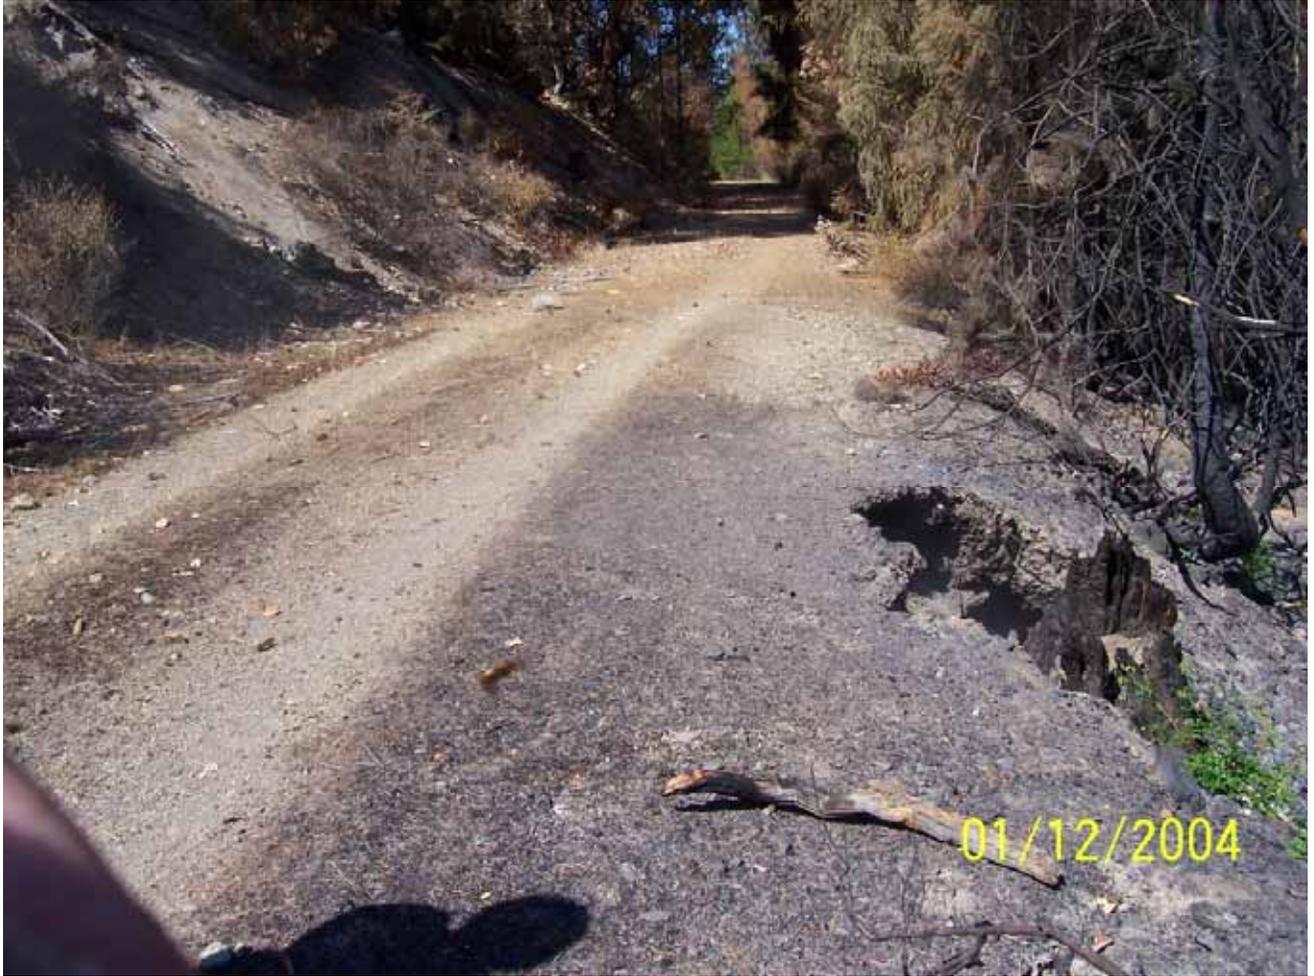
Figure 4. Stump hole in fill slope under cutting road.

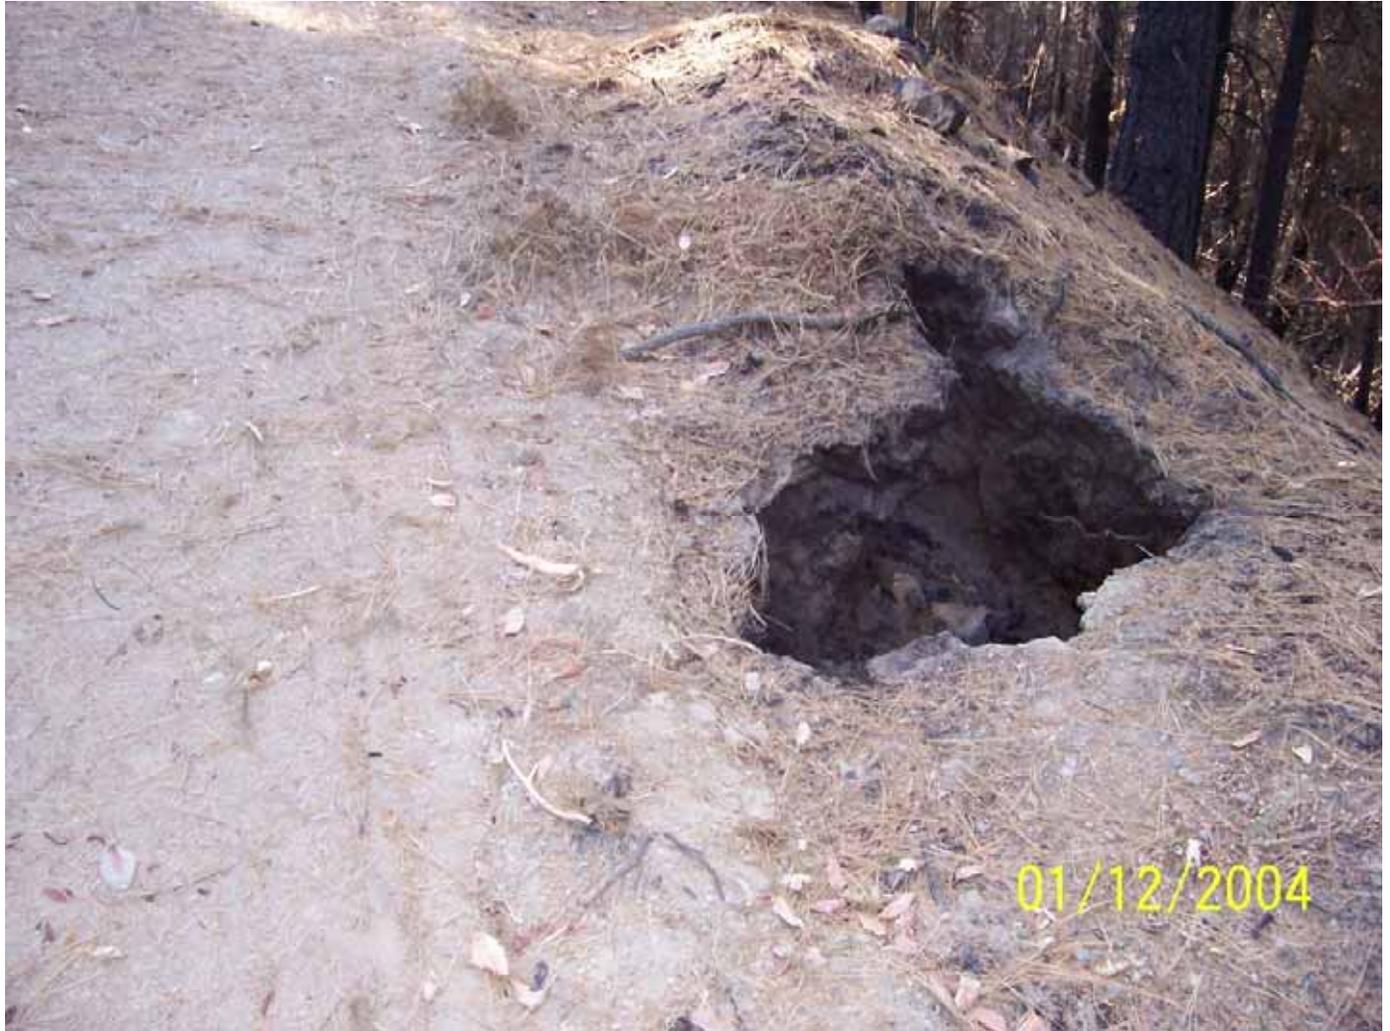
Figure 5. Stump hole in road shoulder.

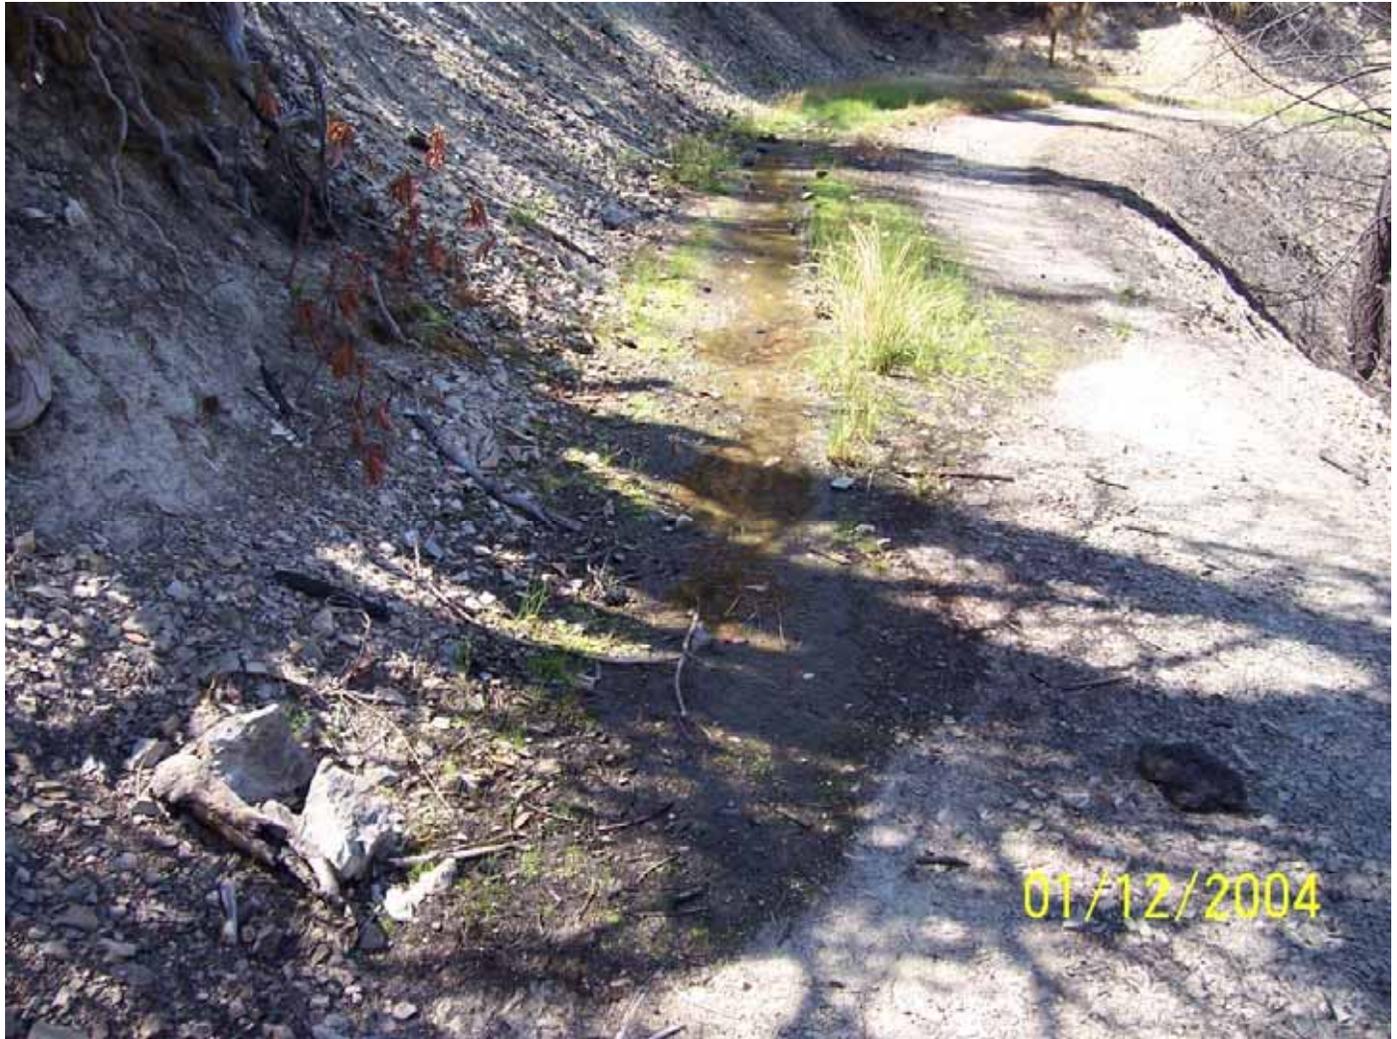
Figure 6. Existing Spring seeping onto road and causing erosion.
