## **Noble Fire**

## **Motion Fire**

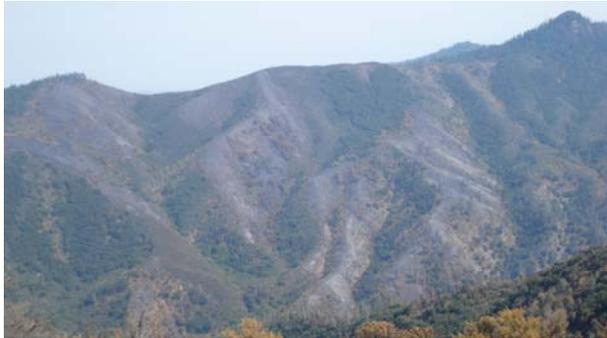
Observations from road reconnaissance of the Noble fire revealed that the most intense fire areas were south facing slopes and ridges dominated by chamise, mountain mahogany, manzanita and scrub oaks. Many drainages retained some vegetation and burned in a mosaic pattern. Soils testing for hydrophobicity in several locations revealed only one site where there was evidence of intermittent hydrophobicity to a depth of 1 cm. This site was located on a ridgetop along Beegum Road. Oaks and chamise are rapidly resprouting. This new vegetative growth in conjunction with the leaf drop that will occur at many sites within the burned over area prior to the rainy season could reduce the raindrop impact and soil erosion potential within these areas. Beegum Road was not surveyed to the campground. No potential Emergency Watershed Program (EWP) projects on private lands were discovered within the Noble fire area.

Noble Fire landscape view

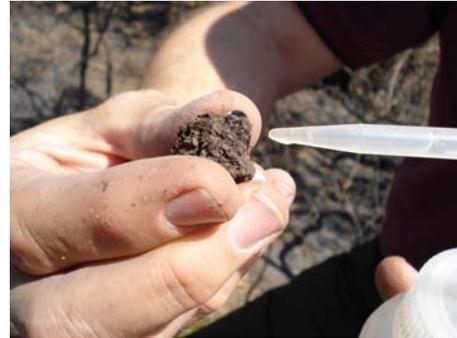
Hydrophobic soil

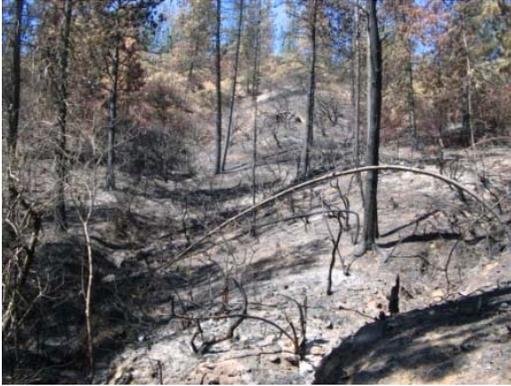
Burned over knobcone pines, Benson Dr.

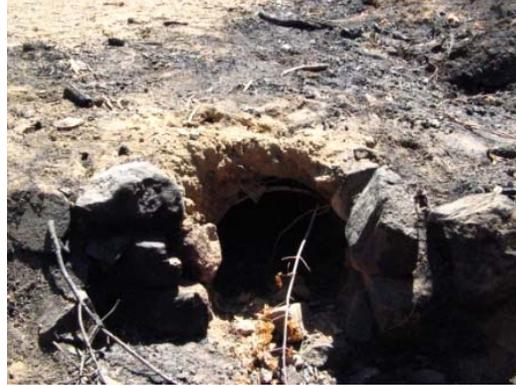
Reconnaissance of the Benson Drive area of West Redding revealed potential hazards as related to the destructive effects of the Motion Fire. A private residence adjacent to the South Fork of Spring Creek, above the Spring Creek reservoir, may be threatened by flooding due to increased flows entering the drainage. Wildfires burned the knobcone pine stand surrounding the home greatly reducing the vegetative cover in the area. An 18inch plastic culvert which directs surface flows into the drainage has been partially burnt out. The extent of the burnt portion of the culvert is unknown, likely 2 or more feet of the culvert has been compromised. Failure of this culvert is highly likely. Headcutting of a portion of Benson Drive is possible if this culvert fails or is not replaced. A second culvert located roughly parallel to the first is buried under the beginning section of an access road and drains the roadside ditch along Benson Drive. This culvert has been covered by piled debris and is no longer functional. This property (11938 Benson Drive) has experienced flooding in the past. The drainage itself did not burn extensively and is well vegetated near the homesite.

Culvert damage

Treatment should include two culvert replacements. NRCS will follow up with the landowner to provide technical information regarding the placement of sandbags or other protective measures, as necessary, to provide flood protection.

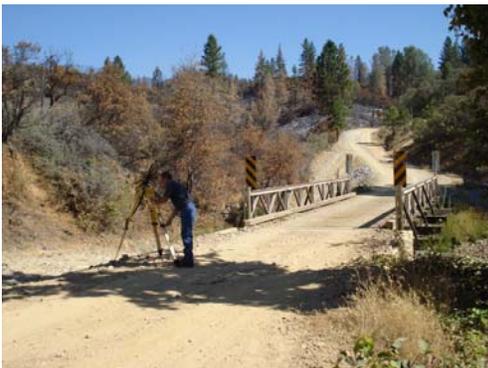
Reconnaissance of the Motion fire along Coram Road revealed Cottonwood Creek could pose a potential problem. A small bridge could be threatened by debris flows as well as increased surface flows from the extensive wildfire damage on the west side of Coram Road. Coram Road served as the fire line and no vegetation was burned east of the Cottonwood Creek Bridge which remains well vegetated. The creek channel is very narrow; it is likely that debris that becomes dislodged with winter flows may get hung up in the channel before making its way to the bridge. Clearance under the bridge is minimal;  $\leq 5$ ft.

Cottonwood Creek Bridge near Coram Ranch

Treatment recommendations may include removal of debris and hazard trees within and along the channel to 150 yards upstream of the bridge. Additional reconnaissance following storm events would be necessary to remove any new accumulations of debris. Further protective measures may be considered to reduce erosion potential near the bridge site.

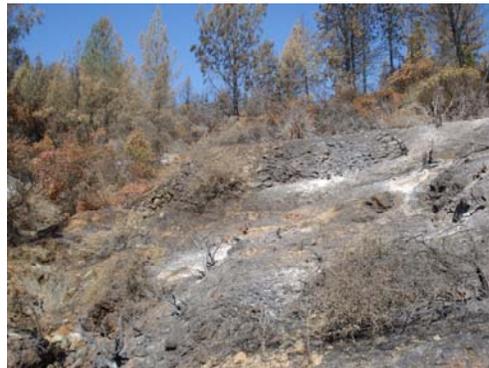
Situated nearby is the historical town of Coram. Old foundations and other remnants of cultural significance have been unveiled following the wildfire. Significant concern exists as to the likelihood of looting at these archaeological sites. There is an erosion feature that is also potentially threatening one historic foundation and possibly Coram Road. Fencing this area of the Coram Ranch property to reduce the likelihood of vandalism and looting of the historic sites is a recommended treatment alternative. NRCS will follow up with the landowner to provide technical assistance as needed. Enforcement of Off Highway Vehicles regulations will also be important to reduce the potential impact to this area. Damage to the Coram Ranch property does not meet the criteria necessary to be treated through the EWP program.

Foundation from historic town of Coram

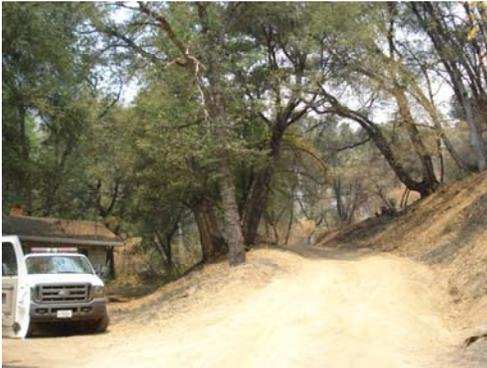
One cabin, presumed to be abandoned, lies between Whiskey Creek Road and Whiskey Creek and may be threatened under circumstances of debris flow. Prior evidence of debris flows exist; it appears that the area has been altered by man as there is an accumulation of bank fill piled along the roadside. Due to steep slopes, rocky soils and hazard trees, debris fall may be a serious hazard. Sedimentation to Whiskey Creek following debris flow is also of concern. In addition, inadequately sized culverts may reduce the drainage capability in this area. Work has been initiated along the road to remove some of the existing hazardous vegetation.

Cabin at Whiskey Creek

Recommendations include the use of signage along Whiskey Creek Road to warn travelers of potential hazards in the area including tree and rock falls. Further investigation is needed to determine the extent of road work that should be completed in the area. Treatment options are limited and do not warrant EWP assistance.

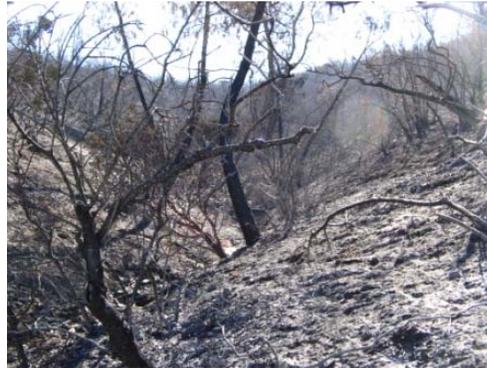
Potential debris flow area

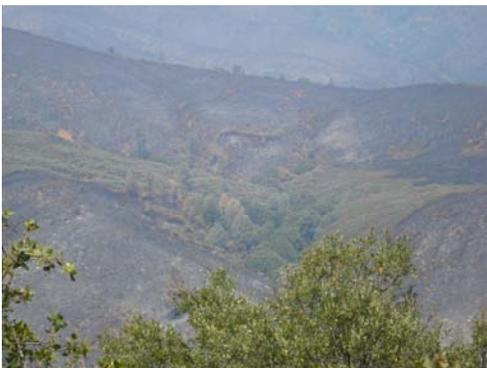
Deerlick Fire

Road reconnaissance initiated in the area of the Deerlick fire revealed no significant concerns. The burned over area has a very low population level and the fire burned primarily in chaparral, an ecosystem that is prone to frequent wildfires. Coarse textured, rocky soils may reduce the amount of erosion that could occur. The probability of flooding of the Graves ranch related to ecosystem damage from the wildfire is considered to be of low probability.

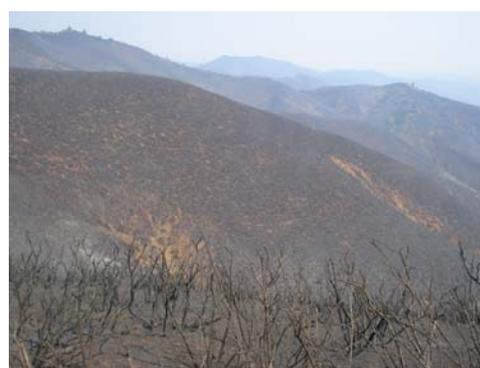
Chemise, following wildfire

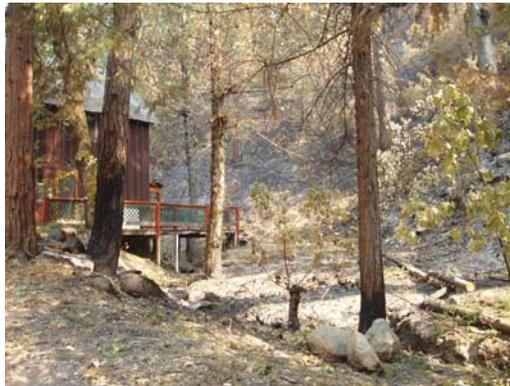
Zogg Mine Rd. House

NRCS assessing the Moon Fires utilized USFS BARC maps to identify broad landscape areas to perform on the ground reconnaissance. Initial on the ground reconnaissance was done in the Igo Area. Houses along Zogg Mine were visited to identify any imminent threats to life and property. No imminent hazards to life or property were identified along the length of this road. A cultural resource site was visited above Zogg Mine Road. NRCS. Field test of hydrophobicity were made and documented on field worksheets at a site past the end of Zogg Mine Road in an area of moderate burn intensity. A GPS location and photographs were taken. The majority of the lower drainage appeared to be low burn intensity. The upper reaches tended from moderate to high.

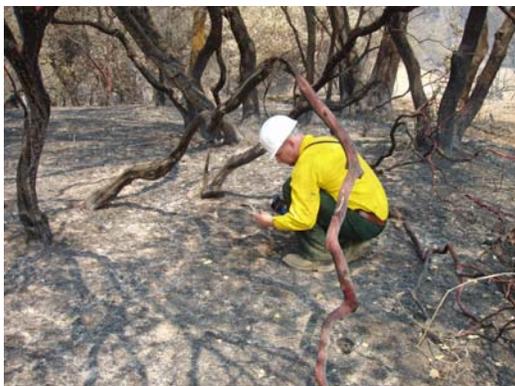
Testing Hydrophobicity

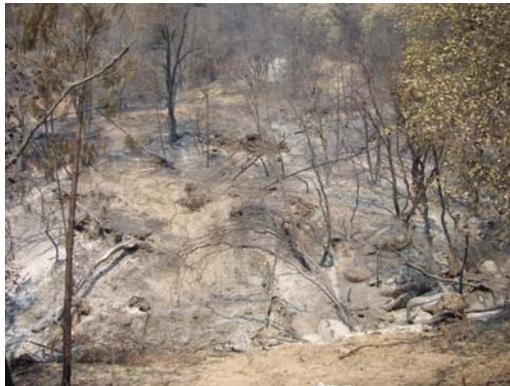
Hulling Creek Drainage

This area of the Moon fire showed areas of moderate to high burn intensities on the BARC map and through ground reconnaissance. No Imminent Threats to Life and Property identified.

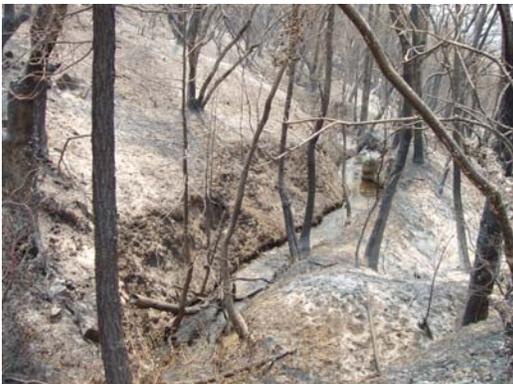
Eagle Creek Irrigation Lateral

Reconnaissance of the Eagle Creek drainage included several cabins and bridges. Burn intensity appeared to be predominantly moderate to high in the mid-elevation range traversed. A value at risk was identified for the Eagle Creek diversion lateral that feeds into the Happy Valley Irrigation Ditch. The ditch is at high risk of blockage due to the high burn intensity on steep decomposed granitic soils and the high tree and

brush mortality adjacent and upslope of the ditch. Liveoak, Manzanita, Blue Oak and Gray Pine Trees are dominant in the area and several example of trees and branches falling into the ditch were noted. The ditch area of concern runs for 1.3 miles. Treatment measures for this site include: Hazard tree removal, Upslope Straw Mulching and sediment removal & debris removal over the winter. The Igo-Ono Community Service District which maintains the Canal was notified by NRCS of the existing hazards on 8/1/08.

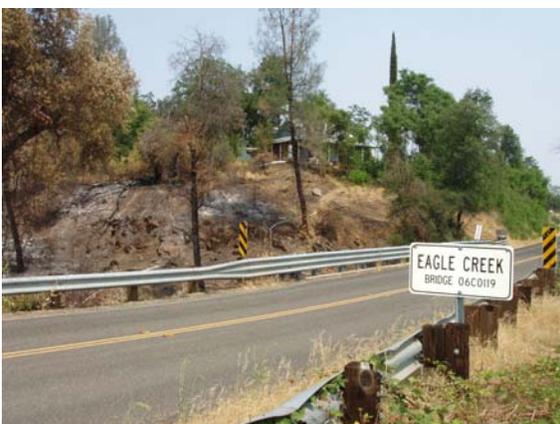
Eagle Creek Bridge at Ono

The Eagle Creek Bridge crossed Eagle Creek at the Town of Ono in Shasta County. The Moon Fire burned the riparian area immediately up to the Bridge. There is a existing hazard posed by the trees in the active floodplain should be fall into the floodplain or channel and precipitate a blockage at the bridge. The Eagle Creek Bridge is the Value at Risk should this occur as hydrology modeling indicates an increase of sedimentation and peak flows will likely occur this winter due the burn severity and scope of burns. Recommended treatment is remove hazard trees in the floodplain 300-500 feet upstream of the bridge. Monitor and perform necessary maintenance to prevent any debris blockages at the Bridge. This is a Shasta County Bridge and the Public Works Office was contacted by NRCS on 8/6/08 regarding this hazard.

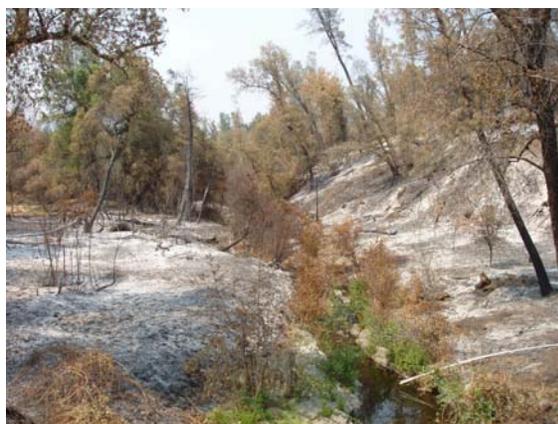
Dead Trees present an obstruction Hazard at Bridge

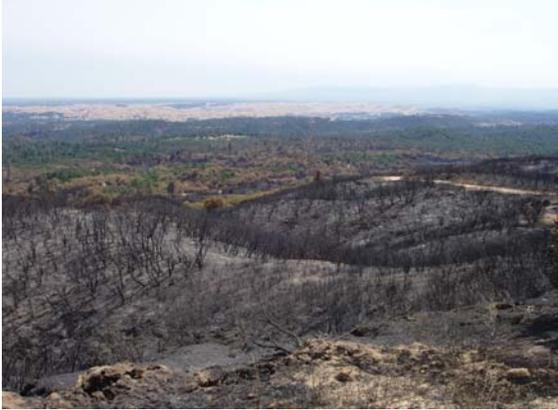
Private Roads above Ono

Due to a combination of moderate to high burn intensity, steep slopes, highly erodible decomposed granite soils and high rainfall, unsurfaced roads on private lands above Ono are at risk for accelerated erosion and

washouts. A significant roaded area exists in the decomposed granite soils above Ono. Private landowners should have their roads inventoried for potential problems and take one or more of the following treatment measures: Remove sediment in existing culverts, upgrade culverts, install rolling dips, grade out rills and outslope road surfaces, rock rolling dips, install energy dissipaters, perform annual or more frequent inspection and maintenance, close roads during wet periods. NRCS will host a public meeting with local Conservation District Officials and Agencies to encourage landowners to take preventive actions before winter storms if possible. Local Technical Assistance and Cost-Share Programs will be presented.

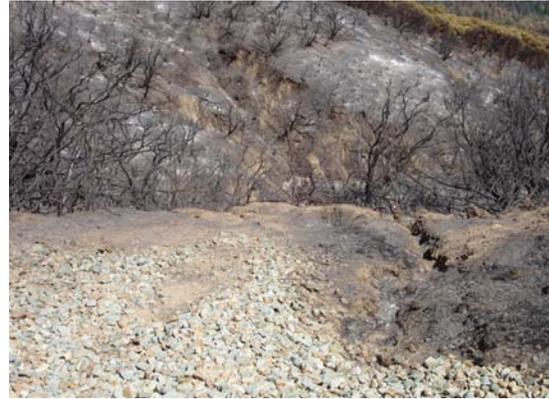
Existing road erosion on decomposed granite soils

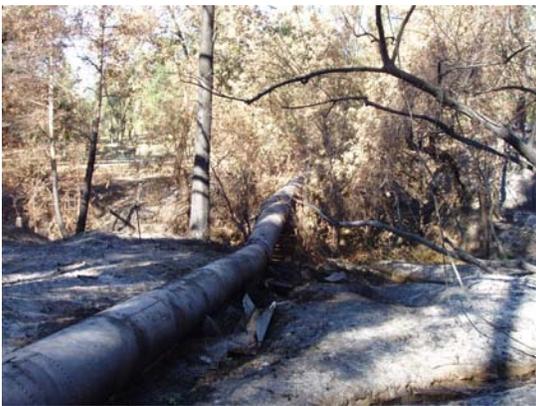
The Rector Creek Flume sustained damages to the wooden support structures upholding the flume. This resulted in collapse of a portion of the 170 foot 30 inch steel pipe causing cracking and large leaks. An emergency, temporary repair was completed by the Igo-Ono Community Service District so that irrigation delivers could continue. The entire structure is at high risk of collapse. If the structure does not collapse immediately it may be washed out by the elevated peak flows and sediment yield and debris that may come down Rector Creek this winter as the diversion supports are in the active channel and floodplain. Treatment recommendations: NRCS has informed the Igo-Ono Community Service District that the Emergency Watershed Protection Program (EWP) may be able to provide technical and financial assistance To repair or replace this structure so that total failure of the flume does not occur. New support structures and pipeline are needed due to the age and condition of these structures. A Damage Survey Report is being prepared for this Value at Risk.

Collapsed Rector Creek Flume

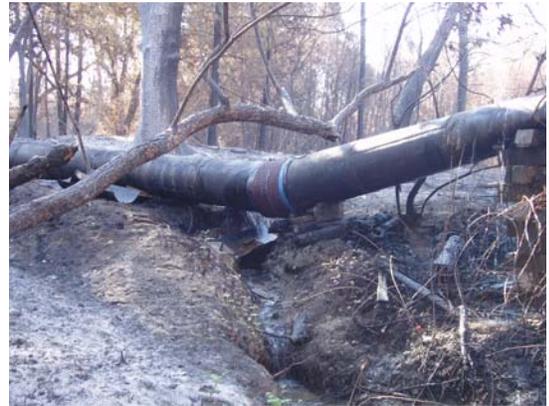
Emergency Repair of Flume

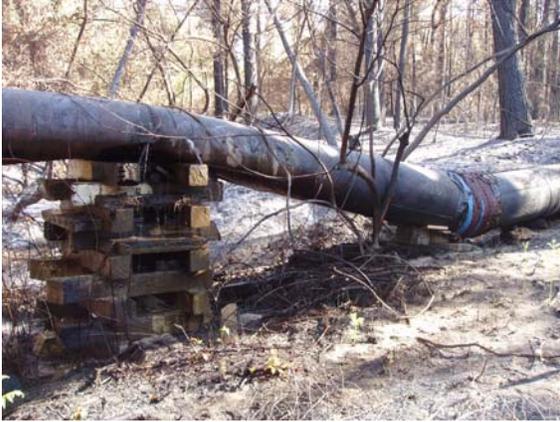
Wooden Support Destroyed in Fire

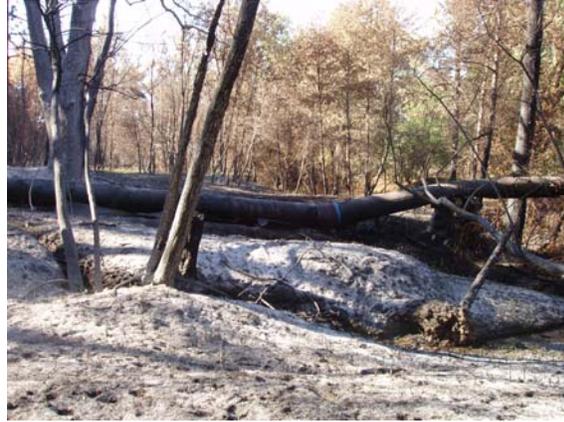
Collapsed pipe in Floodplain

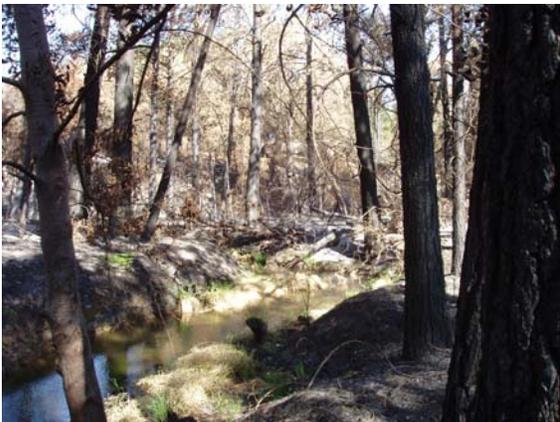
The Happy Valley Irrigation Ditch is at risk of plugging due to the high mortality and burn intensity along 2.5 miles of the ditch in the Rector Creek and Eagle Creek Drainages. Trees are currently falling across the ditch and into the ditch which could cause plugging and overtopping of the ditch which could erode the outer earthen bank leading to a failure of the ditch. Upslope sheet, rill or gully erosion could move significant amounts of sediment into the ditch which could reduce ditch capacity or cause a plug. Treatments recommended for the 2.5 mile reach are: Removal of hazard trees that could fall in the ditch or damage the earthen bank when they fall. Trash racks installed at entrance to Eagle Creek Flume, straw mulch 30 feet upslope of the ditch to prevent sedimentation of the ditch, ditch inspection, sediment and debris removal after major storm events this winter.

Tree fallen across ditch

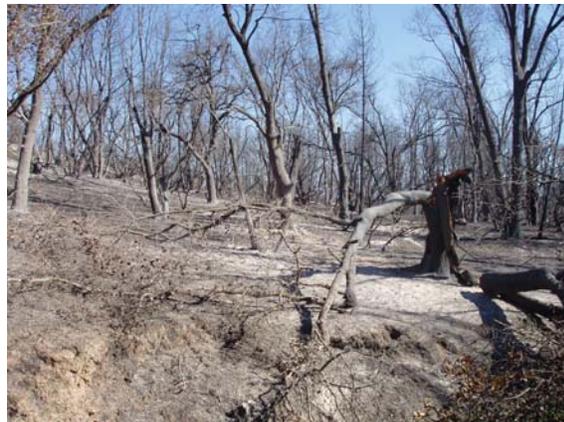
Upslope hazards to ditch – trees & sediment

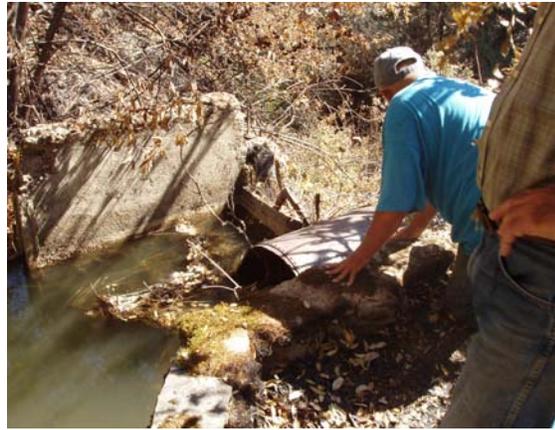
Trash Rack needed to prevent clogging of pipe
