Photos of Three Years Monitoring of Winged Subsoiler Treatment Areas

Rio Grande National Forest, Colorado

July 3, 2006

Million Fire Subsoiler Monitoring Project

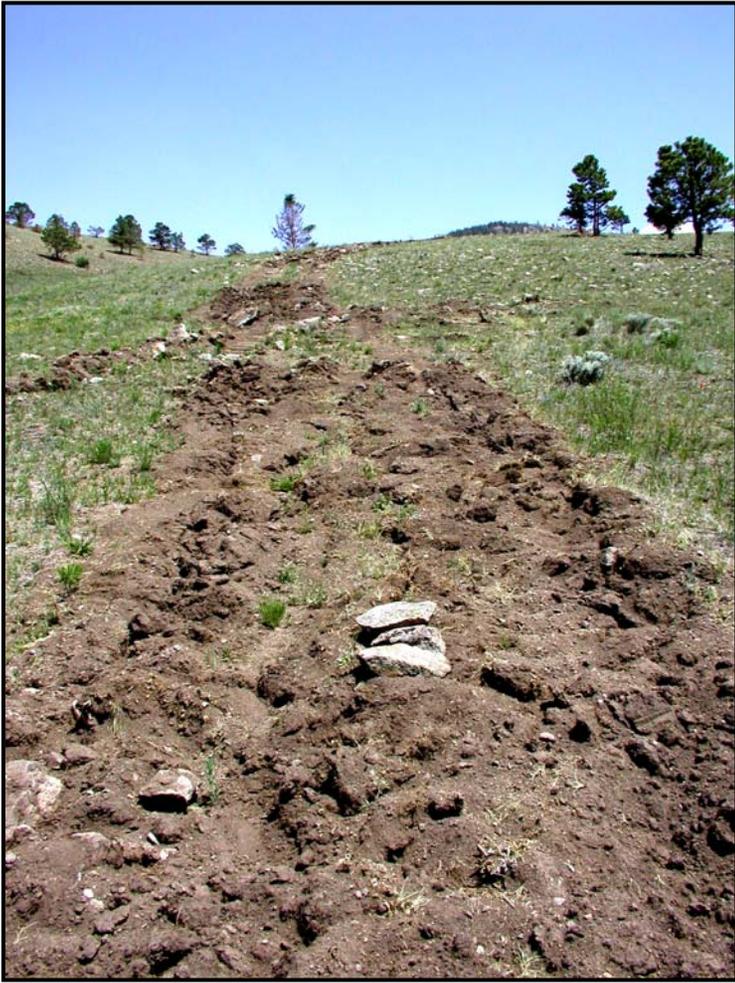
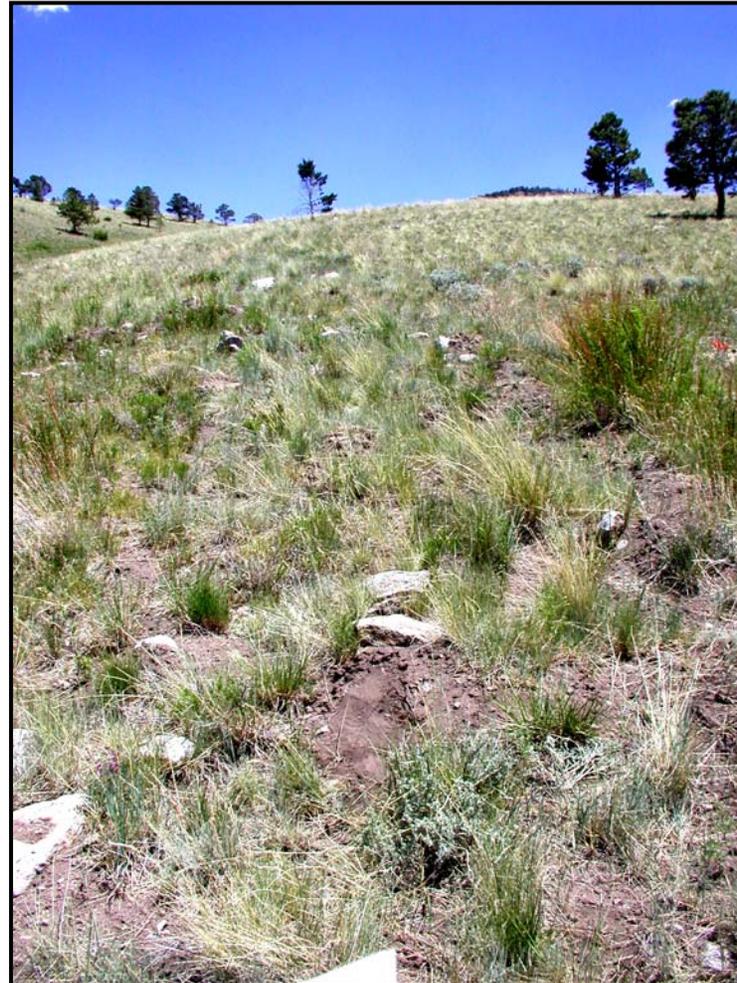
This set of photos shows a road that was used to access a staging area during the Million Fire, which occurred on June 19, 2002. The photo on the left was subsoiled in June 2003 and the photopoint was marked with 3 rocks. The same location was re-visited and photographed on June 20, 2006, three years later. The subsoiled area is revegetated and water is entering into the soil instead of running off the soil. No further vehicle use has occurred and there is a carsonite sign below this photo site. This is evidence that route closure using subsoiling

can effectively be done. 13S 0359505/4167079

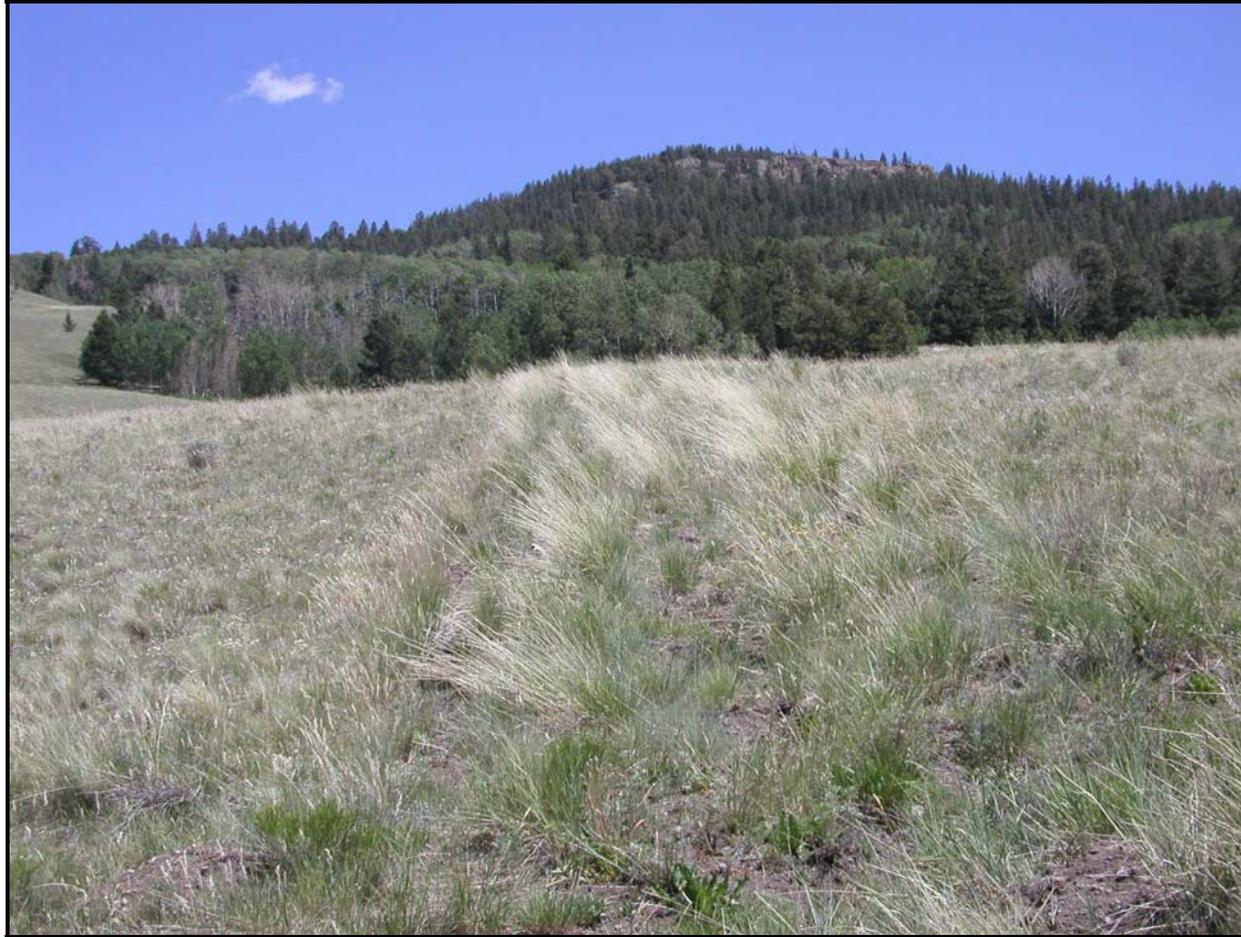
This is another portion of an access road used during the Million fire. Photographed 6-20-2006. The photo above shows more vegetation on the subsoiled and seeded route than in the nearby native ecosystem.

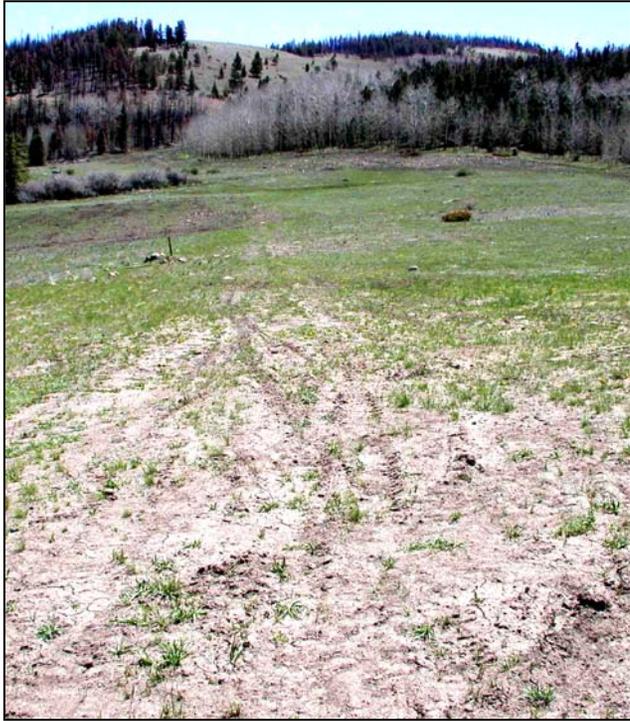
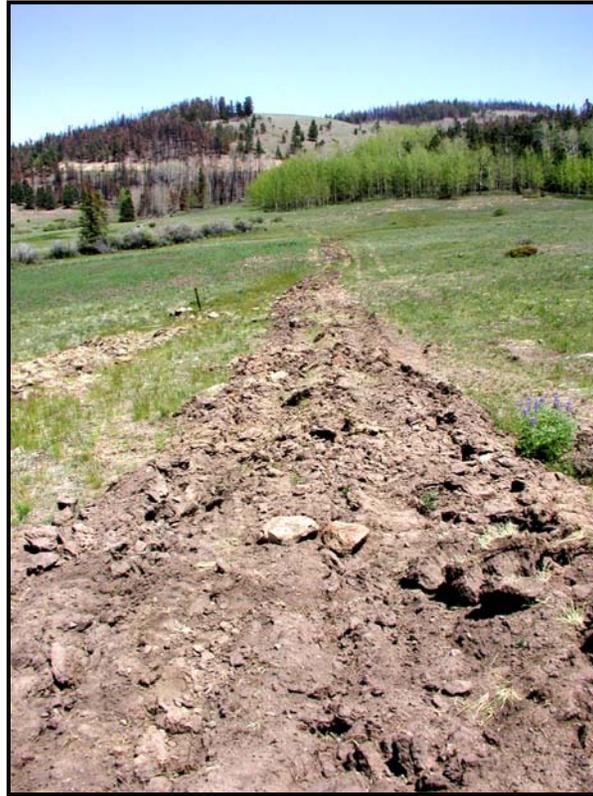
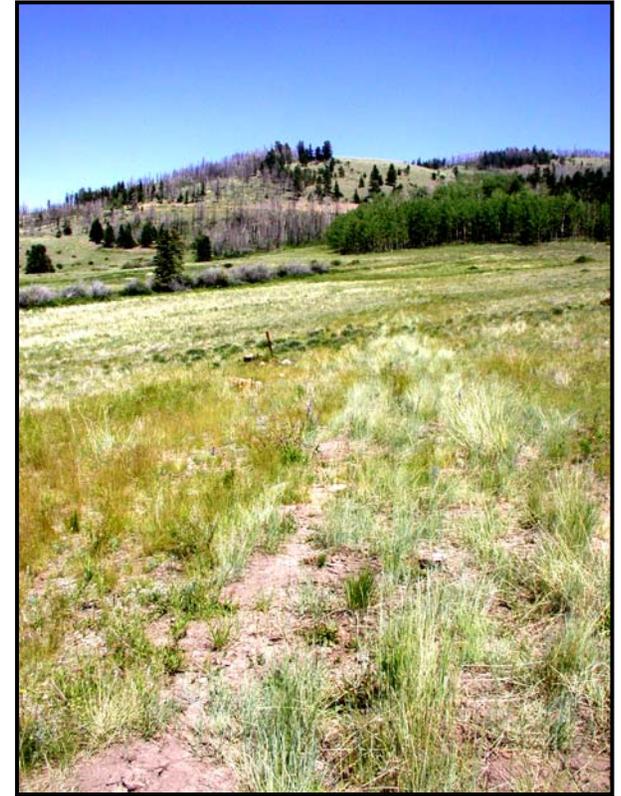
This was called the Six-wide Meadow, a staging area for crews and equipment during the Million Fire. The photo on the far left is of a main access road to the staging area, taken prior to subsoiling in spring 2003. The middle photo shows after subsoil June 2003. About 3 years later (photo taken June 20, 2006), the soil is producing ample vegetation and no runoff or erosion is apparent. 13s 0360058/4167744

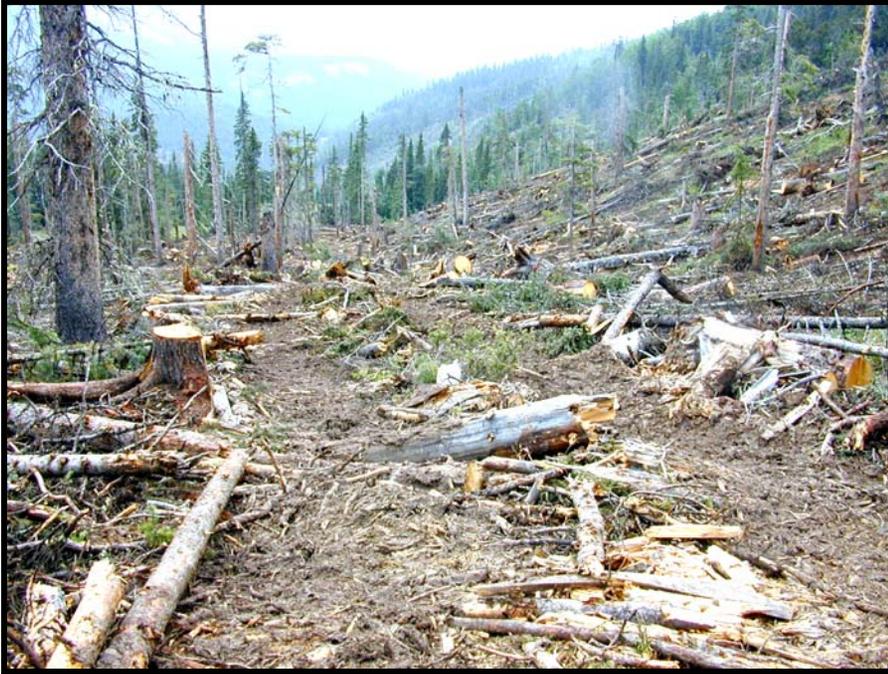
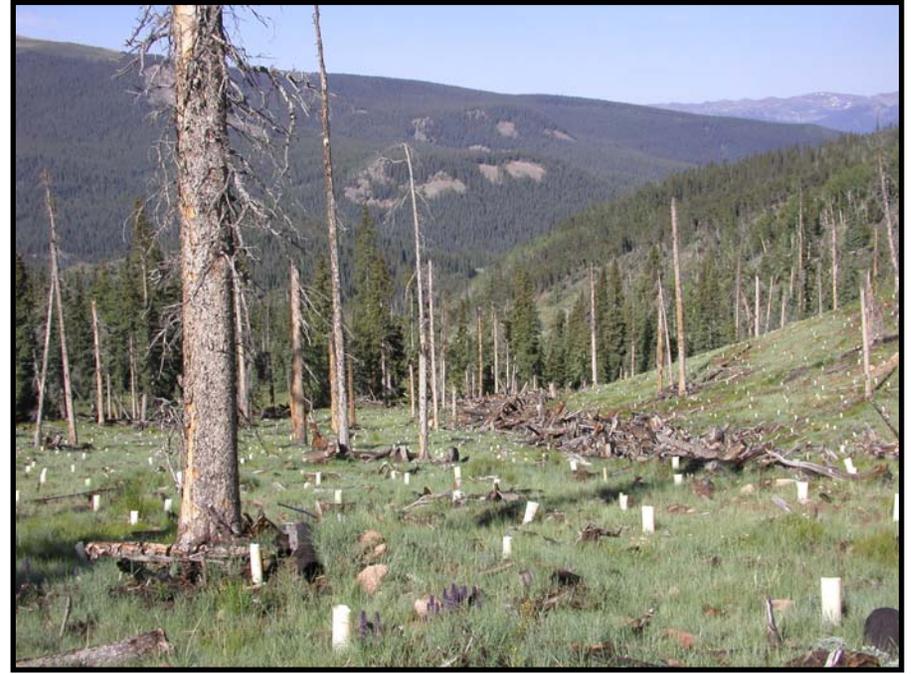
The left side photo is taken on a skid trail after harvest in 1999. This area was subsoiled in 2003. Ideally, we would have subsoiled immediately after logging, but it took a few years to obtain the subsoiler and get it operational. The photo on the right was taken June 28, 2006. The planted stock seems to have good survival in the subsoiled areas.

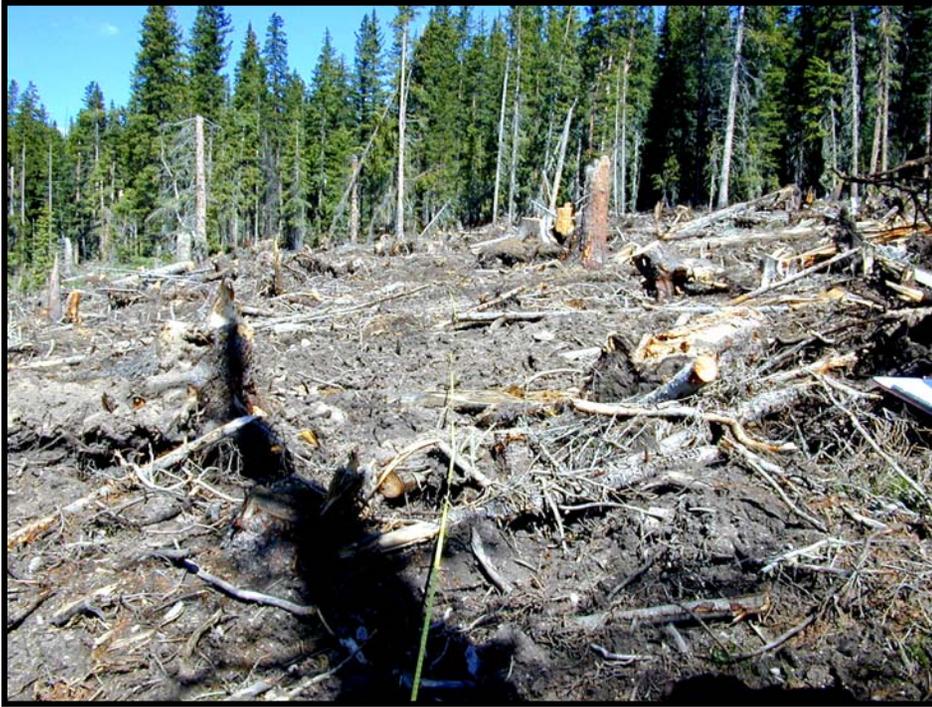
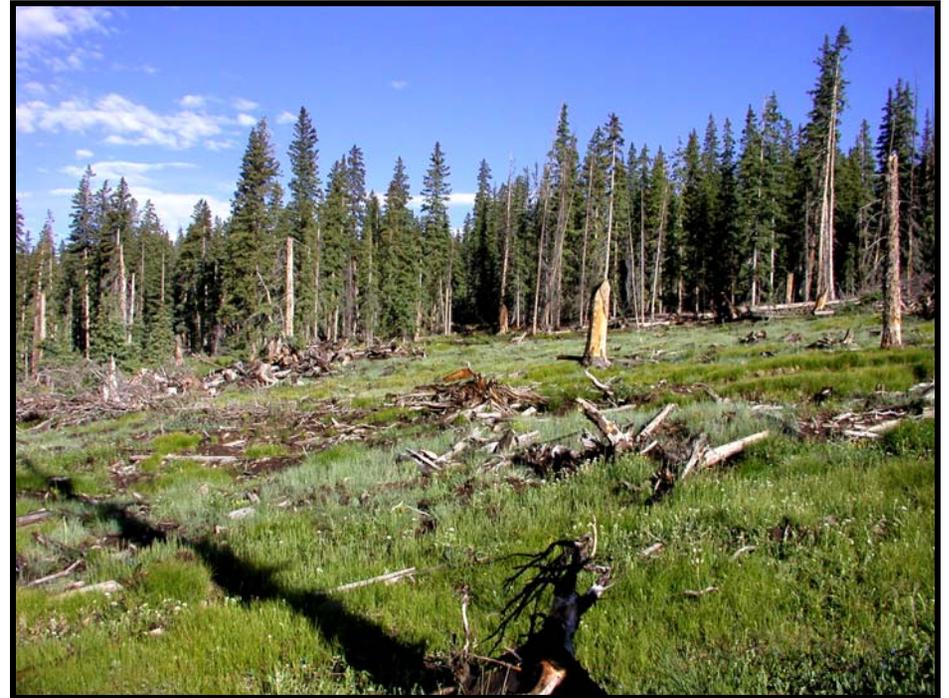
The following photos show another area that was subsoiled in 2003. This was the site of a soils transect that was sampled in the lab for bulk density (compaction) prior to and after logging. In the photo at left, there is considerable soil exposure from logging activity. Lab results showed that soil standards for compaction were exceeded on the 6 core samples along this transect. Subsoiling was done in 2003. Photo on right, taken 6-28-06 shows excellent growth of cover and no evidence of erosion.

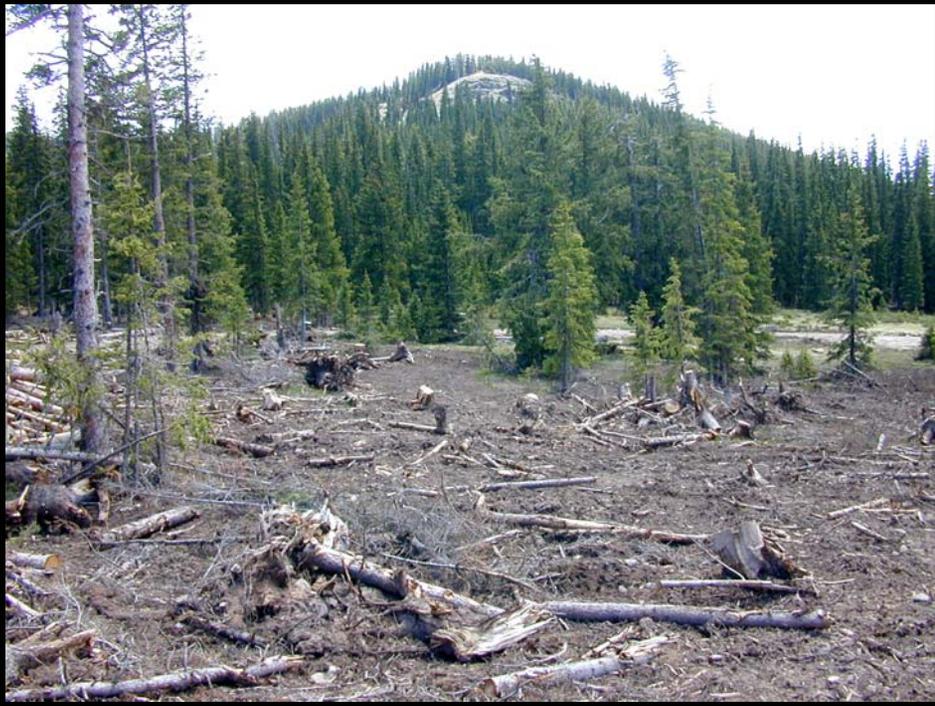
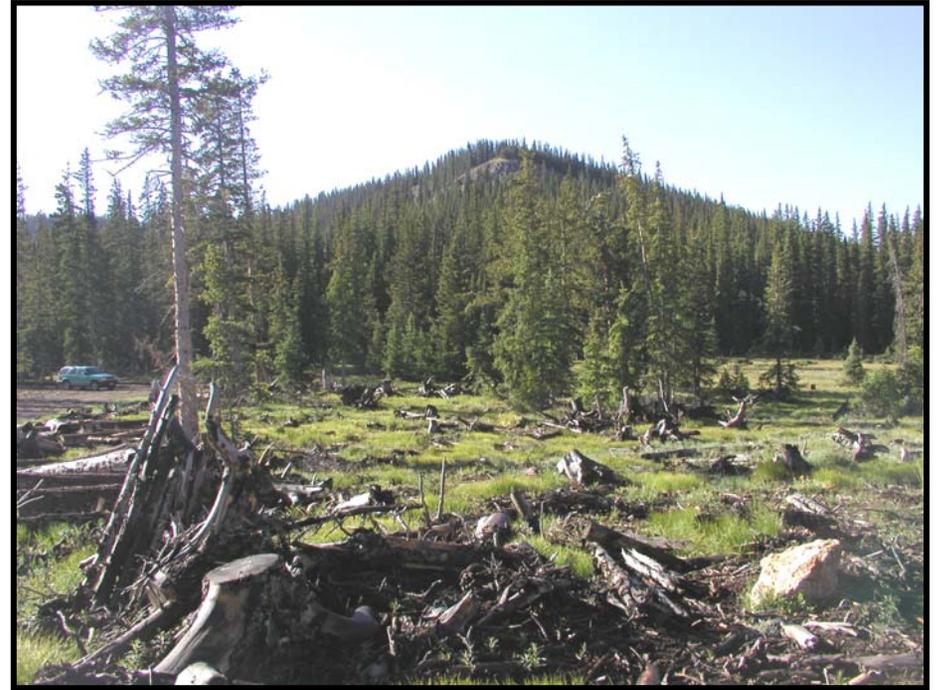
The left photo was taken after logging in 1999 near a landing at the summit of the divide that borders the backcountry cutting unit. It was subsoiled in 2003. Photo at right was taken June 28, 2006. It shows very good recovery. It has not been replanted. Throughout the subsoiled areas there has been isolated pockets of Canada Thistle. There was Canada Thistle present prior to logging in the area as well as after logging. There has been good response from seeding and from the natural sedges that occur on this site.
